Bridge #02840(Routine, Underwater type 2)

SH 1-01 LM 15.45 over Amos Bayou

Team Lead: Sharon Hooks Inspection Date: January 20, 2021

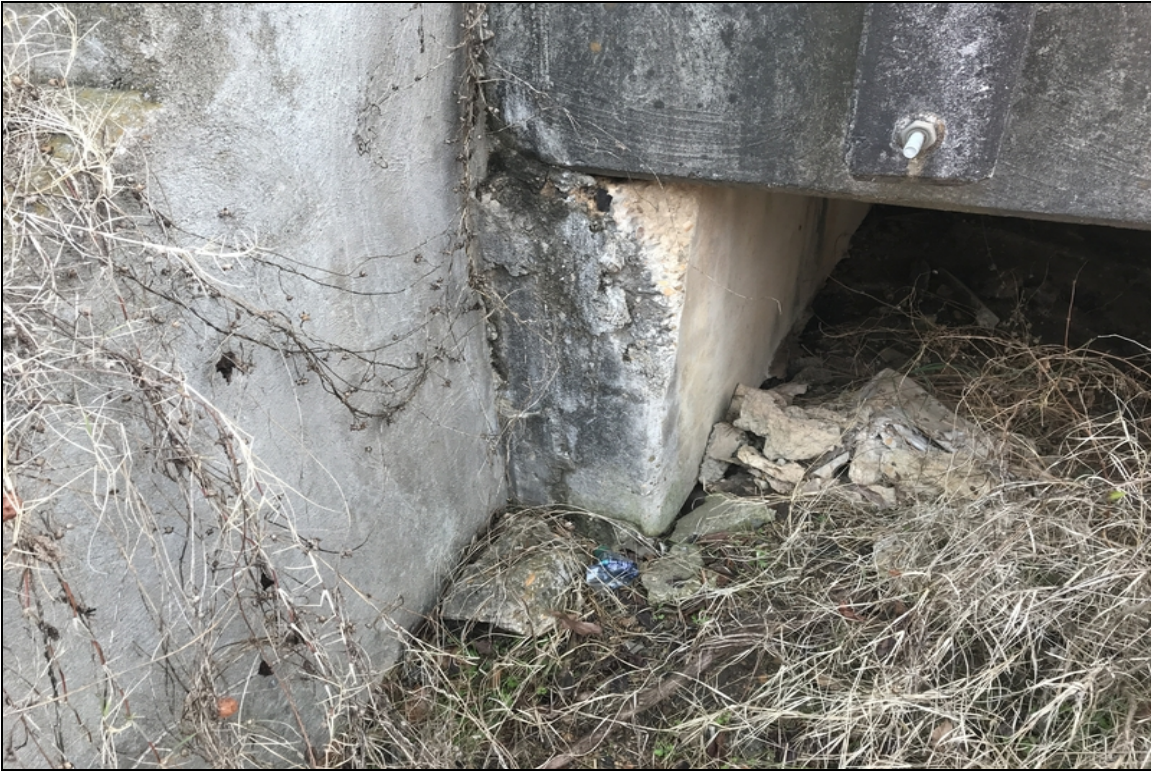
(215)							
Abutments: 34' each / Bents 1 & 4. Bent 4 has small contact spalls with exposed rebar.							
228	Timber Pile	EA	10	1	0	9	0
1020	Connection	EA	5	0	0	5	0
1140	Decay/Section Loss	EA	4	0	0	4	0

Bent 4 abutment left side has spall.

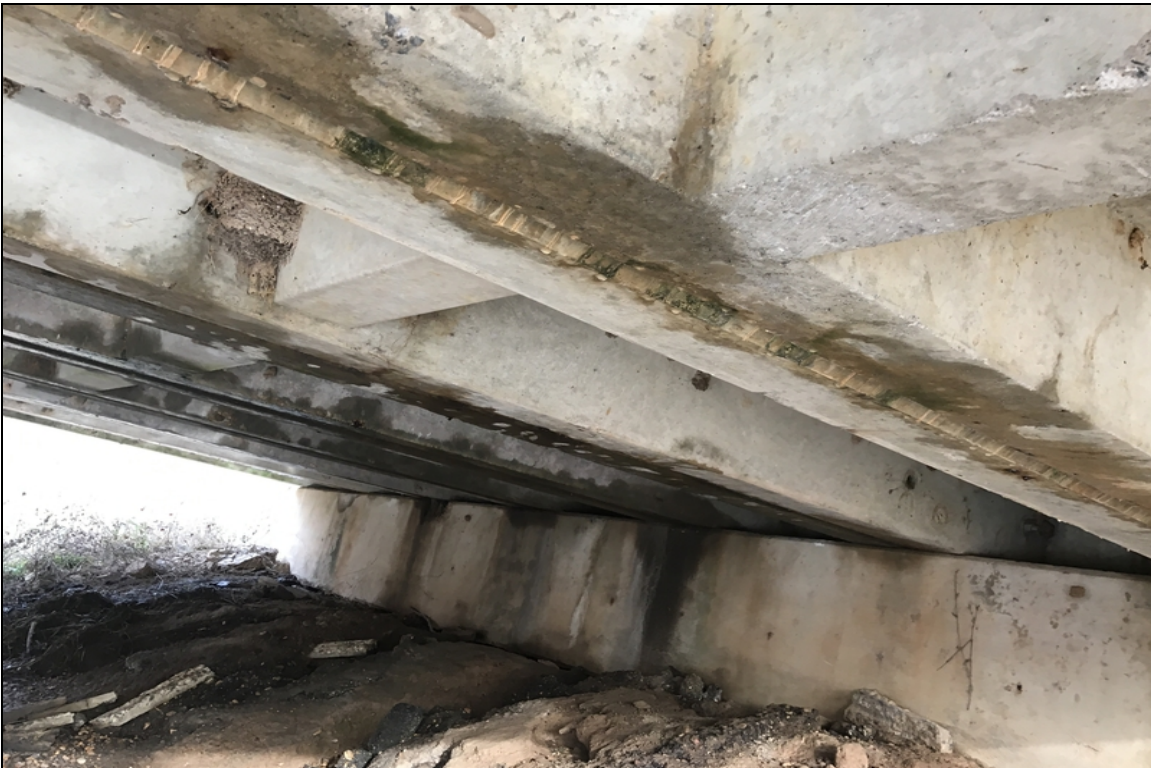
Overview of soffit and girders.

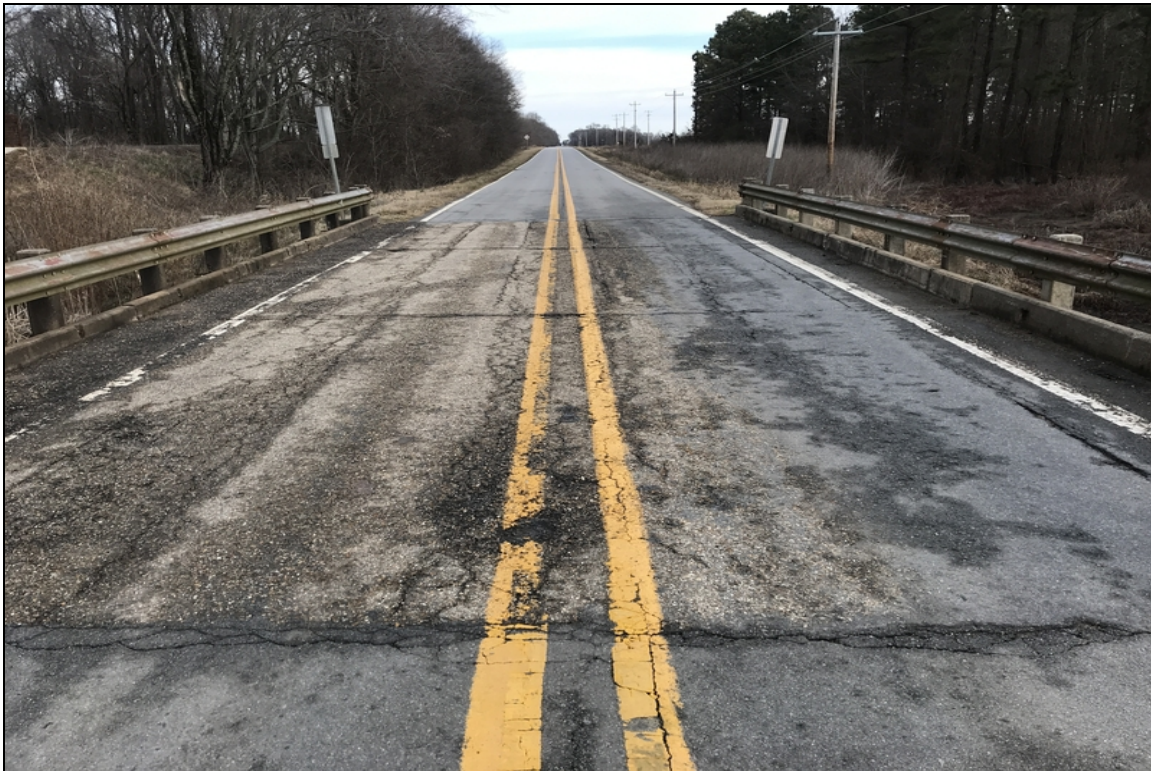
Deck overview.

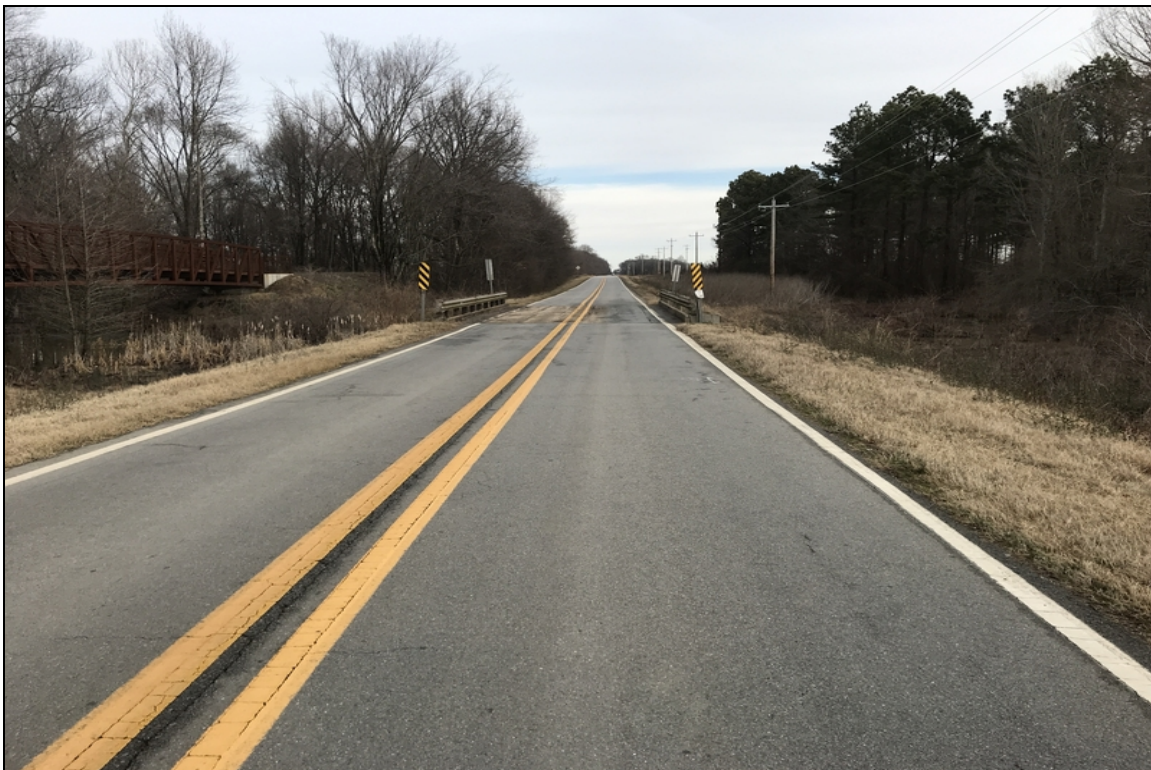
Approach.

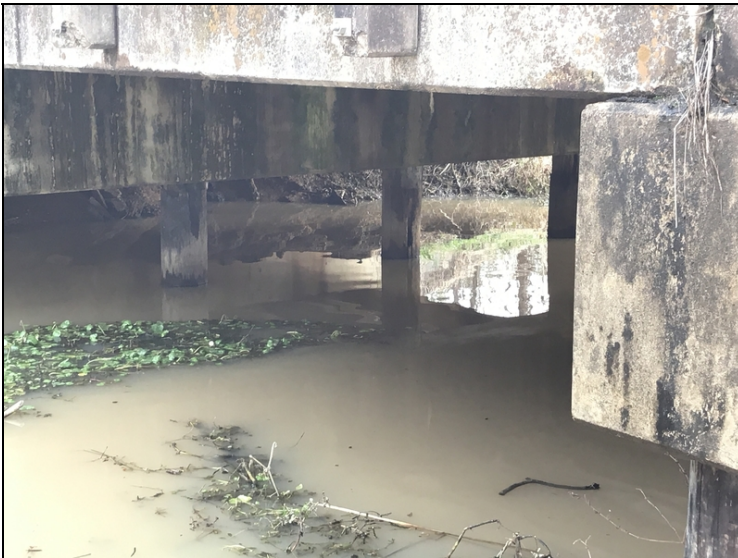
Bent 3 Pile 3: Large-sized checking with moderate decay (hole rotten on back side near waterline).

Bet 3 pile 3 hollow area 2' down from cap.

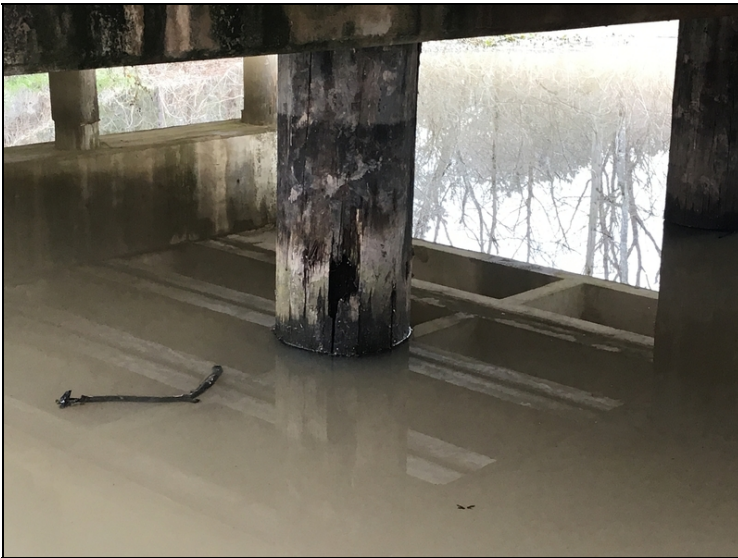
Bent 2 Pile 2: Moderate-sized checking with moderate decay (hole rotten on back side near waterline).

Changed from priority "C" to "B" SDH 2021.

Bent 2 pile 2 hollow area 2' down from cap.

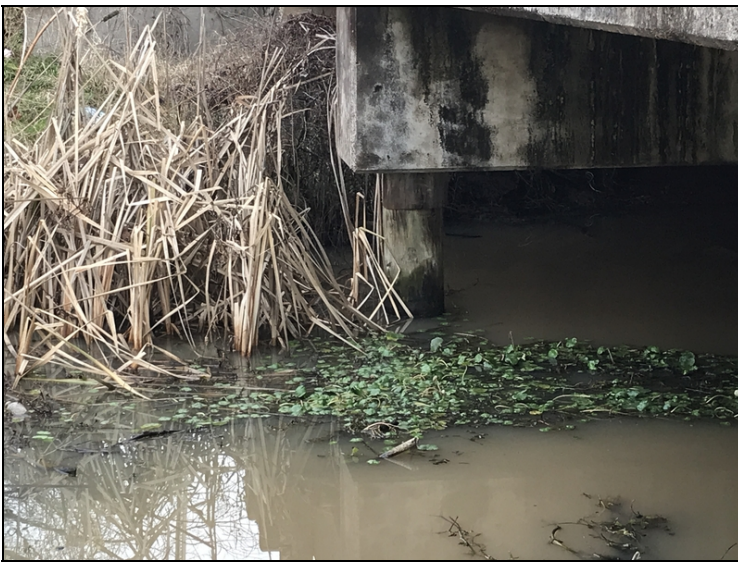
Bent 2 pile 3-4 have been repaired in past with no collars in place.

Bent 3 pile 1 no collar.

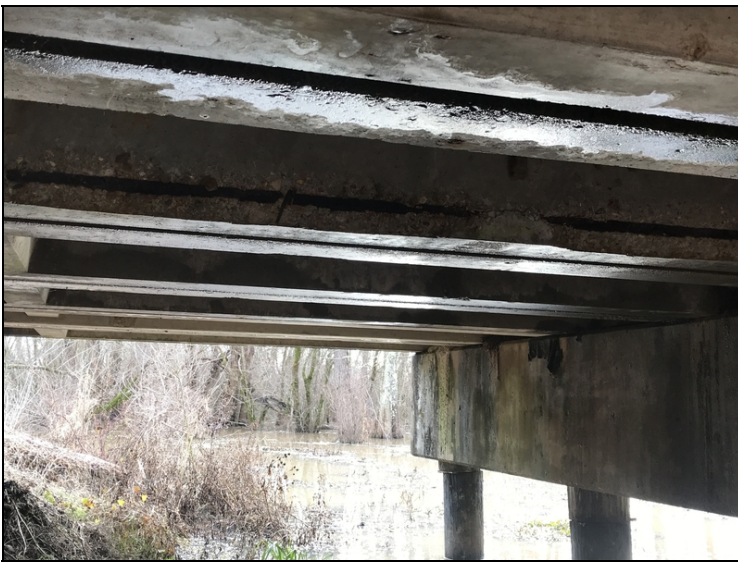
Bent 2 unit 1 and bent 3 unit 3 have spalls with exposed rebar on channel legs.

Span 3 unit 3 spall with exposed rebar from bent 3 ahead to mid span.
