Bridge #02841 (Routine, Underwater type 2)

SH 1-01 LM 18.41 over Drainage Ditch

Location: 4.0 Mi N SH 138-Watson

Team Lead: Sharon Hooks **Inspection Date:** January 20, 2021

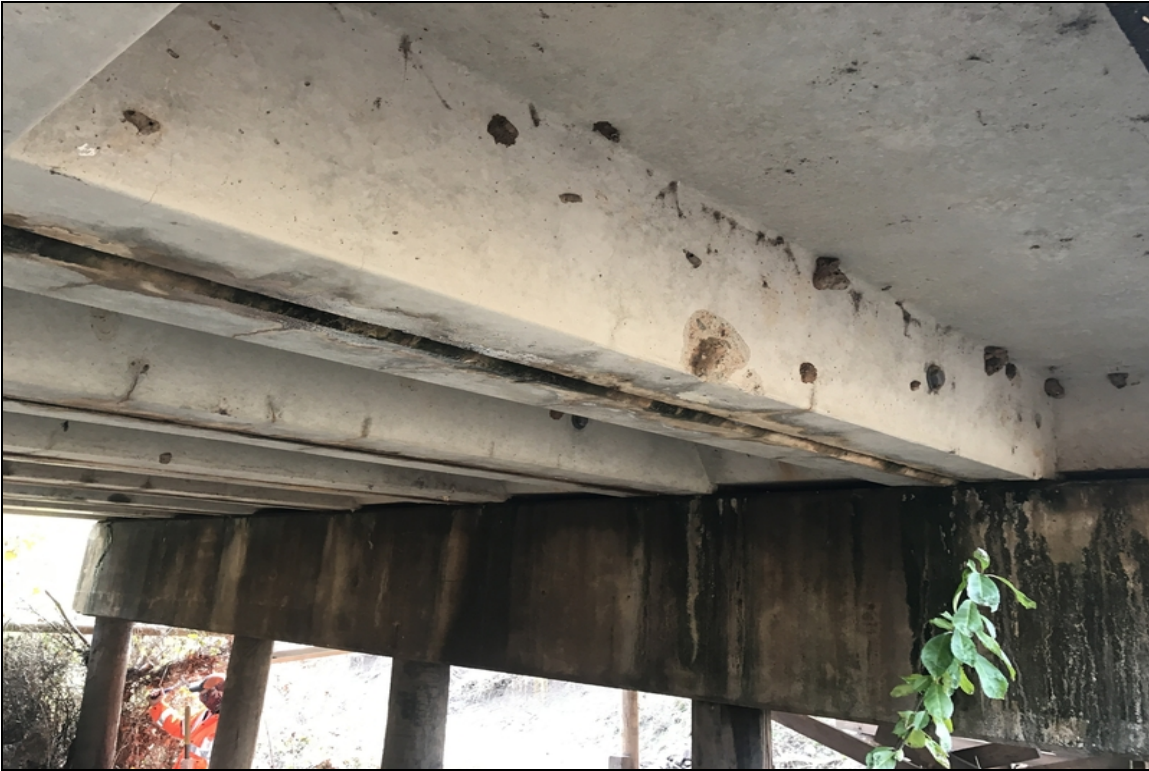
Overview of soffit and girders.

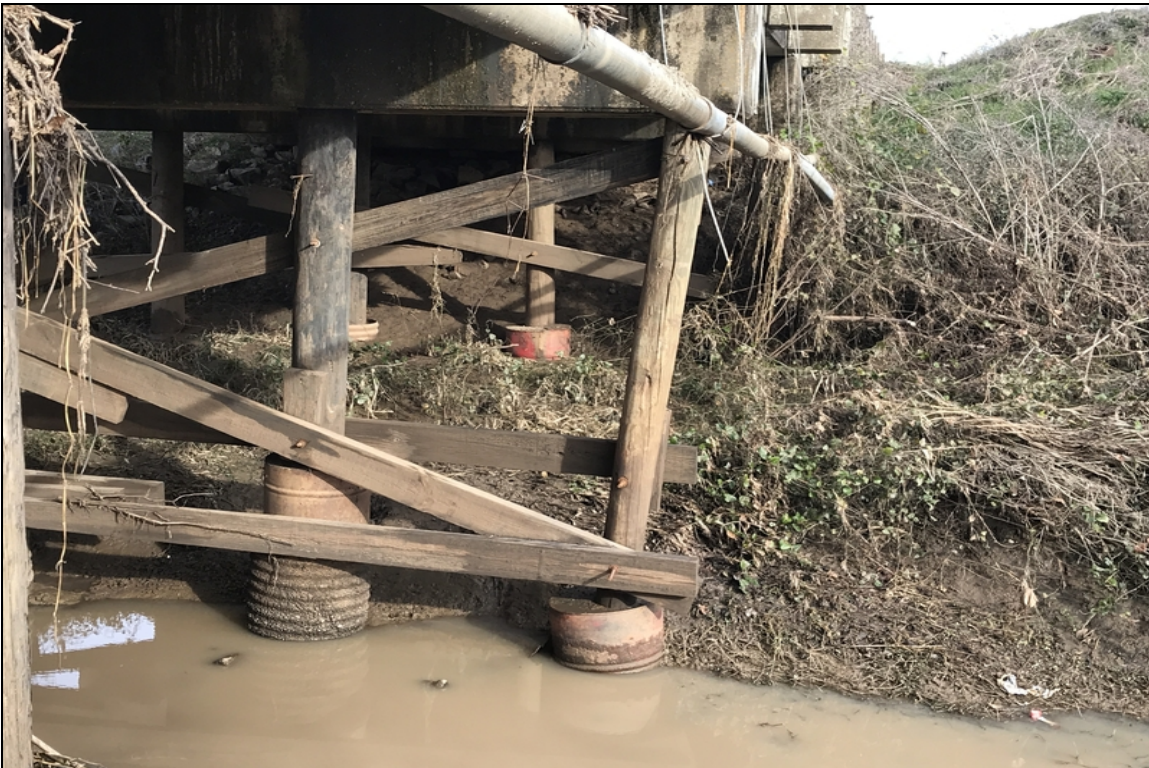
Ben 3 pile 5 has large checks.

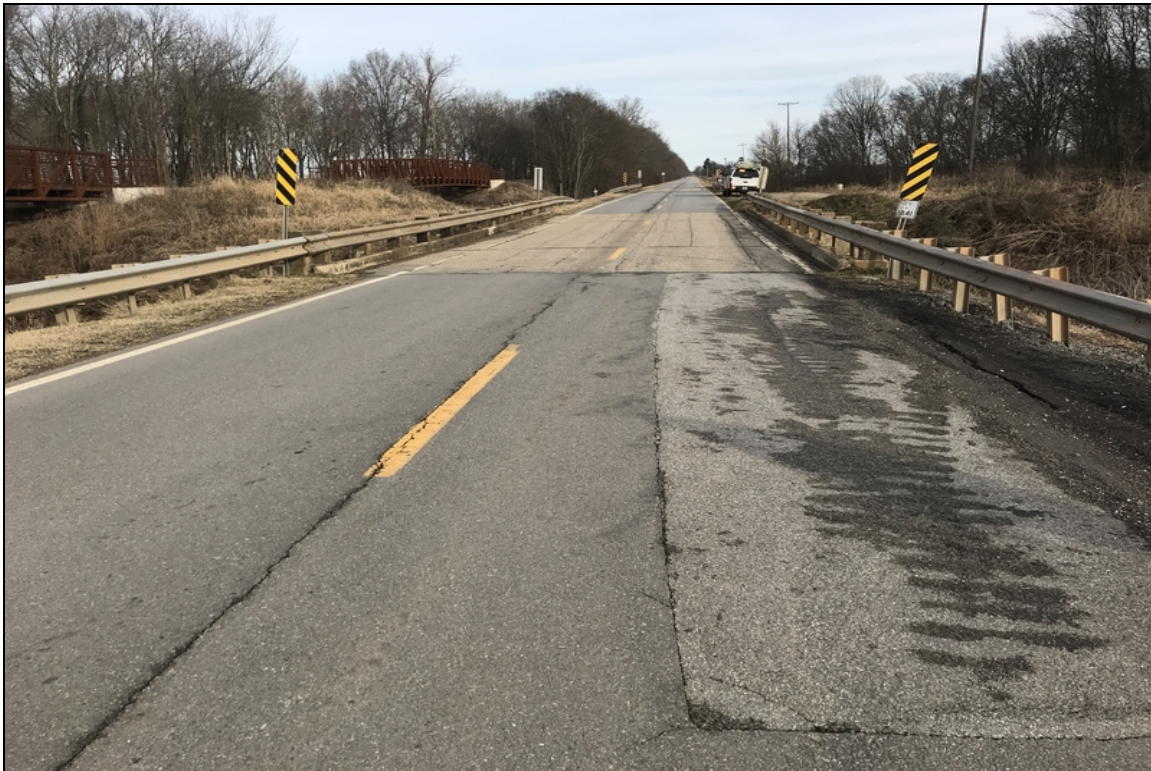
Approach.

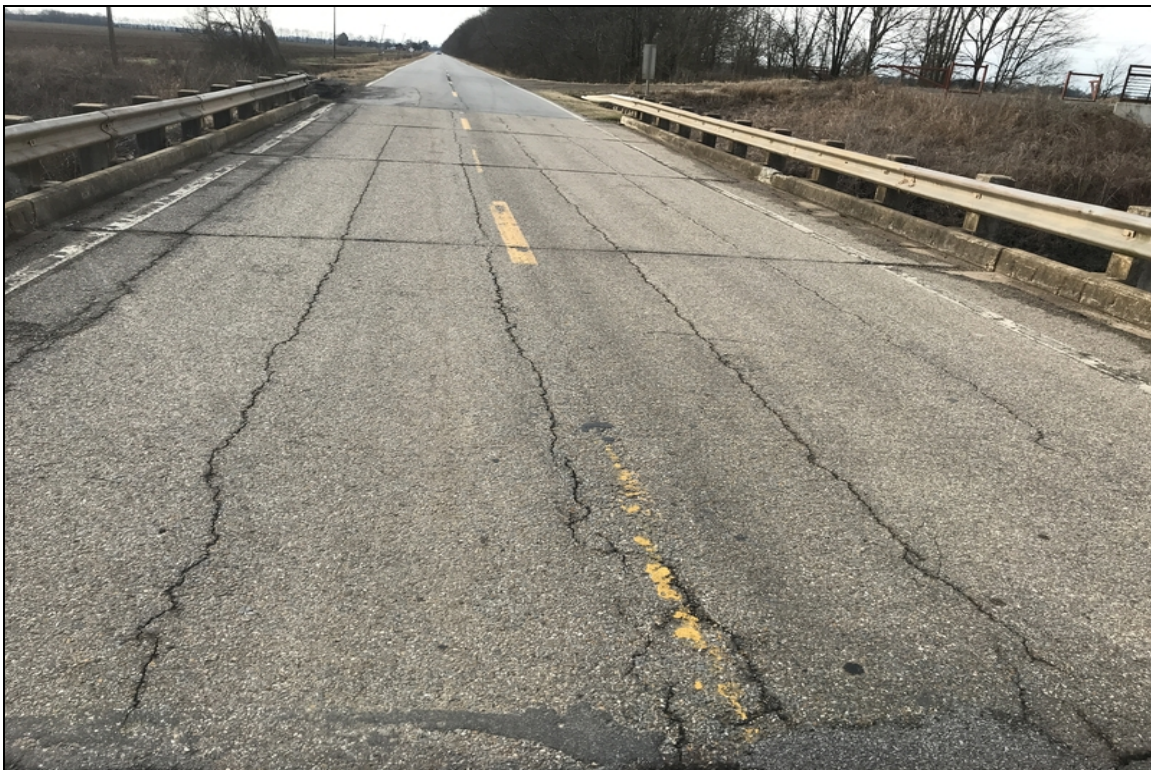
Deck overview.

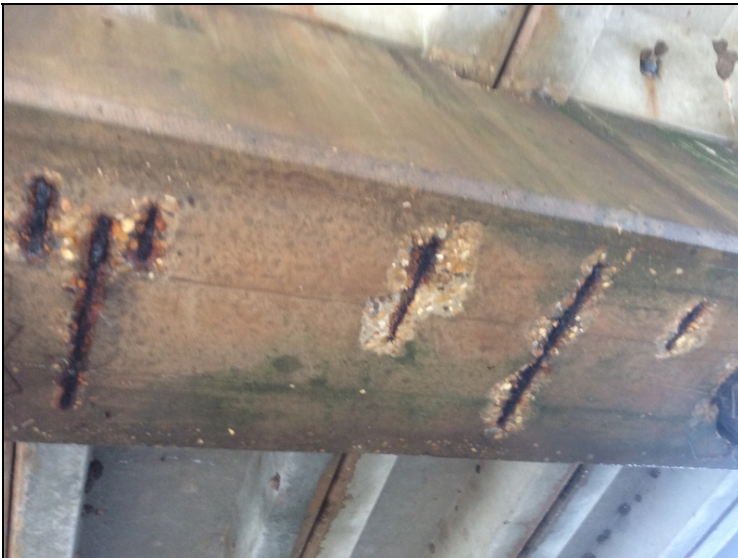
Cap - Bent 2: Small areas of delaminations and spalling on bottom face of cap - reinforcing steel exposed with some rust and section loss.

Cap - Bent 2 bottom face (corrosion)

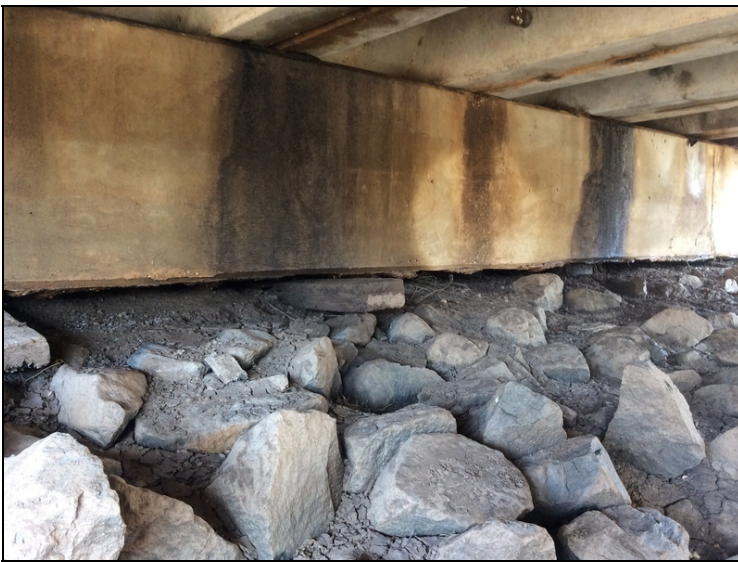
Endslope - Bent 5: - Minor settlement (4-5") of fill material under bottom face of cap - full length of abutment.

Endslope - Bent 5 (settlement)

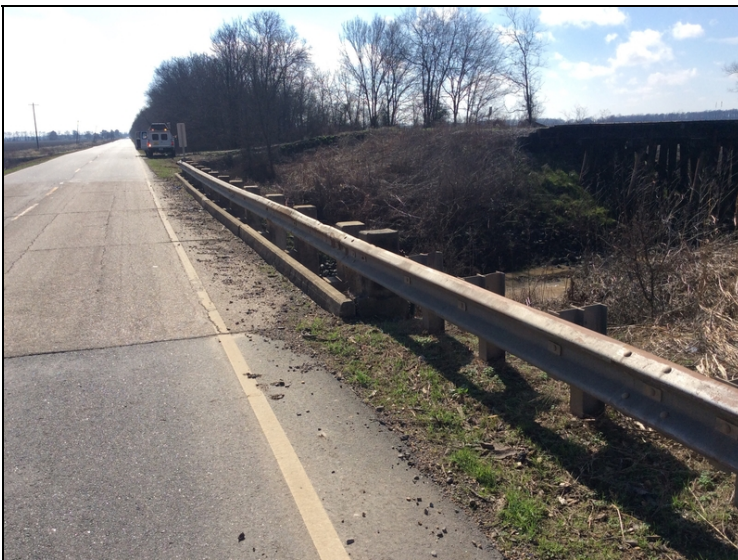
Signs - Bent 5: Object markers, posts, and log mile signs are missing (have been knocked down) on both side - object marker and broken post currently lying down behind railing on right side.

Sign - Bent 5 left (missing)

Repaired by state forces.

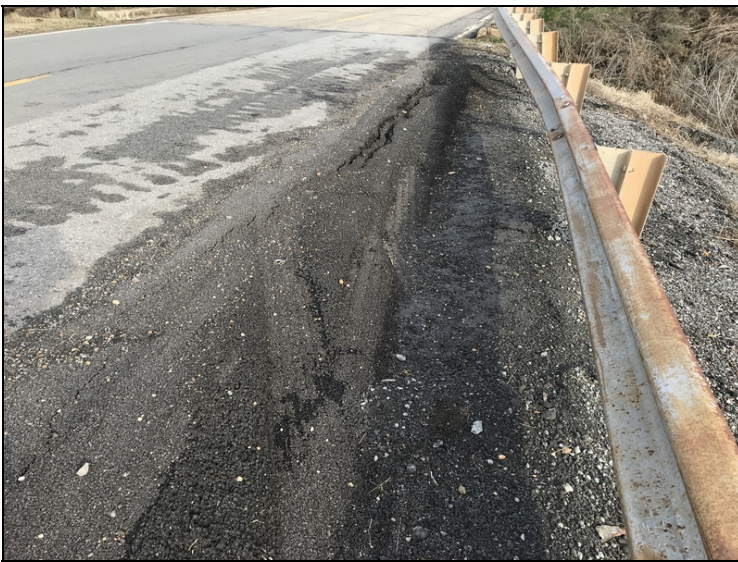
Approach roadway right side, south end has settled causing cracking in asphalt and 1' vertical drop near edge of pavement.

Approach roadway right side south end has settled causing cracking in asphalt and 1' vertical drop near edge of pavement.
