Bridge #02842(Routine, Underwater type 2)

SH 1-01 LM 18.45 over Cyress Creek

Location: 4.1 Mi N SH 138-Watson

Team Lead: Sharon Hooks **Inspection Date:** January 20, 2021

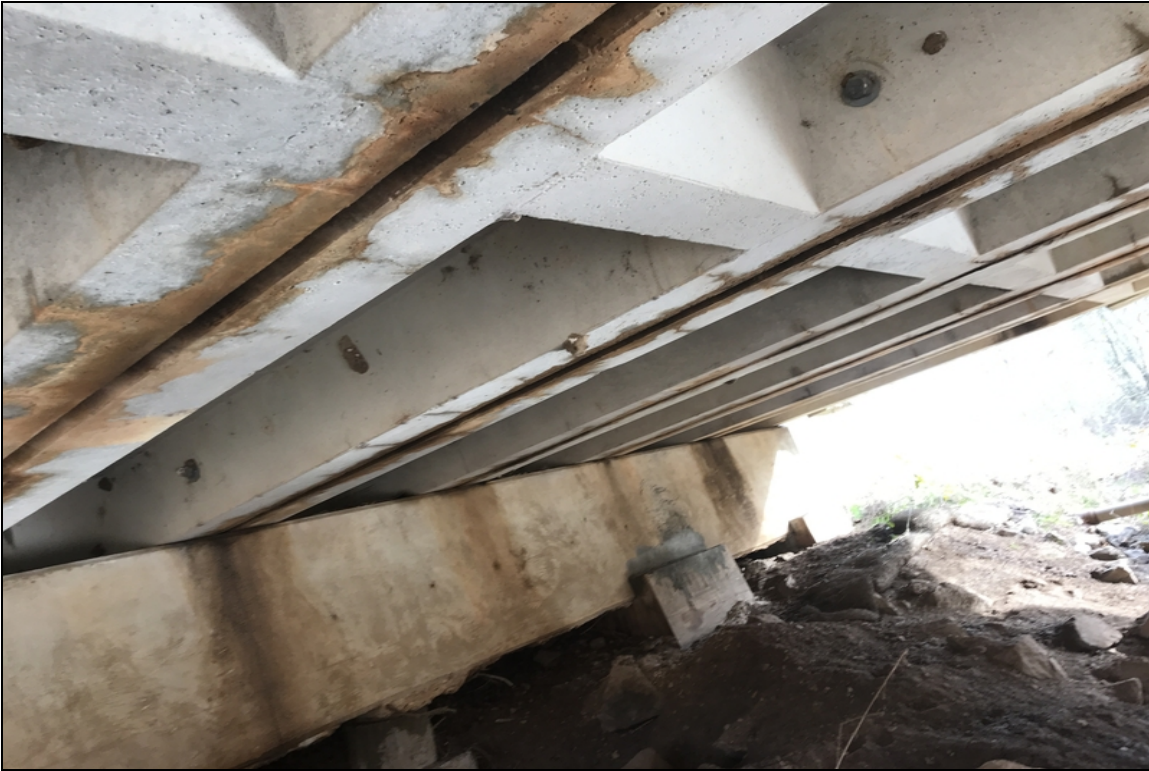
Overview of soffit and girders.

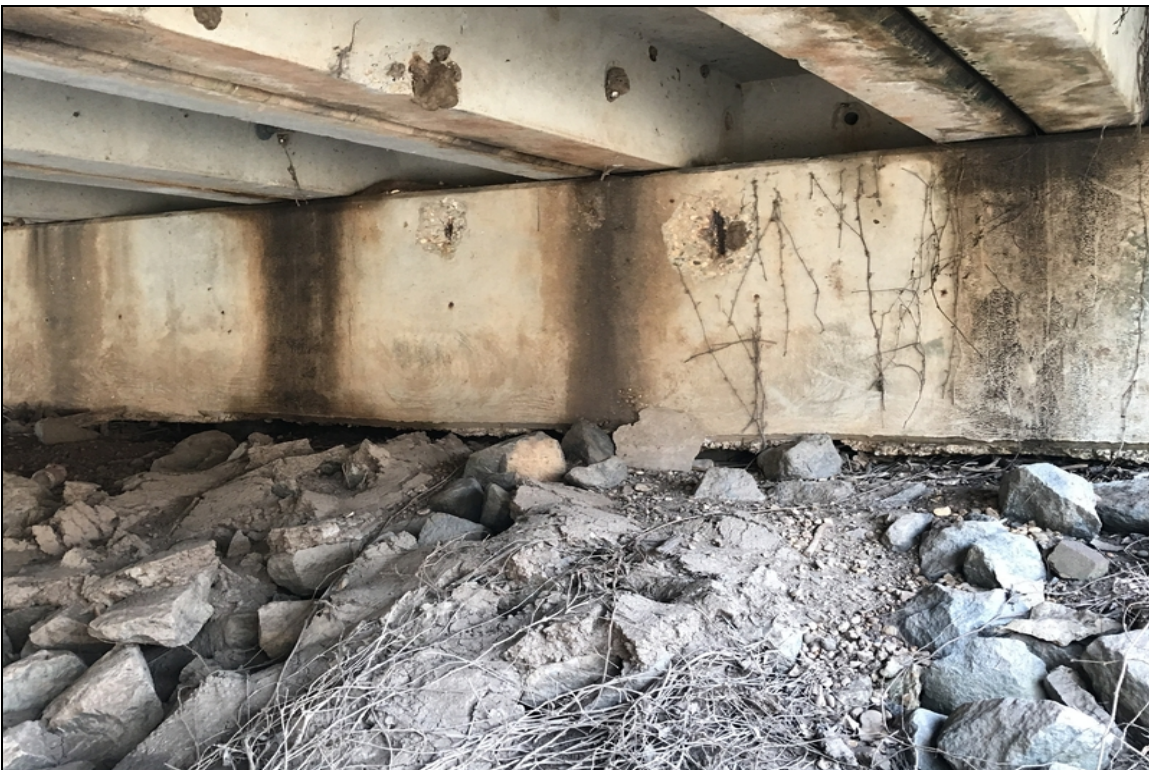
(215)							
Abutments: 34' each / Bents 1 & 5. Bent 1 has small spall with exposed rebar. Endslope - Bents 1-5: - Minor settlement (4-5" @ Bent 1, 10-12" @ Bent 5) of fill material under bottom face of cap - full length of abutment.							
228	Timber Pile	EA	20	0	8	12	0
1020	Connection	EA	11	0	7	4	0
1140	Decay/Section Loss	EA	6	0	1	5	0
1150	Check/Shake	EA	3	0	0	3	0

Bent 1 cap spalls with exposed rebar.

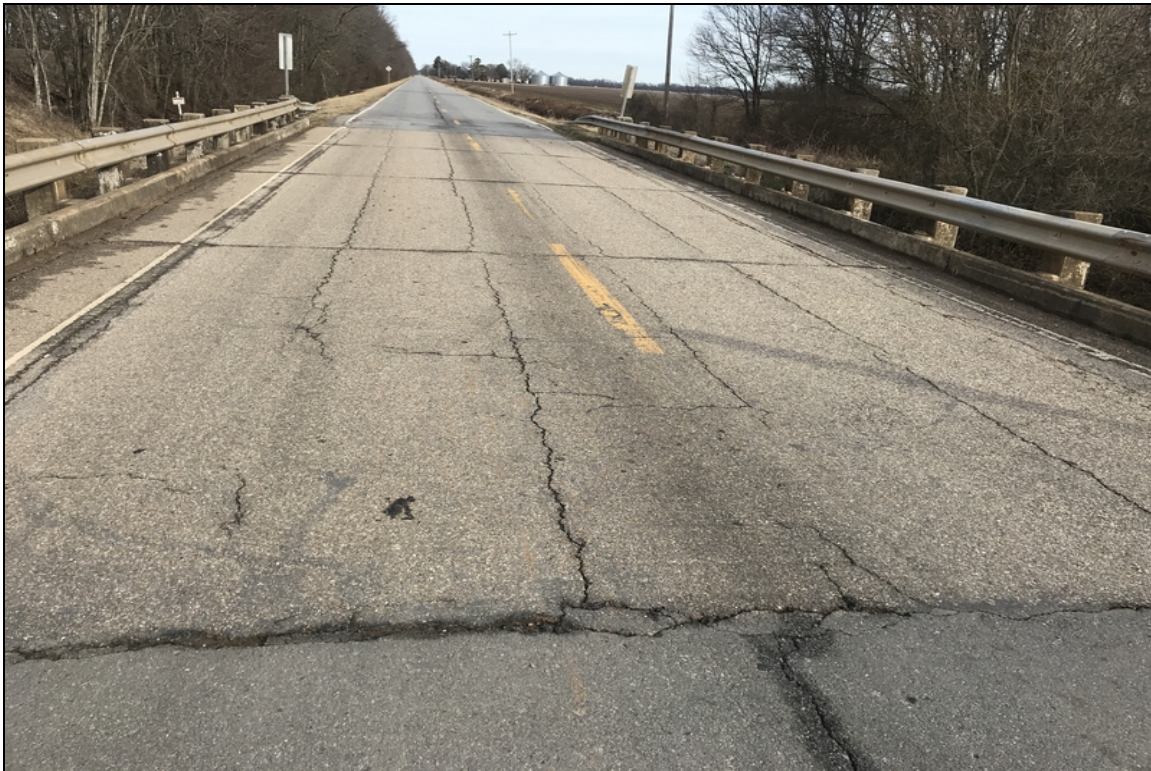
Deck overview.

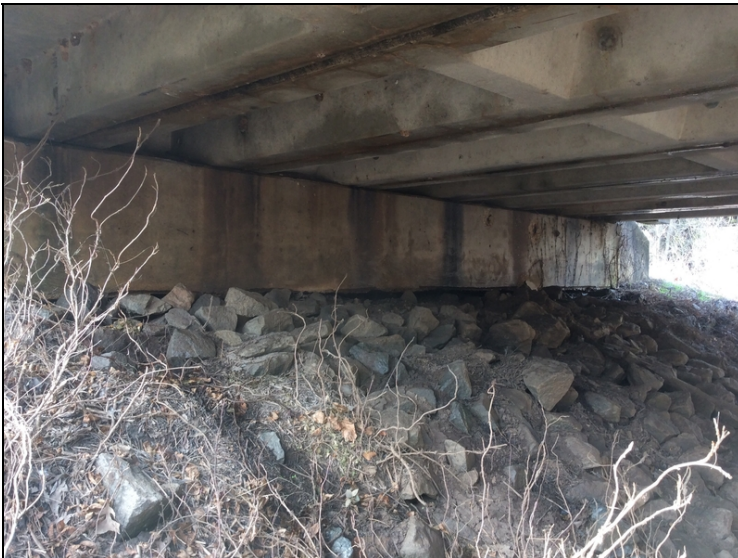
Endslope - Bents 1-5: - Minor settlement (4-5" @ Bent 1, 10-12" @ Bent 5) of fill material under bottom face of cap - full length of abutment.

Endslope - Bent 1 (minor settlement)

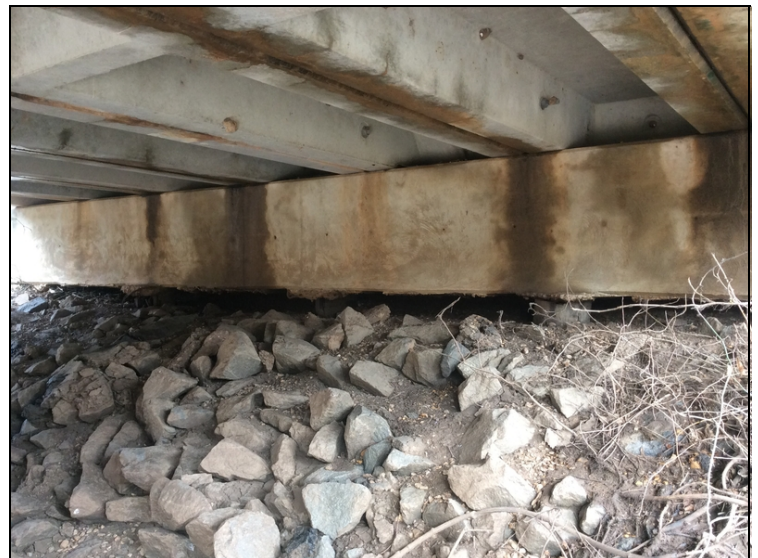
Endslope - Bent 5 (settlement)

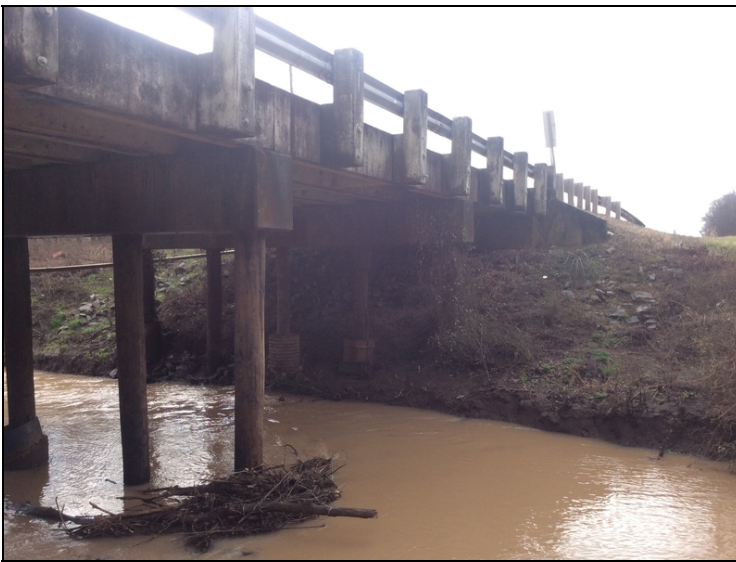
Endslopes - Span 1 & 4: Vines and other vegetation growing on slopes and up piling at Bents 2 & 4.

Endslope - Span 1 left (vegetation)

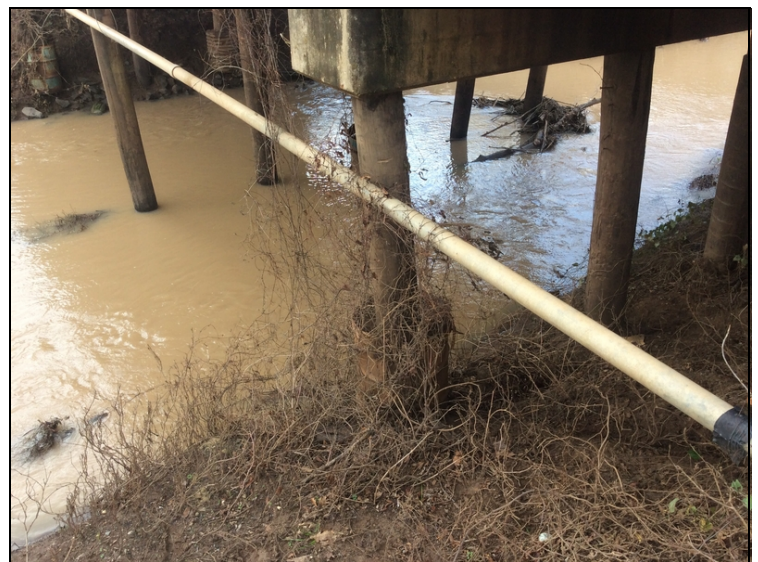
Bent 4 Pile 5 (vegetation)

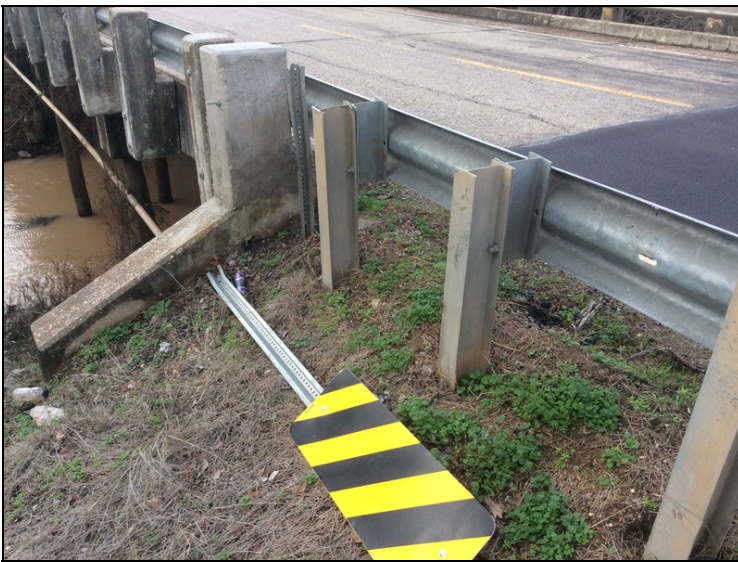
Signs - Bent 5: Object markers, posts, and log mile signs are missing (have been knocked down) on both side - Object marker and broken post currently lying down behind railing on right side.

Sign - Bent 5 right (knocked down)

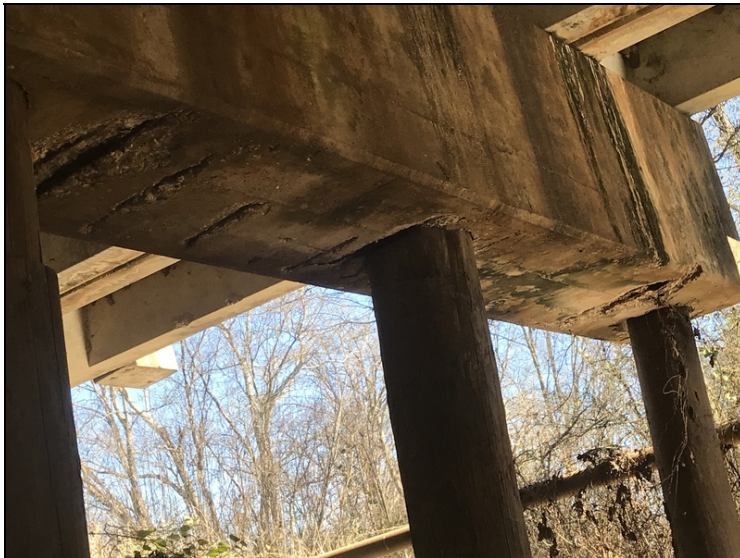
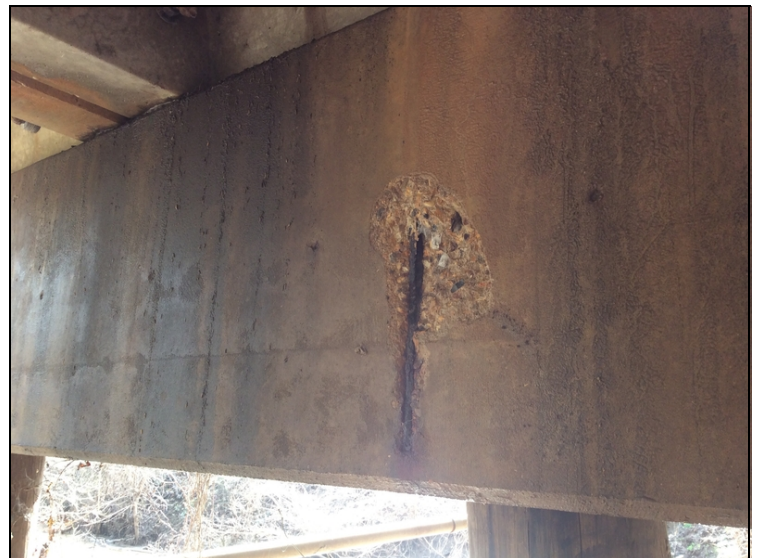
Bent 2: Small areas of delaminations and spalling on bottom face of cap - reinforcing steel exposed with some rust and section loss.

Bent 4: Small areas of delaminations and spalling on right ahead and bottom face of cap - reinforcing steel exposed with some rust and section loss

Bent 4 cap has spall with exposed rebar under and on edges of cap.

Review and repair as necessary.

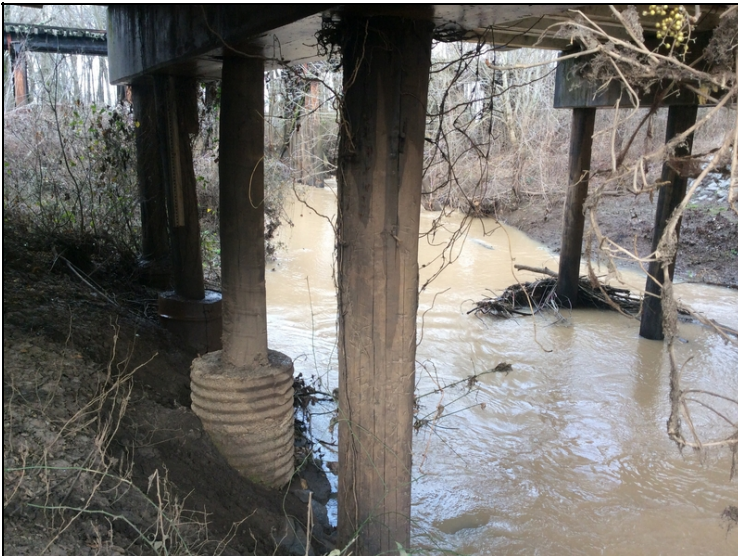
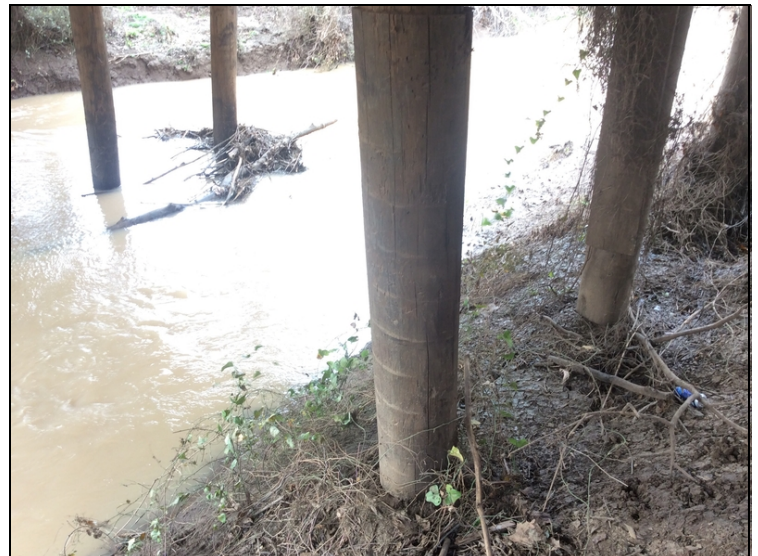
Piling: Changed MN from "D" to "B" SDH 2021
Bent 2 Piles 4: Moderate checking with hollow area near ground line.

Bent 3 Pile 1: Hollow-sounding 4' down from top.
Bent 3 Pile 5: Moderate checking with decay.

Bent 4 Pile 1: Hollow-sounding.
Bent 4 Pile 3: Top 1' is hollow below splice.
Bent 4 Pile 4 hollow from ground up 3'.

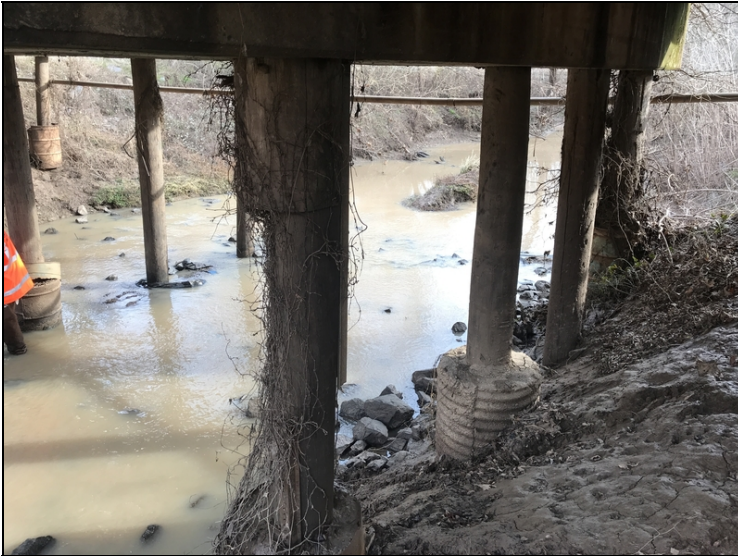
Bent 2 pile 2 splice with no collars.
Bent 3 pile 3 splice with no collars.
Bent 4 pile 2-3 splice with no collars.

Bent 2 pile 2 no concrete collar on splice.
