Asset #04447(Routine)

Wrape Road-CR 83 over Little Bayou Meto

Location: 1.6 Mi N CR 686-Reydel

Team Lead: Sharon Hooks Inspection Date: 12/18/2023

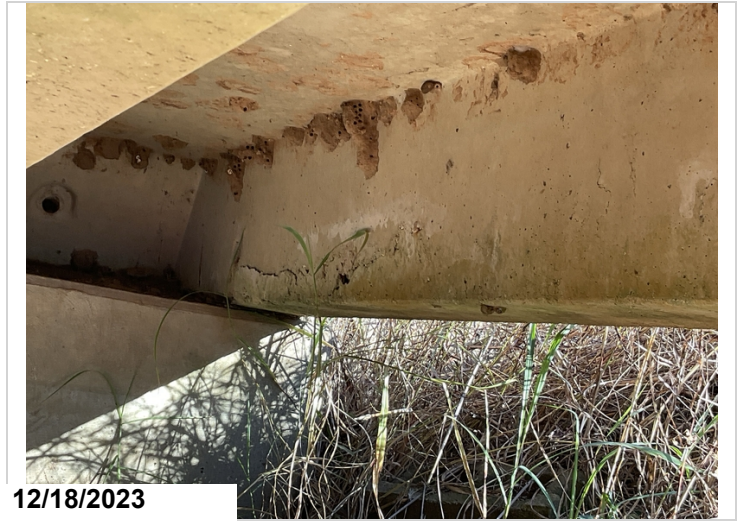
(110) Girders: 6 precast channel beam units per span / Spans 1-3 (31' each = 93' total span). Units are bolted transversely and longitudinally - no noted missing or loose bolts. A couple of small spalls along channel legs various locations.							
215	Reinforced Concrete Abutment	LF	58	58	0	0	0

Span 3 unit 6 has delam in right leg near bent 4.

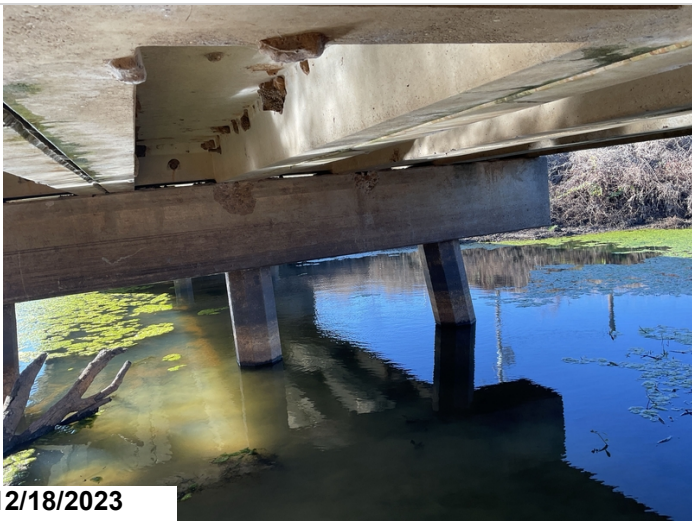
Bent 3 cap has small contact spalls on back and ahead face.

(234) Caps: 21'-6" = 22' each / Bents 2 & 3. Bent 3: Several 1' x 1' spalls in various locations.							
301	Pourable Joint Seal	LF	38	0	38	0	0
2350	Debris Impaction	LF	38	0	38	0	0

Bent 3 cap ahead has contact spalls.

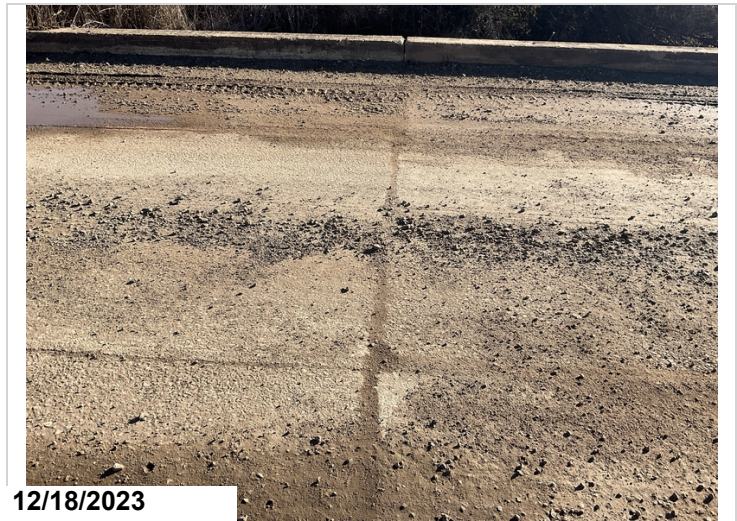
(301) Pourable joint seals at bents 2-3. 19' each Joints have debris impaction.

Bent 3 joint seal has debris impaction.

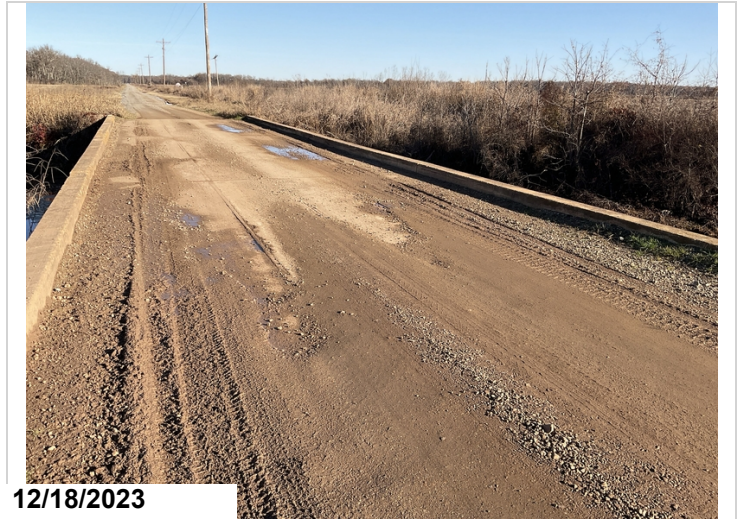
Some abrasion due to gravel on deck.

(16) Deck: 21' wide x 93' long = 1953 sqft. Joints are completely grouted and grout is in good condition. Dirt/gravel covering most of deck surface with only a few areas where deck shows through. Scattered abrasive wear from gravel. Span 1 Unit 3 left side: Spall along top edge.							
110	Reinforced Concrete Open Girder/Beam	LF	558	546	12	0	0
1080	Delamination/Spall/Patched Area	LF	12	0	12	0	0

Deck over view.
