**Bridge #03095(Routine)**  
**SH 19-SEC.05-11.46 over LITTLE MISSOURI RIVER**

**Team Lead: Charlie Rogers Inspection Date: September 16, 2019**

Bridge #03095(Routine)

SH 19-SEC.05-11.46 over LITTLE MISSOURI RIVER

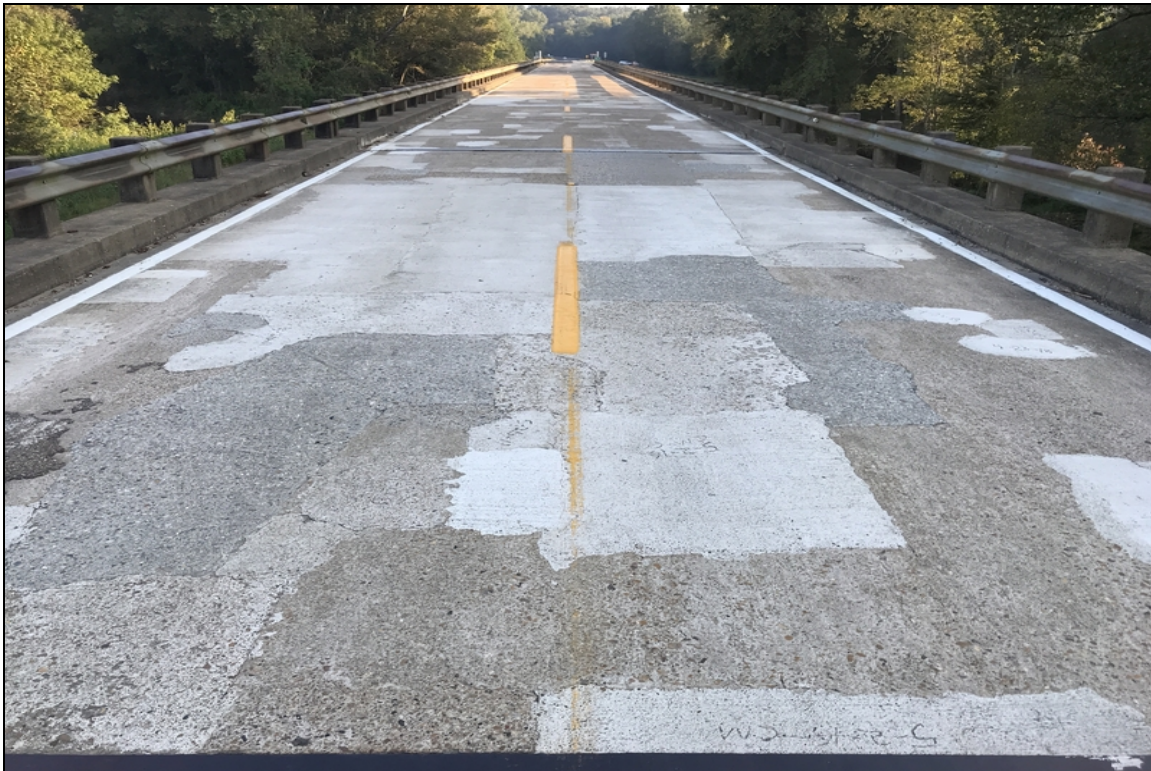
Deck

4 POOR.DECK PATCHES.... 09/18/2017 AL AND SS PHOTOS TAKEN. PINS TESTED WITH ULTRASONIC DEVICE AND NO CRACKS WERE FOUND.SPAN 4 OVERHANG SMALL SPALL W/REBAR EXPOSED.SPAN 6 BAY 4 MEDIUM SPALLS WITH REBAR EXPOSED AND LEFT AND RIGHT SIDE OVERHANG SPALLED W/REBAR EXPOSED. VARIOUS UNDER DRAINS SPALLED WITH REBAR EXPOSED.09/17/2018 AL,SS, pins tested and no cracks found..09/16/2019...AL,SS,DECK,DEF. PHOTOS TAKEN. UPDATED DECK PATCH QUANTITIES IN ELEMENTS...
