Bridge Inspection Report

05156
SH 41 SEC.02- 4.50
over
CANEY CREEK RELIEF

Structure Number: 05156

Facility Carried: SH 41 SEC.02- 4.50

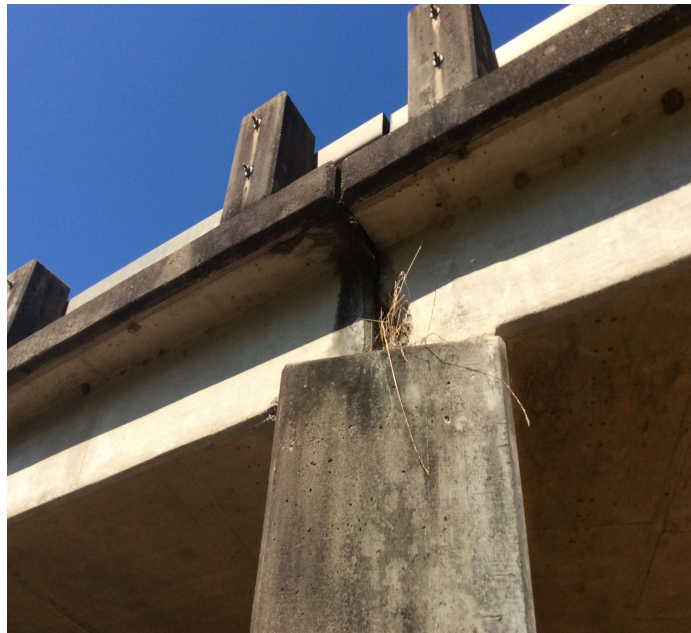
. BT 3 LT SIDE.....SPALL W/REBAR EXPOSED ON CORNER OF SLAB.

PHOTO 1 Description Bent 3 left side spall in corner of slab

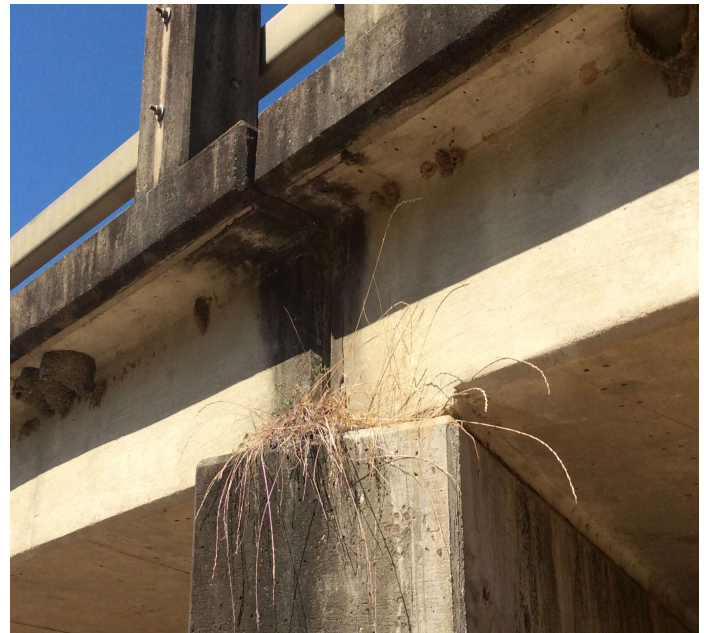
. BT 2 LT SIDELG CRACK IN CORNER OF SLAB

PHOTO 2 Description Bent 2 left side corner of slab
