Bridge Inspection Report

05157
SH 41 SEC.02- 4.20
over
CANEY CREEK

Structure Number: 05157

Facility Carried: SH 41 SEC.02- 4.20

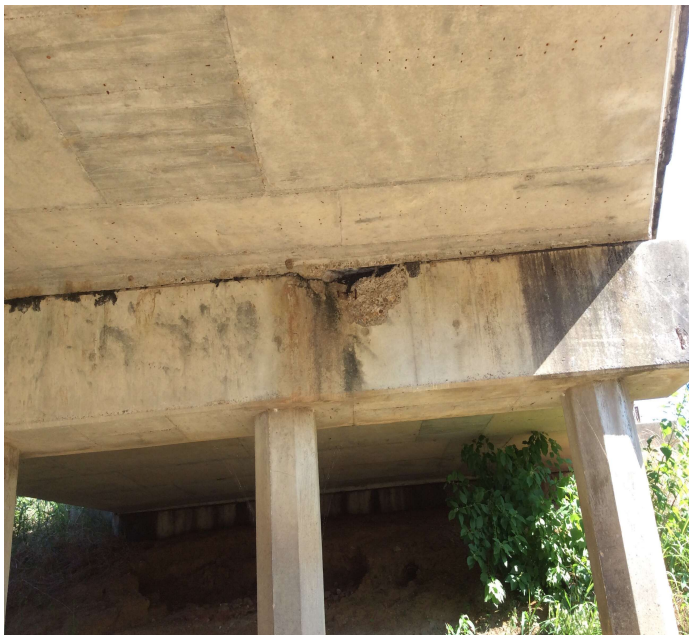
BENT 2, 3, 4, 5, AND 6 CAPS HAVE MINOR SPALLS AND DELAMS ON CAP FACES IN VARIOUS LOCATIONS.

PHOTO 1 Description Spall cap bent 2
Spalls on cap faces bent 2, 3, 4, 5, & 6

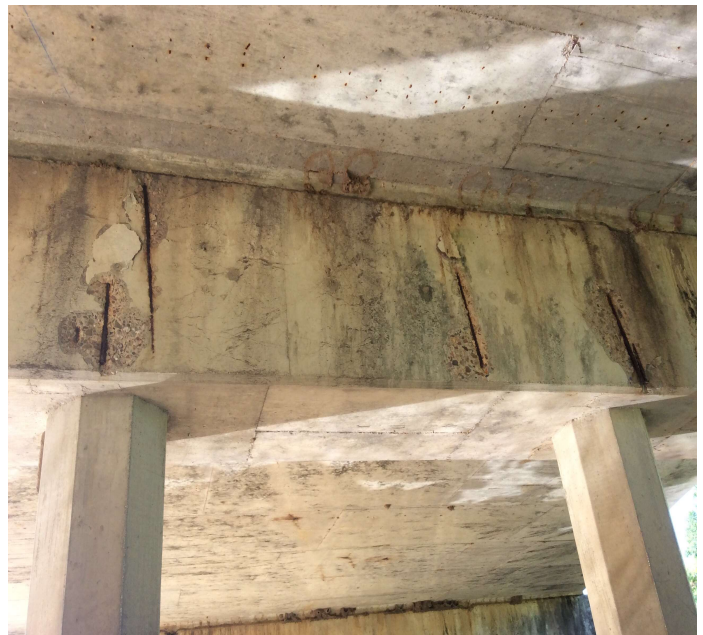
PHOTO 2 Description Bent 3 rebar exposed

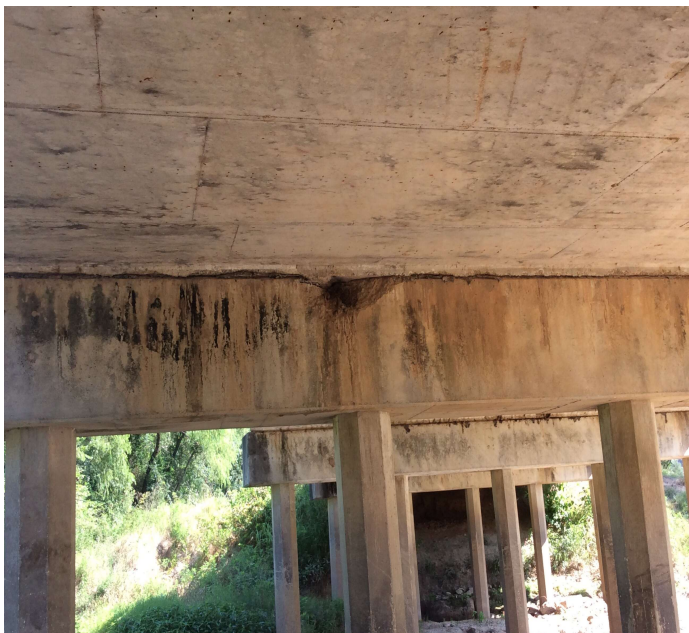
PHOTO 3 Description Bent 4 cap spall south face

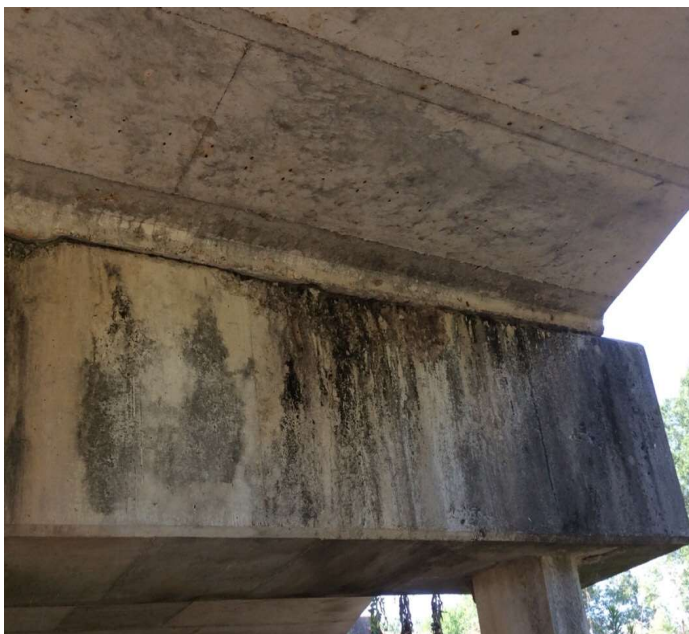
PHOTO 4 Description Spall bent 5 cap north face

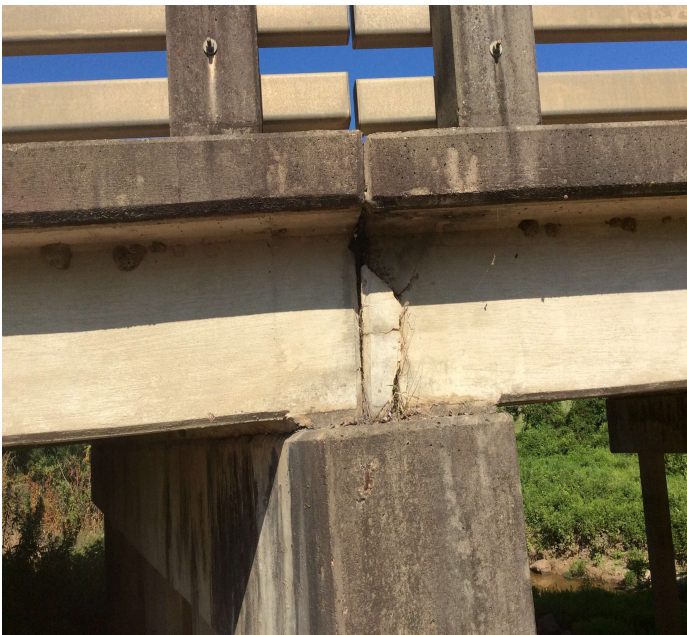
BT 5 SPAN 4 CORNER OF SLAB IS SPALLED DUE TO 1 3/4" LATERAL MOVEMENT IN ALL SPANS.

PHOTO 1 Description Bent 5 left side corner of slab spall
