# Bridge Inspection Report

**05158**

**SH 41 SEC.02 -2.42**

**LITTLE RIVER RELIEF**

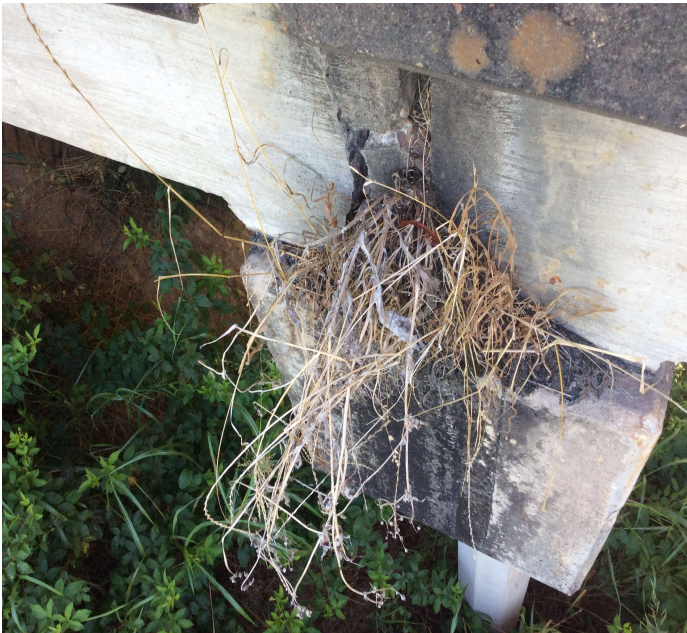
BT 2 HAS A CRACK IN CORNER OF SLAB, SPAN 1

PHOTO 1      Description      Bent 2 right side of slab crack

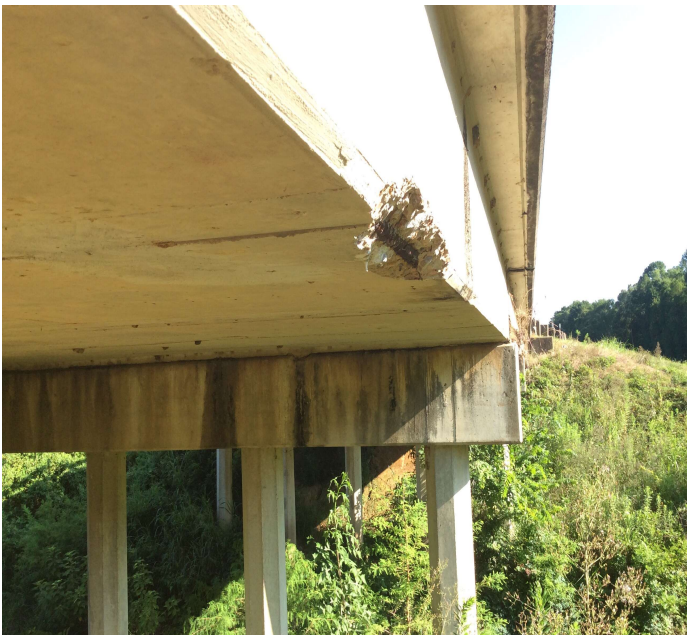
SPALL W/ REBAR EXPOSED ON BOTTOM OF SLAB OUT SIDE EDGE IN SPAN 3 ON LT SIDE OF BRIDGE

PHOTO 1      Description      Rebar exposed span 3 left side edge of slab

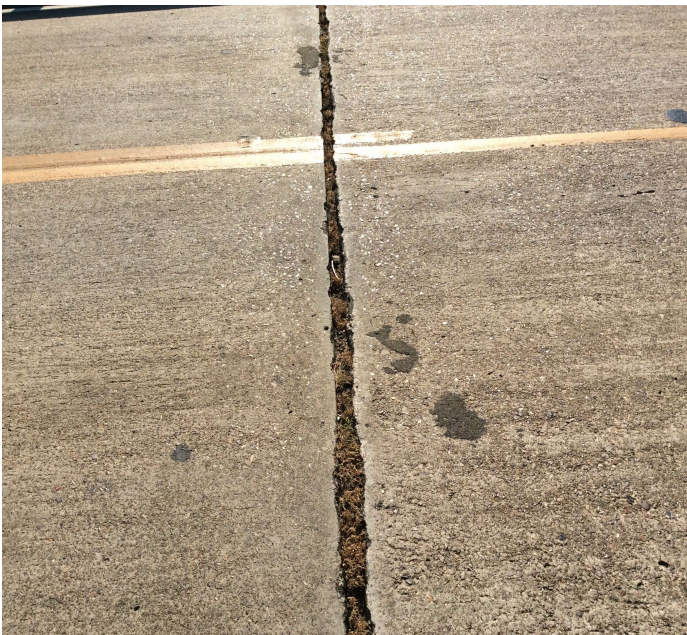
JOINTS NEED CLEANED AND FILLED ,NOTE JOINTS WERE 1/2" AND NOW ARE 1 1/2"

PHOTO 1      Description      Joints need cleaned and refilled

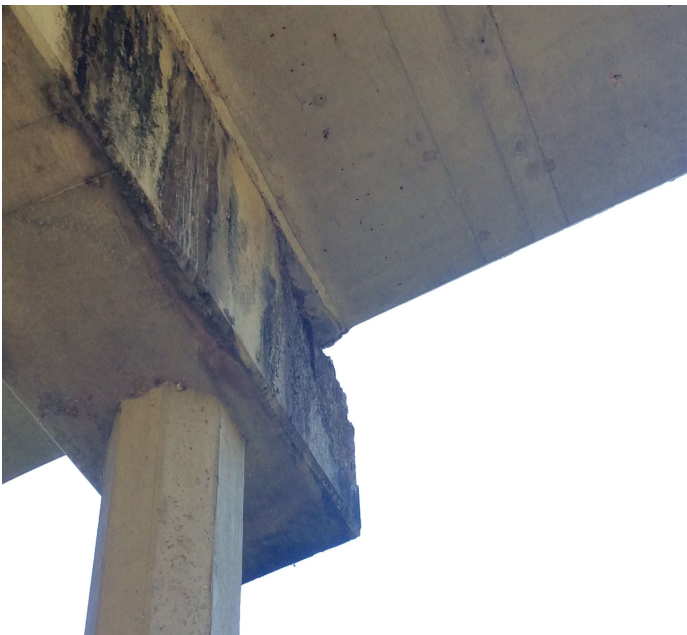
BENT 3 CAP LG SPALL W/REBAR EXPOSED ON RT END AND SOME SMALL SPALLS ON NORTH FACE.

PHOTO 1      Description      Spall right end of bent 3 cap with rebar exposed
