Bridge Inspection Report

05159

SH 41 SEC. 02-1.97

LITTLE RIVER RELIEF

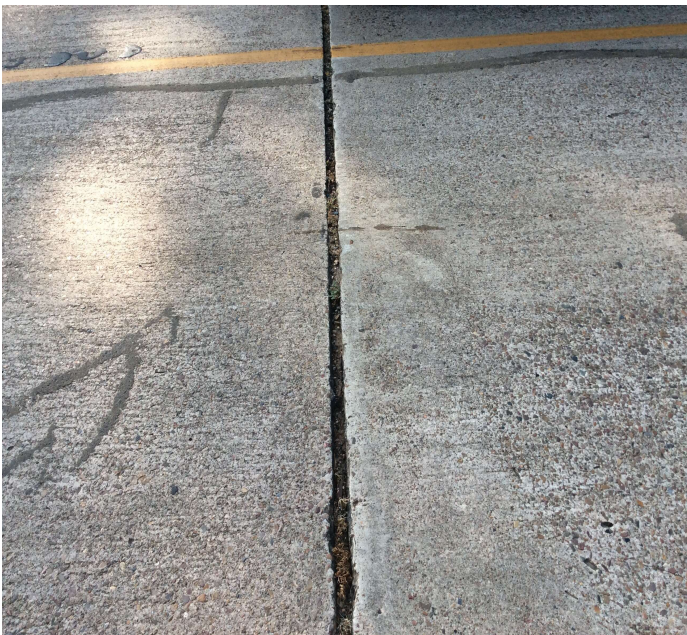
JOINTS NEED CLEANED AND FILLED TYP. @ ALL BENTS

PHOTO 1 Description Joints need to be cleaned and refilled

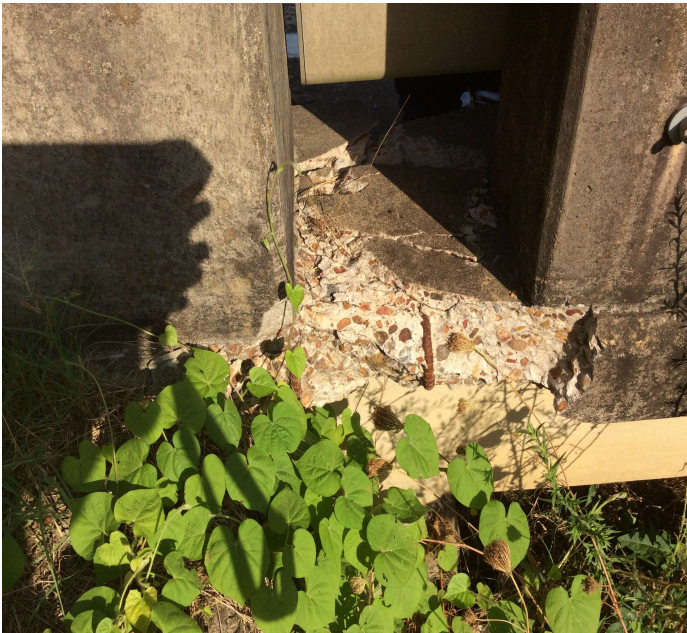
Damage to curb and overhang left side at bent 4. Spall with rebar exposed

PHOTO 1 Description Damage to curb and overhang left side at bent 4

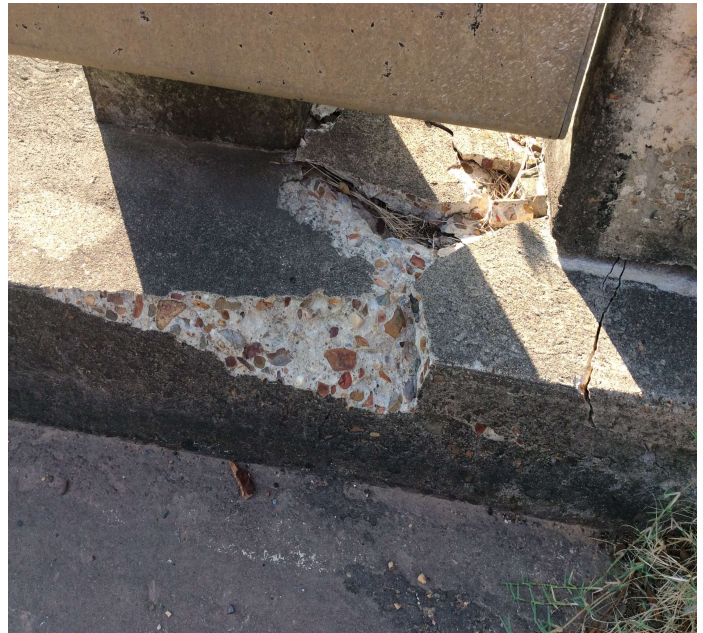
PHOTO 2 Description Curb and overhang at bent 4 left side damaged
