Bridge Inspection Report

05160
SH 41 SEC.02 -1.34
over
LITTLE RIVER RELIEF

Structure Number: 05160

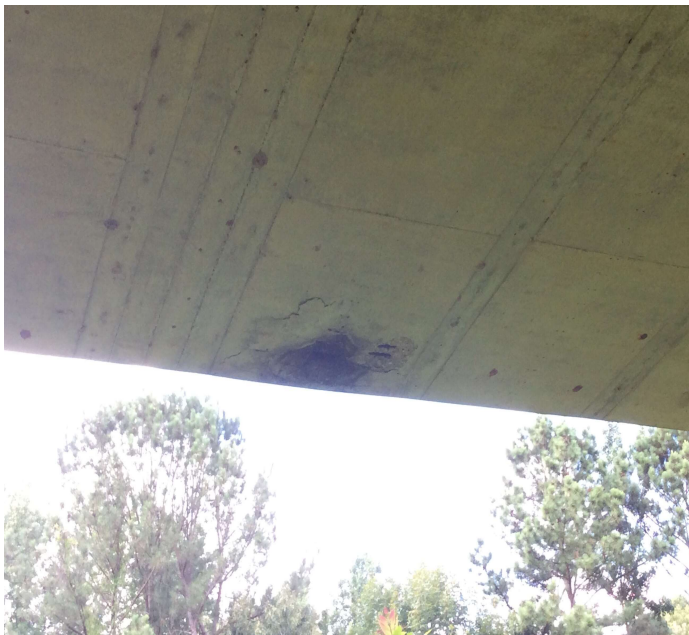
MODERATE SIZE SPALLS w REBAR EXPOSED AND DELAMS IN SPAN 2, 3, 4, & 5 ON BOTTOM OF SLAB.

PHOTO 1 Description Span 5 delam and spall bottom of slab left side

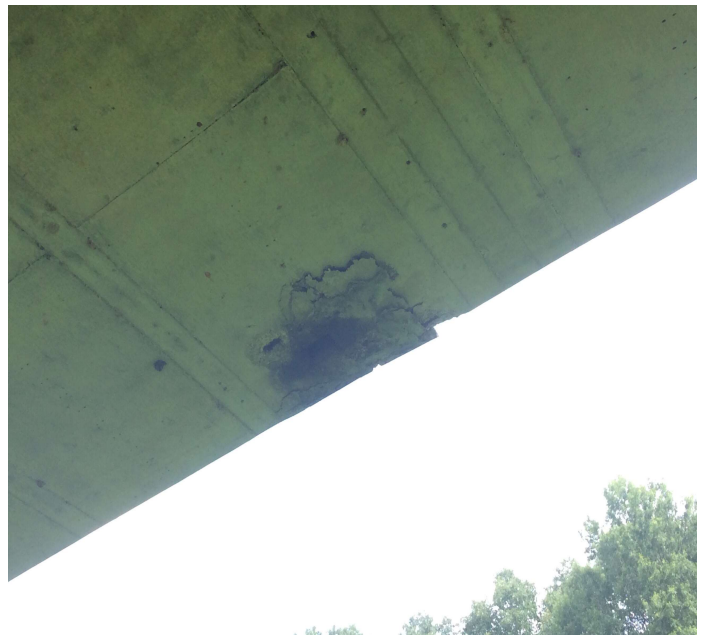
PHOTO 2 Description Spall and delam span 5 right side

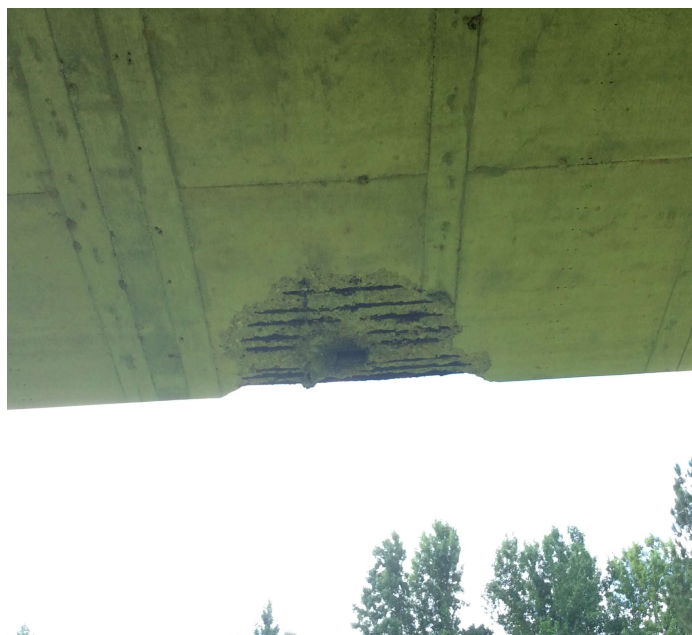
PHOTO 3 Description Spall with rebar exposed left side span 4

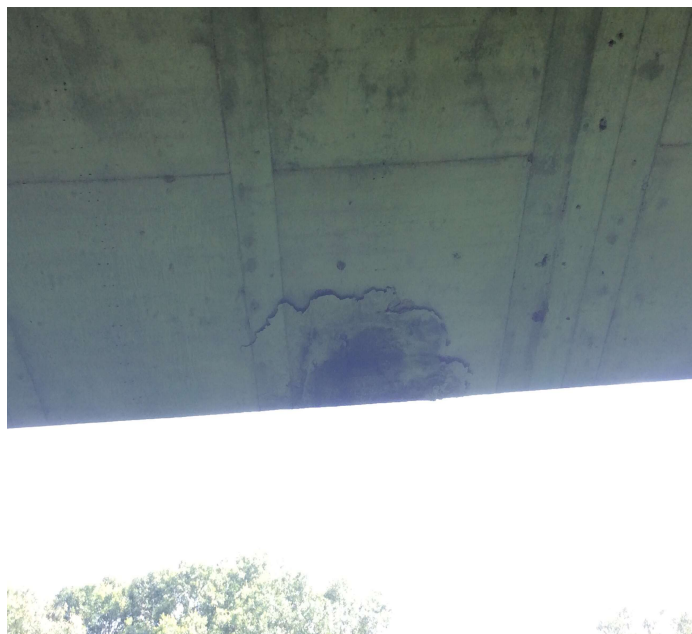
PHOTO 4 Description Delam right side span 4

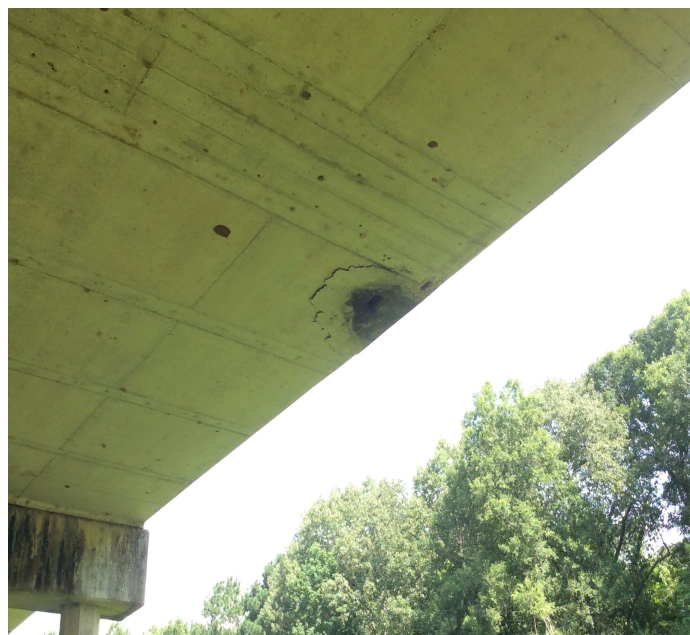
PHOTO 5 Description Span 3 right side delam bottom of slab

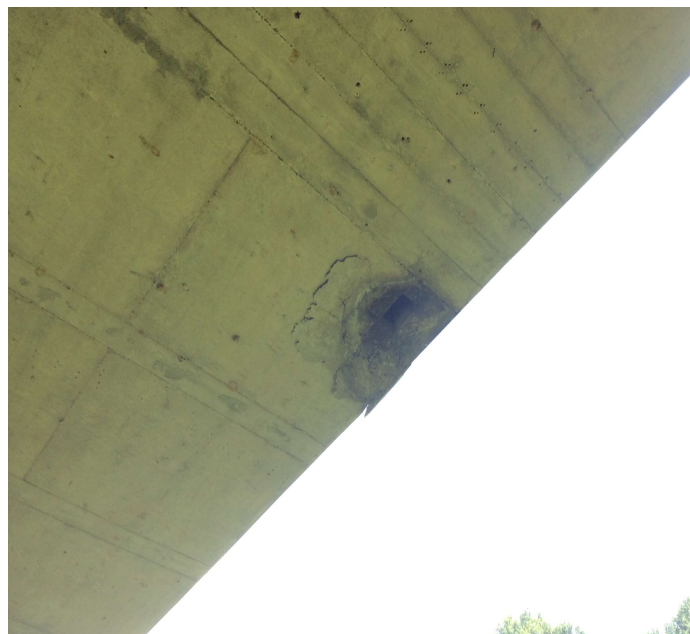
PHOTO 6 Description Span 2 right side delam bottom of slab

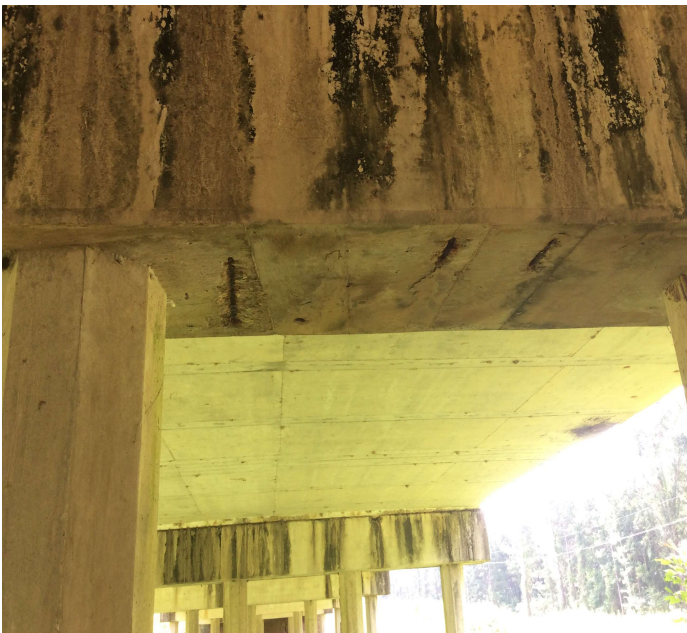
MINOR SPALLS W/ REBAR EXPOSED BOTTOM OF CAP AT BT 2 & 6

PHOTO 1 Description Spalls bottom of bent 6 cap

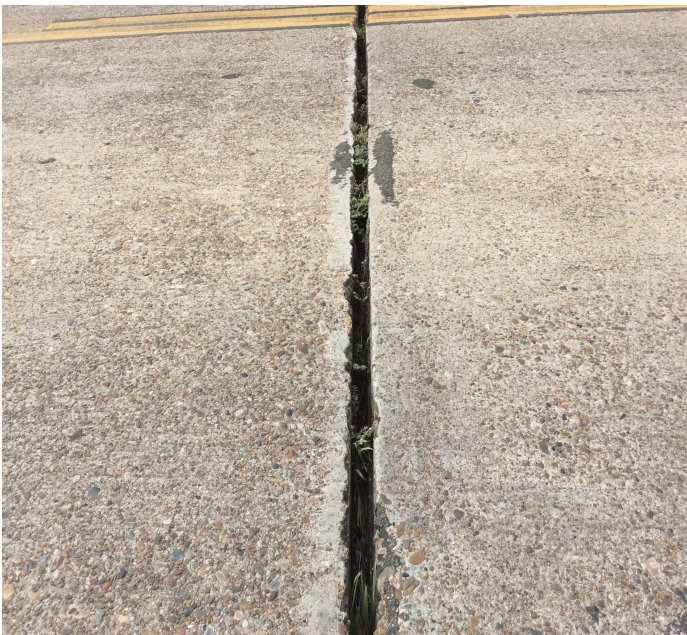
JOINTS OVER ALL BENTS NEED CLEANED AND RE-FILLED WITH JOINT MATERIAL

PHOTO 1 Description All joints need cleaned and refilled
