Bridge Inspection Report

05161

SH 41-SEC.02- 0.92

LITTLE RIVER RELIEF

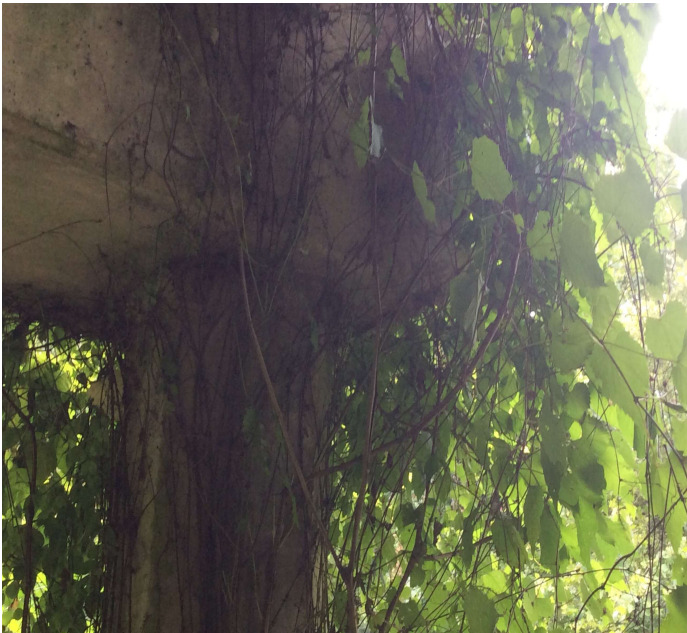
CONCRETE CAP AT BT 5 HAS A SPALL ON BOTTOM OF CAP AT EACH END W/ REBAR EXPOSED.

PHOTO 1 Description Spalls on ends of bent 5 cap not visible due to vegetation
