Bridge Inspection Report

M3614
S.H 8 SEC. 04-1.39
over
ROCK CREEK

Structure Number: M3614

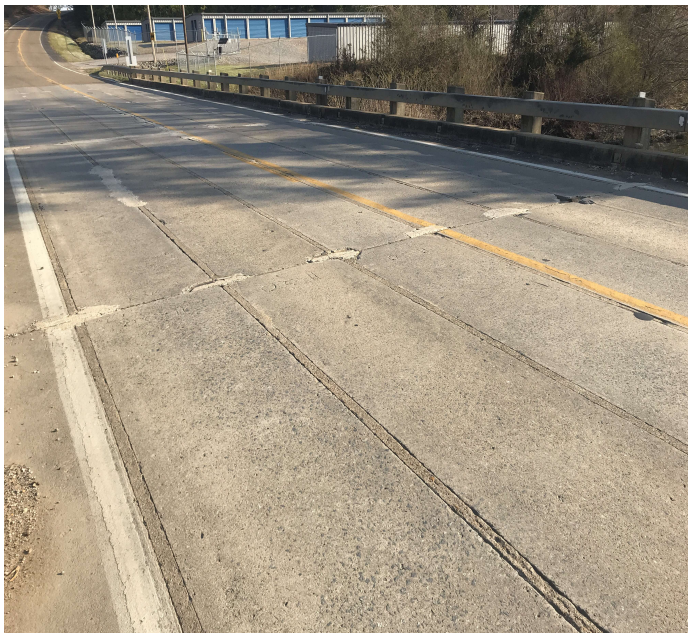
PHOTO 1 Description Deck photo end of bridge

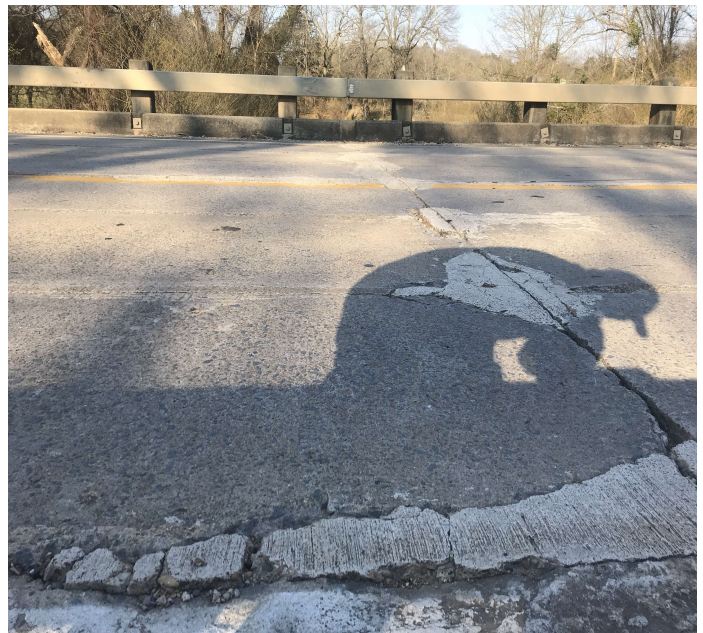
PHOTO 2 Description Joint 3 patch unsound

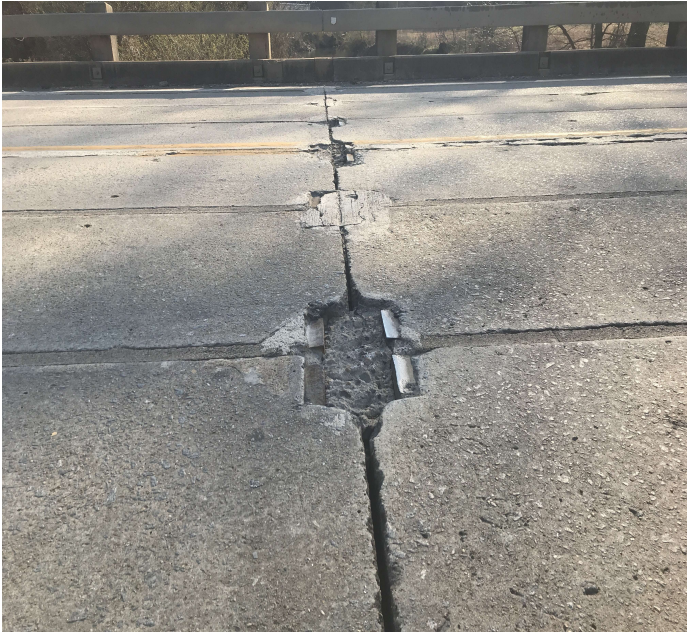
Priority: C - Important

Joint #4 Spall joints #2,#3,#4 have spalls with metal exposed

PHOTO 3 Description Joint #4 Spall joints #2,#3,#4 have spalls with metal exposed

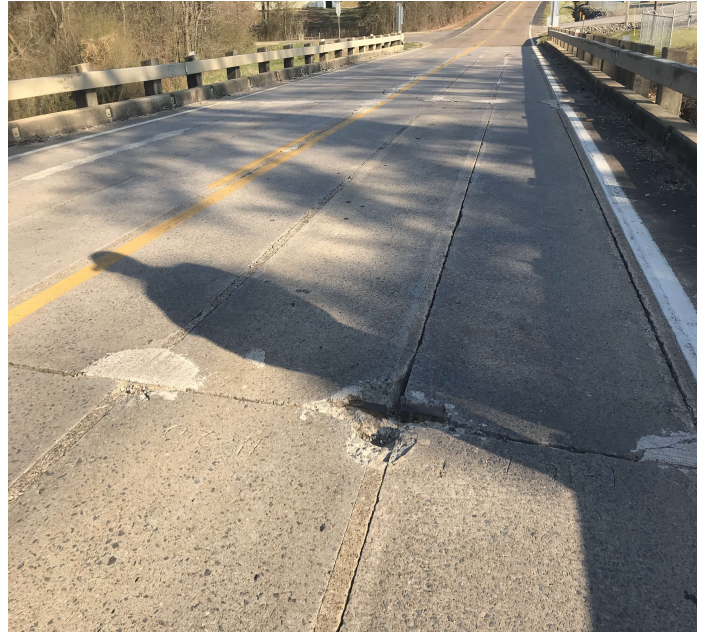
PHOTO 5 Description Spall at joint #5 corners of units are spalled at joints 2 and 3

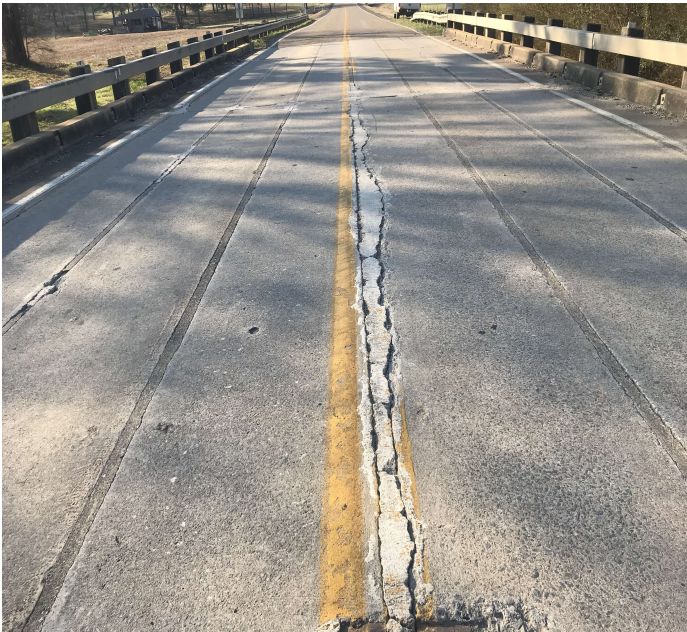
PHOTO 4 Description Center of bridge at joint #3

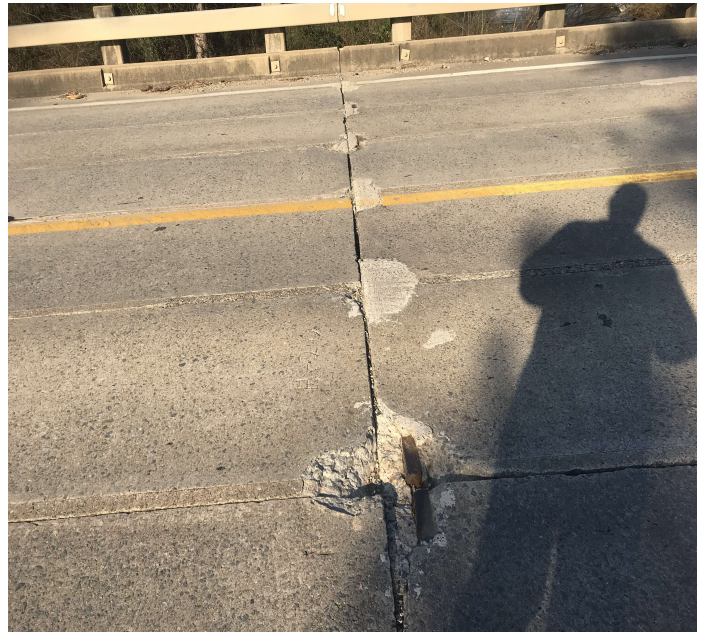
PHOTO 6 Description Joint #3

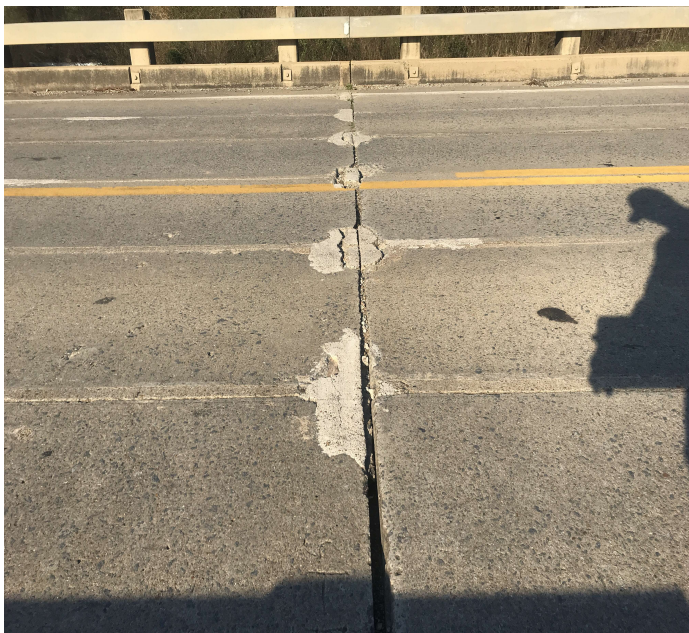
PHOTO 7 Description Joint #2

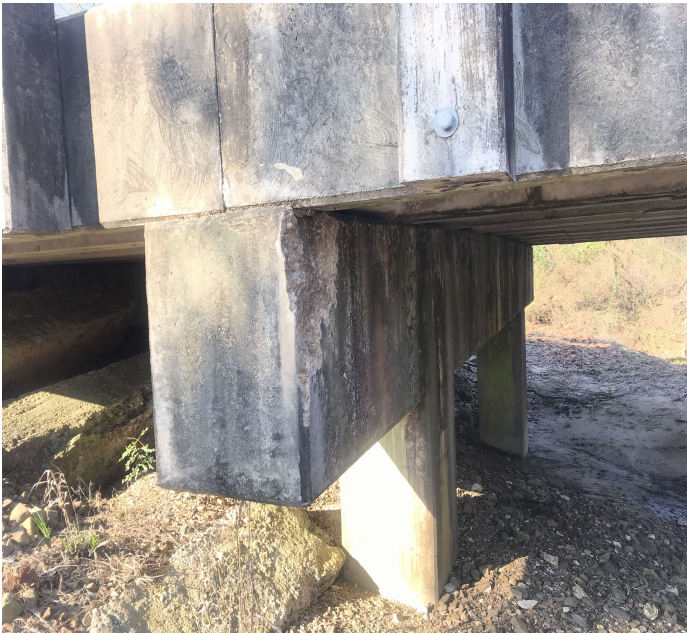
Priority: G - General/ Preventive maintenance

Spall Bent #5 left side on cap

PHOTO 1 Description Spall Bent #5 left side on cap
