Bridge Inspection Report

02549
US 82 SEC.01 -7.37
over
MILL CREEK

Structure Number: 02549

IDENTIFICATION		INSPECTIONS	
(1) STATE CODE	056 - Arkansas	(90) INSPECTION DATE	08/03/2017
(8) STRUCTURE NUMBER	02549	(91) DESIGNATED INSPECTION FREQUENCY	24

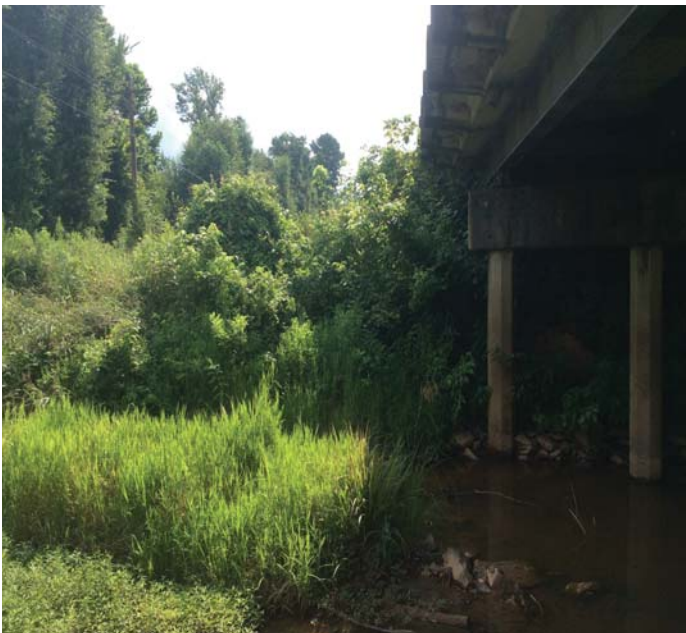
Trees growing end of bridge right and left side need to be cut back.

PHOTO 1 Description Trees growing end of bridge right and left side need to be cut back.

AMS will handle

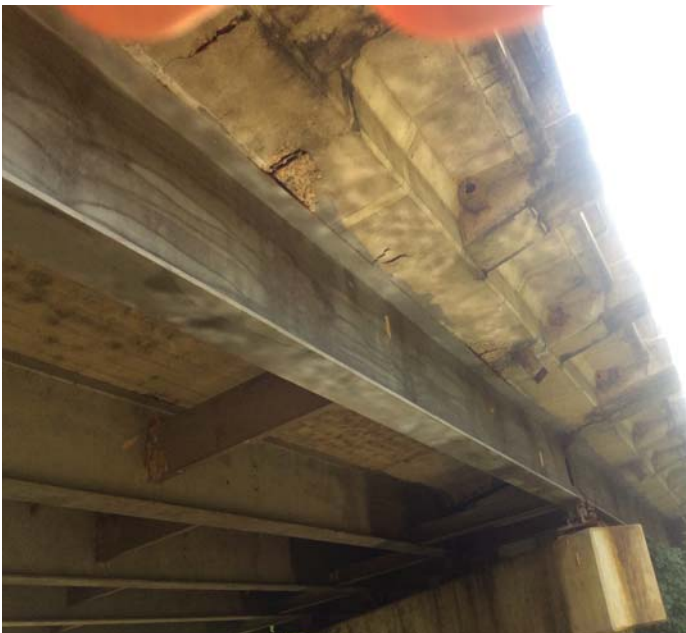
Bottom of deck span 3 right side spall with rebar exposed.

PHOTO 1 Description Bottom of deck span 3 right side spall with rebar exposed.

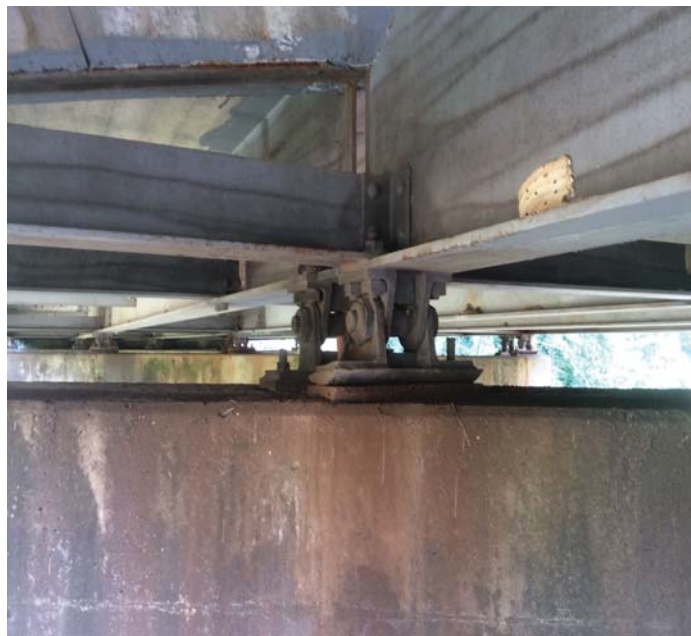
Span 1 beam 2 bearing shows some vertical movement 1/8" under heavy truck traffic. Sole plate are showing signs of wearing on rocker bearings typical all.. some bearing have heavy pack rust and anchor bolt are rusted

PHOTO 1 Description Span 1 beam 2 bearing shows some vertical movement 1/8" under heavy truck traffic. Sole plate are showing signs of wearing on rocker bearings typical all.. some bearing have heavy pack rust and anchor bolt are rusted into.....

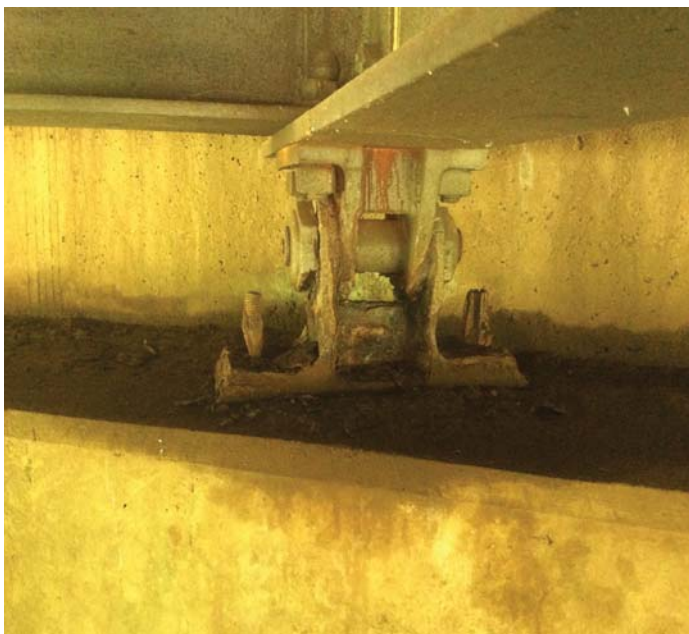
PHOTO 4 Description Abutment 2 beam 3 pack rust on bearings.

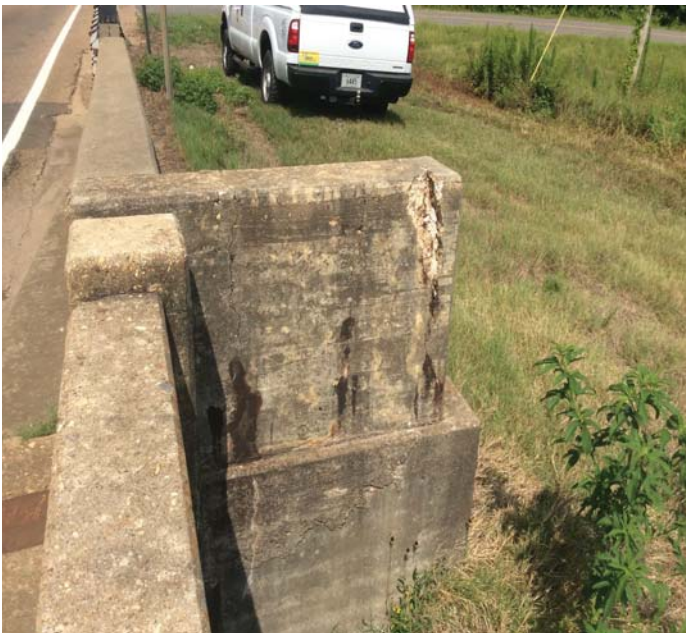
Left side top wing wall cracked and spalled beginning bridge.....

PHOTO 1 Description Left side top wing wall cracked and spalled beginning bridge.....
