Bridge Inspection Report

03860
US 82 SEC.01-13.08
over
MCKINNEY BAYOU

Structure Number: 03860

Facility Carried: US 82 SEC.
01-13.08

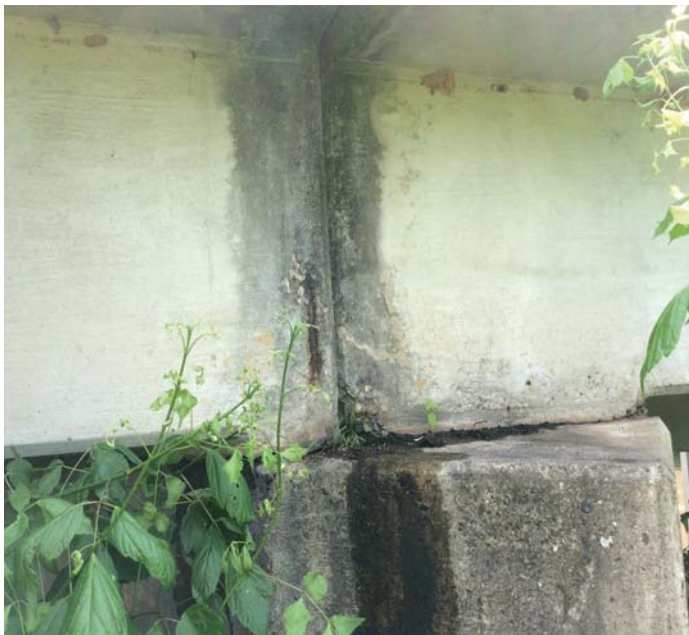
Slab corners at bent 7 and 9 left side spalls. Bent 7 spall has rebar exposed

PHOTO 1 Description Spall bent 9 left side corner of slab

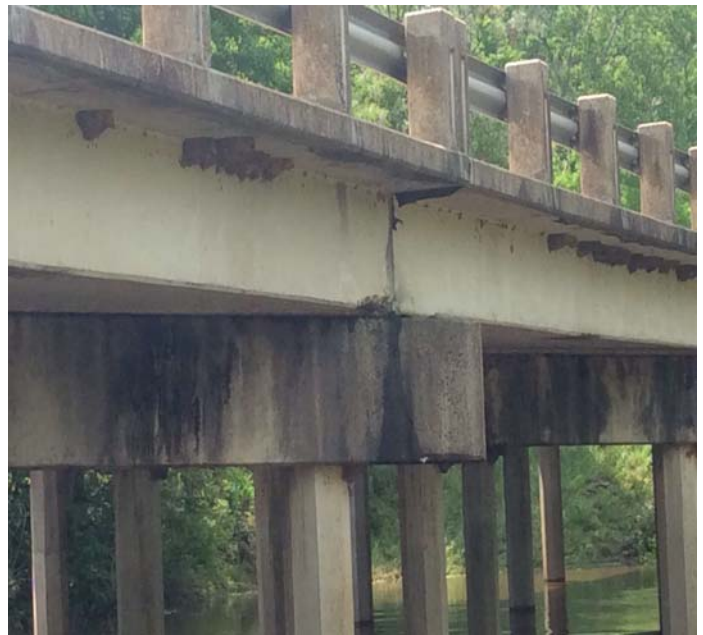
PHOTO 2 Description Spall bent 7 corner of slab left side
rebar exposed

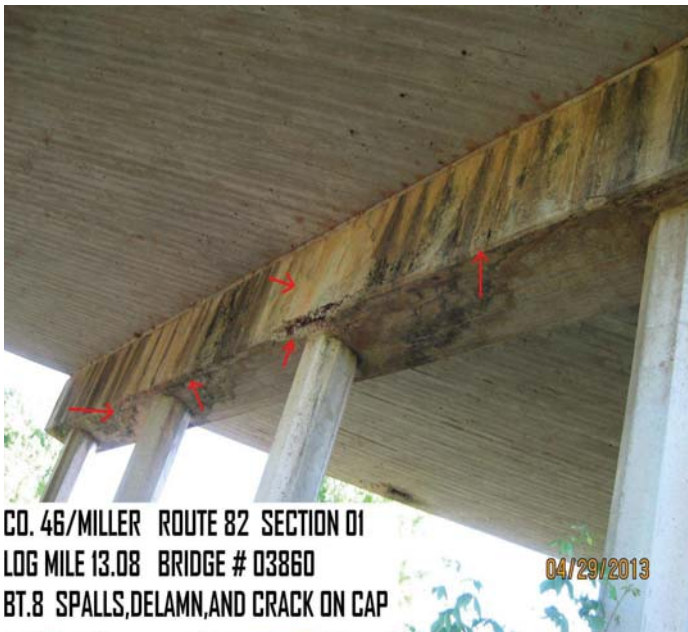
PHOTO 1 Description

CONCRETE CAP AT
BENT #8 WEST FACE

DELAMS & AND CRACKS FULL LENGTH BETWEEN PILES #1 AND #4 ON BOTTOM.

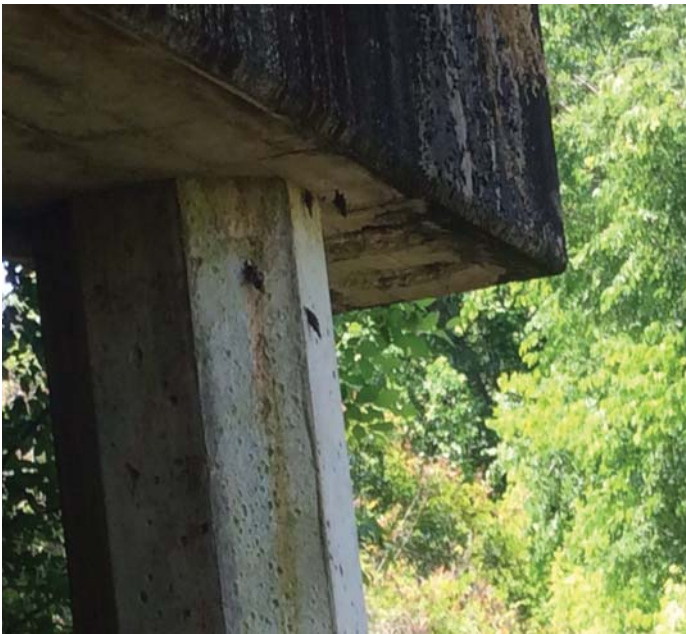
CONCRETE CAP BENT #2-LT. END

MINOR SPALL W/ REBAR EXPOSED ON BOTTOM. ALSO, DELAM BETWEEN PILE 1 and 2 WEST FACE OF BENT 2 CAP

PHOTO 1 Description SPALLS on the left end of cap at bent 2

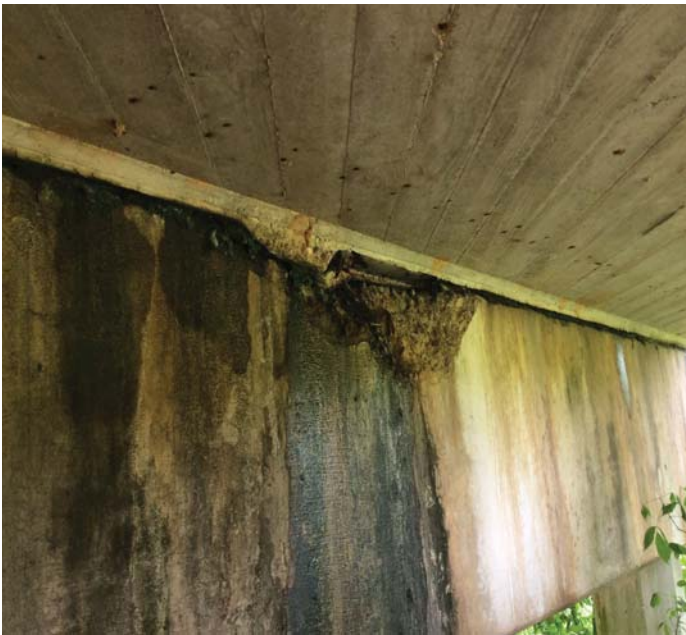
CONCRETE CAP BENT #9 EAST FACE TOP
OF CAP

2' X 8" SPALL W/ REBAR EXPOSED. AND
1' X 6" SPALL

PHOTO 1 Description Bent 9 east face top of cap between
piles 1 and 2. 2' x 18" spall

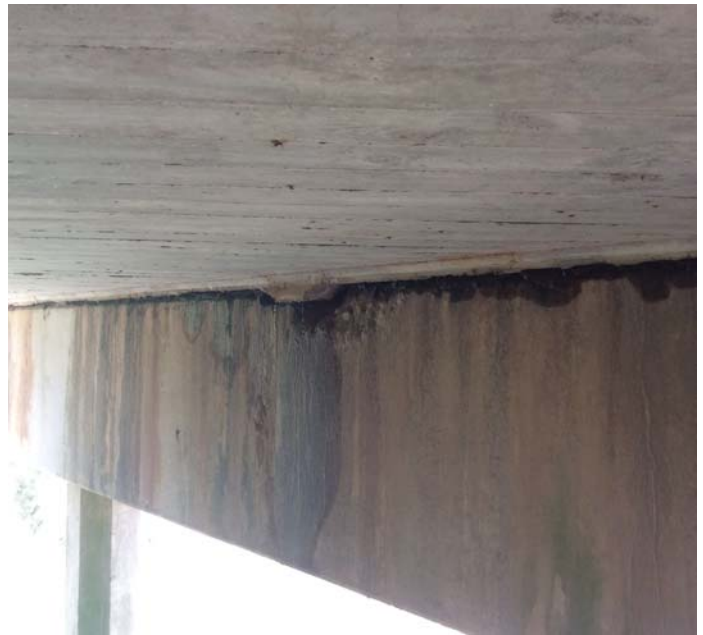
PHOTO 2 Description Bent 9 east face top of cap between
piles 4 and 5. 1' x 6" spall

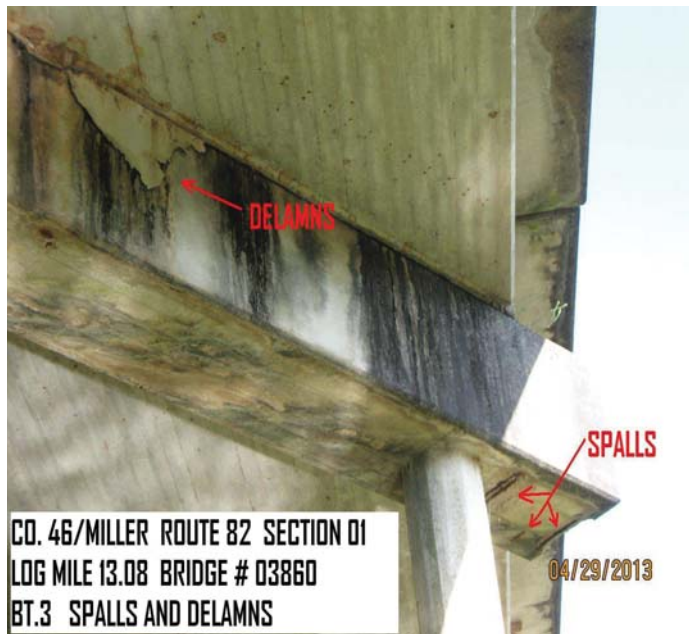
PHOTO 1 Description

CONCRETE CAP BENT #3- LT. END

MINOR SPALL W/ REBAR EXPOSED ON BOTTOM.

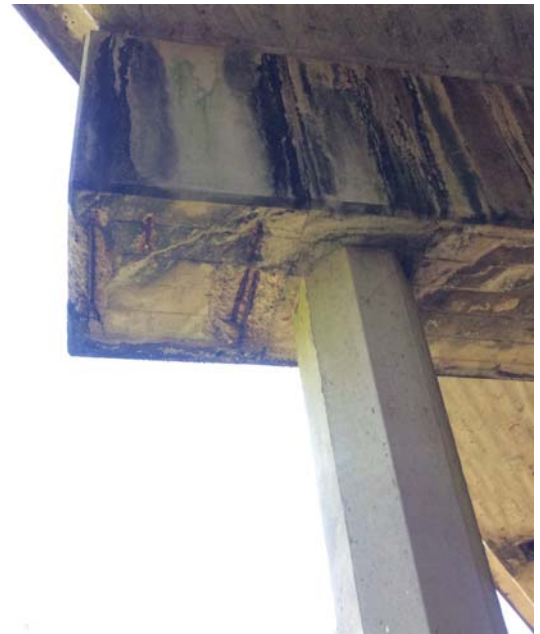
PHOTO 2 Description Spalls at the left end of cap at bent 3

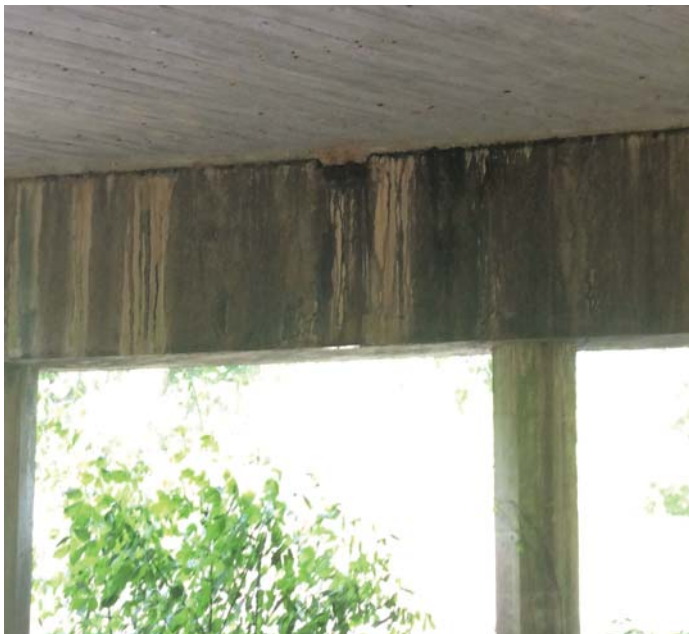
CONCRETE CAP BENT #3- LT. END WEST FACE

DELAMINATION BETWEEN PILES # 1 & #2.
DELAMINATION BETWEEN PILES 2 and 3 BENT 3 CAP.

PHOTO 1 Description Delam between pile 1 and 2 west face of bent 3 cap.

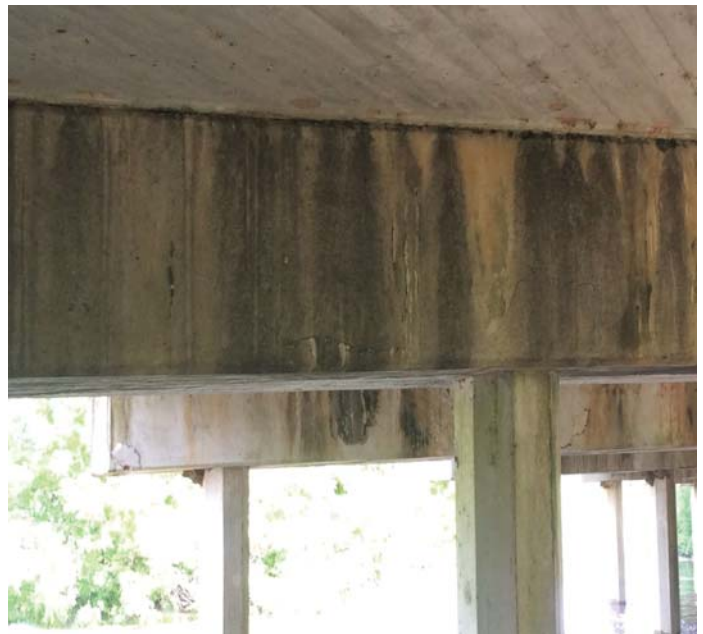
PHOTO 2 Description Delam between pile 2 and 3 west face of bent 3 cap.

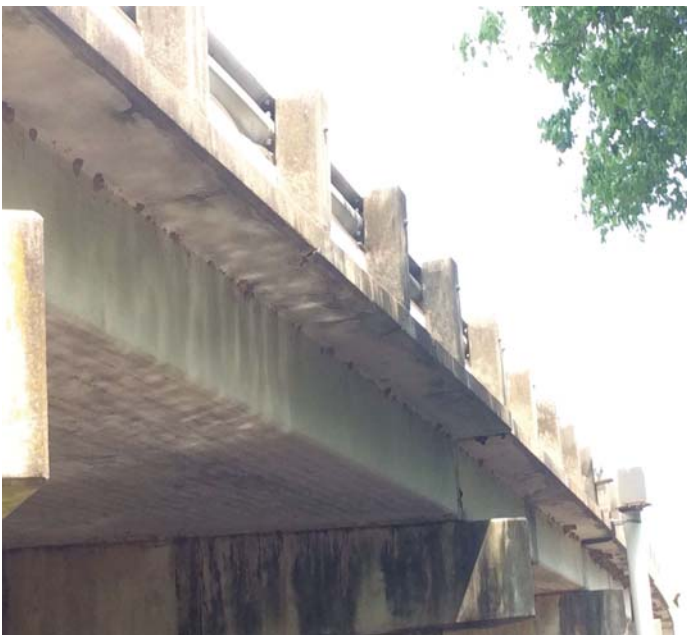
DELAMS IN OVERHANG SPAN 3 RIGHT SIDE UNDER GUARDRAIL POSTS
APPROX. 5' DELAM IN RT.SIDE OVERHANG

PHOTO 1 Description Span 3 overhang right side delams
under guard rail posts

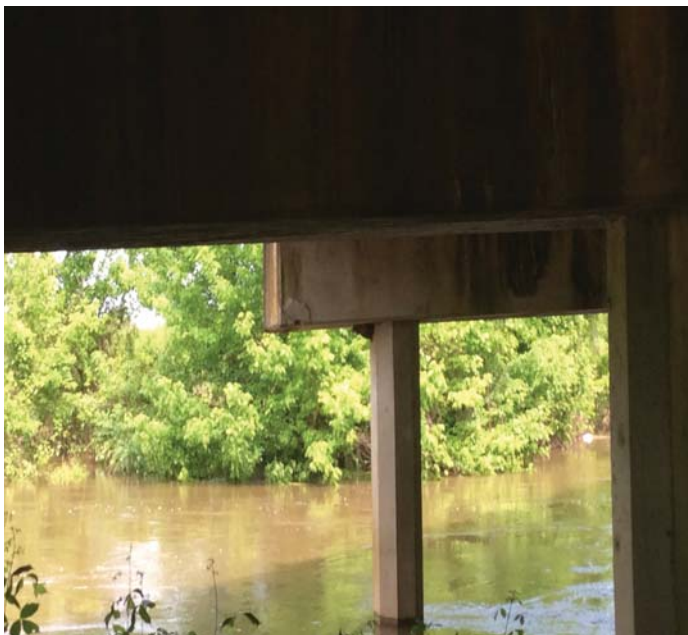
CONCRETE CAP BENT #4- LT. END.
MINOR SPALLS & DELAMS

PHOTO 1 Description Delam bent 4 cap left end west face

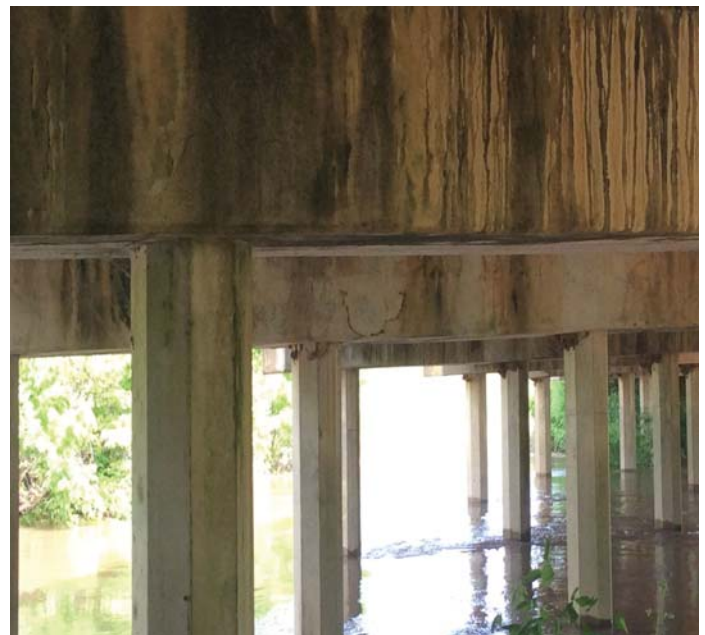
PHOTO 2 Description Delam bent 4 cap between pile 2 and 3 west face

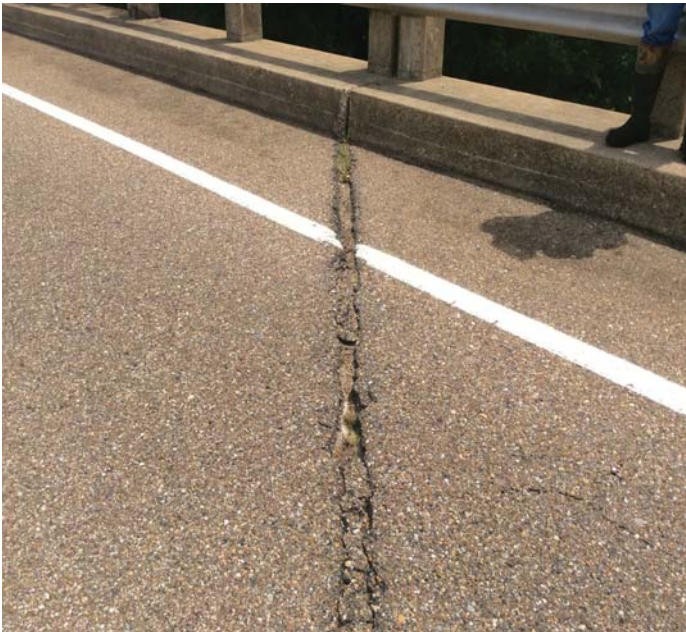
ALL JOINTS HAVE GRASS GROWING OUT OF THEM
AND NEED TO BE CLEANED AND REFILLED

PHOTO 1 Description Joints need cleaning some have grass growing

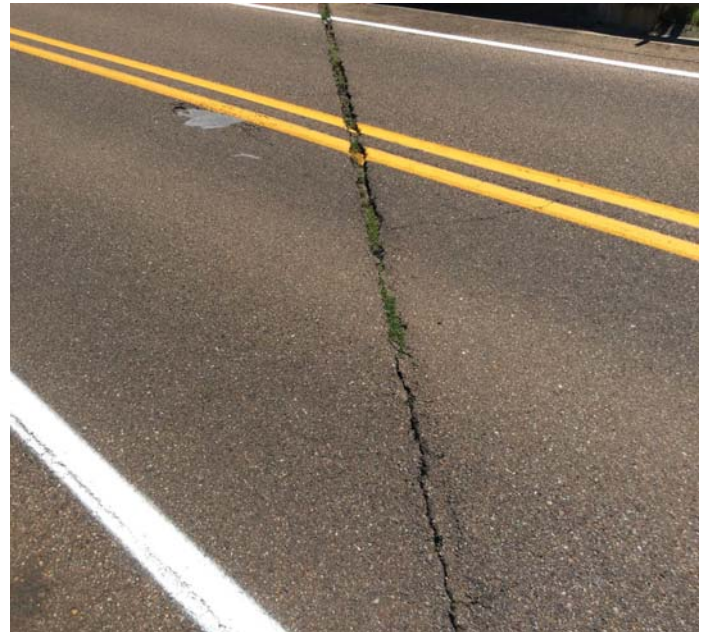
PHOTO 2 Description Typical of all joints

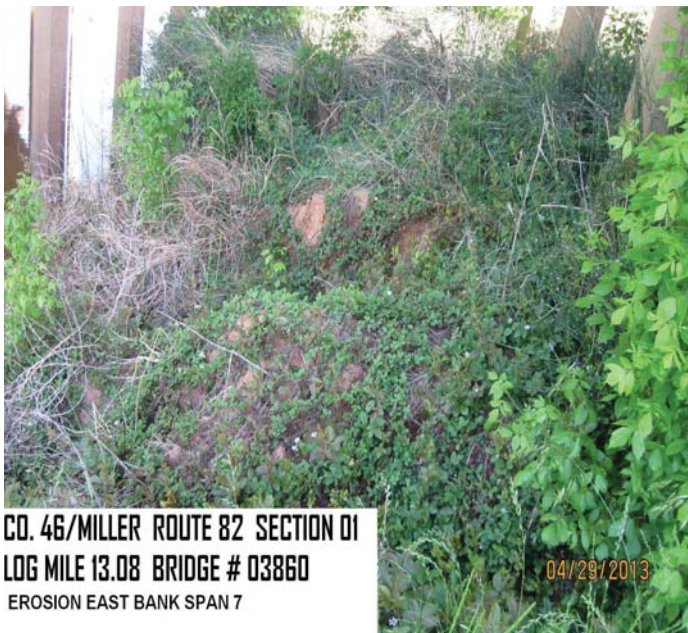
PHOTO 1 Description

MODERATE EROSION UNDER SPAN 7
ON EAST BANK

CO. 46/MILLER ROUTE 82 SECTION 01
LOG MILE 13.08 BRIDGE # 03860
EROSION EAST BANK SPAN 7
