Bridge #02122(Routine)

US 82-02-10.60 over BODCAW CREEK

Location: 1 MI WEST OF STAMPS

Team Lead: Dale Bittle Inspection Date: January 24, 2020

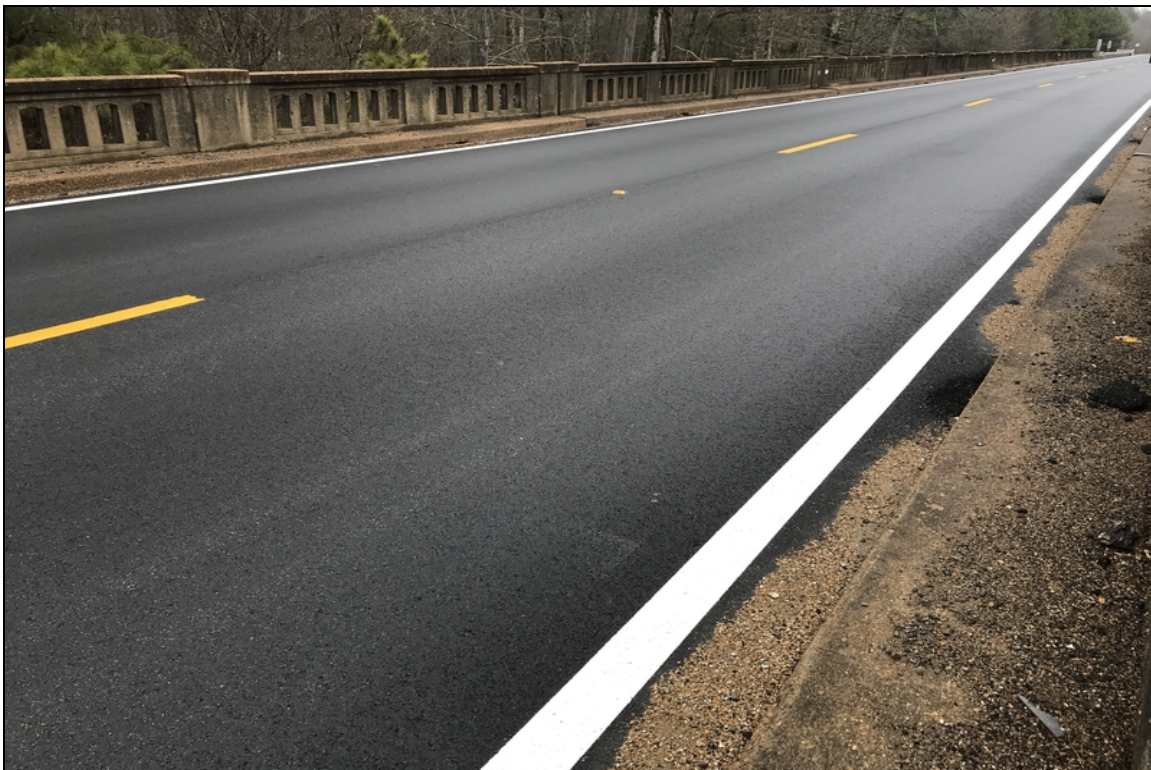
Deck

CONC. CURBS HAVE HEAVY SALT DAMAGE IN VARIOUS LOCATIONS....1/24/2019...AL, SS, Deck, Def. Photos taken. All joints have asphalt that is becoming unraveled and or missing causing impact loading in the adjoining spans and causing water and debris to collect on the caps...8/6/2019...Wearing surface on deck has changed from 2.5 in. to 3.5 in. due to mill and inlay on job #030540...08/07/2019 The referenced bridge has been load rated and a change in load posting is recommended. per ABM Abdullah...9/4/19....a semi truck damaged 160 ft of the guardrail on the southwest side of the bridge and broke the 3' wing loose from it's foundation,no other damage noticed..

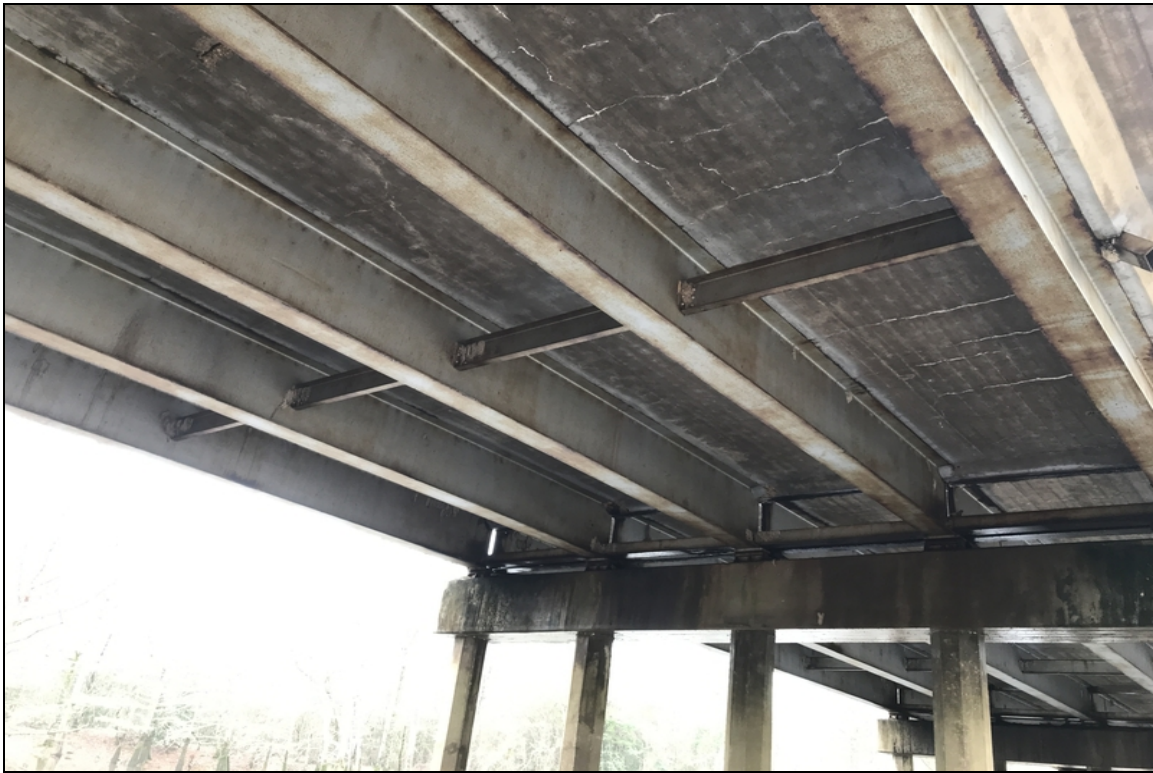
(12)							
1120- cracking with efflorescence all spans							
3210- potholes and spalling in AC overlay at joints							
3220- Map like cracking in AC overlay							
Spalls w/ rebar exposed in span 6 and 7, bottom of deck							
Spall on edge of deck at span 4, bent 5 RT side							
107	Steel Open Girder/Beam	LF	1811	1411	0	400	0
1000	Corrosion	LF	400	0	0	400	0
515	Steel Protective Coating	SF	15049	0	14249	800	0
3440	Effectiveness (Steel Protective Coatings)	SF	15049	0	14249	800	0

Underside of deck typical all spans

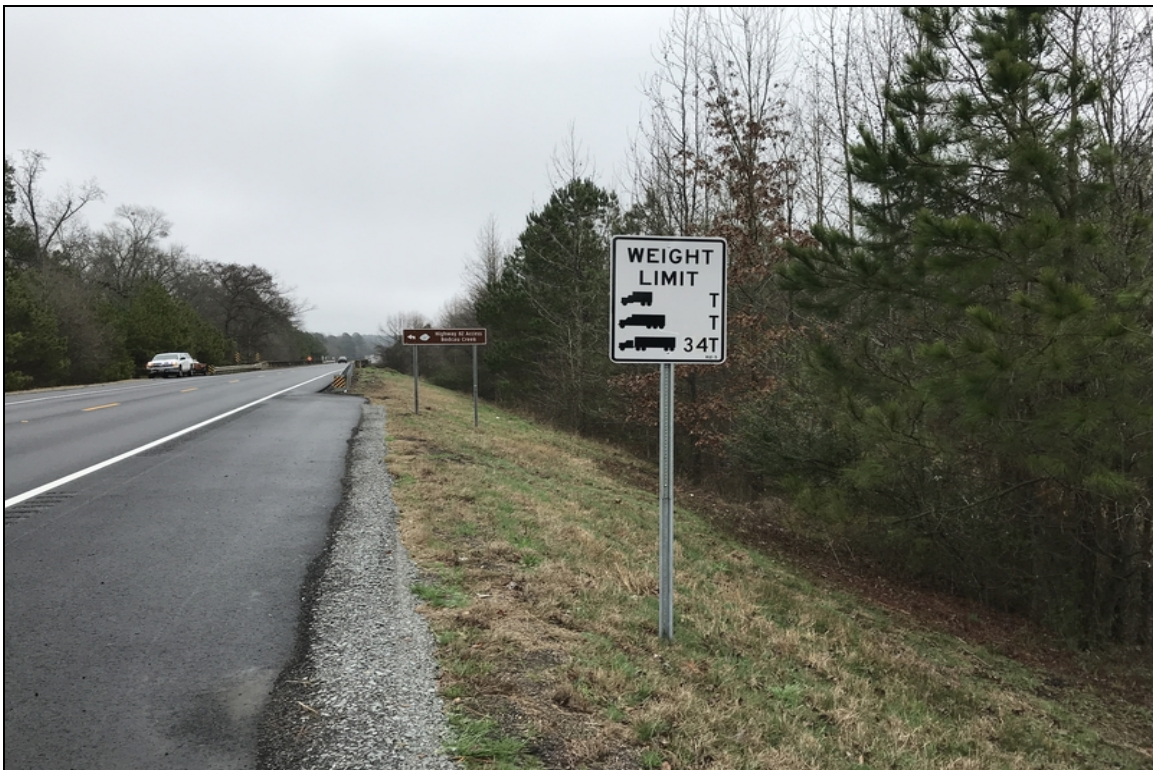
Posting beginning of bridge

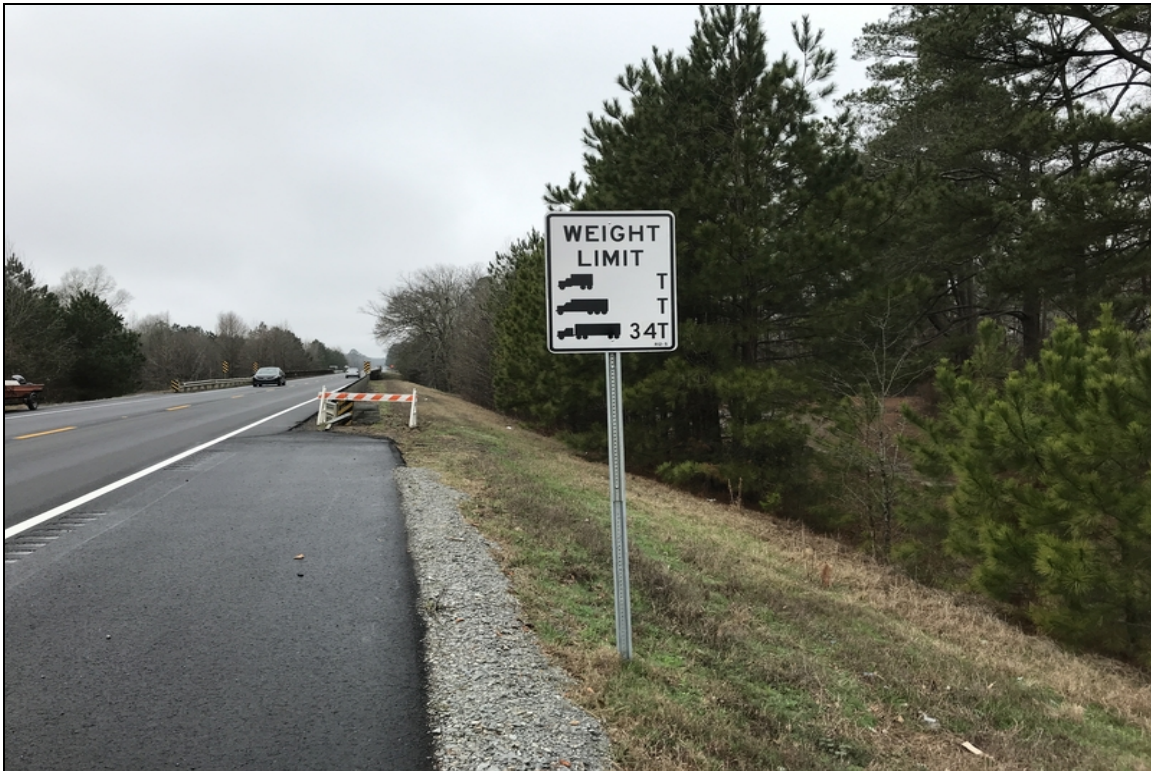
Posting end of bridge

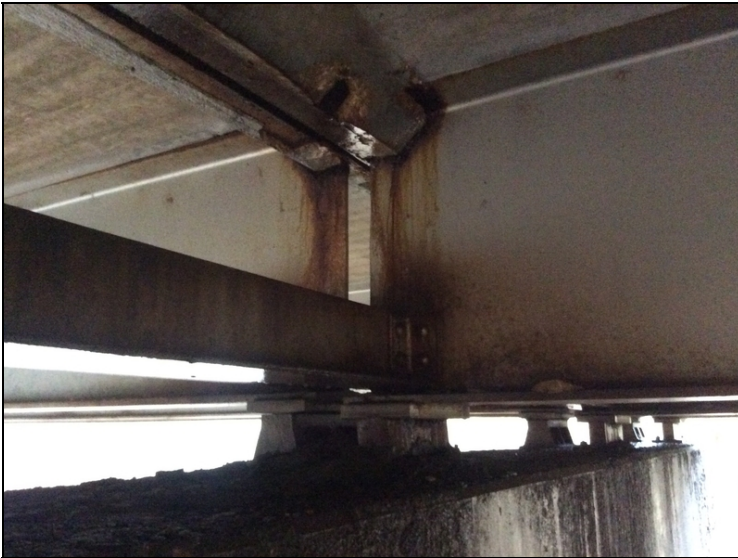
APPROX. 40% PAINT
DETERIORATION
WITH HEAVY RUST & SOME SECTION LOSS TO BEAM ENDS.

Rust at beam ends

6 SATISFACTORY PAINT SYSTEM HAS FAILED ON BEAMS W/ SURFACE RUST AND SOME SECTION LOSS TO ENDS OF BEAMS OVER CAPS.

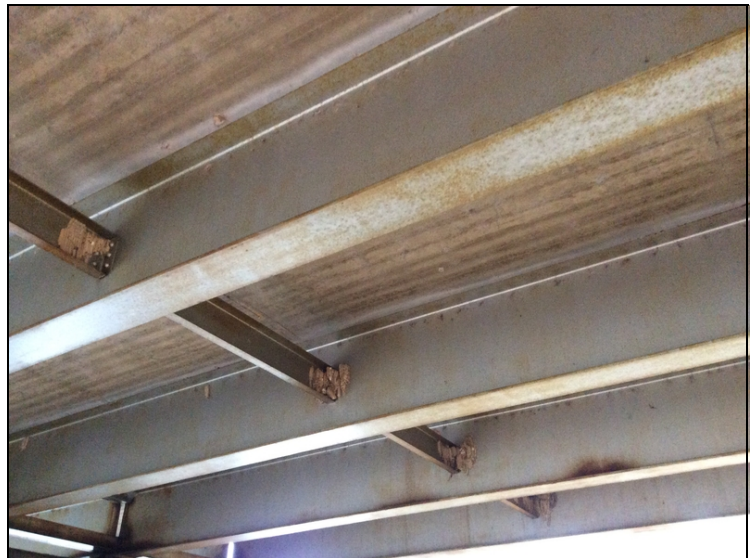
Rust on beams all spans typical

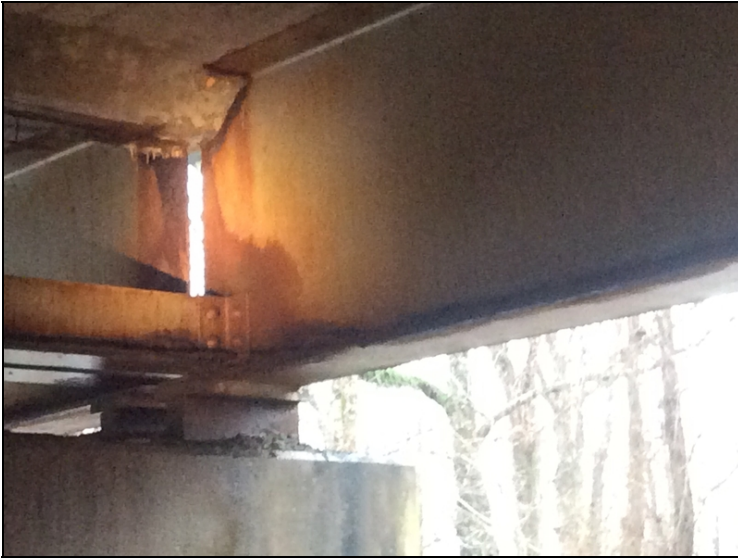
End of beam and bottom flange beam 1 span span
8 over bent 7

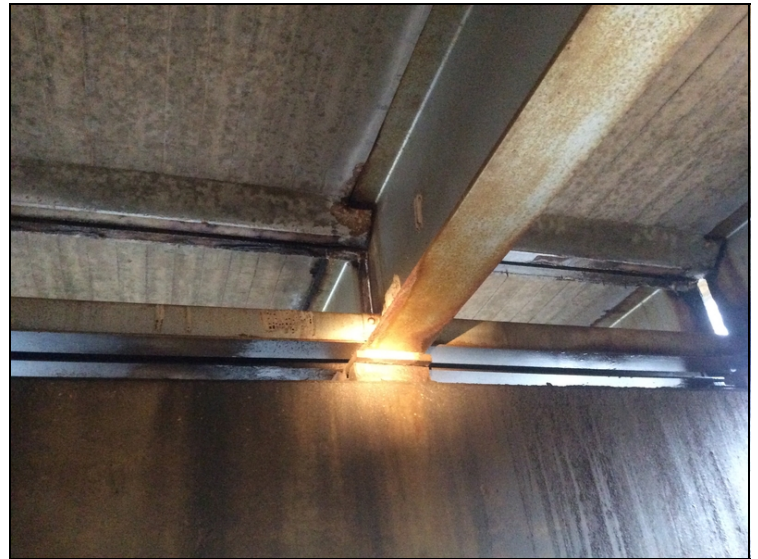
Beam rust typical

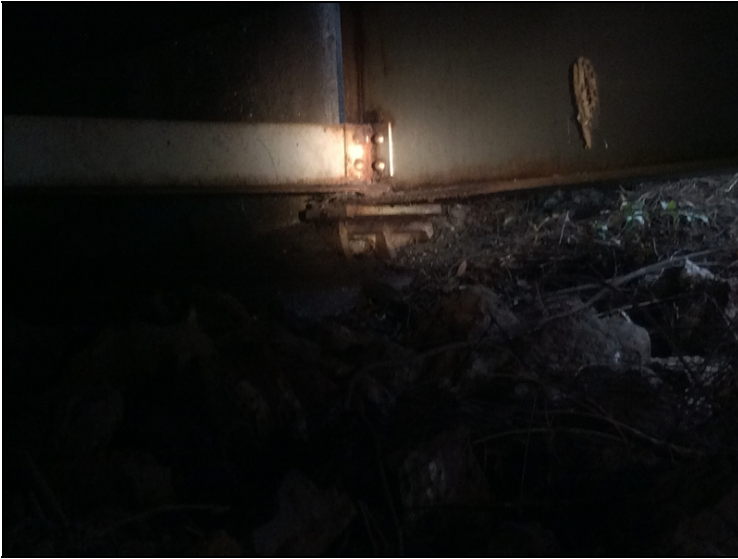
(107)							
1000- section loss to beam ends							
3440- condition 2 for freckled rusting in all spans all beams. condition 3 for heavier rust at beam ends.							
215	Reinforced Concrete Abutment	LF	72	72	0	0	0
220	Reinforced Concrete Pile Cap/Footing	LF	63	63	0	0	0
226	Prestressed concrete piles	EA	37	31	6	0	0
1080	Delamination/Spall/Patched Area	EA	6	0	6	0	0

Corrosion end of beam 5 bent 8 pack rust and
section loss

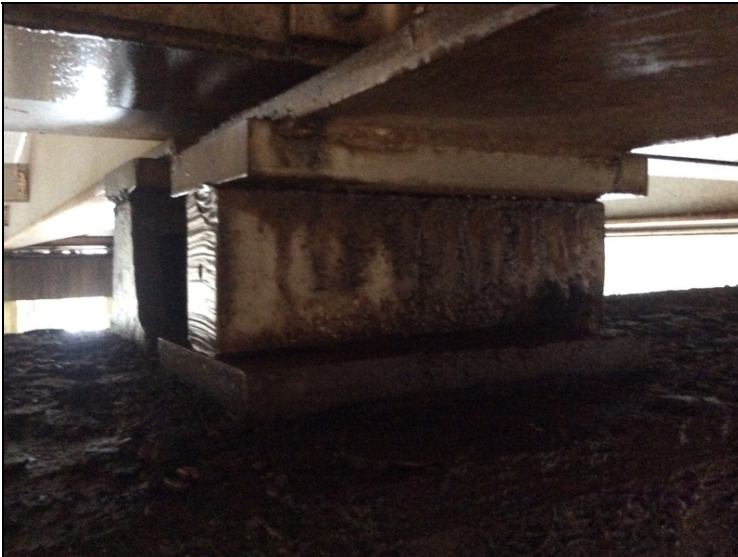
ADVANCED RUST WITH
SECTION LOSS TO ALL
BEARINGS.

Bearings rust and section loss Bents 1-9

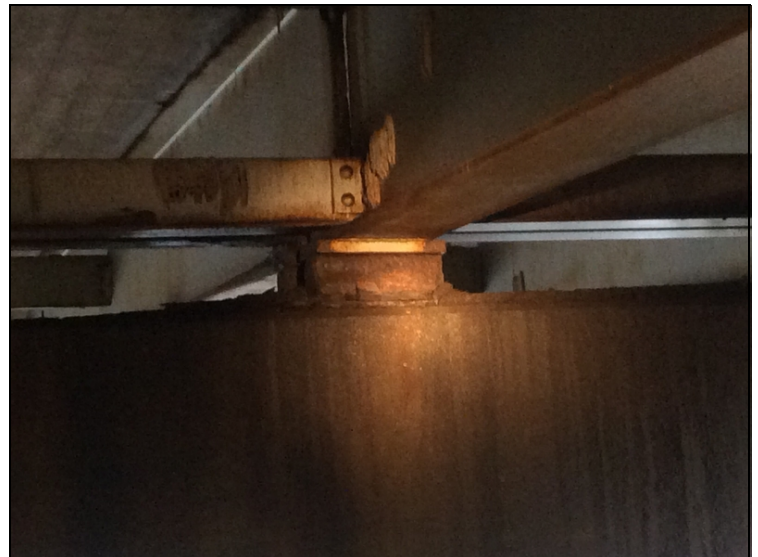
Section loss to bearings

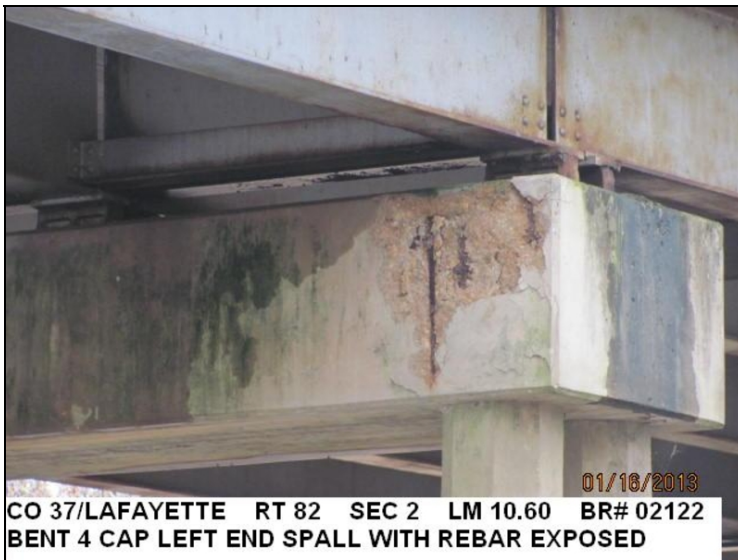
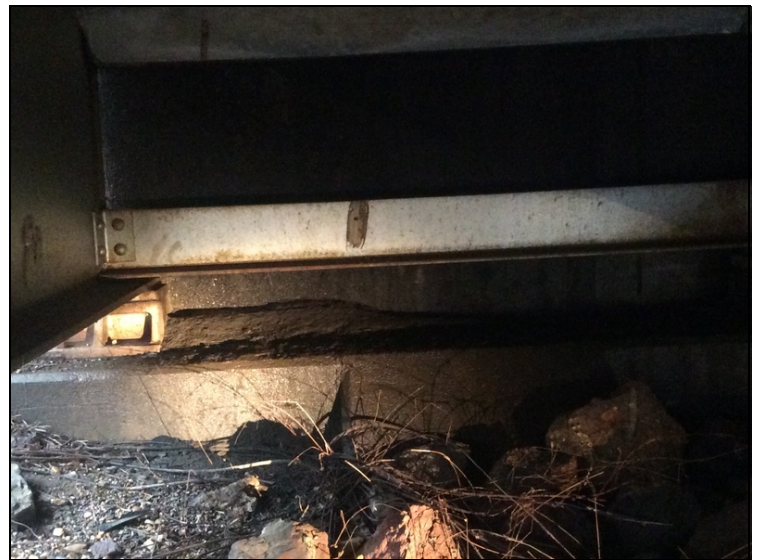
- 1) BENTS #4 & #5
SPALLS & DELAMS. ON
FACE OF CAPS AT ENDS OF CAP
- 2) BENTS #1 & #9
DEBRIS ON CAPS AND
BEARINGS

Debris on caps 1&9

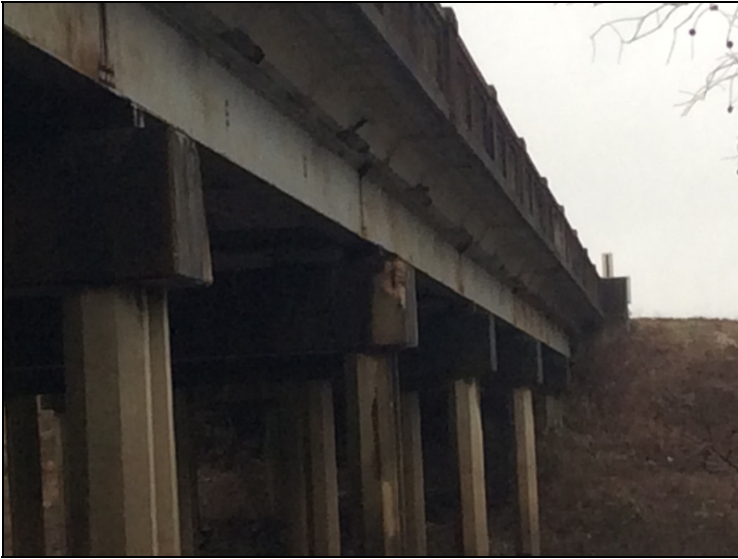
(226)							
1080- patched piling at Bents 4 and 5							
234	Reinforced Concrete Pier Cap	LF	200	194	0	6	0
1090	Exposed Rebar	LF	6	0	0	6	0
(234)							
1090- bent 4 and 5 cap right and left end rebar exposed							
303	Assembly Joint with Seal	LF	236	236	0	0	0
311	Movable Bearing	EA	40	0	0	40	0

Rebar exposed and spall right end of bent 5 cap

6 SATISFACTORY PILE/COLUMNS @ BT. #4 & #5 ARE SPALLED W/ REBAR EXPOSED SPALLS ON CAPS AT BENT #4 & #5.

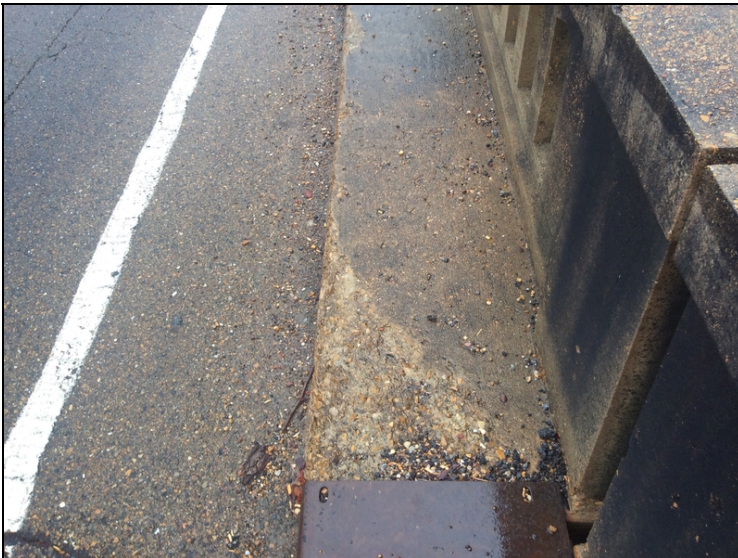
LT. SIDE OF DECK HAS
SALT CONTAMINATION
W/ REBAR EXP'D TO CURB
AND SIDEWALK. 1/14/2020...RT side curb and sidewalk has loose asphalt and debris.

Curb left side various locations spalls

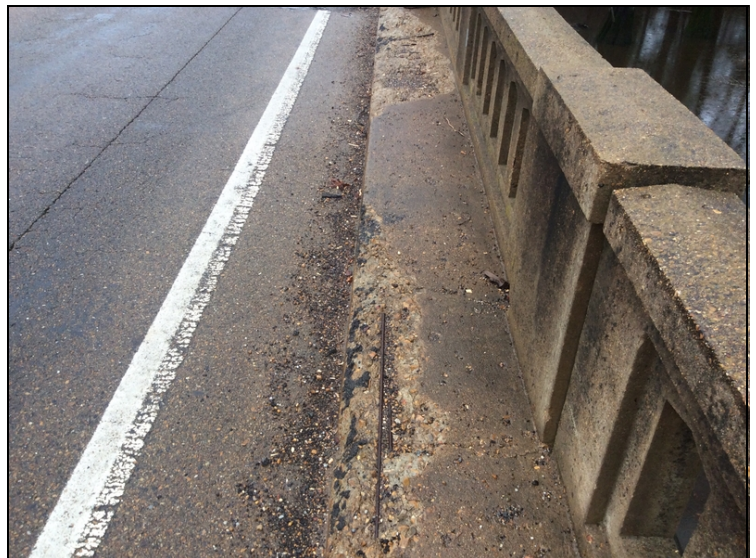
Spalls with rebar exposed curb left side various locations

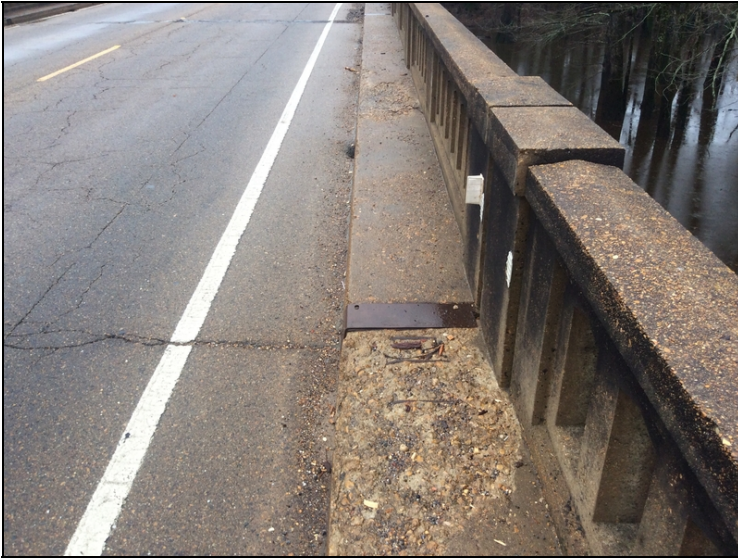
Curb left side spalls various locations

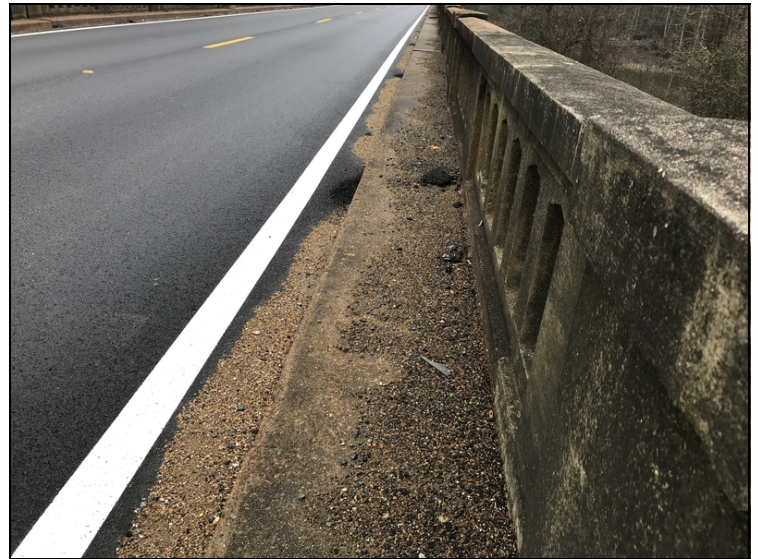
RT side curb and sidewalk has loose asphalt and debris.

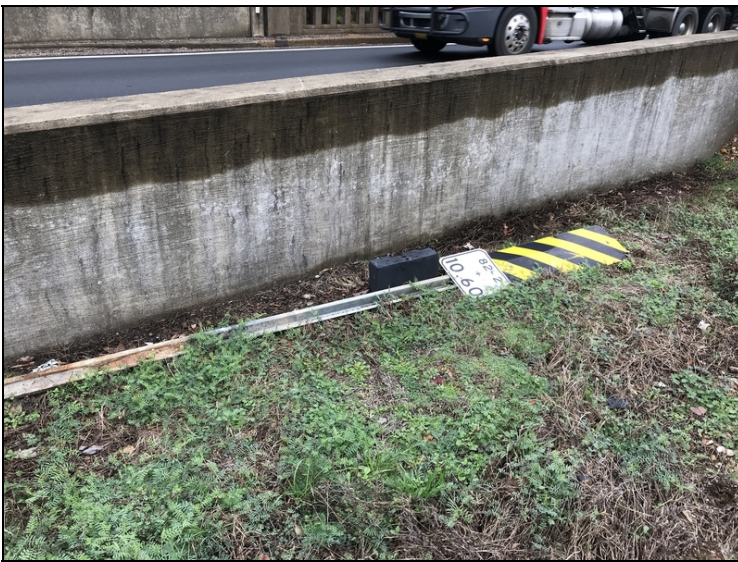
Log mile sign down at beginning of bridge, RT side.

Date Reported: 01/15/2020
Priority: D- Routine
Type of Work: Repair
Status: Assigned
Component: Approach
