Bridge #02549(Routine)

US 82 SEC.01 -7.37 over MILL CREEK

Team Lead: Charlie Rogers Inspection Date: August 21, 2019

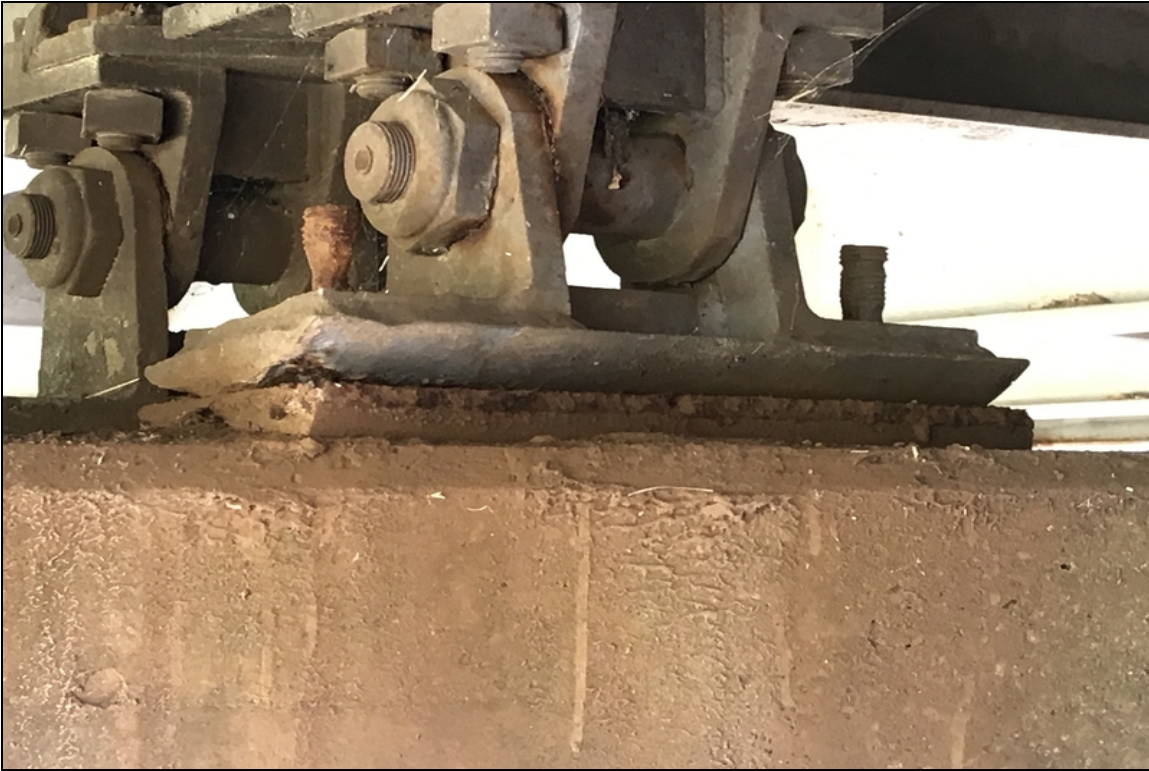
(311)	Span 1 beam 2 bearing shows some vertical movement 1/8" under heavy truck traffic. Sole plate are showing signs of wearing on rocker bearings typical all.. some bearing have heavy pack rust and anchor bolt are rusted in two.....						
313	Fixed Bearing	EA	20	0	0	20	0
1000	Corrosion	EA	20	0	0	20	0

(313)	Span 1 beam 2 bearing shows some vertical movement 1/8" under heavy truck traffic. Sole plate are showing signs of wearing on rocker bearings typical all.. some bearing have heavy pack rust and anchor bolt are rusted into.....						
331	Reinforced Concrete Bridge Railing	LF	245	245	0	0	0

Typical of all bearings

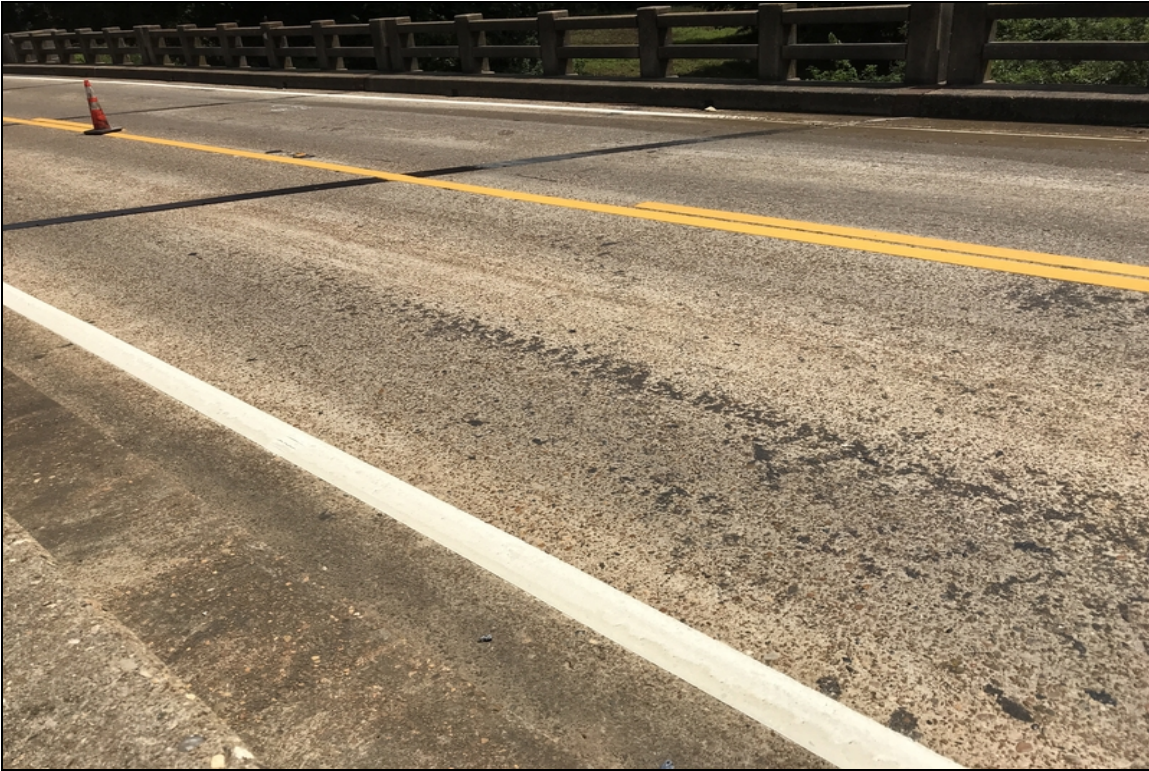
Deck

(12)	Rebar exposed RT side span 3.. cracks sealed in past....						
107	Steel Open Girder/Beam	LF	600	540	60	0	0
1000	Corrosion	LF	60	0	60	0	0
515	Steel Protective Coating	SF	4206	3206	1000	0	0
3430	Oxide Film Degradation Color/Texture Adherence(Steel Protective Coatings)	SF	1000	0	1000	0	0

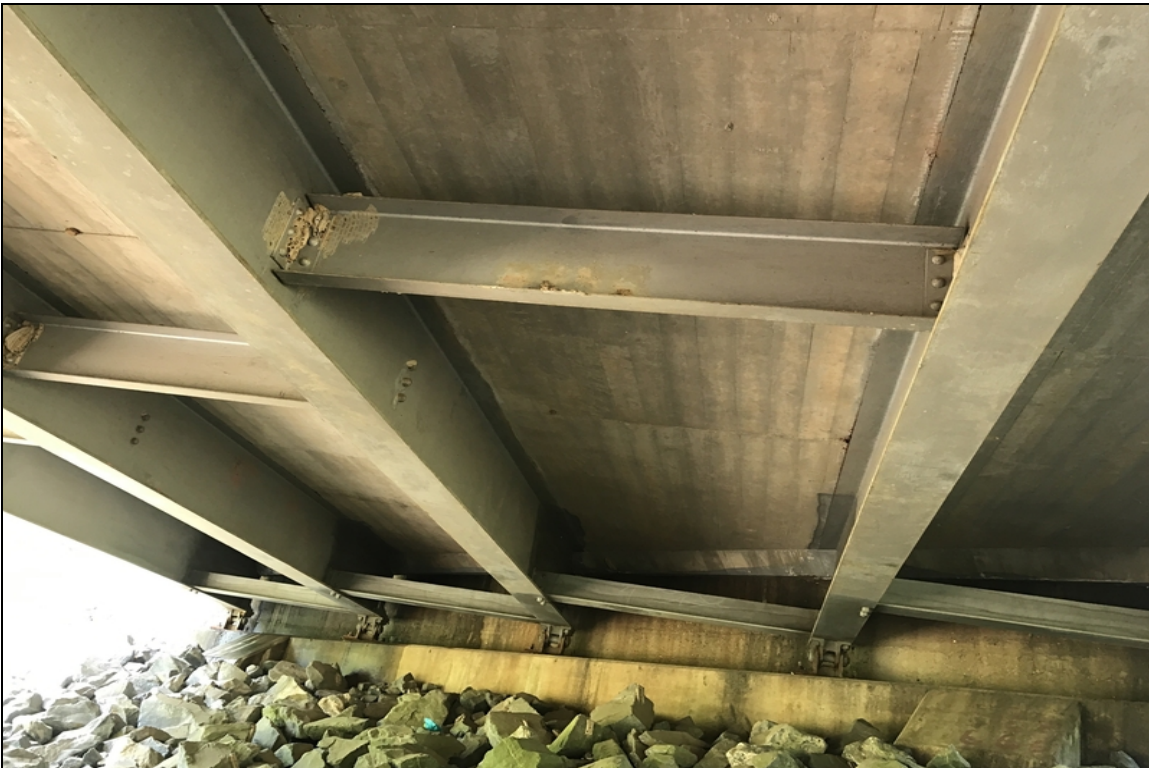
Underside of deck typical all spans

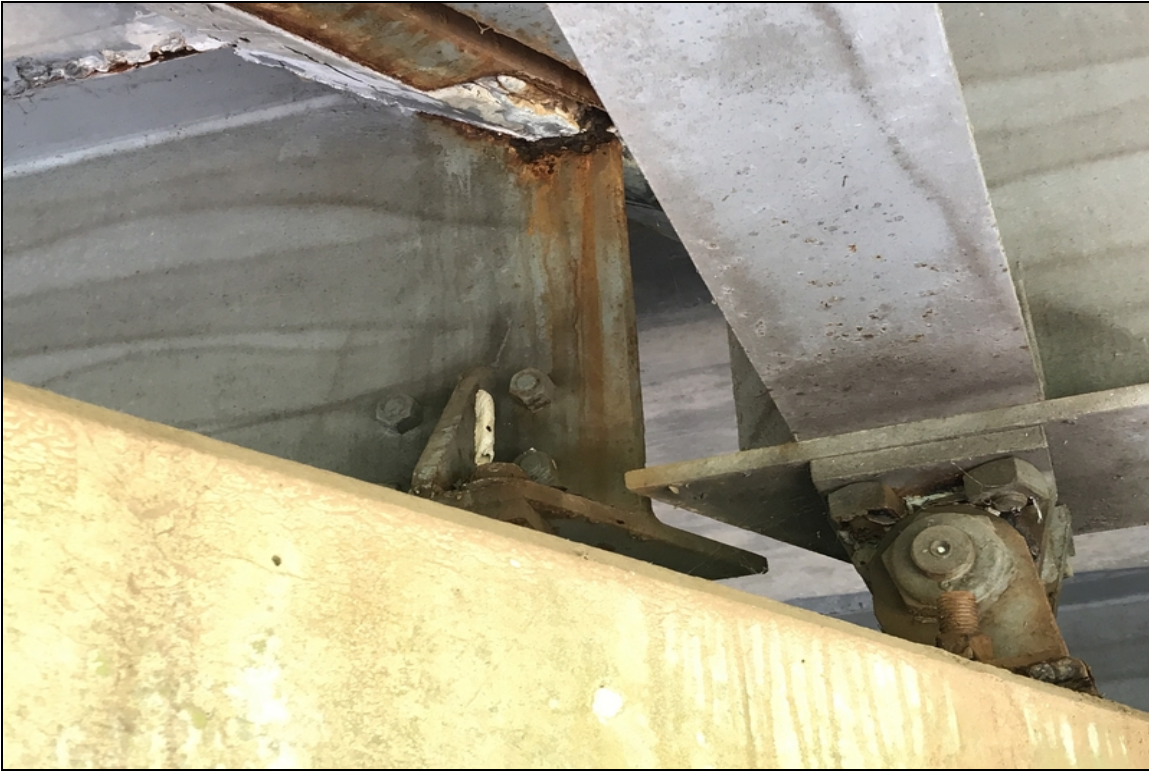
(107)	Beam ends have rust and some section loss in various locations...						
215	Reinforced Concrete Abutment	LF	92	92	0	0	0
227	Reinforced Concrete Pile	EA	15	15	0	0	0
234	Reinforced Concrete Pier Cap	LF	153	153	0	0	0
303	Assembly Joint with Seal	LF	170	170	0	0	0
311	Movable Bearing	EA	20	0	0	20	0
1000	Corrosion	EA	20	0	0	20	0

Typical of the beam ends

8/21/2019...Beam ends have some section loss in various locations....Dropped superstructure to a 4 due to beam ends showing some rusting and section loss in various locations, advanced section loss to fixed and movable bearings...
