Bridge #03089(Routine)
US 70 SEC.05 -8.74 over CADDO RIVER

Location: .05 MI E JCT SH 8 SEC 4

Team Lead: Charlie Rogers Inspection Date: July 23, 2019

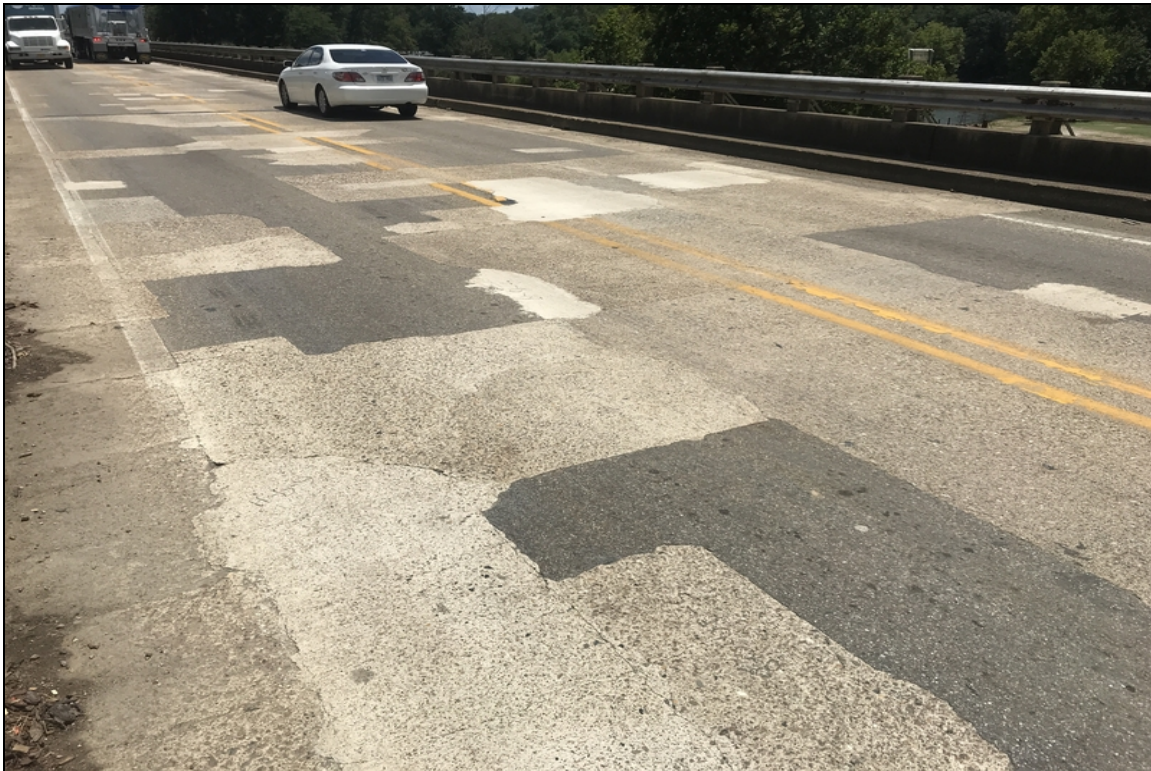
Deck

07/20/2017 AL,SS,CH,DECK,DEF PHOTO TAKEN. Large amounts of patch area top of deck...
BOTTOM SIDE OF DECK HAS SOME SPALLS W/REBAR EXPOSED DRAINS RT AND LT SIDES TYP. ALL SPANS SPALLS
AND DELAMS...SPAN 1 RIGHT SIDE CURB SPALL VARIOUS LOCATIONS...SPAN 8, RIGHT CURB SALT DAMAGE
W/REBAR. SOME PATCH WORK DONE IN 2017 NEW DRAWINGS DONE7/03/2018 AL,SS,DECK,REPAIR PHOTOS
TAKEN...7/23/2019...AL, SS, Deck photos taken. Updated deck patch quantities per this inspection...

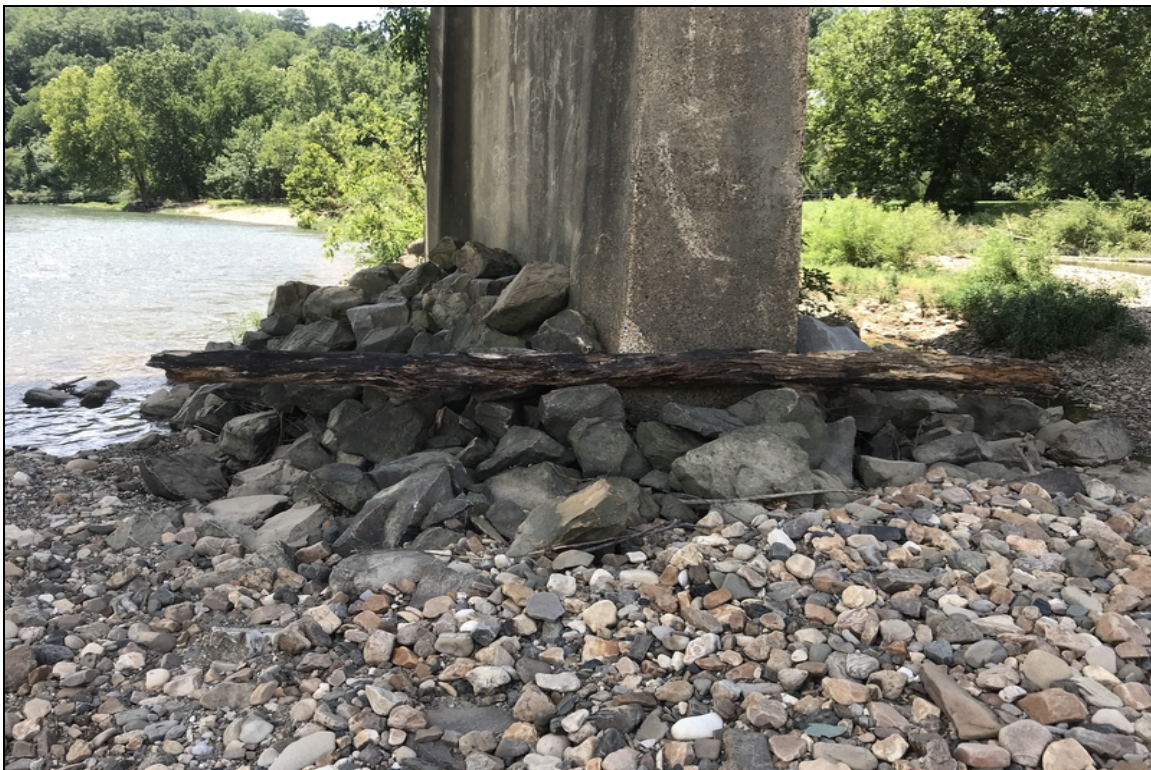
Bent 5 rip rap

Columns: riprap placed at bents 3,4,5,6,7,8,and 9 by crew 03551 in 2011.....CONCRETE CAPS:

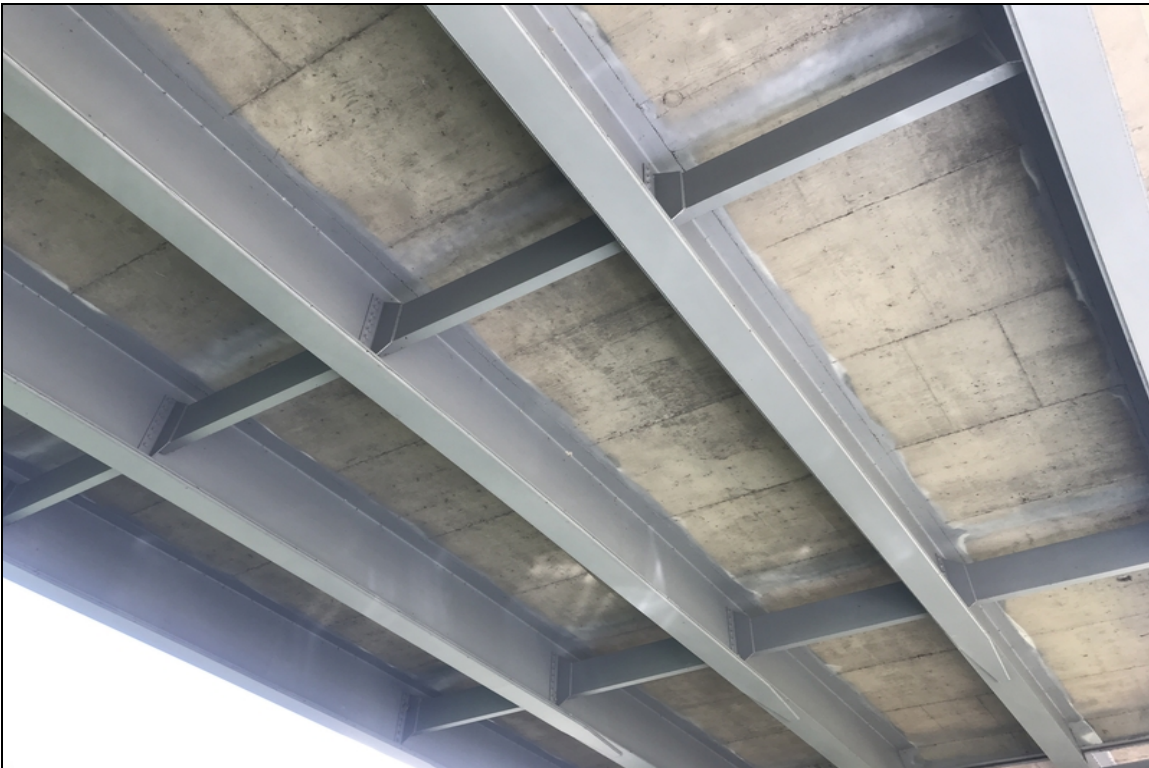
Underside of deck typical all spans

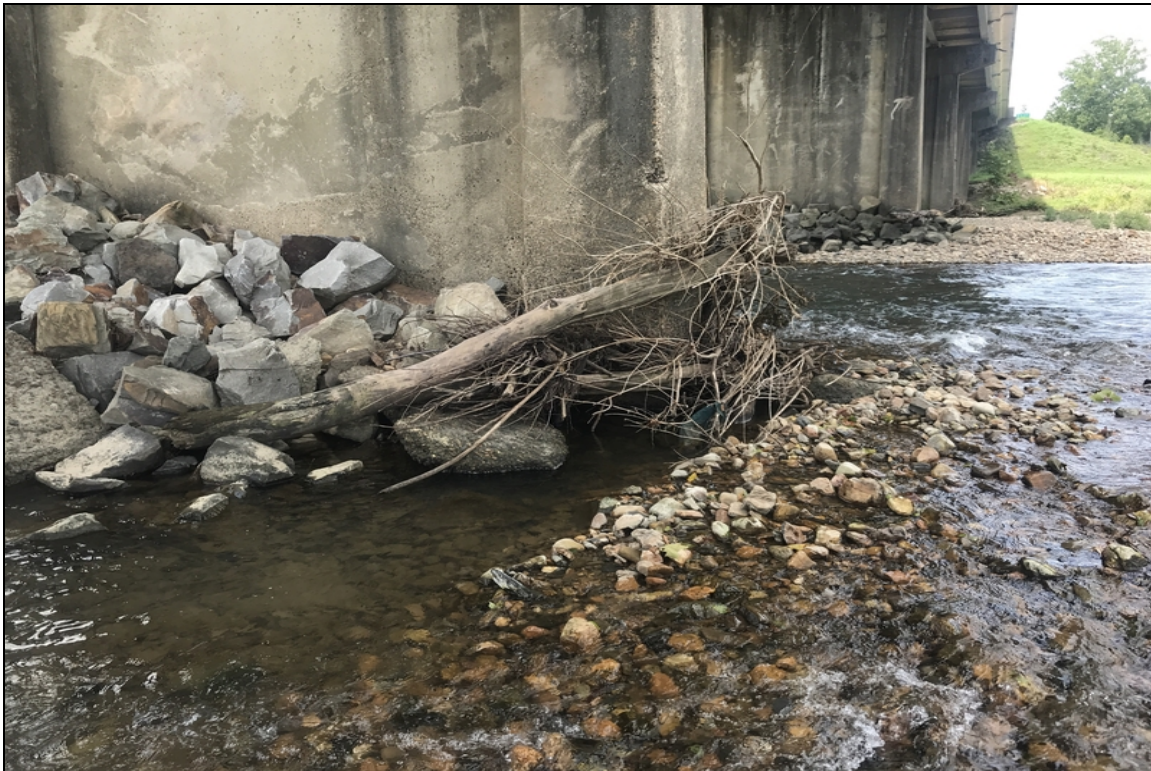
Drift at bent 6

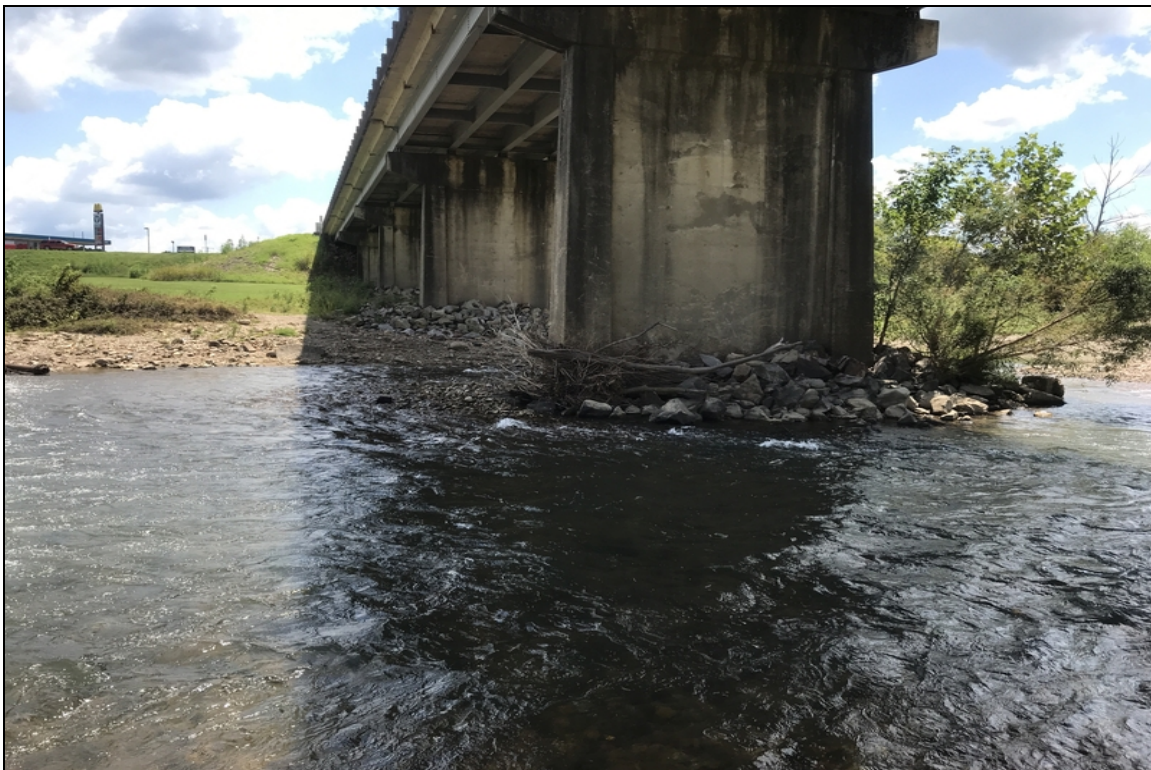
Bent 6 and 7 rip rap
