Bridge #03602(Routine)

US 278-02-19.09 over SALINE RIVER

Team Lead: Charlie Rogers Inspection Date: December 04, 2019

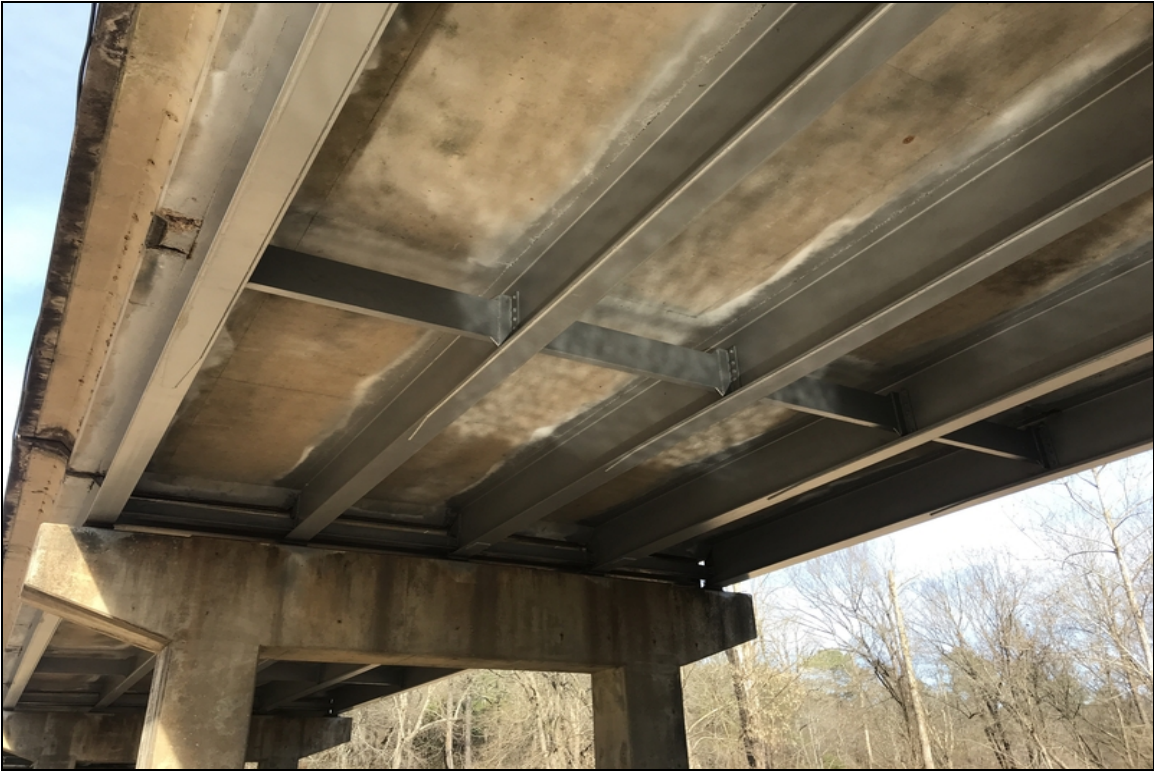
Under photo

Underside of Deck: spalls with rebar exposed in some areas

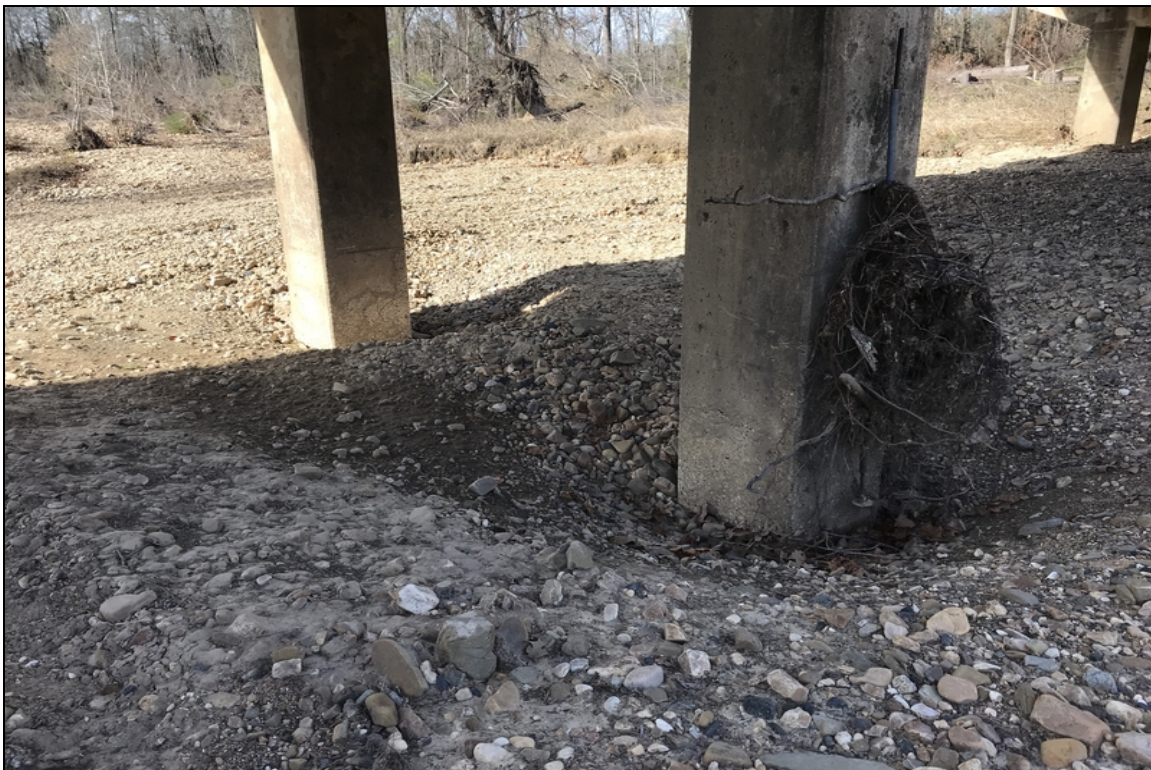
Bent #5 scour around columns

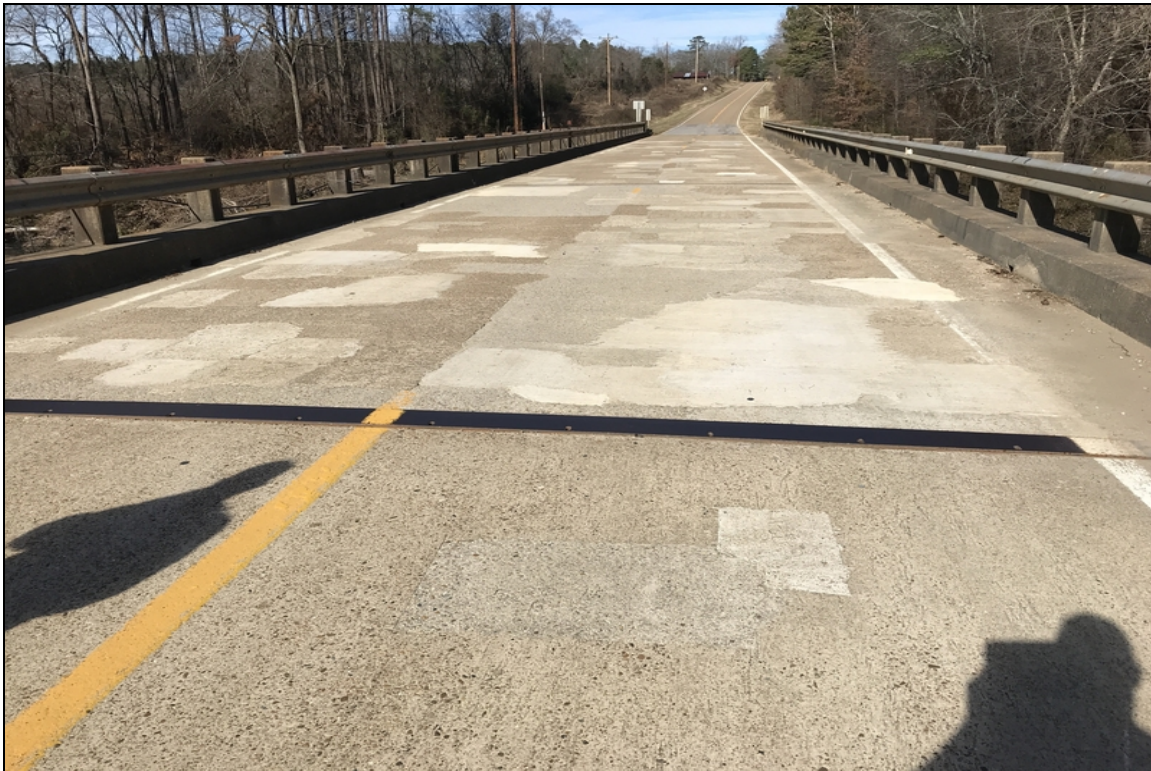
Deck photo

Wearing Surface: 74 % patch area on top of deck
