# Bridge Inspection Report

**05817**  
**US 71\_04\_0.30 (NB)**  
**over**  
**RED RIVER**

Structure Number: 05817

Facility Carried: US 71\_04\_0.30  
(NB)

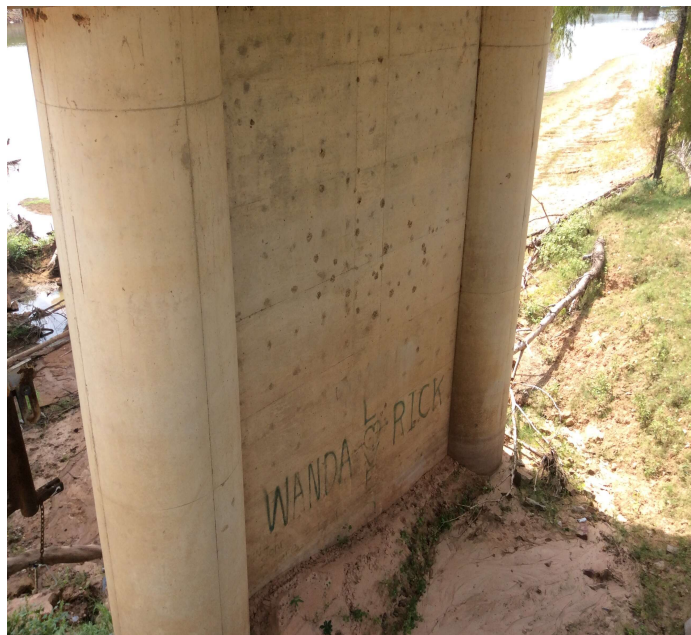
PHOTO 1 Description BENT 10

-COLUMNS AND WEBWALLS-  
MINOR SPALLS CAUSED BY BULLET IMPACTS.TYPICAL CONDITION BT 10, 11 AND 14

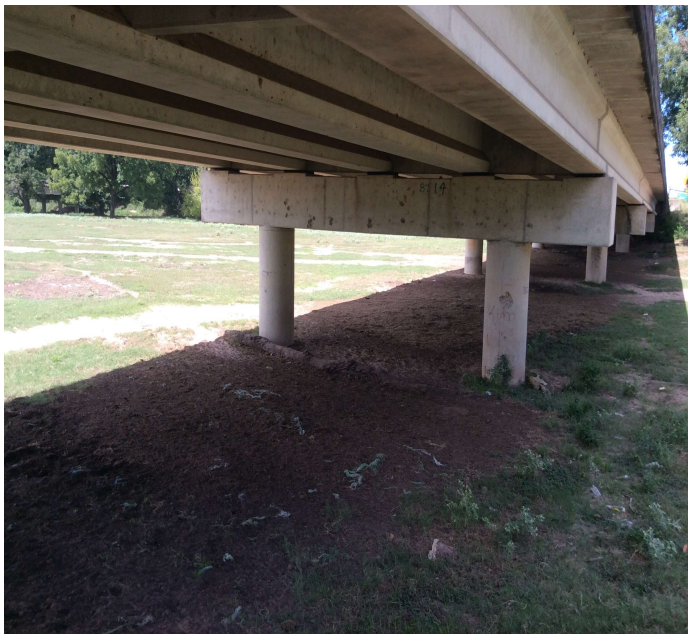
VERTICAL CRACKS AT ALL CAPS... MINOR SPALLS CAUSED BY BULLET IMPACTS ON CAPS TYPICAL... BT 10 CAP HAS SMALL SPALL AT THE BOTTOM RT END... BT 15, GIRDER 3,4,5, SPALLS DEVELOPING AT BEARING AREA

PHOTO 1      Description      BENT 14 BULLET HOLE SPALLS.  
TYPICAL OF CAPS

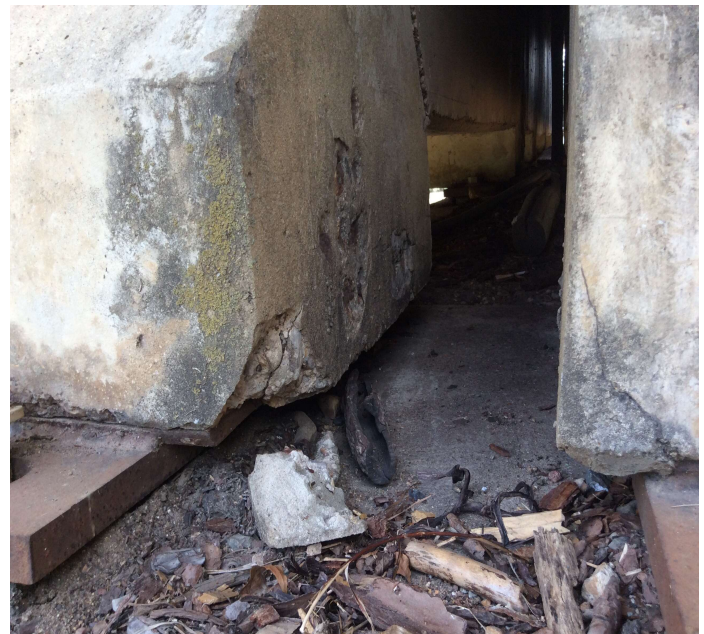
PHOTO 2      Description      BENT 15 SPALLS AT BEARING AREA  
BEAM 3,4, AND 5

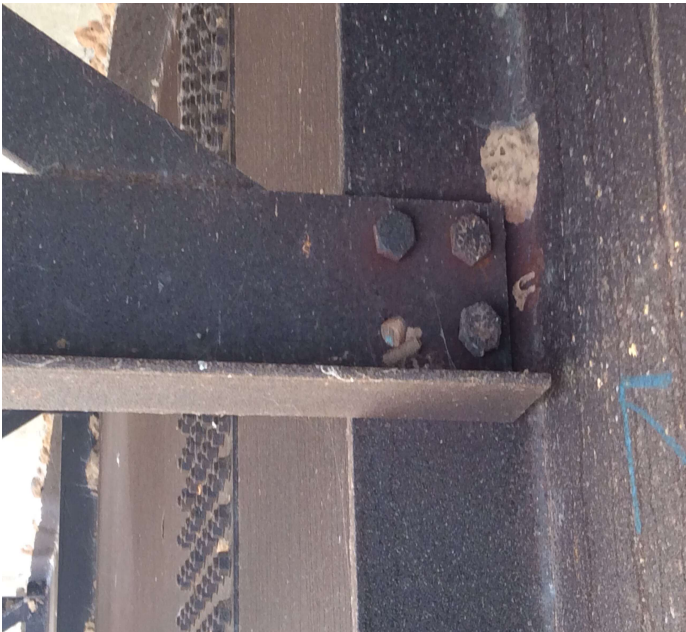
2 BOLT MISSING AND 2 BOLTS LOOSE AT BM 2  
2ND CROSS BRACE ,SPAN 9 JUST PAST BT 9

PHOTO 1      Description      1 missing bolt and 1 loose bolt beam 2  
bay 1 span 9 2nd crossbrace in span 9

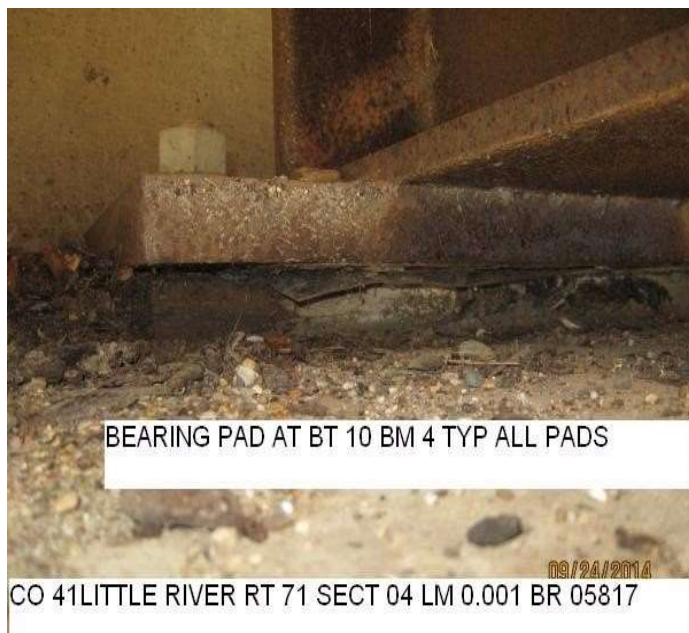
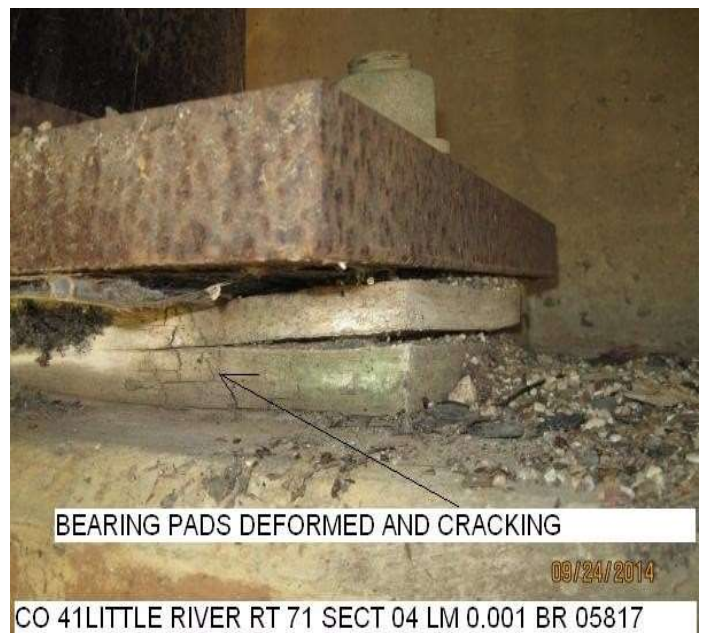
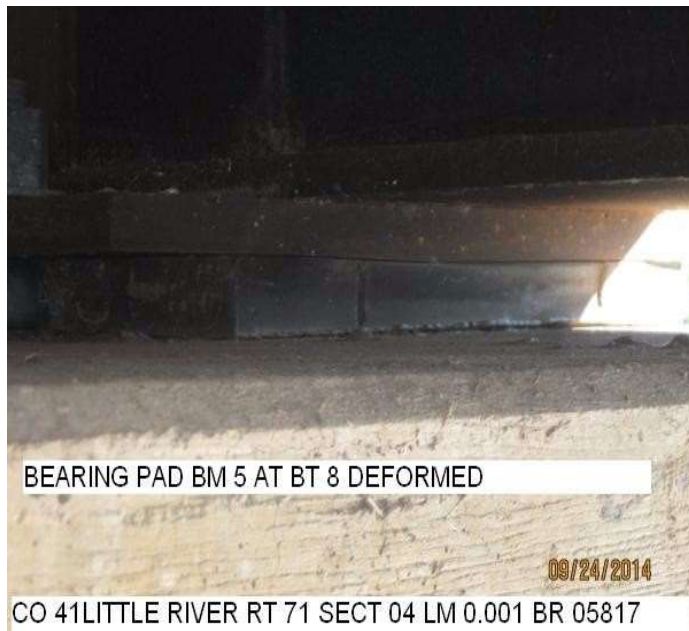
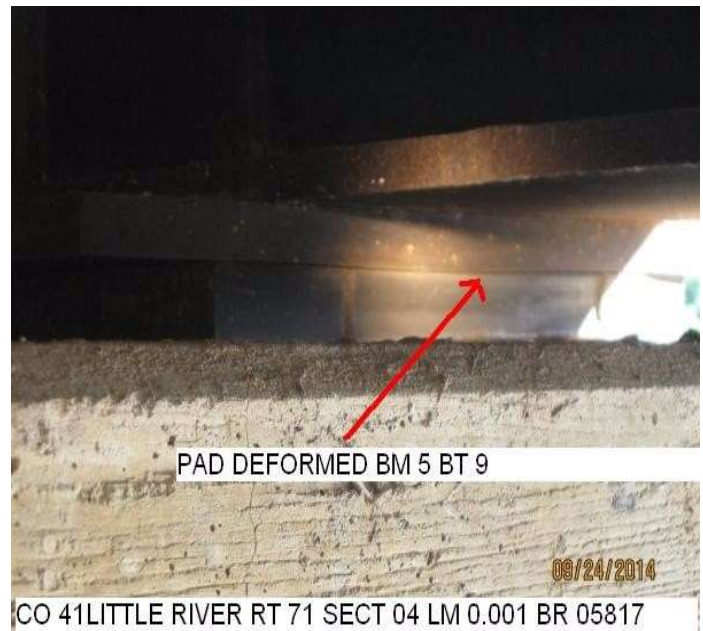
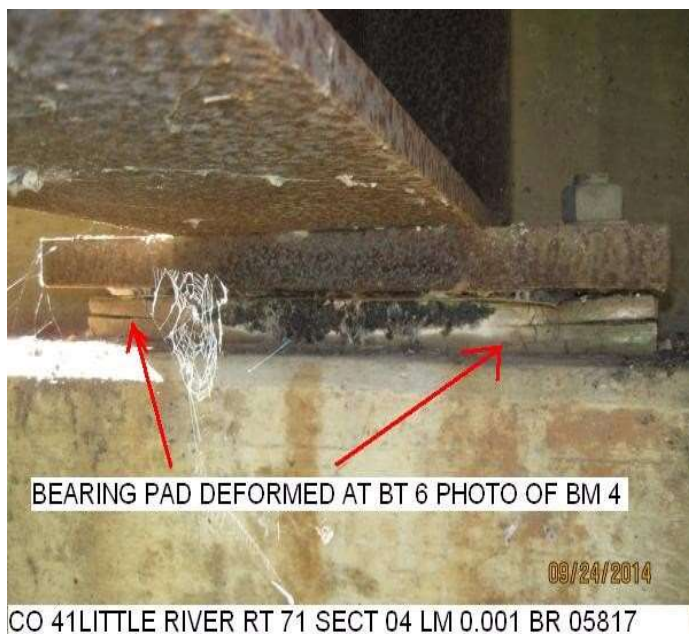
BEARING DEVICES AT BT 6 , 9, 10, 15 PACK RUST FORMING BETWEEN THE STAINLESS STEEL SLIDE AND THE SOLE PLATE ON THE GIRDER. PADS ARE DEFORMED AT THESE LOCATIONS.

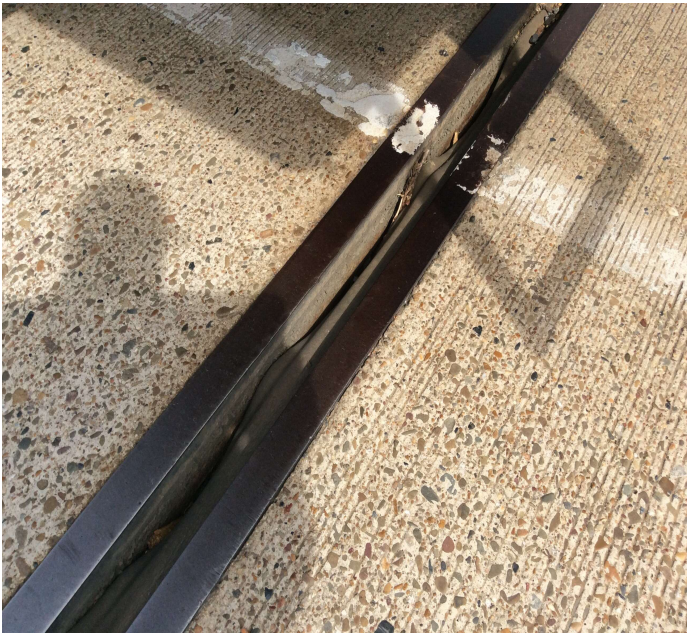
PHOTO 1      Description

BT 15 SSI JOINT SEAL MATERIAL HAS LOST ADHESION TO THE JOINT ARMOR

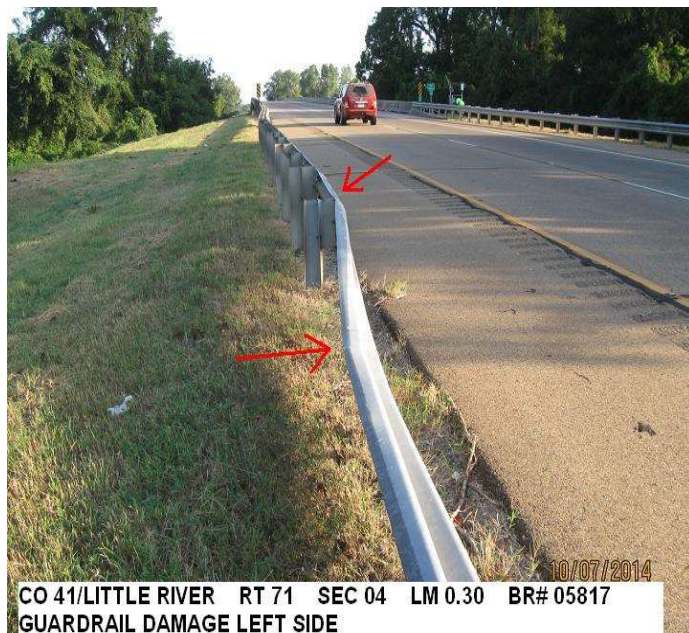
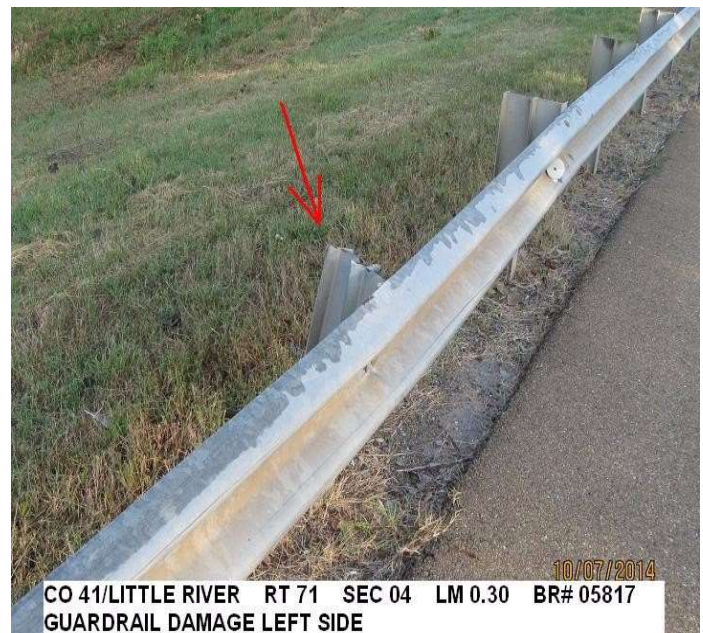
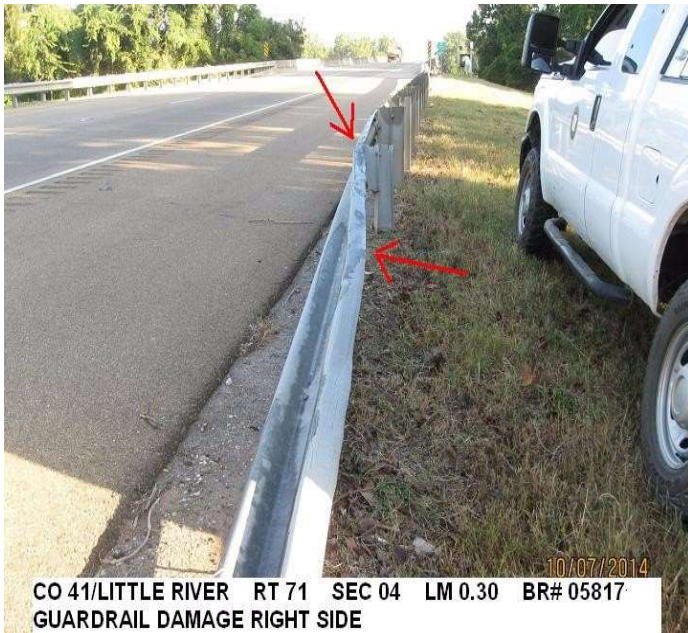
SOUTH APPROACH HAS MINOR COLLISION DAMAGE TO APPROACH RAIL LT AND RT SIDE

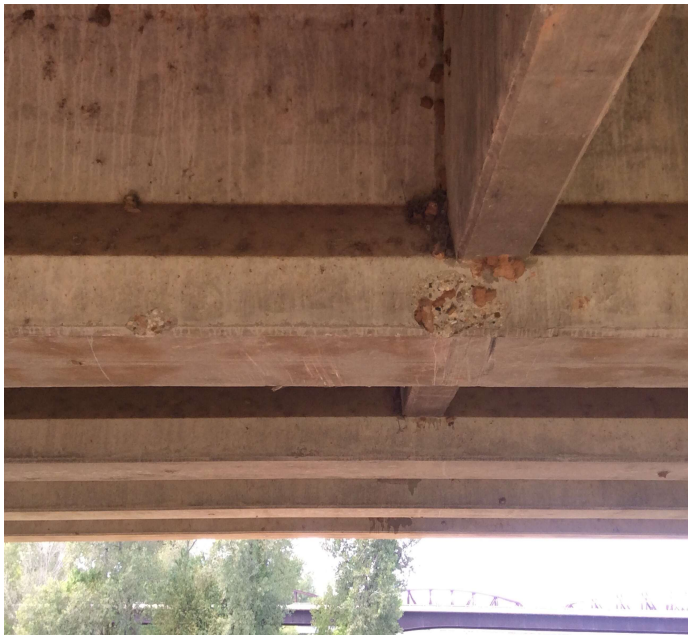
SPAN 5 BEAM 4...

PHOTO 1      Description      SPAN 5 BEAM 4 SPALL

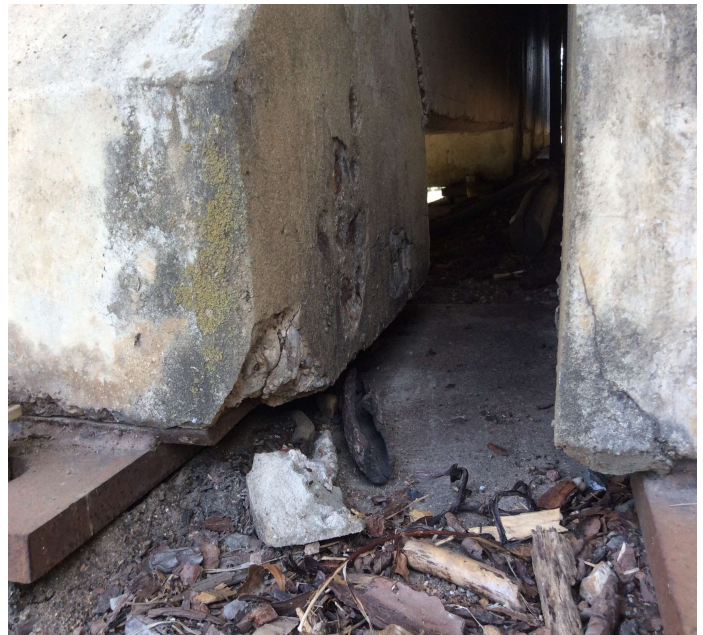
PHOTO 2      Description

BT 15 MINOR SPALL AT END GIRDER AT BEARING AREA...

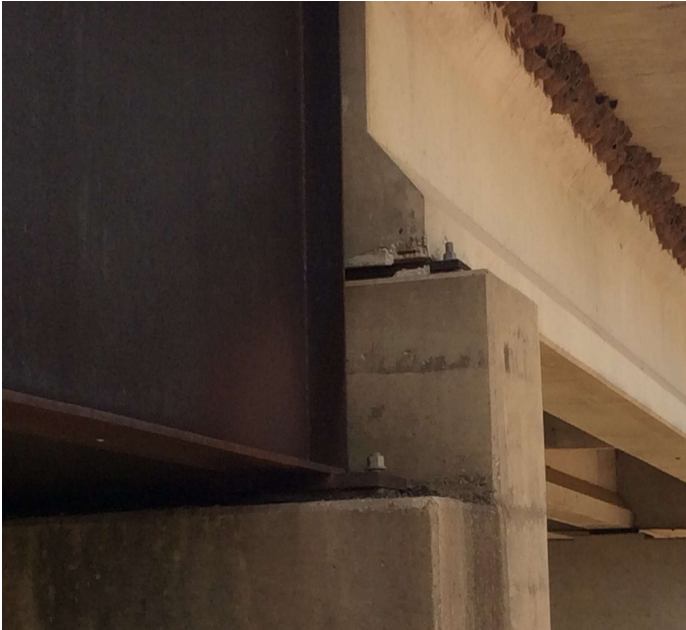
PHOTO 3 Description BENT 10 BEAM 5

BT 10 BM 5 RT END GIRDER SMALL SPALL...

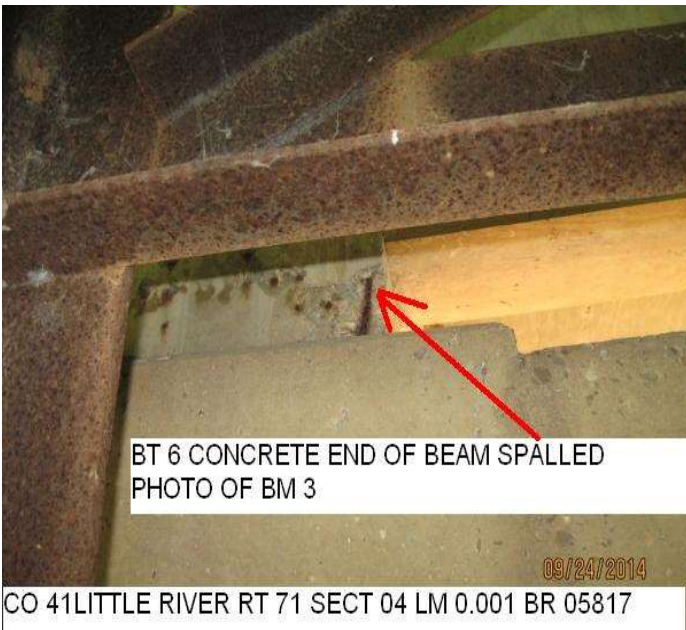
PHOTO 4 Description BENT 6 END OF BEAM

BT 6 BM 3 END SMALL SPALL TYP ON CONCRETE ENDS...

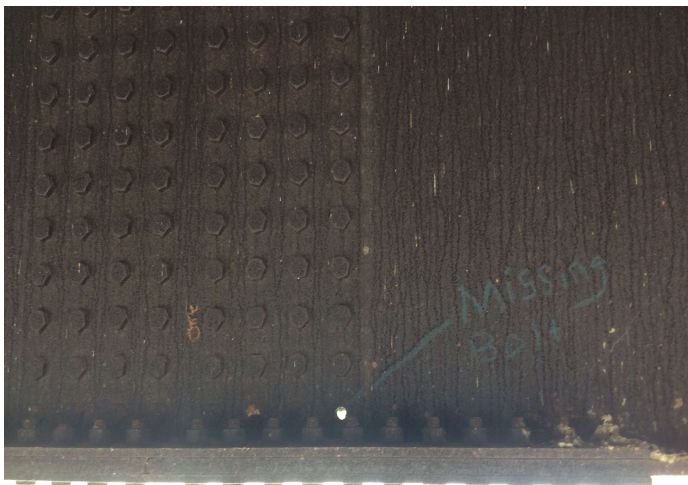
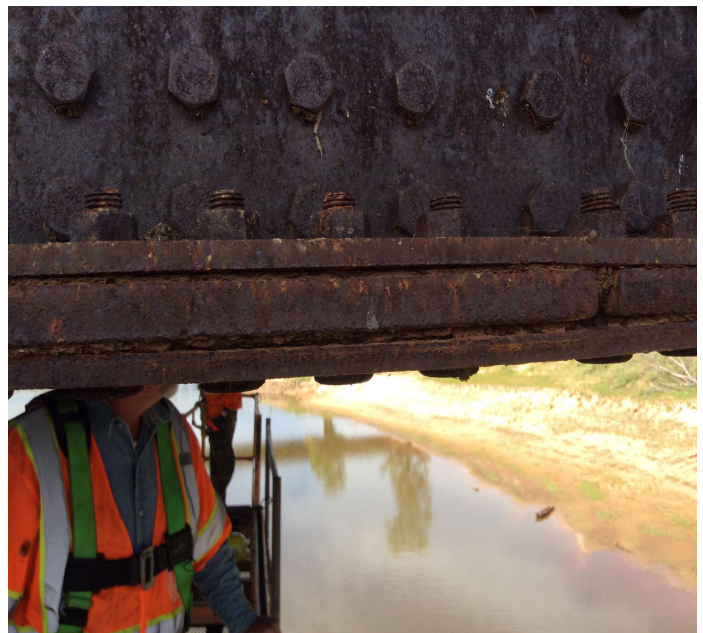
1 BOLT MISSING AT BT 8 1ST SPLICE PLATE SPAN 8  
CLOSE TO BOTTOM OF WEB , NEXT TO BOTTOM FLANGE.
