Bridge #02621 (Routine)
State Highway 59 over Huey Creek - Crawford Co

Location: 18.25 N JCT I 40

Team Lead: Jeff Jones Inspection Date: April 30, 2020

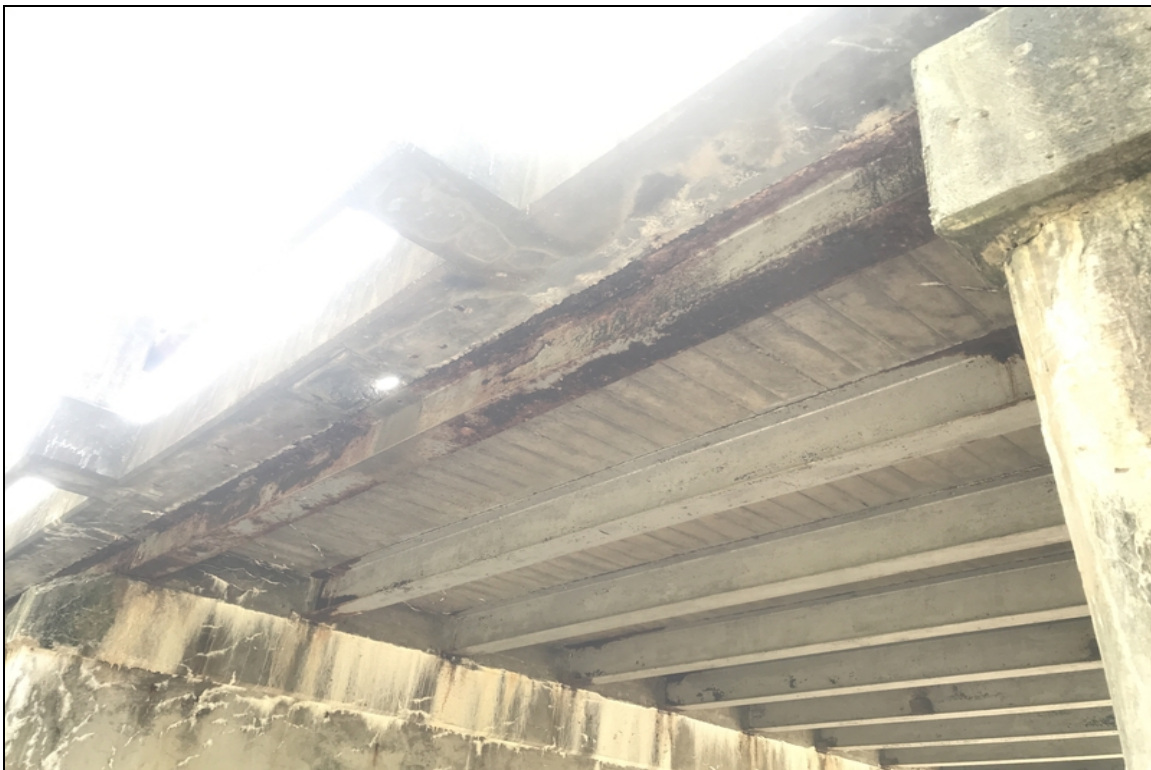
Span 3 Beam 1 active corrosion.

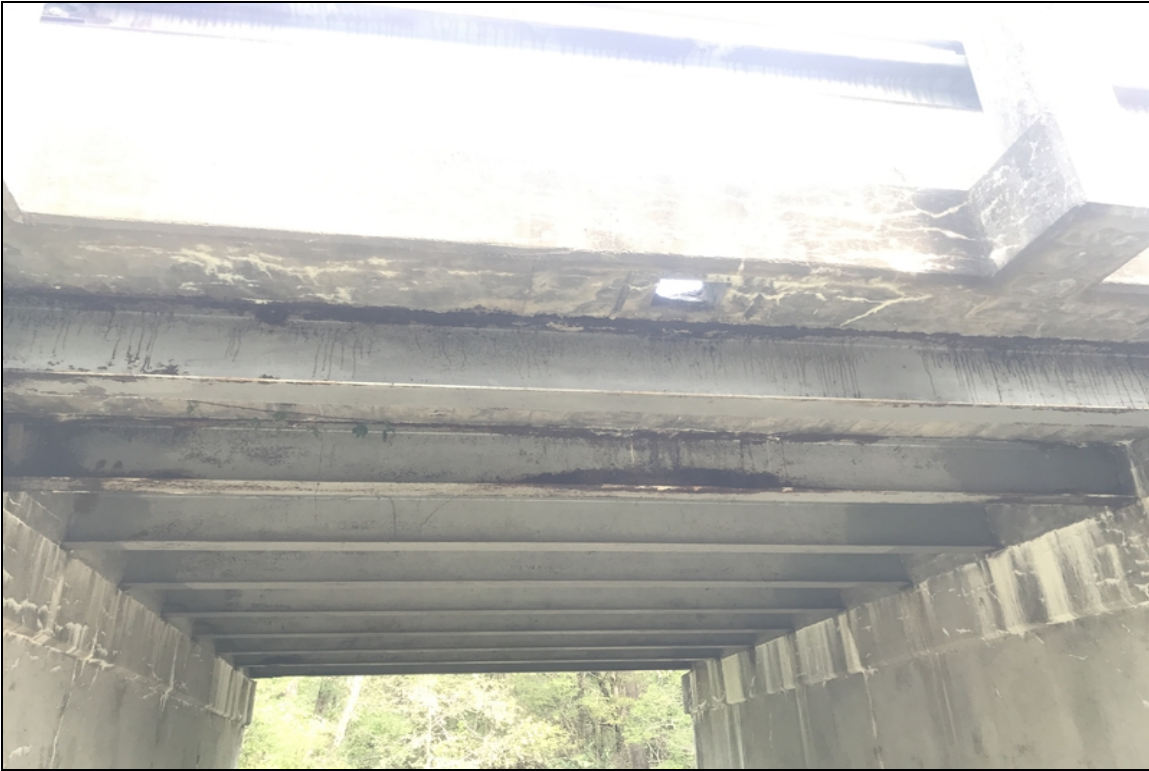
Span 2 Beams 8 & 9 active corrosion.

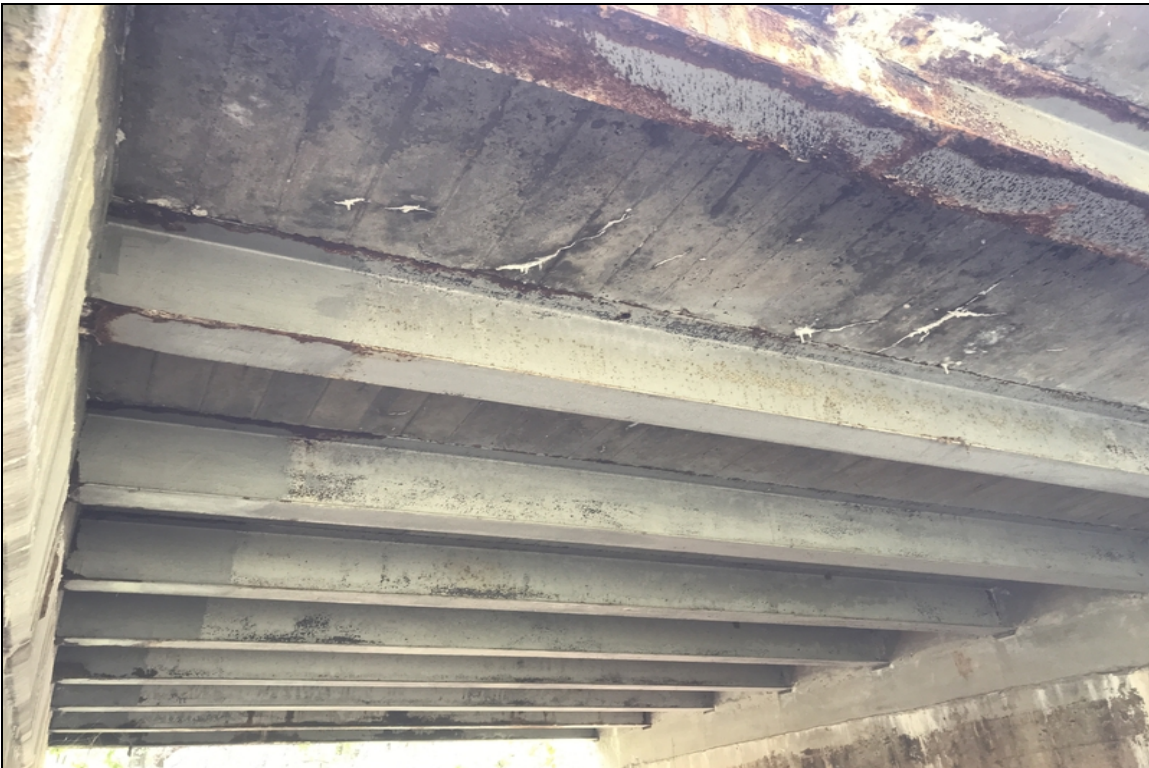
Span 1 typical superstructure.

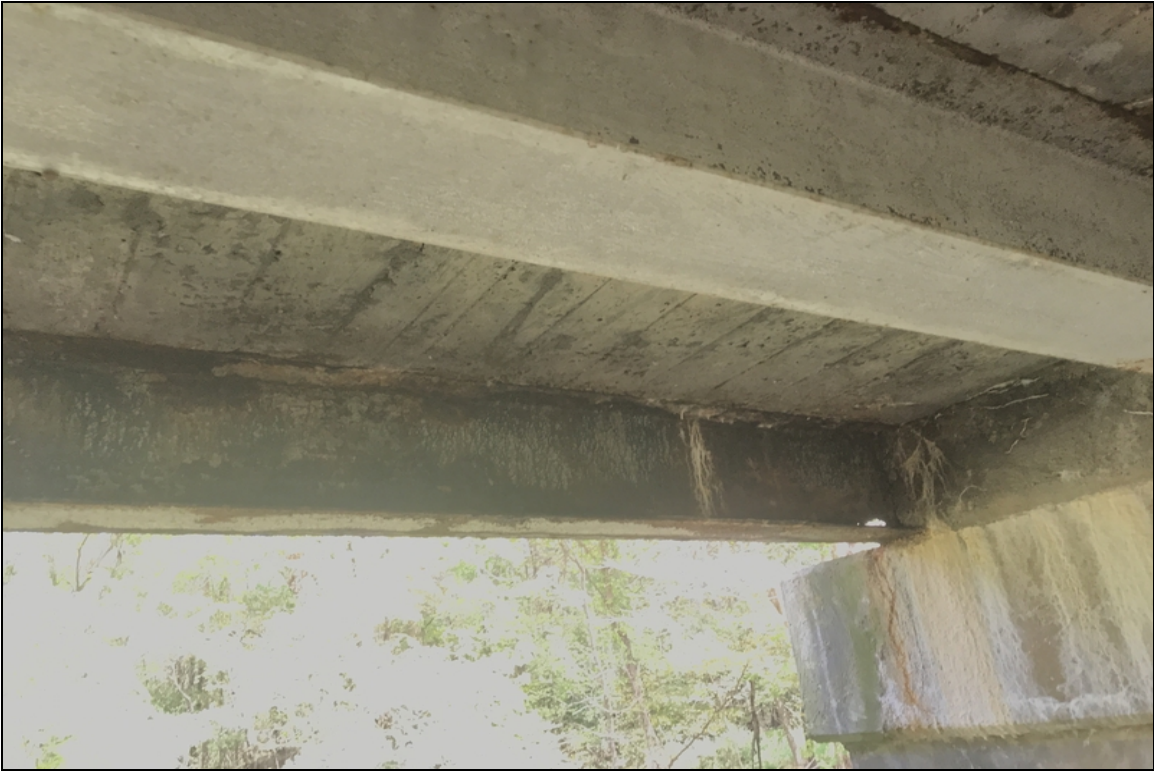
Span 1 Bent 2 holes rusted through the web.

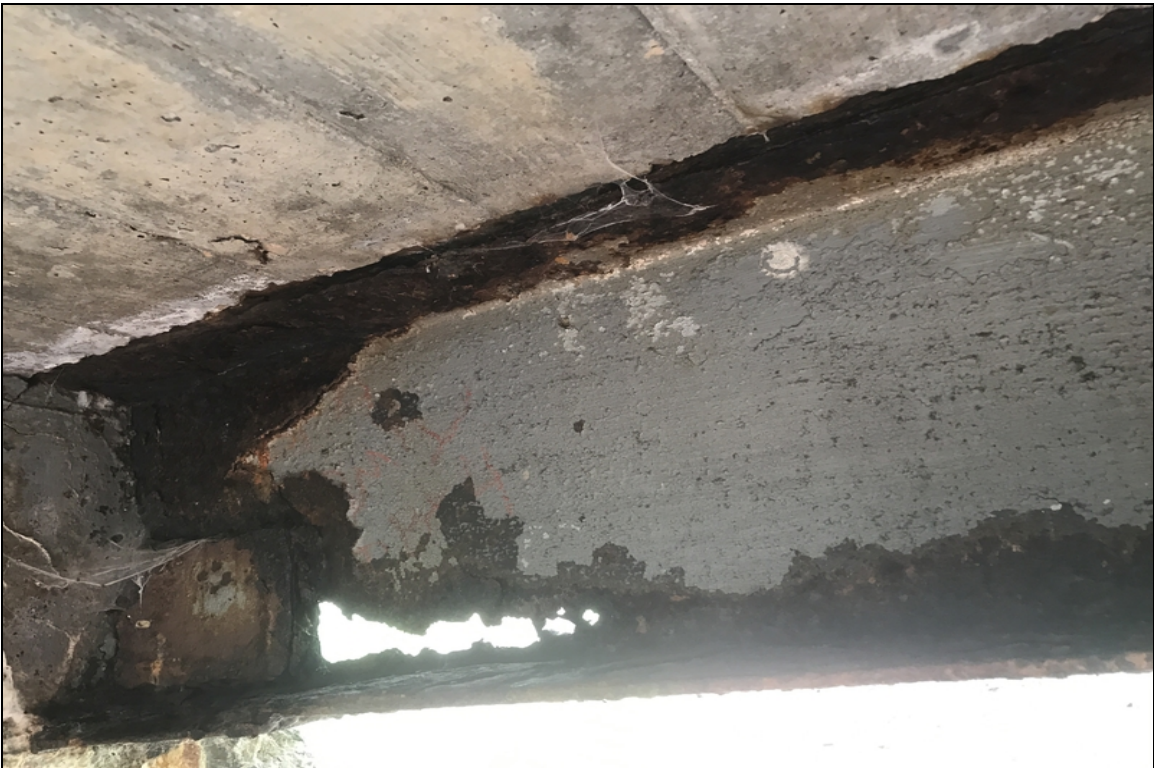
Span 4 Bent 4 Beam 1 large hole through the web.

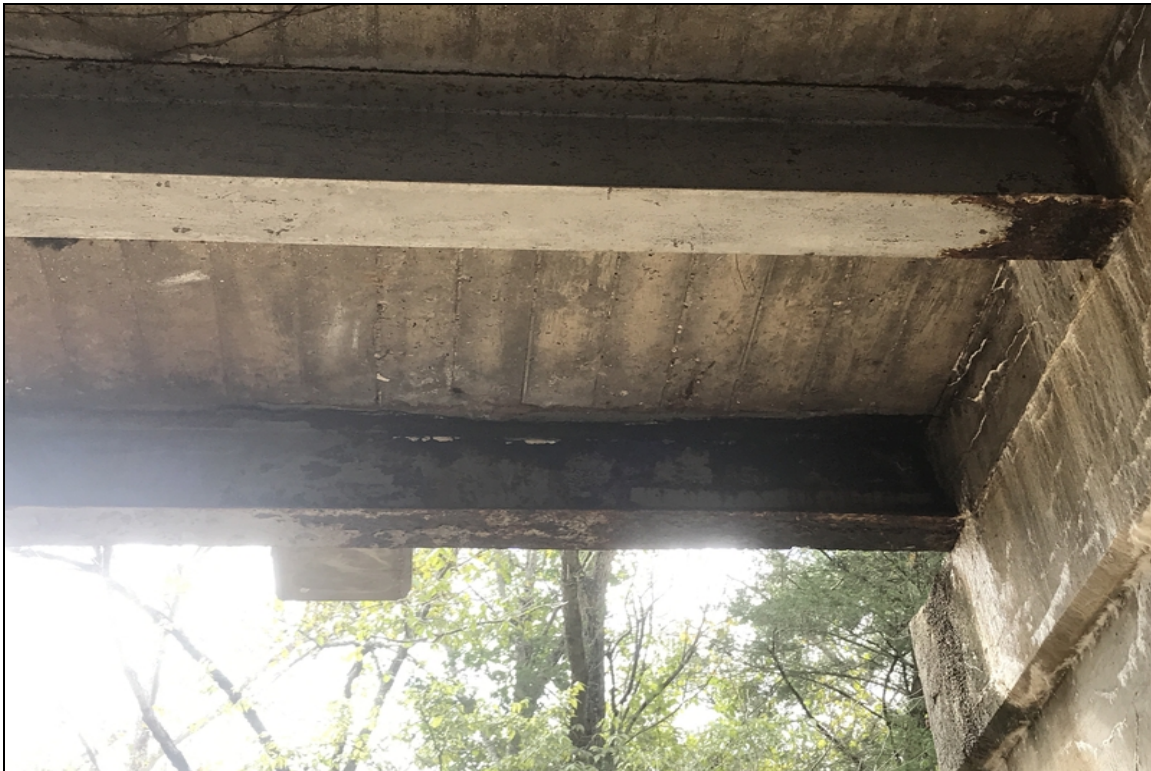
Span 3 Beam 9 @ Bent 3 holes in the web.

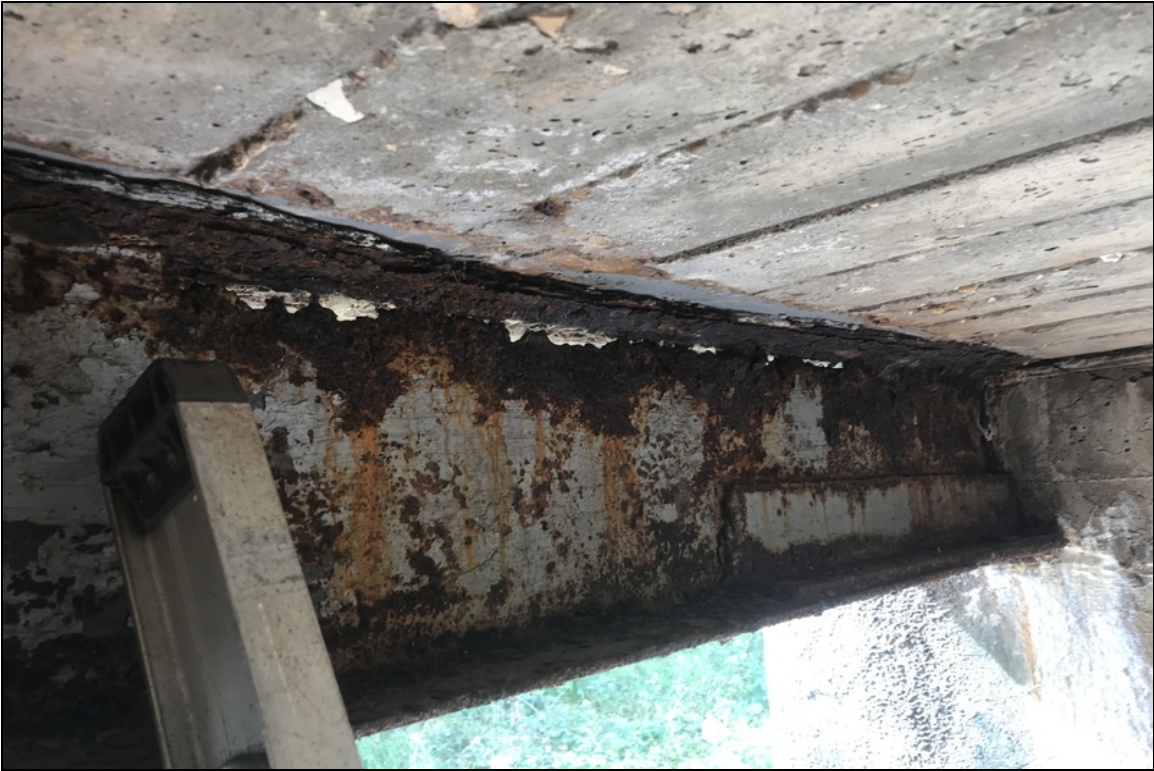
Span 3 Beam 9 Numerous holes in the web.

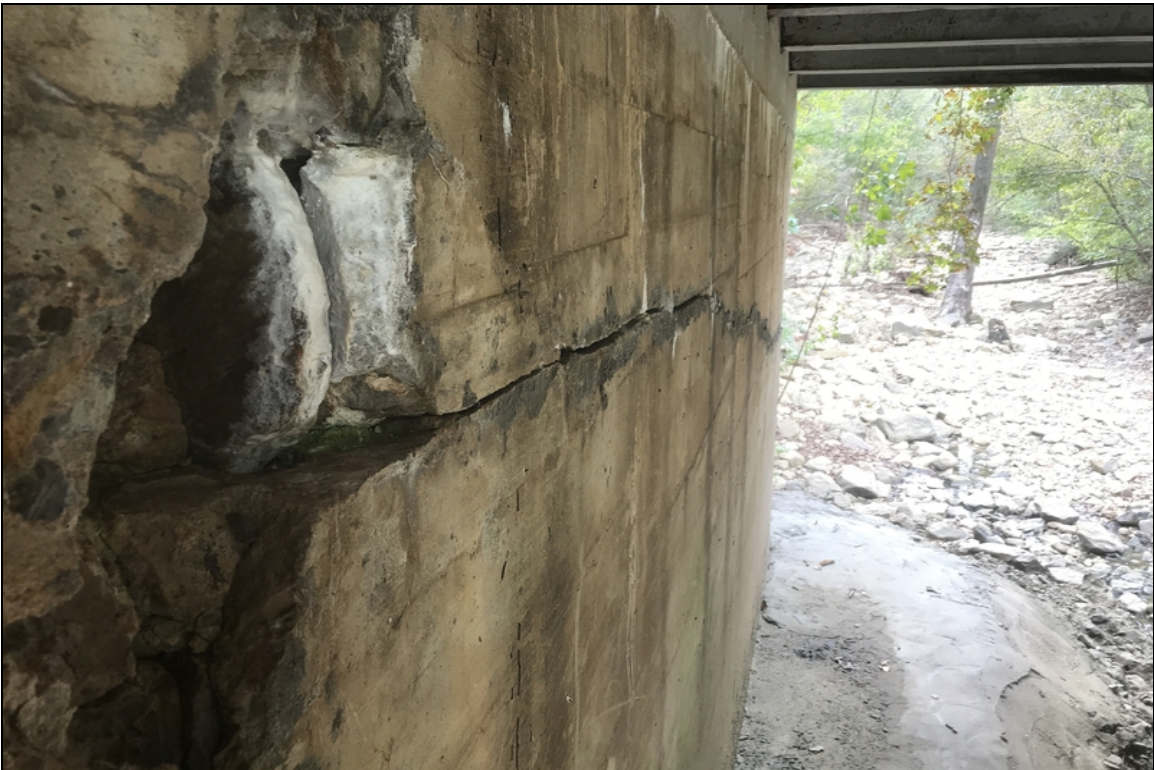
South abutment horizontal cracking.

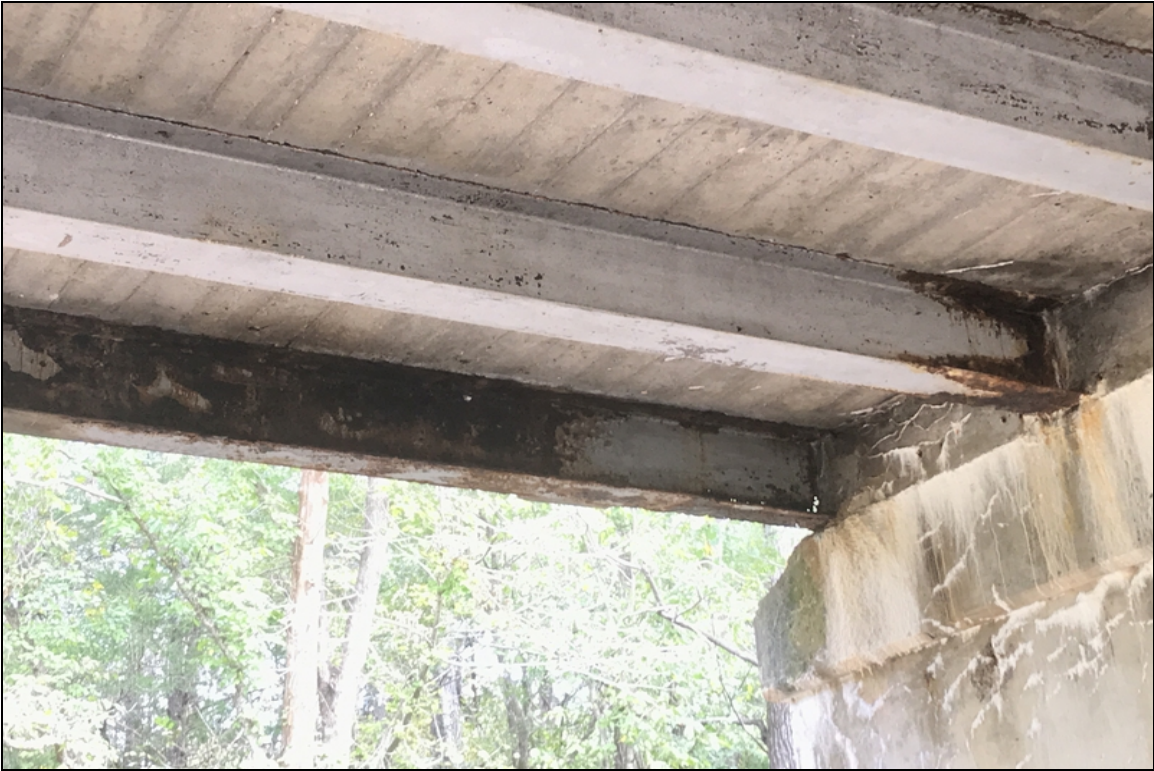
Span 3 Bent 4 active corrosion with holes through the web.

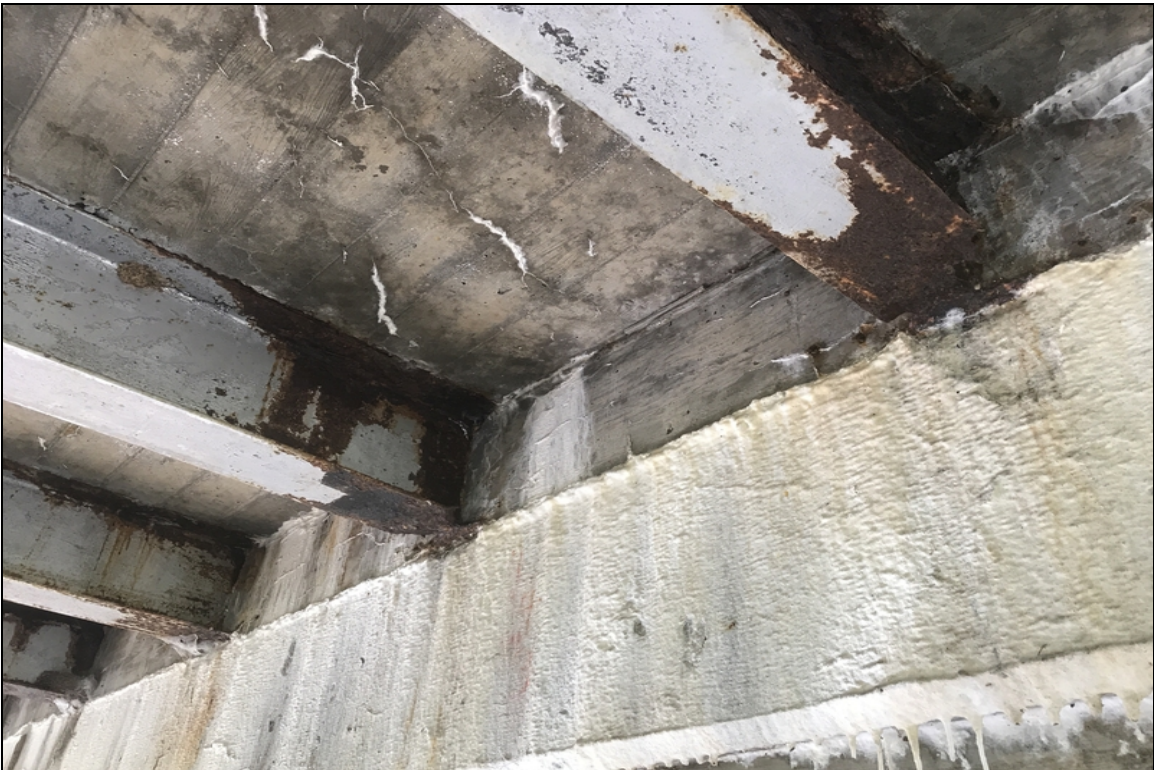
Bent 4 Span 4 Beams 2 & 3 holes in the bottom flanges.

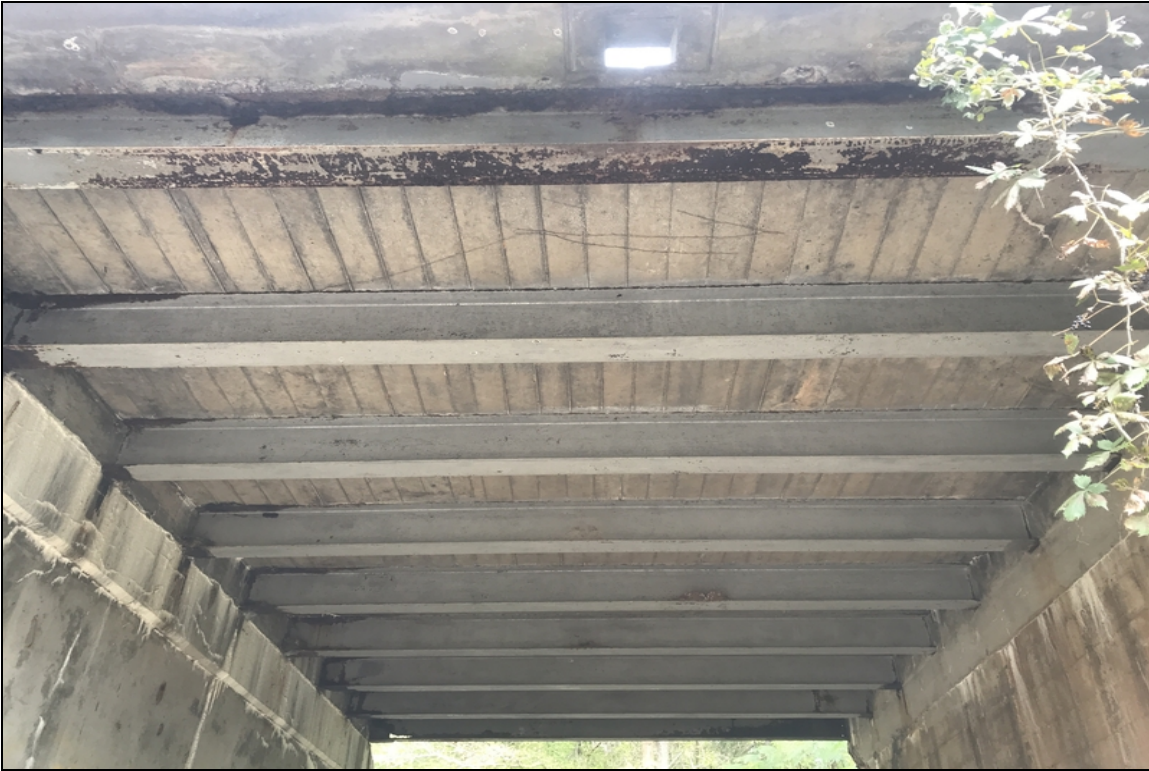
Span 4 typical active corrosion in the superstructure.

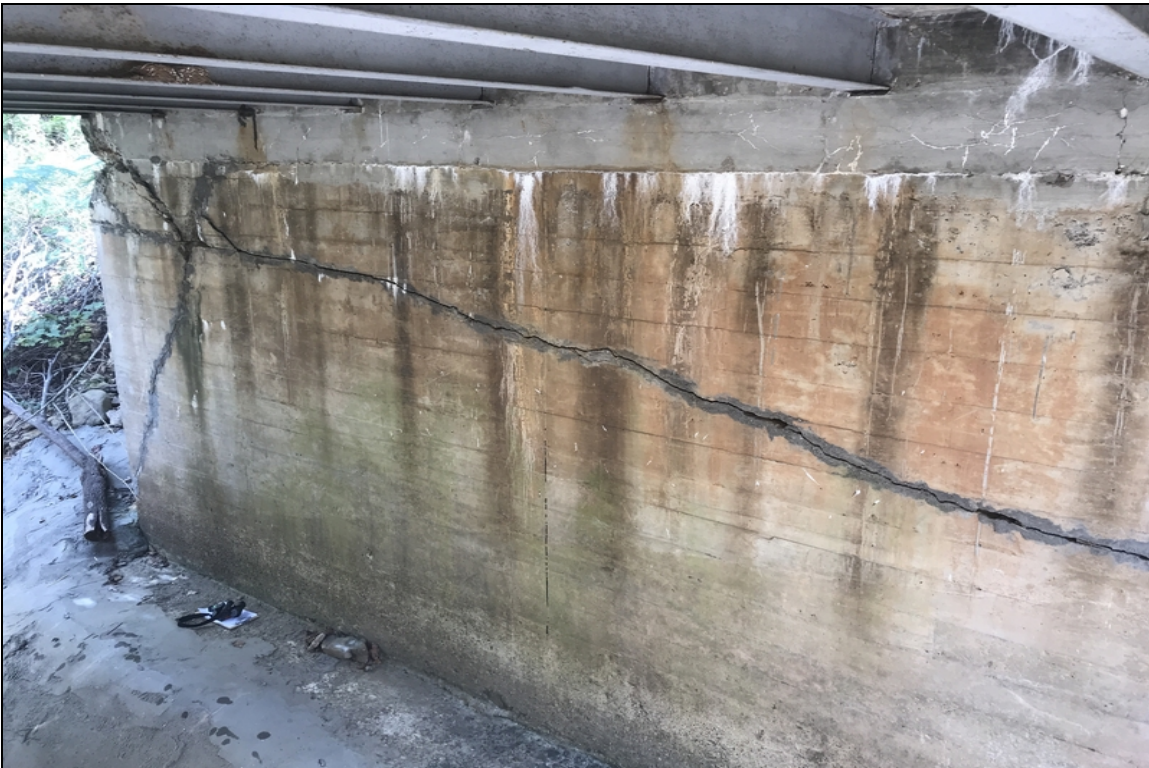
Bent 5 cracking.

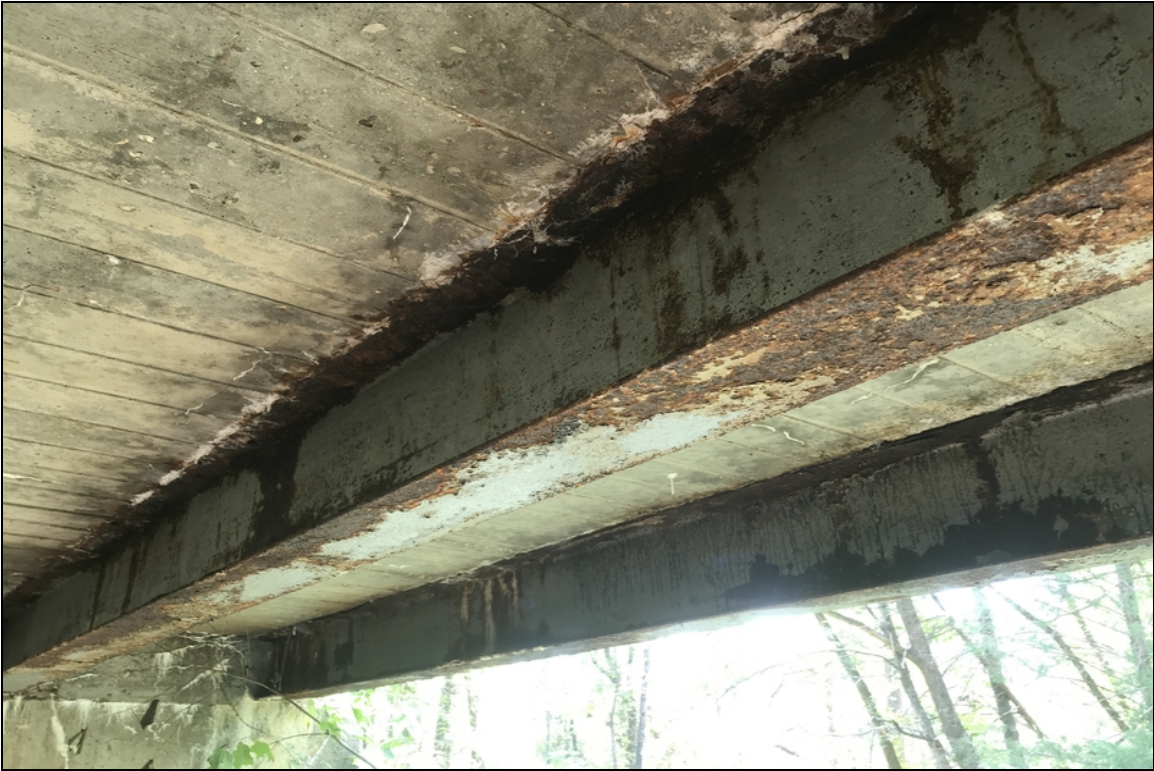
Span 1 Beams 8 & 9 active corrosion.

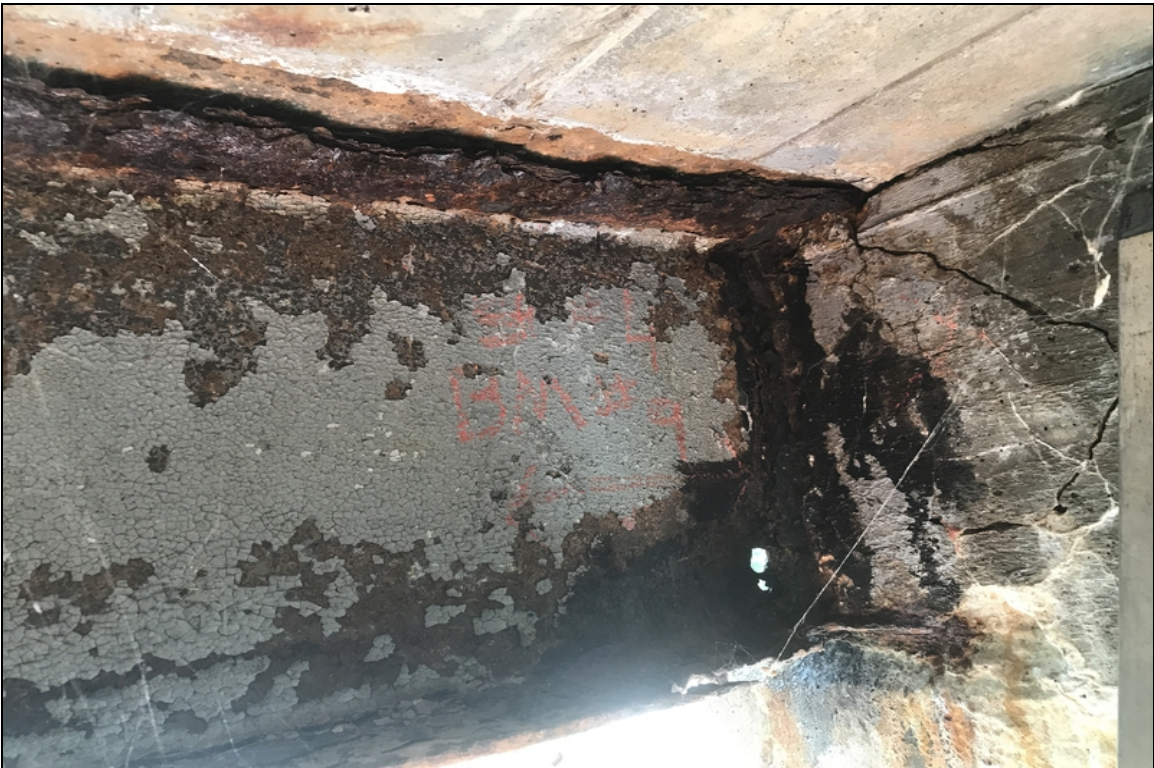
Bent 4 Span 4 Beam 9 holes through the web.

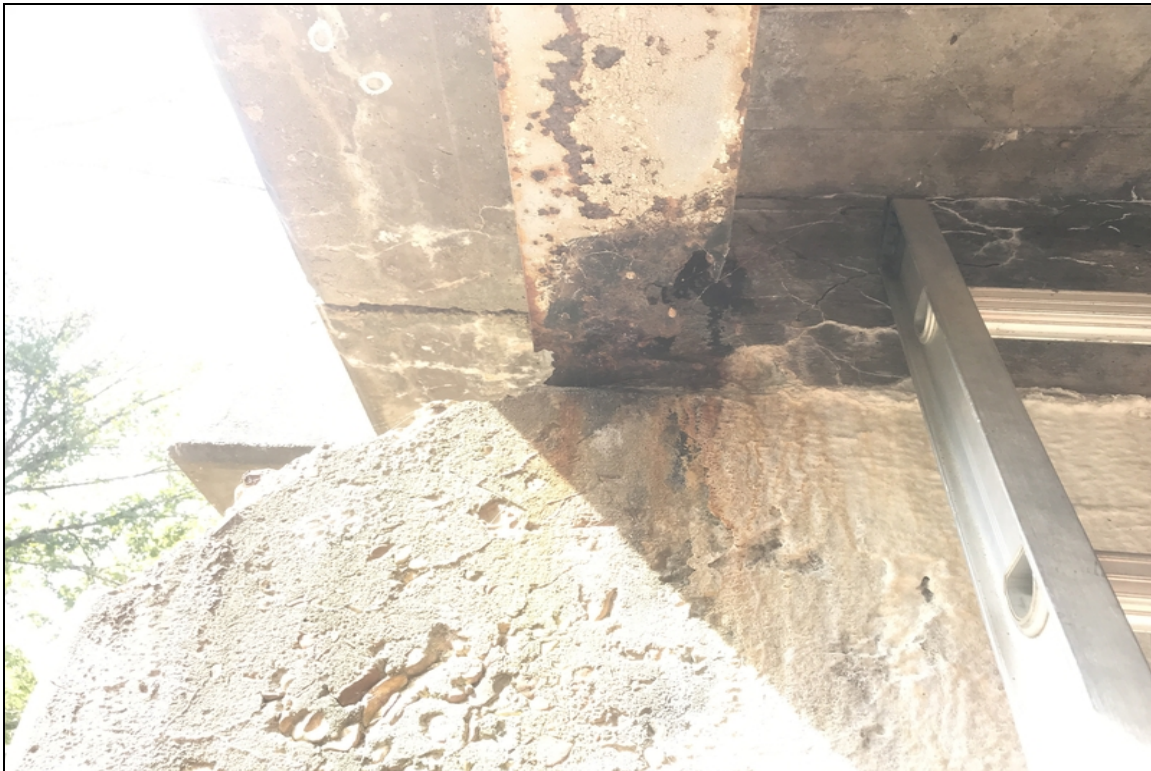
Span 4 Bent 4 Beam 9 hole in the bottom flange.

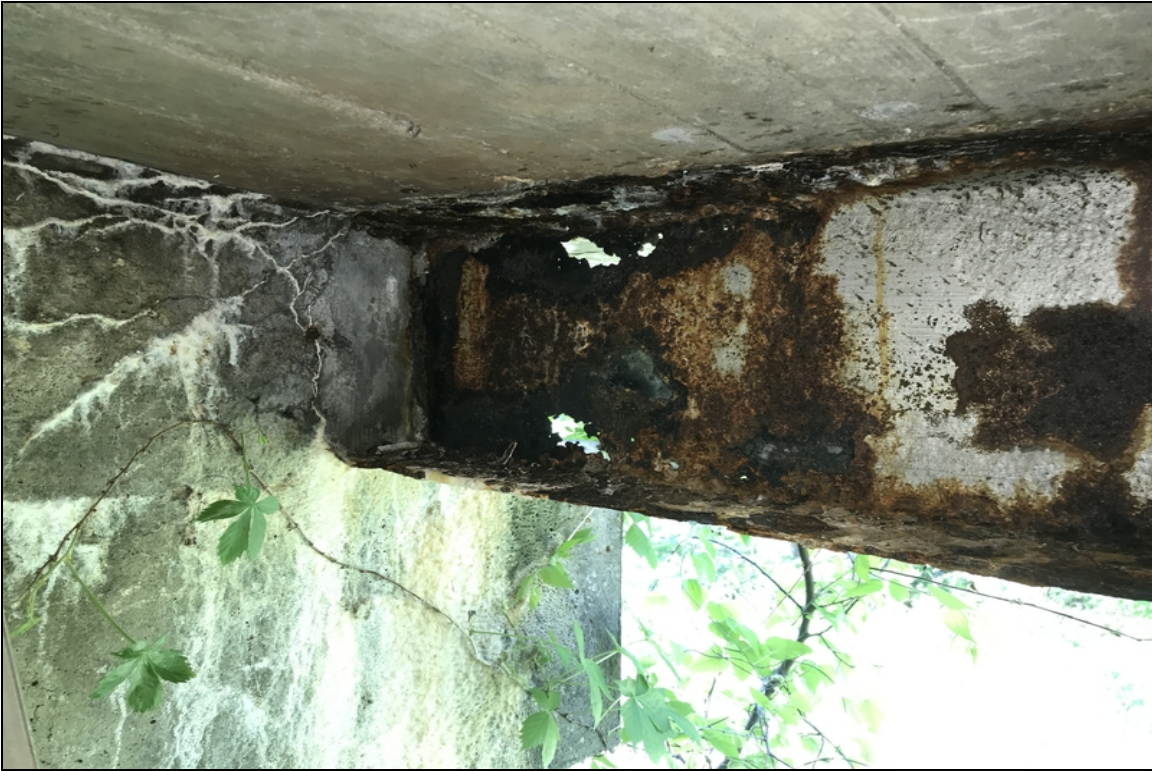
Span # 1. Beam # 9 at Bent # 2. 12" area that is paper thin with multiple holes rusted through the web. Top and Bottom flanges are paper thin and reduced in width to 5".

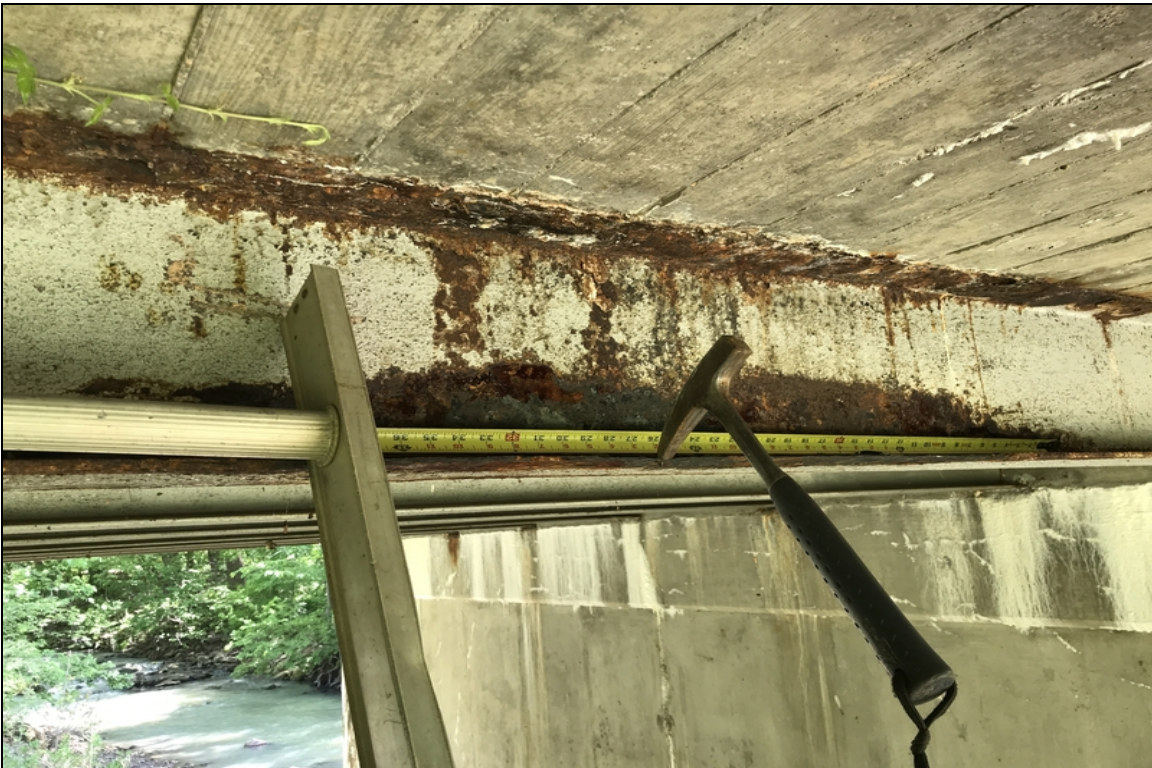
Span # 2, Beam # 8 located near mid-span- bottom flange is paper thin with perforations. Web is reduced to approximately 1/16". 3" tall x 3' long area.

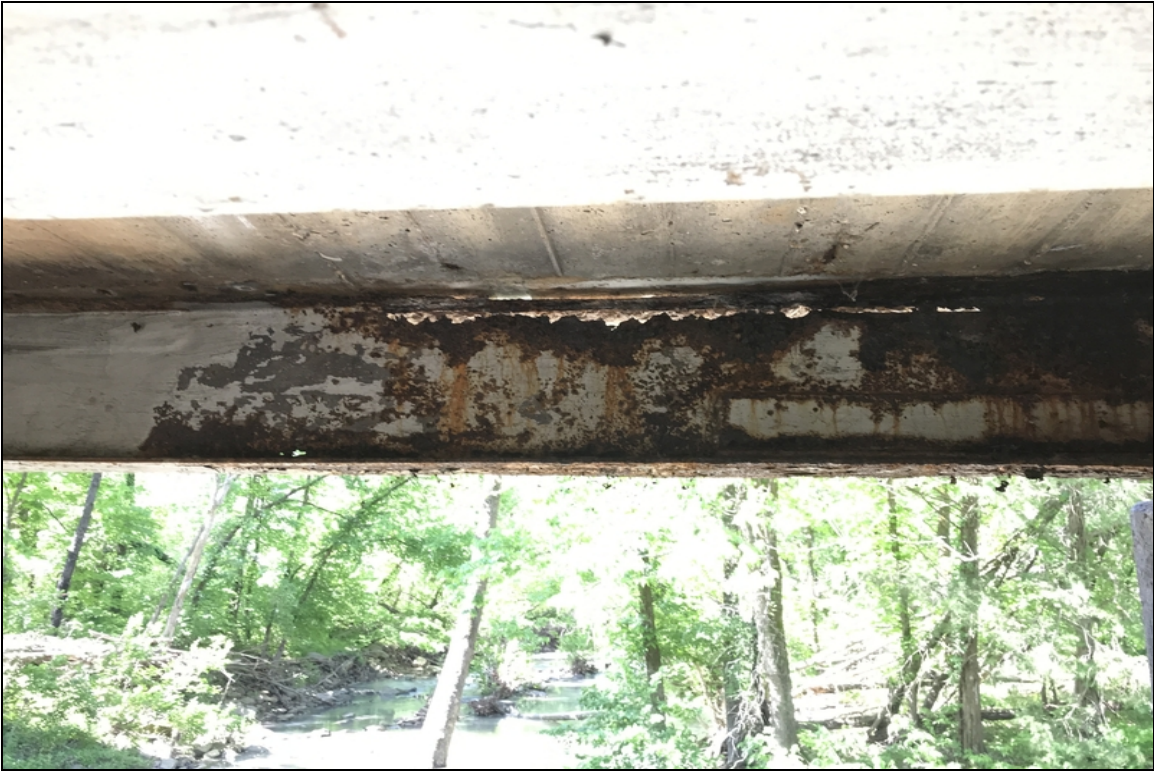
Span # 3, Beam # 9. 3' section of web missing.

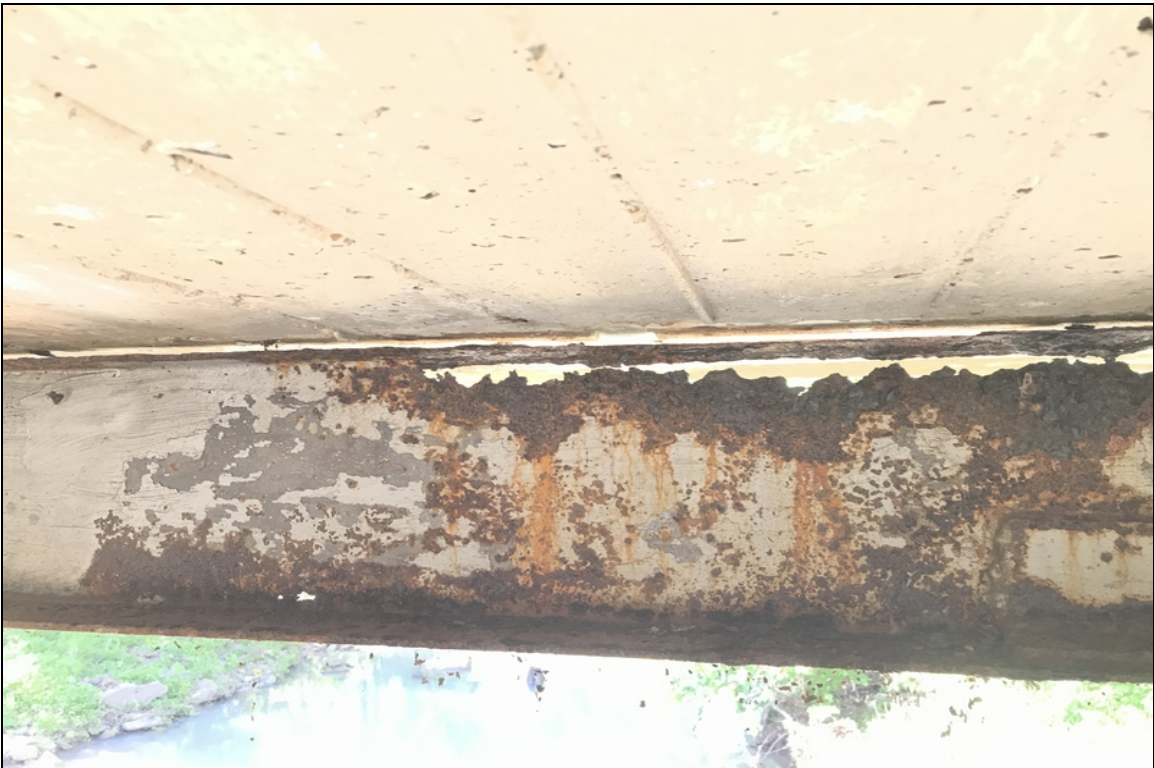
Span # 3. Beam # 9 section loss with 1/2" space between the top of the beam and the undersurface of the deck.

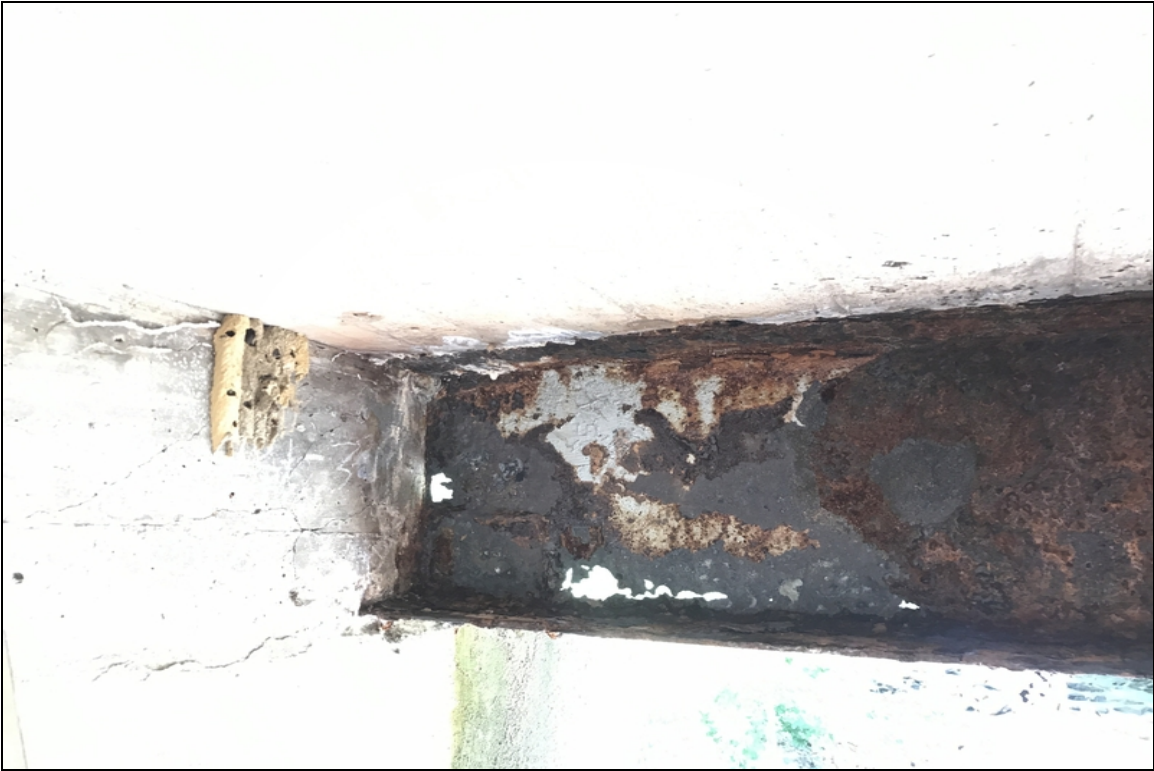
Span # 3- Beam # 1 Bent # 3 face- multiple holes rusted through base of web.

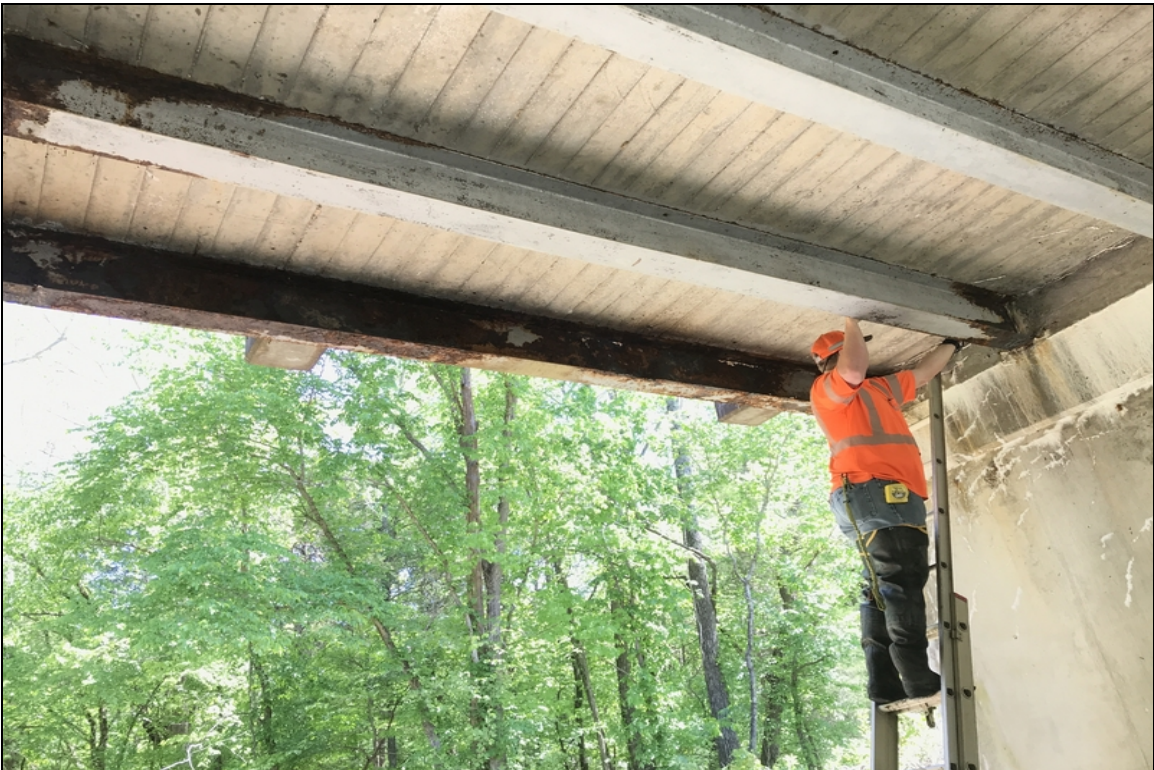
Span # 3. Beam # 1. Active corrosion with multiple holes rusted in the web.

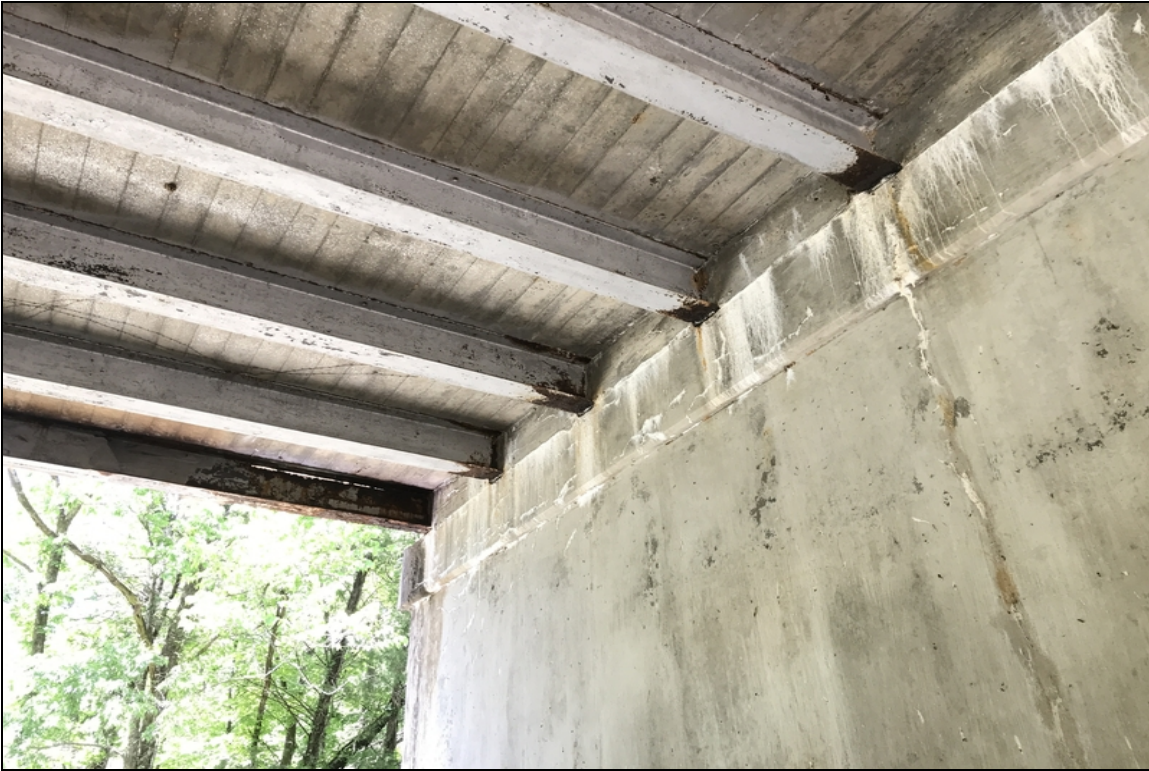
Span # 3 superstructure at Bent # 3. Typical of Beam corrosion.

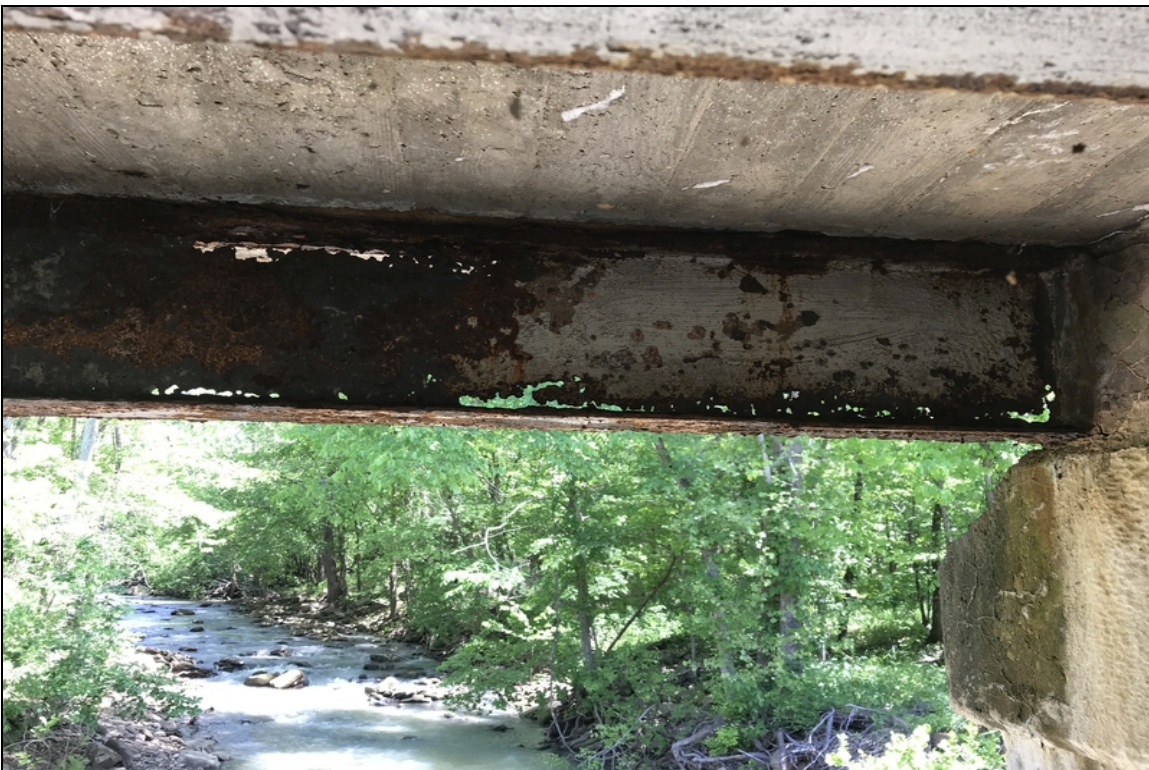
Span # 3 Beam # 1 Bent # 3- multiple holes within 4' of Bent # 3.

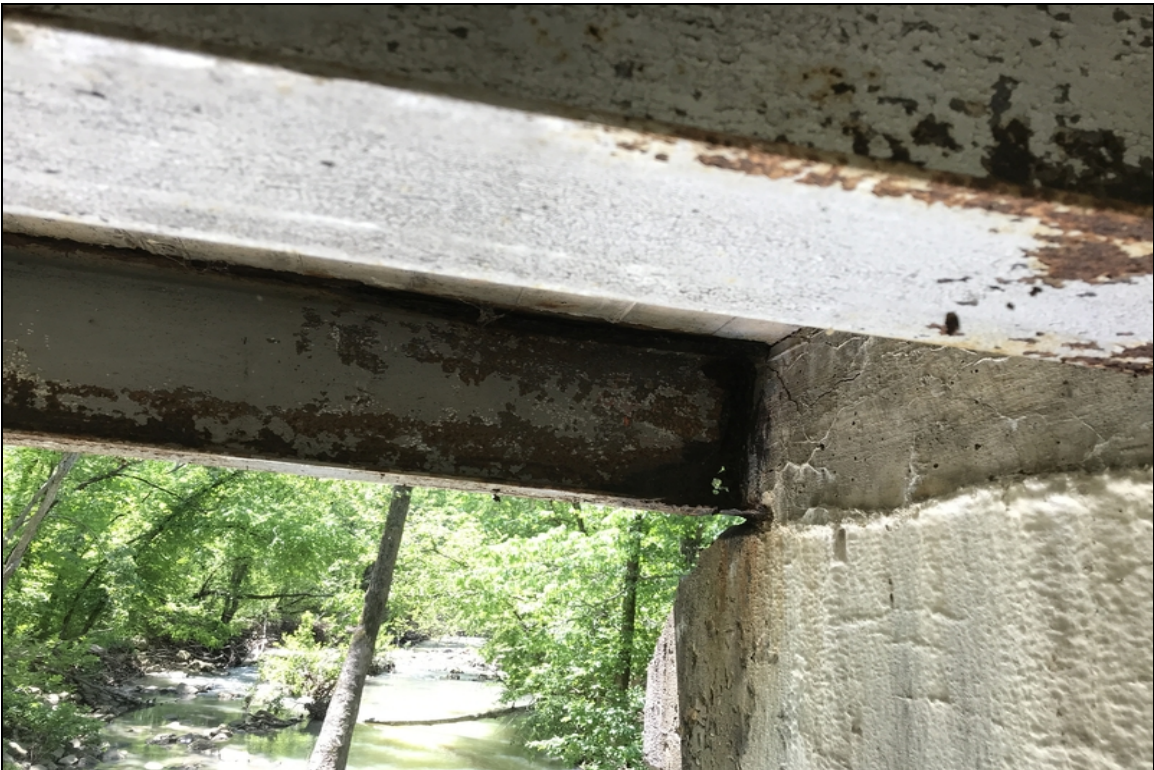
Span # 4 - Beam # 9 Bent # 4 face - Bottom flange has knife edge section loss and is reduced to 2 3/4" in width. The base of web has a 2" hole. Top flange is reduced to 3" in width.

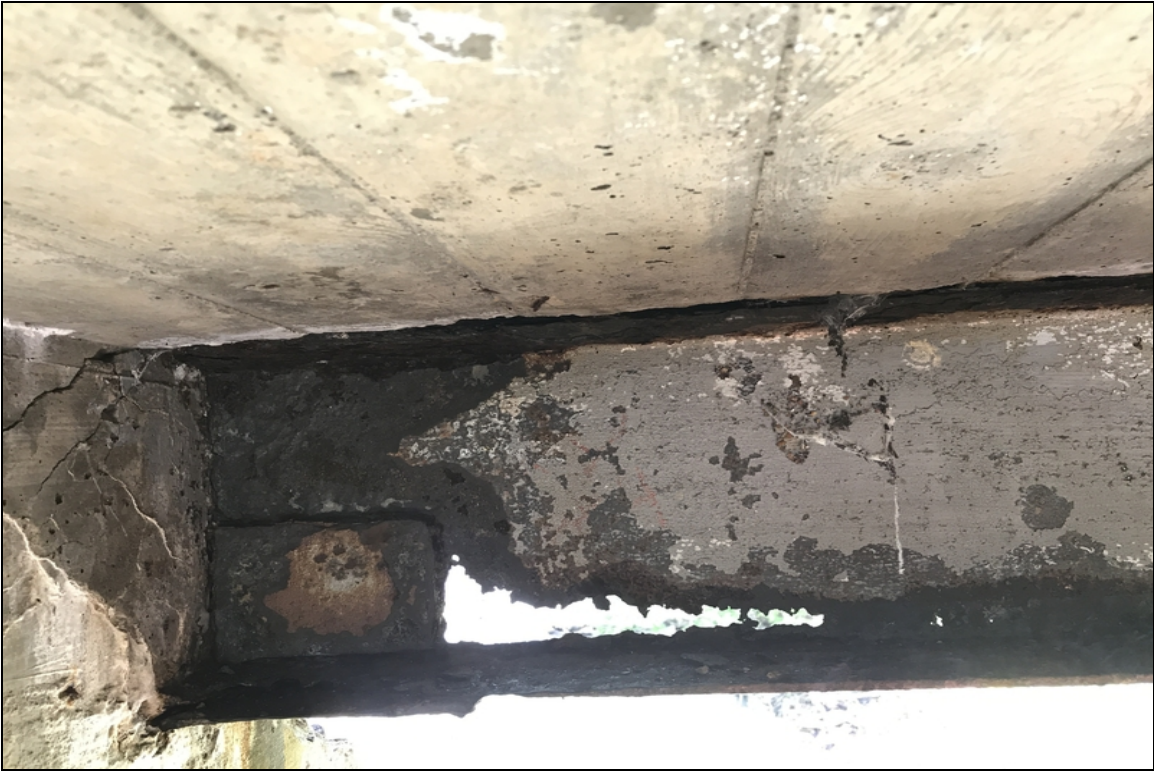
Span # 4- Beam # 1 Bent # 4- 10" x 3" hole adjacent to fish plate repair.
