Bridge #02621 (Routine)
State Highway 59 over Huey Creek - Crawford Co

Location: 18.25 N JCT I 40

Team Lead: Jeff Jones Inspection Date: April 30, 2020

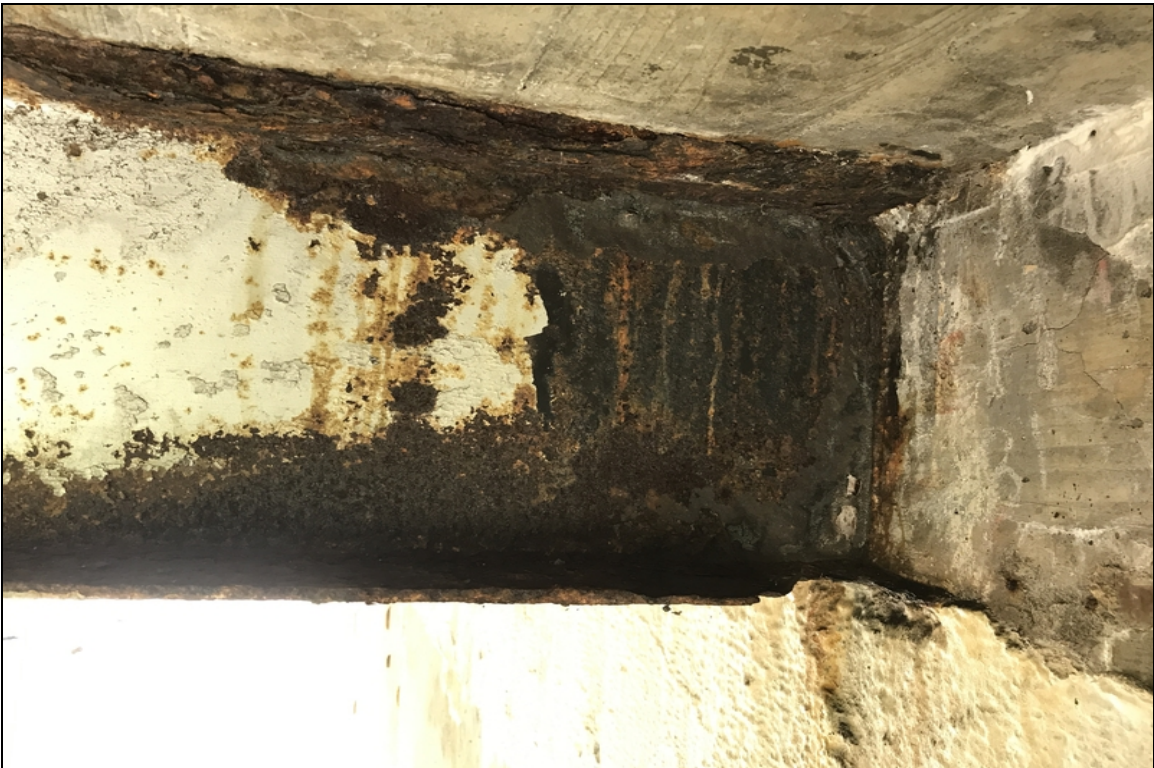
Span # 4 Beam # 2 Bent # 4 face- 2" hole, bottom flange reduced to 2" in width.

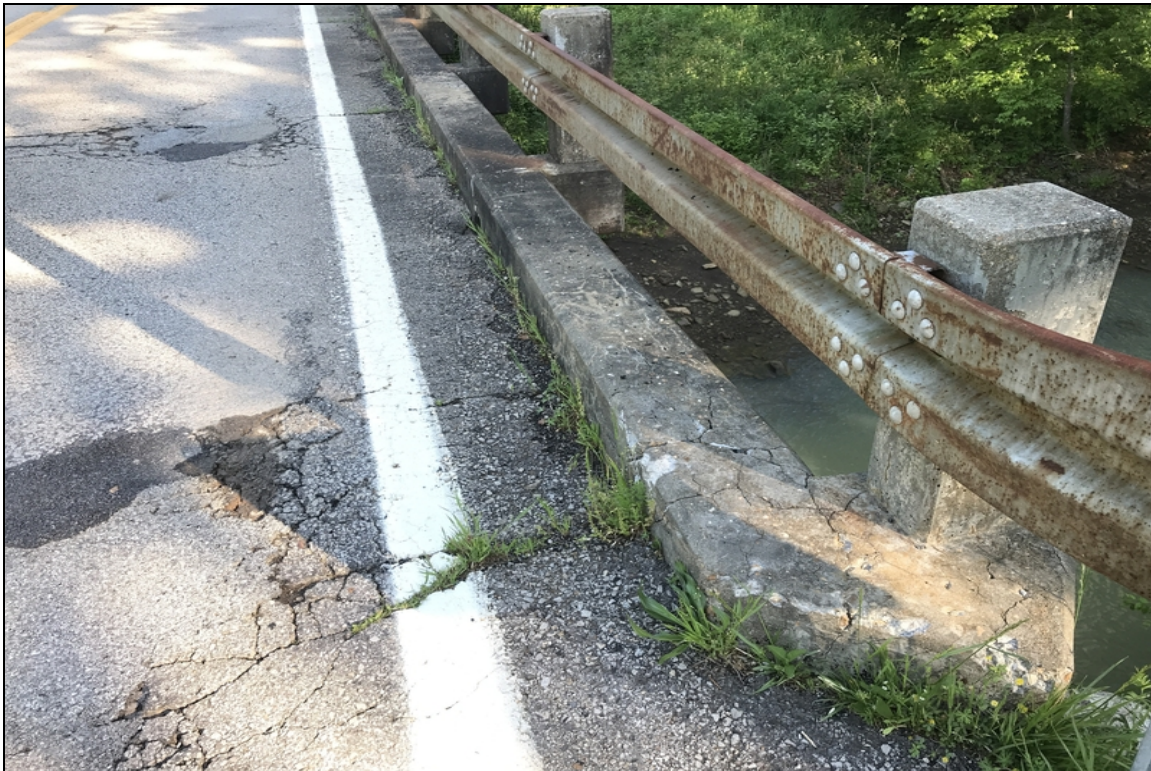
Left curb. Span # 4. Map cracking.

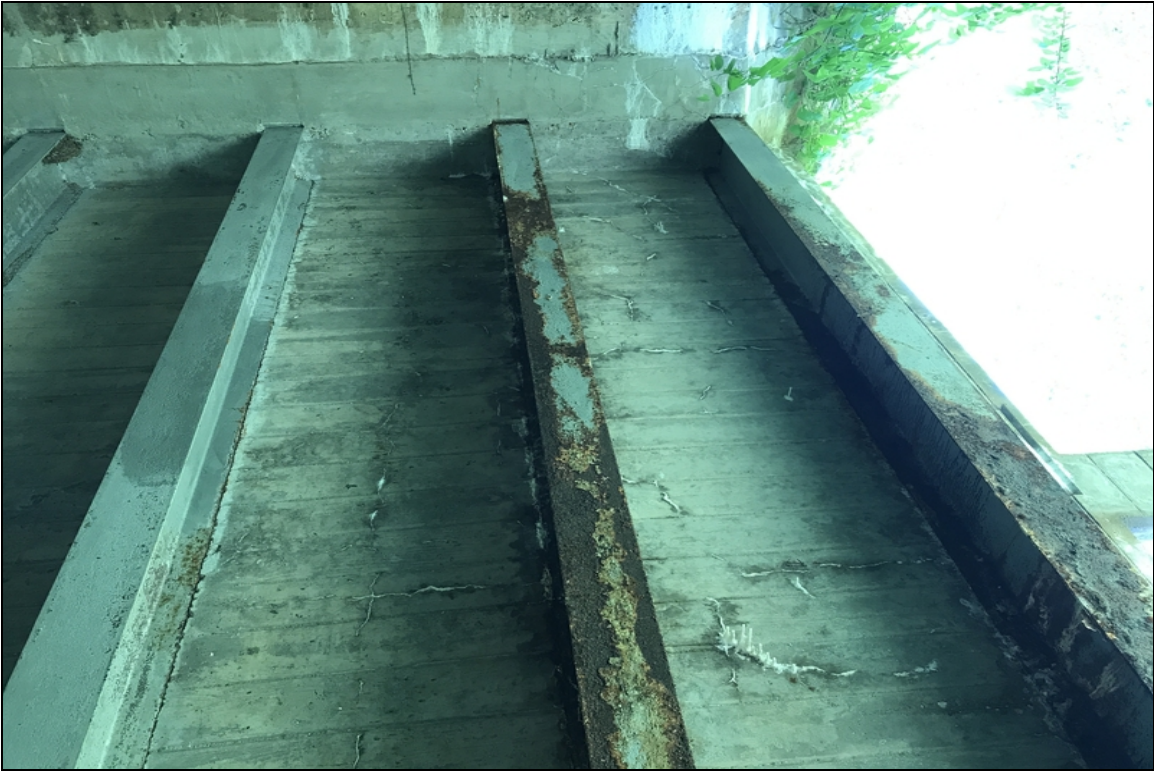
Undersurface of Span # 1. Efflorescence.

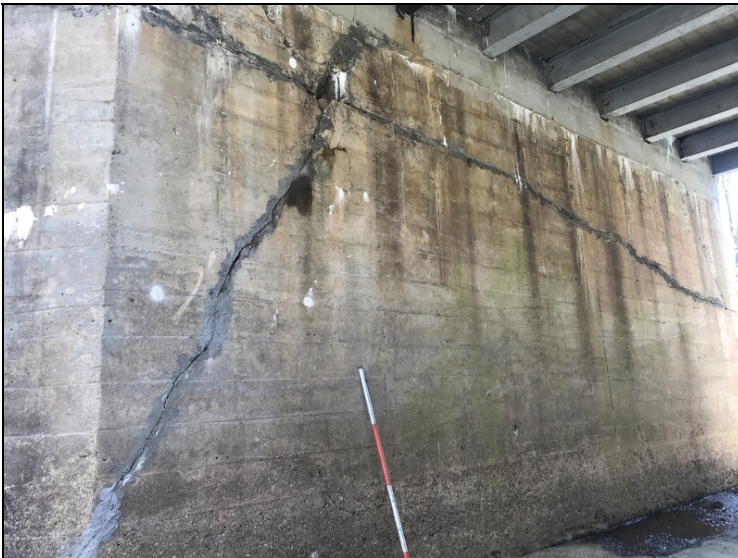
The south abutment breast wall has wide horizontal and diagonal cracking the full width of the breast wall due to apparent rotation. Actual field measurements taken in the field indicate that there is no significant additional rotation of the south abutment or changes to the horizontal or diagonal cracks in the breast wall since the 07-07-2011 inspection. The spalled area in the Left side of breast wall with exposed reinforcing steel has no apparent noteworthy changes since last inspection. The top of abutment appears to be supported by the superstructure. See documentation and history files for field measurements and sketch of rotation.

Bent # 5 cracking in the abutment stem.

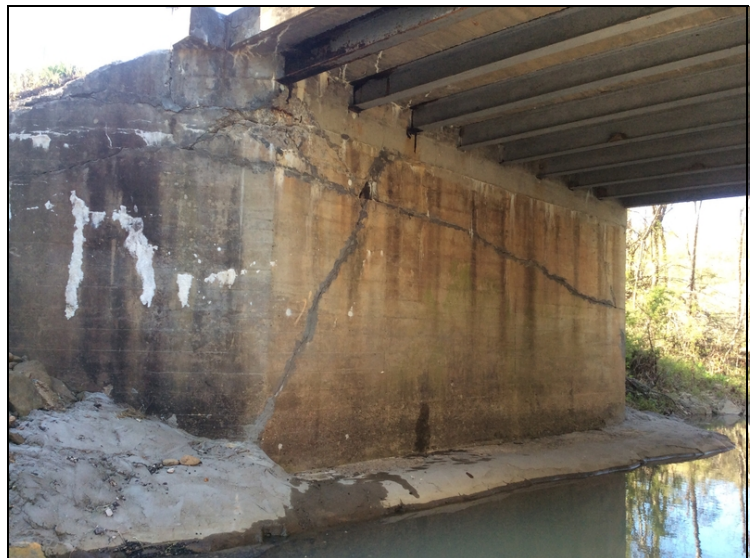
Bent # 5 cracking and concrete deterioration.

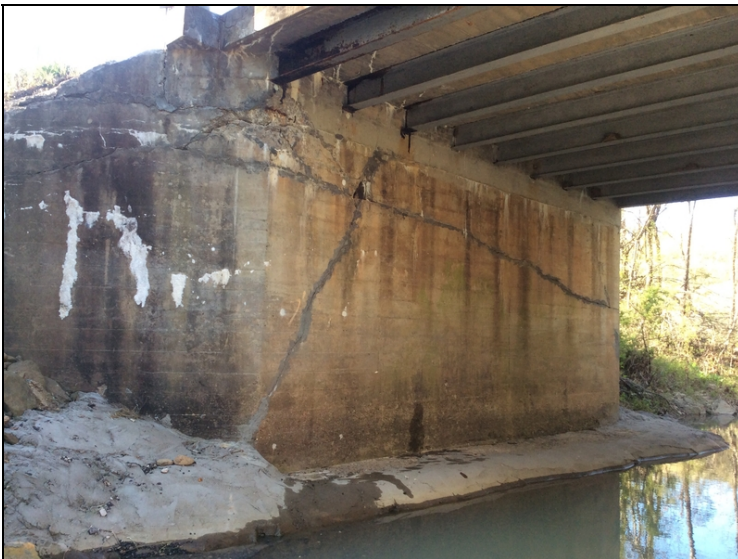
Bent # 5 cracking and concrete deterioration.

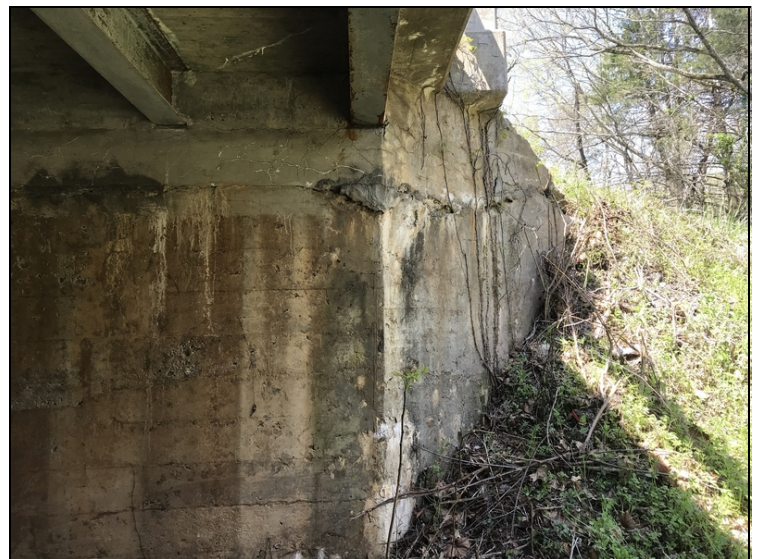
Bent # 1 Lt wing wall deterioration.

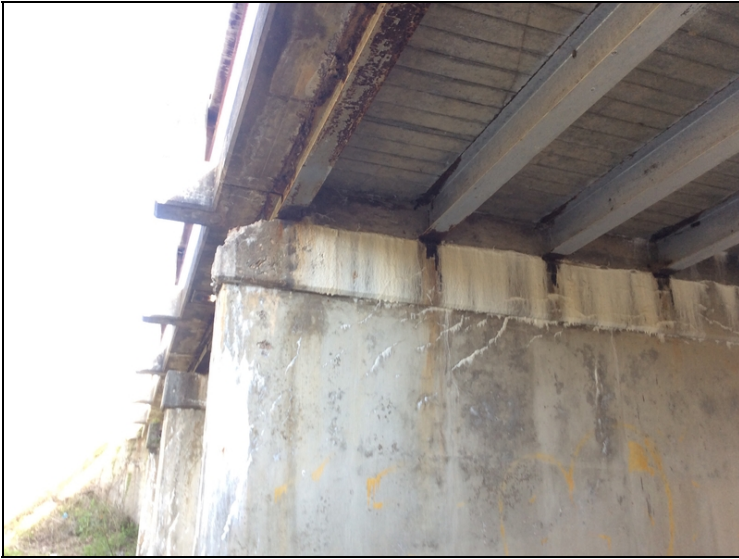
The left and right ends of Bent # 4 cap have soft and deteriorated concrete that has caused the ends of the cap to spall exposing the reinforcing steel. The northeast and southeast wing walls have horizontal fractures approximately 2' from the top of the wing walls that extend the full width of the wing wall and are beginning to spall along the fractured areas.

Typical concrete deterioration in the cap of Bent # 4.

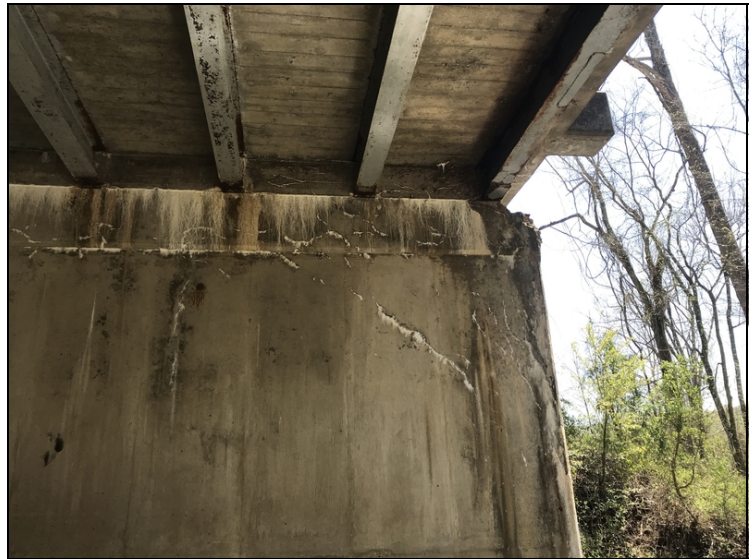
Bent # 4 Rt concrete deterioration and section loss with exposed reinforcing steel.

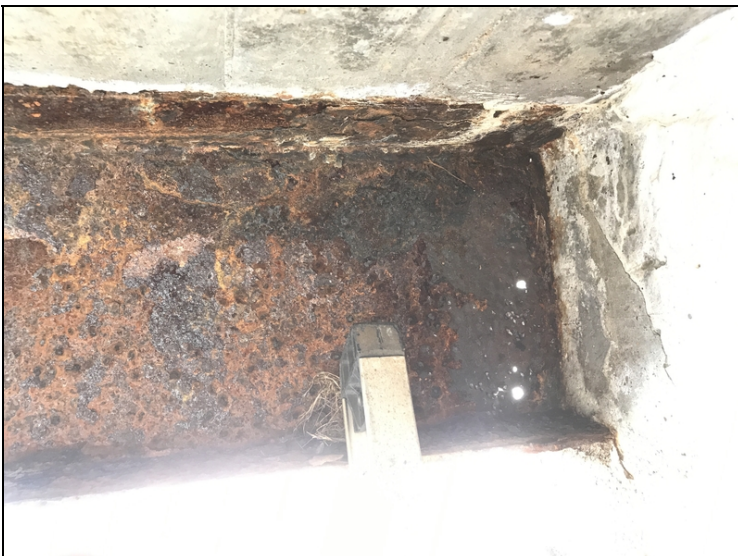
The superstructure has numerous areas of active corrosion, section loss, and holes rusted through in the beams. The section loss ranges from initial up to areas of complete section loss with holes in the webs and top and bottom flanges.

Bent # 5 Beam # 1 with holes rusted through the web adjacent to the bent cap.

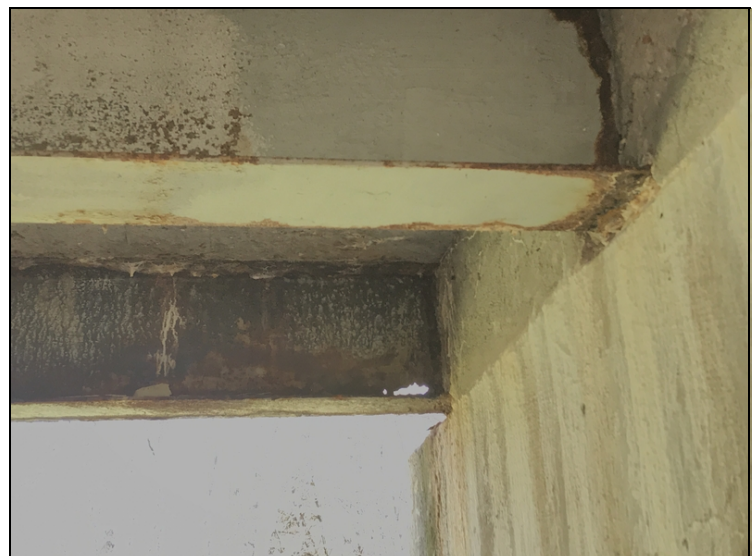
Span # 1 Beam # 1 @ Bent # 2 with a hole rusted through the base of the web.

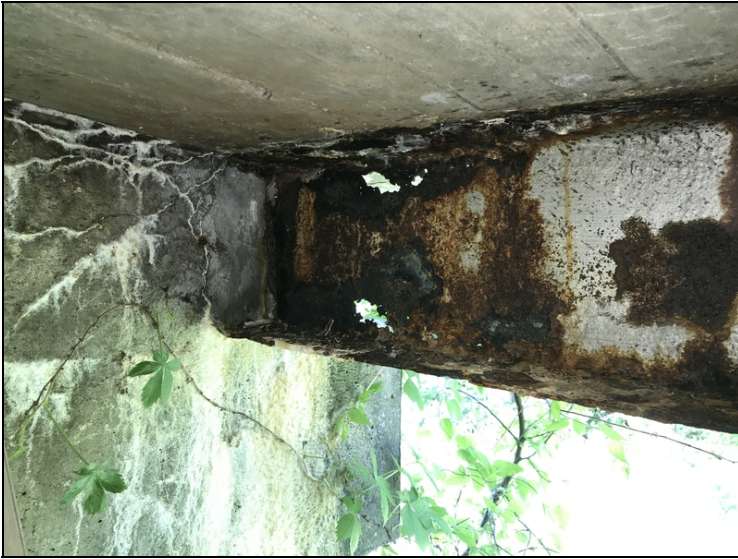
Span # 1. Beam # 9 at Bent # 2. 12" area that is paper thin with multiple holes rusted through the web. Top and Bottom flanges are paper thin and reduced in width to 5".

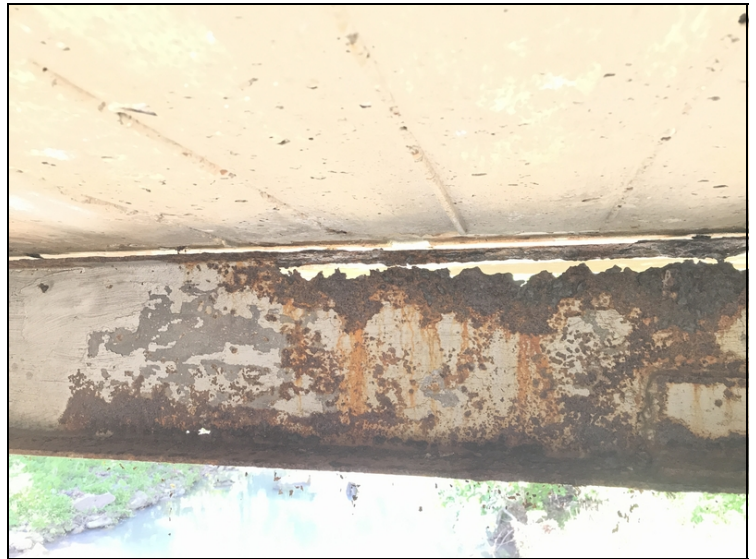
Span # 3. Beam # 9 section loss with 1/2" space between the top of the beam and the undersurface of the deck.

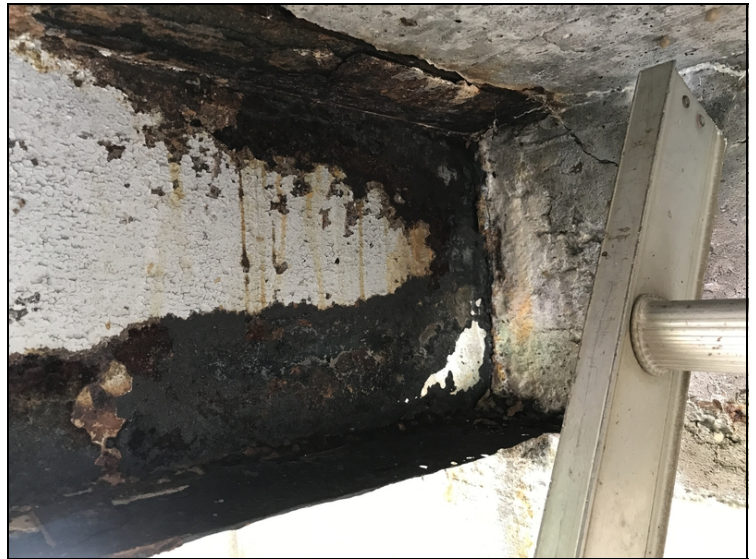
Span # 3 Beam # 2 Bent # 3 - a 4" hole in the web at Bent # 3 face.

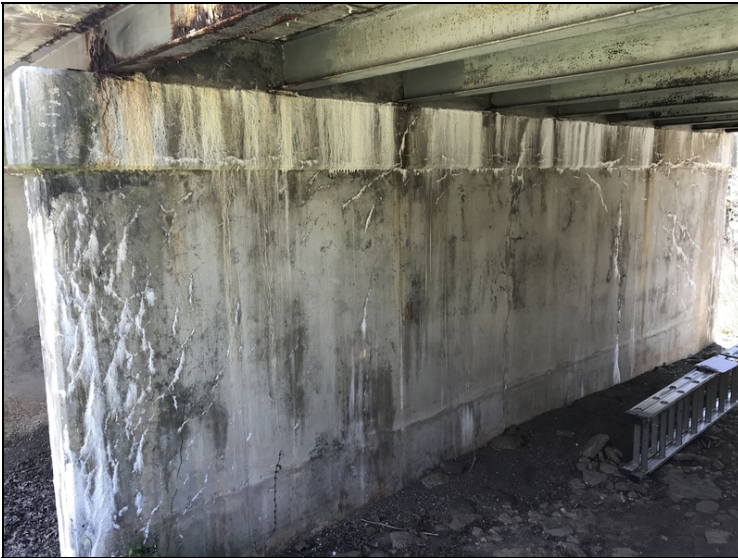
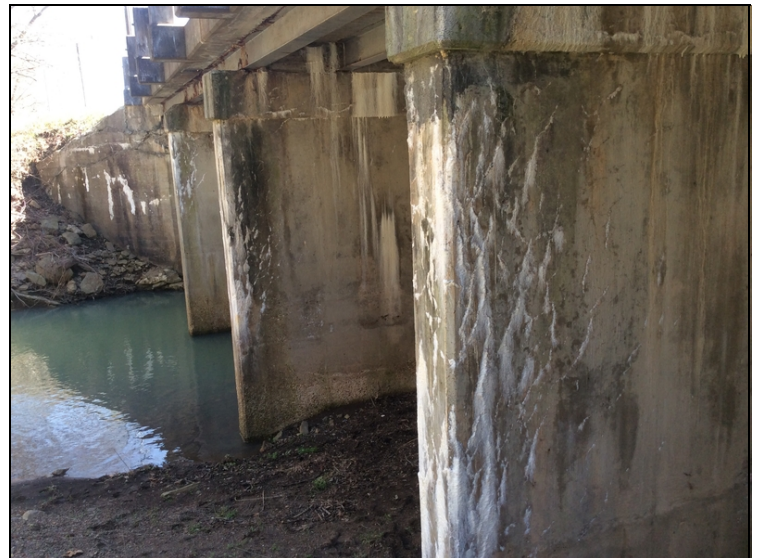
Bent # 2 cracking with efflorescence buildup.

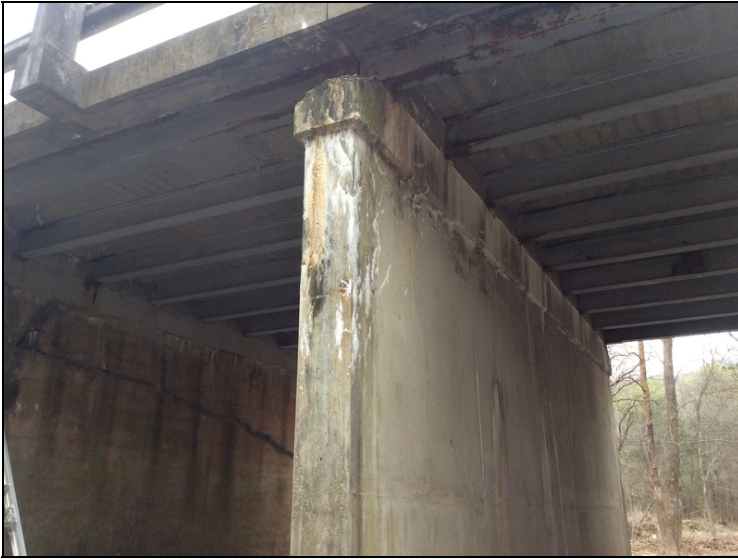
The exterior edges of the intermediate bents have vertical and map cracking with efflorescence.

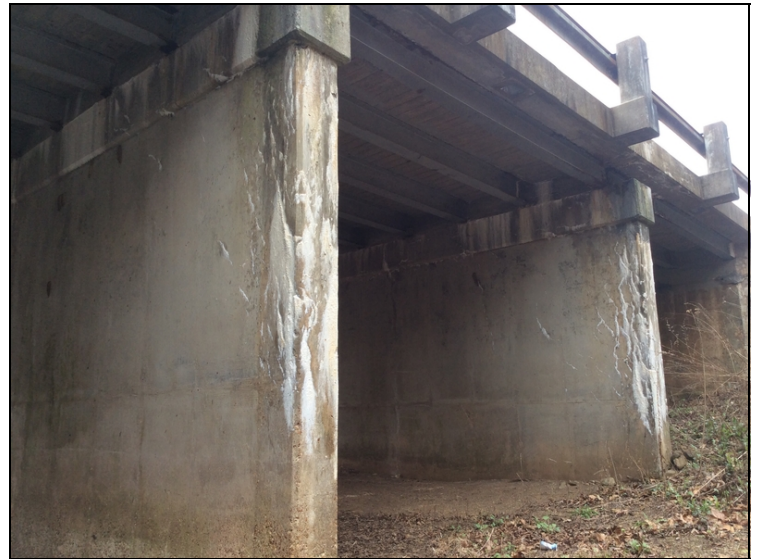
The exterior edges of the intermediate bents have vertical and map cracking with efflorescence.

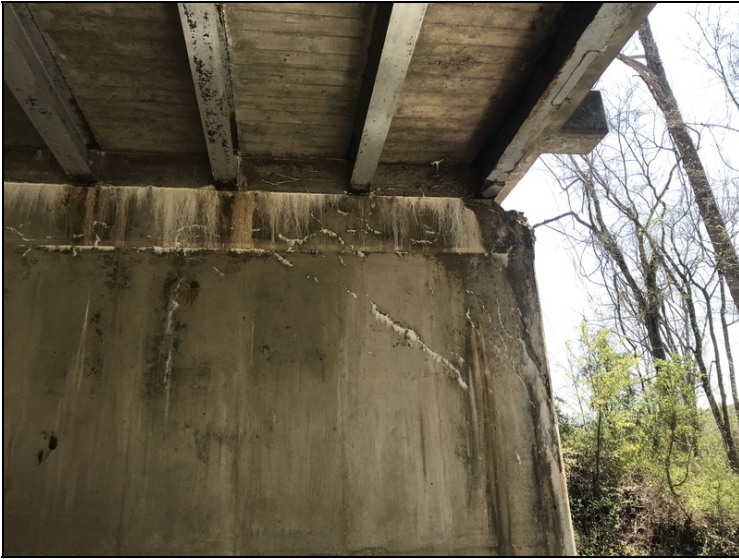
Bent # 4 Rt concrete deterioration and section loss with exposed reinforcing steel.

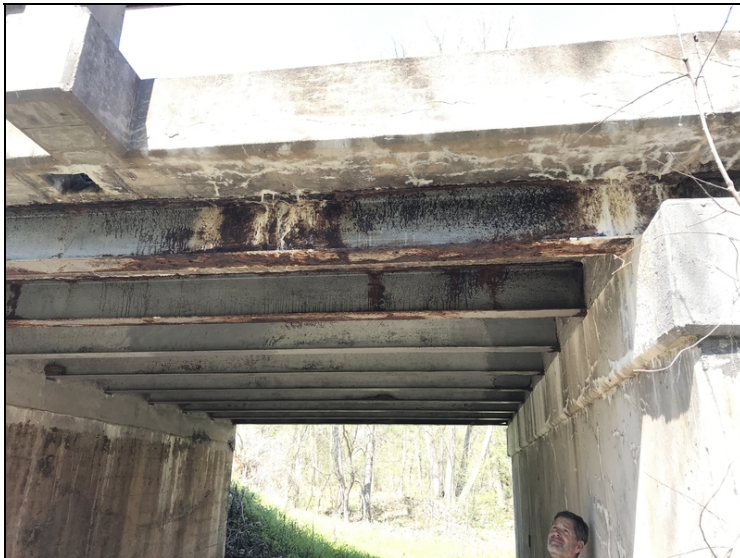
Span # 1 Rt active corrosion in the Beams with soft deteriorated concrete with heavy efflorescence buildup.

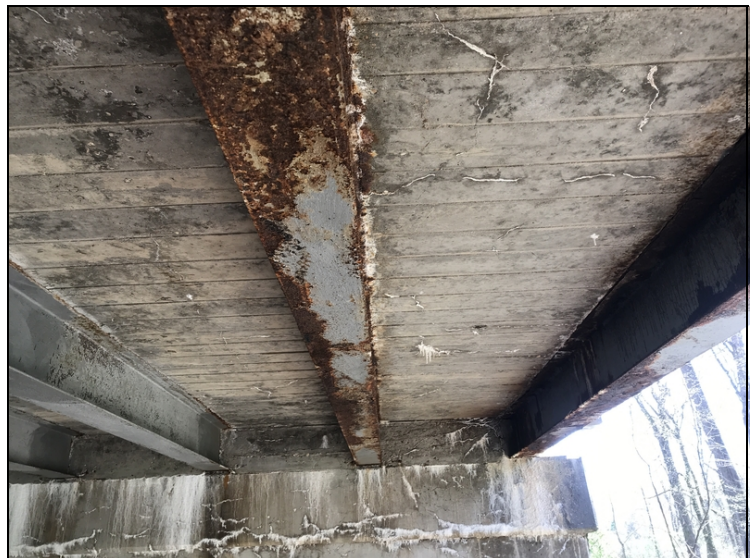
Span # 1 cracking with efflorescence on the undersurface of the deck.

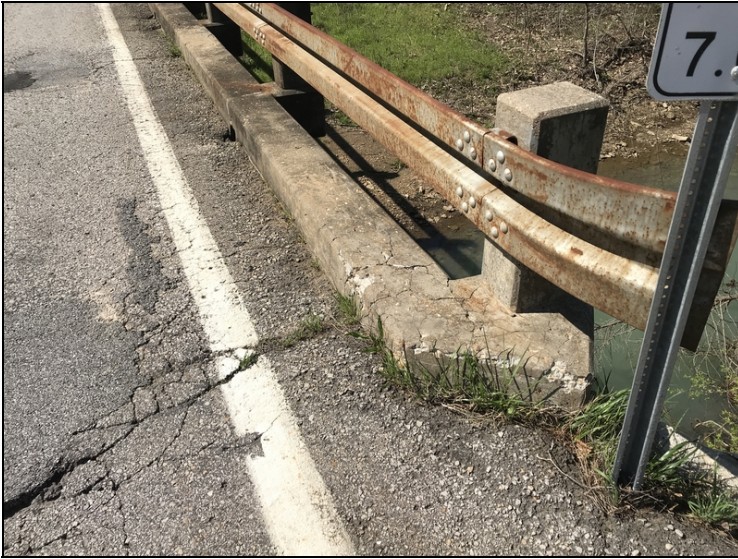
The concrete curbs are deteriorating and have map cracking with efflorescence. The curbs are beginning to lose section due to soft and crumbling concrete in areas. The undersurface of the deck has cracking visible with areas of heavy efflorescence build up.

Cracking in the curbs.

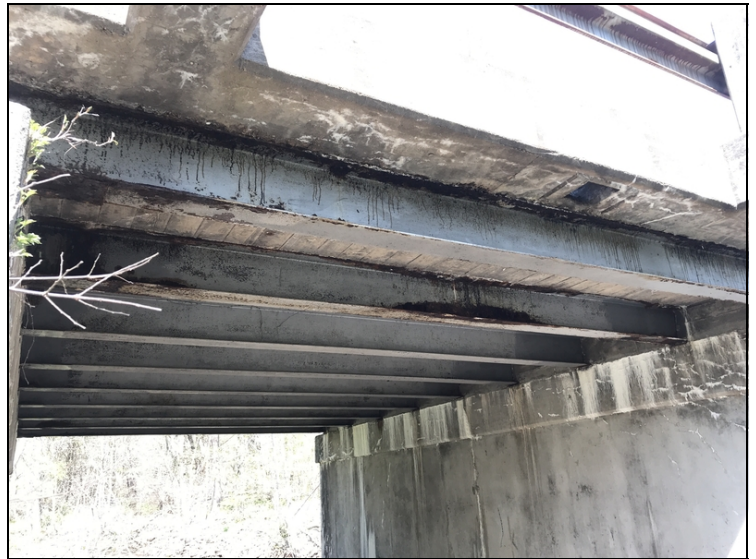
Span # 2 active corrosion with soft deteriorating concrete and efflorescence buildup.
