Bridge Inspection Report

00671

SH 23-Logan Co.
over
Petit Jean River

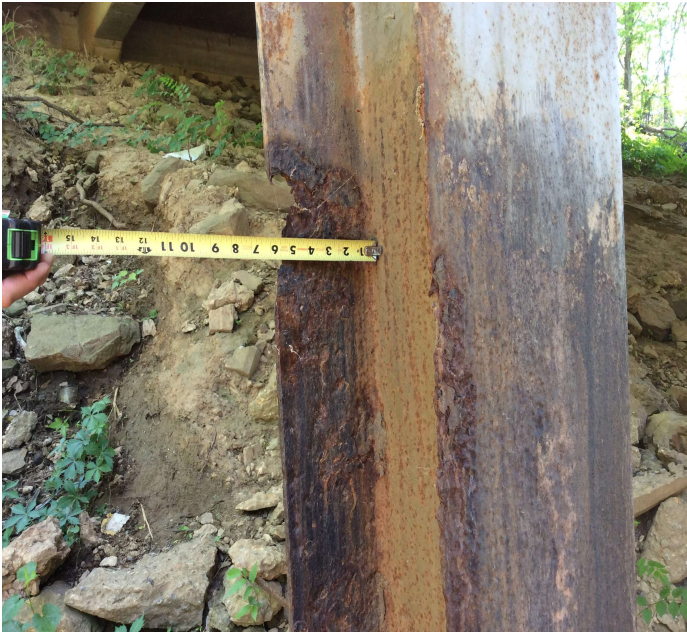
Bent # 2 piling has active corrosion with significant section loss approximately 3' from the bases of piles visible due to embankment erosion that has exposed approximately 3' of the piling that was originally covered. The most notable areas are the flange of Column # 4 which has a area of complete section loss to the exterior side of the flange that is approximately 5" long and 2 1/2" wide.

Column # 1 has pitting and up to 3/8" section loss to the exterior side of the flange in the same location. The tops of the steel pile columns have active corrosion beginning to show through the recent paint job with layers of flaking paint forming at the base of the concrete cap.

PHOTO 1 Description Bent # 2 right steel pile column with up to 2 1/2" section loss to the flange.

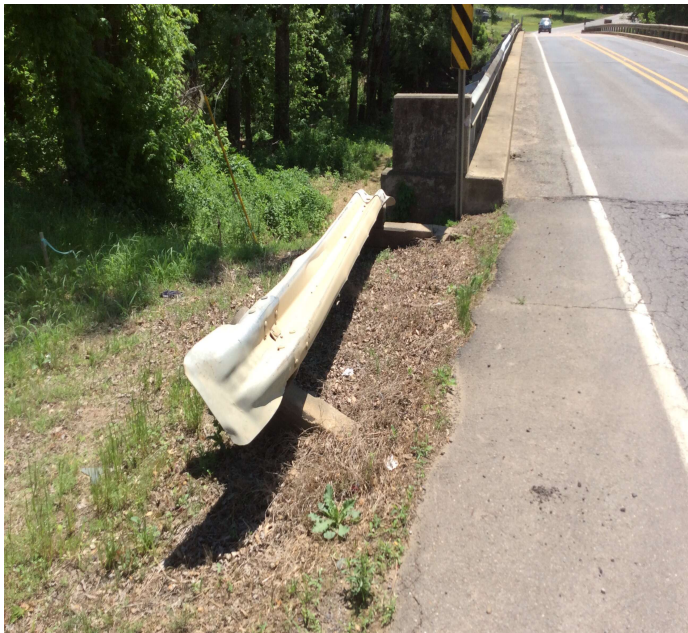
Approach guard rail on the Northeast side has collision damage that has broken four of the concrete post leaving the railing unattached at the broken posts.

PHOTO 1 Description Northeast approach guardrail damage.

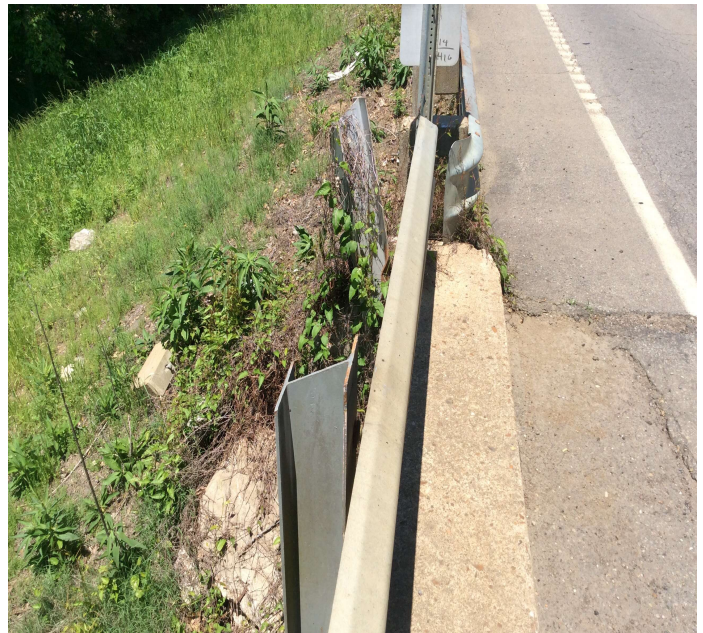
The Left bridge railing at the North bridge end has collision damage to the concrete end post and the first metal post.

PHOTO 2 Description North bridge rail attachment left side.

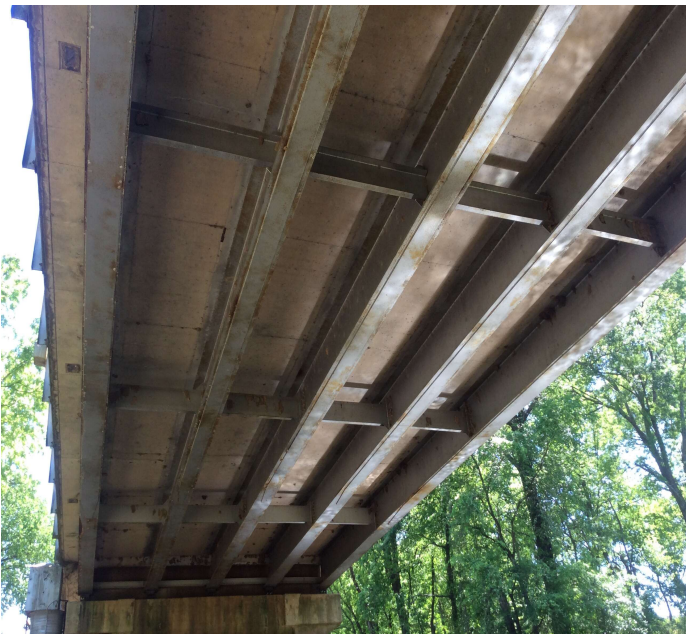
The paint system on Span # 3 steel beams is beginning to fail with areas of active corrosion and flaking rust below the deck drains.

PHOTO 1 Description Failing paint system.

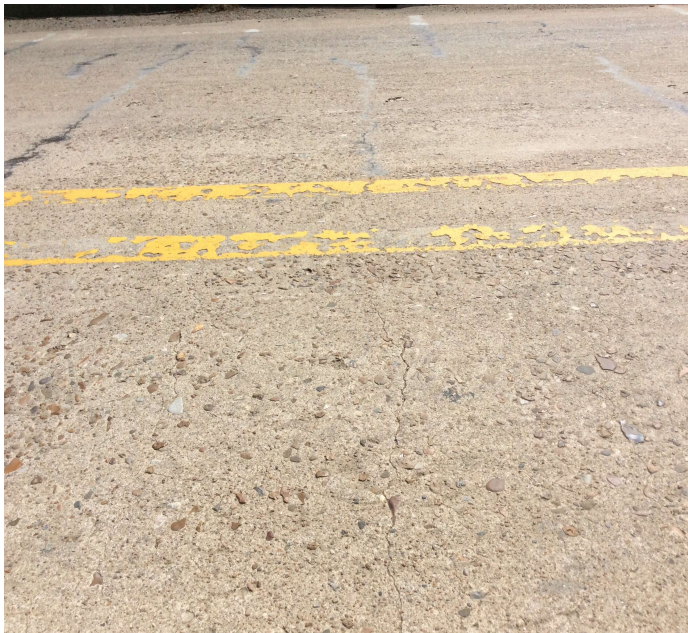
PHOTO 1 Description The driving surface of Span 3 has sealable cracking.

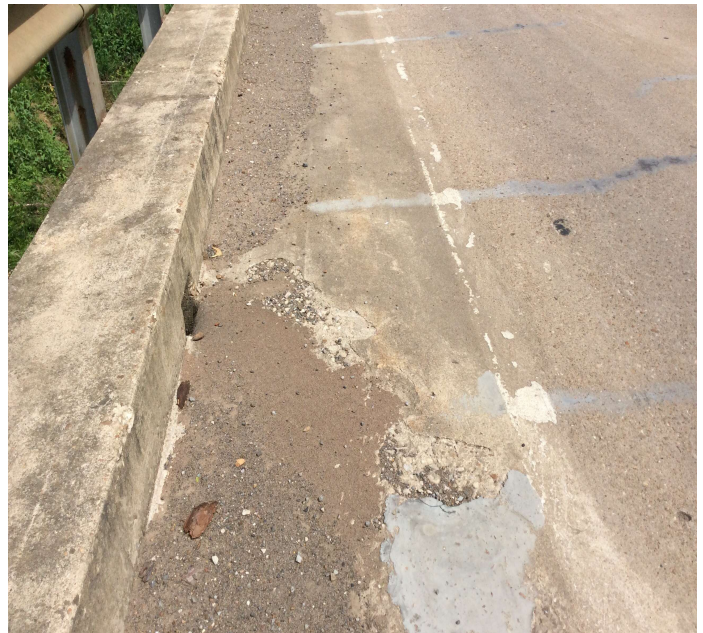
Span # 3 has sealable transverse deck cracking and light scale in the gutters.

PHOTO 2 Description Span 3 has sealable transverse deck cracking and light scale in the gutters.

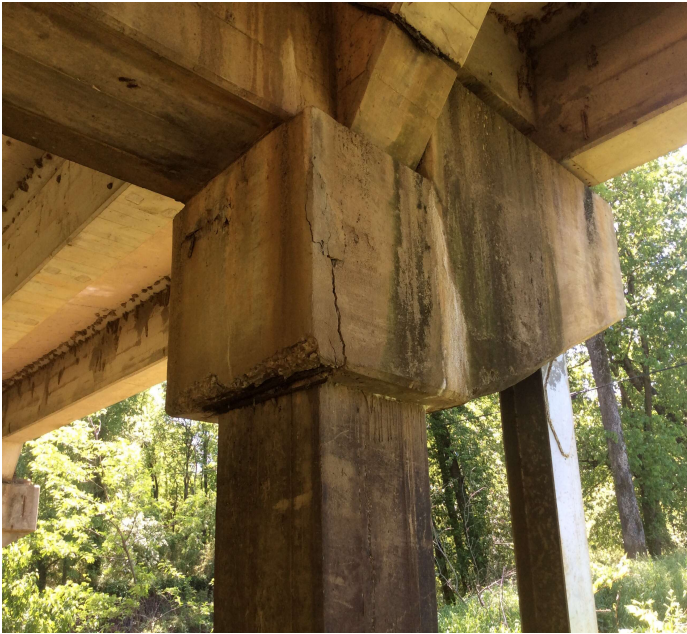
The concrete bent caps have shallow spalling with exposed reinforcing steel in numerous areas.

PHOTO 1 Description Bent # 5 left cap cracking and spalling with exposed reinforcing steel.

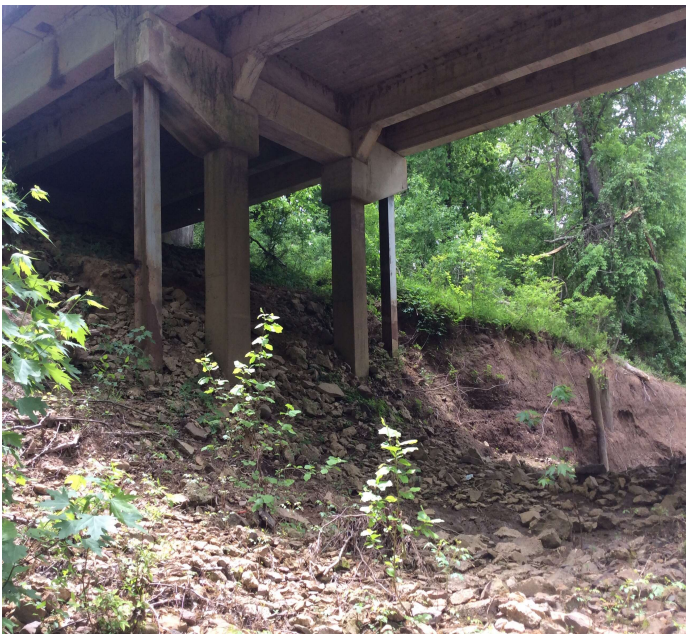
Embankment erosion at Bent 2 that has removed approximately 3' of embankment material from the base of the Columns .

PHOTO 1	Description	Embankment erosion at Bent 2 that has removed approximately 3' of embankment material from the base of the Columns .
---------	-------------	--

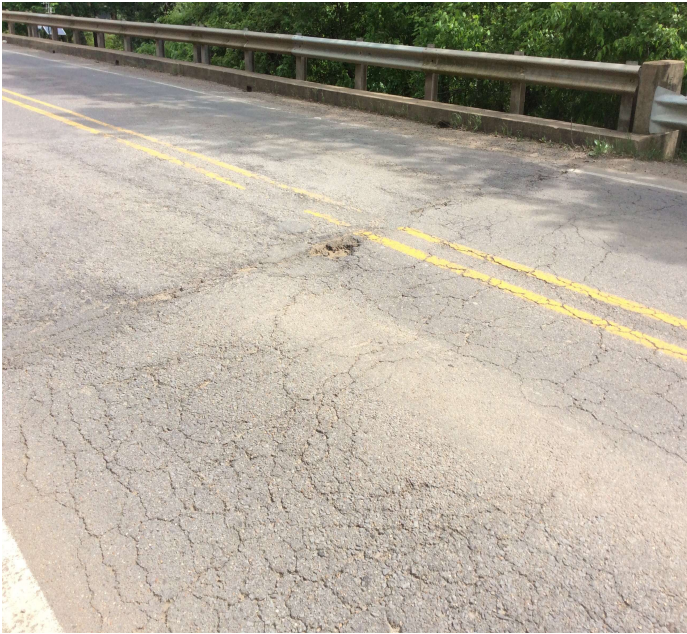
The approach roadway at Bent 1 and 9 is cracked and has potholes at the bridge ends.

PHOTO 1 Description The approach roadway at Bent 1 is cracked and has potholes at the bridge end.

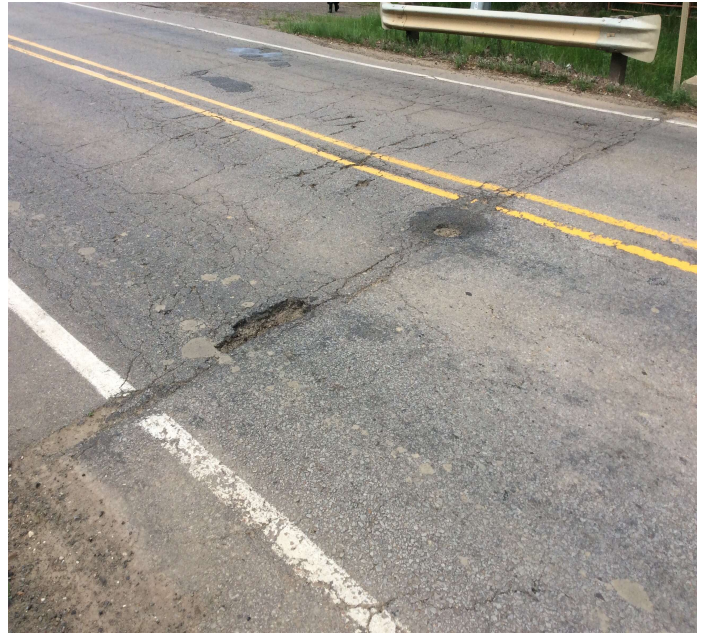
PHOTO 2 Description The approach roadway at Bent 9 (North abutment) is cracked and has potholes at the bridge end.
