Bridge Inspection Report

03368

SH 23-Logan Co.

Petit Jean River Relief

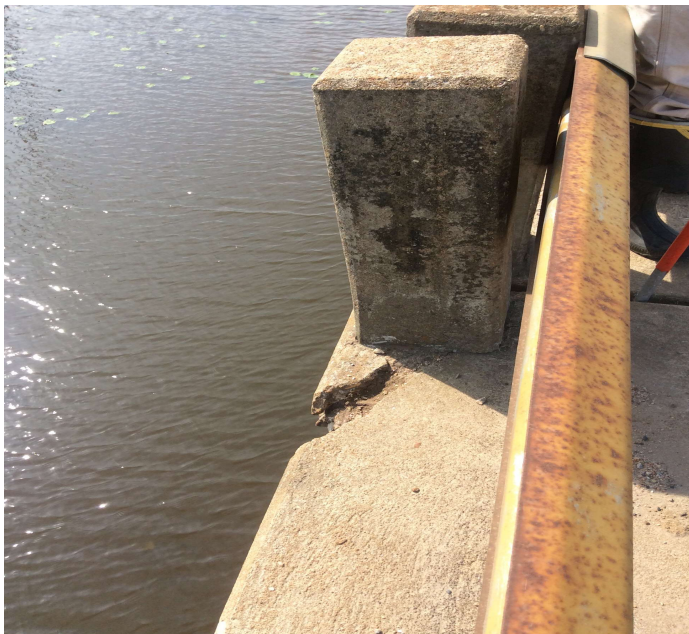
Bridge rail post on the Right side of Span # 17 over Bent # 17.

The deck is fractured at the base of the bridge rail post in Span # 17 over Bent # 17.
Span # 5 Left side has collision damage with spalling and exposed reinforcing steel on the rail post.

PHOTO 1 Description Fractured bridge rail post located over span 17 right

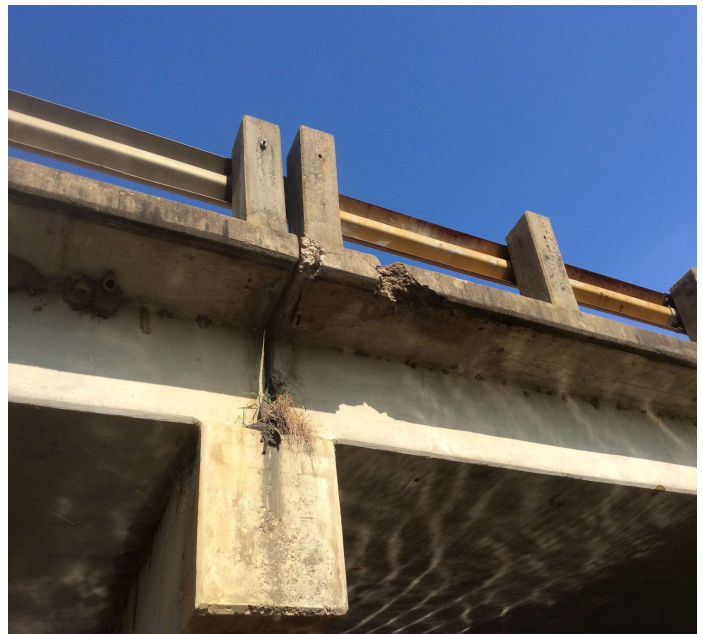
PHOTO 2 Description Span # 17 RT fractured rail post.

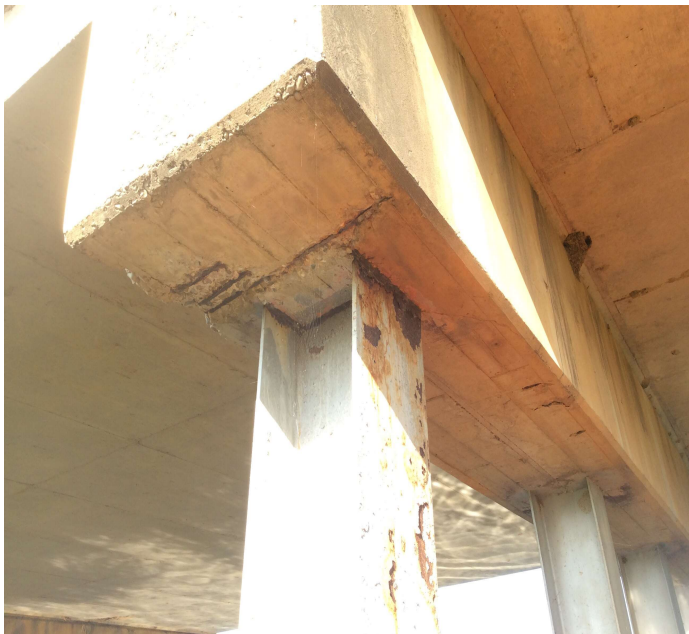
-Painted steel columns have active corrosion at the water elevation and at the cap juncture in locations. -Most extreme case is Bent 5, Column 5, Steel column is reduced to 1/8" thickness at the cap juncture.

Painted steel columns have active corrosion at the water elevation and at the cap juncture. Most extreme case is Bent # 5, Column # 5, Steel column is reduced to 1/8" thickness at the cap juncture.

PHOTO 1 Description Bent # 5 Column # 5 active corrosion with section loss.

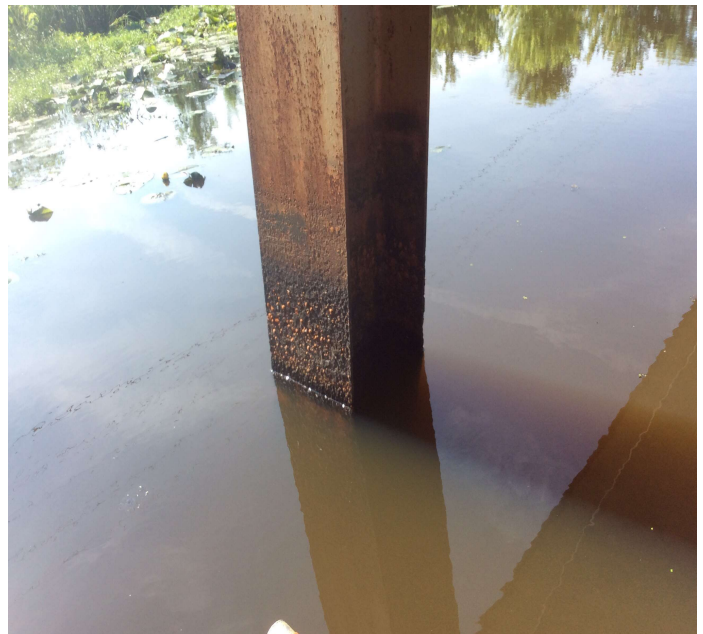
-The bases of the columns below the normal pool elevation have nodules of active corrosion with up to 1/8" deep pitting in numerous locations.

PHOTO 2 Description Heavy pitting at the column bases.

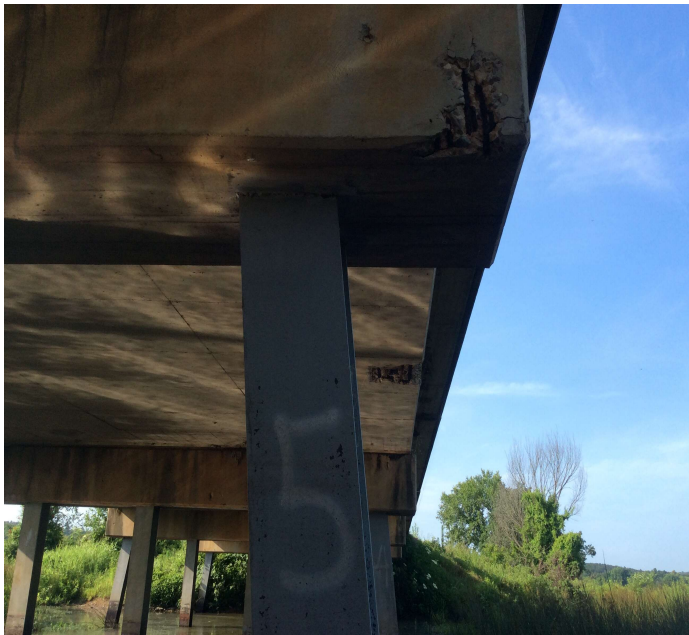
Substructure caps have numerous delaminated areas, spalls with exposed reinforcing steel that have active corrosion with up to 1/8" section loss at this inspection. Water stains on the substructure indicate that the deck joints leak water and debris on the caps.

PHOTO 1 Description Bent # 5 Lt spalling with exposed reinforcing steel on the bottom of the cap.

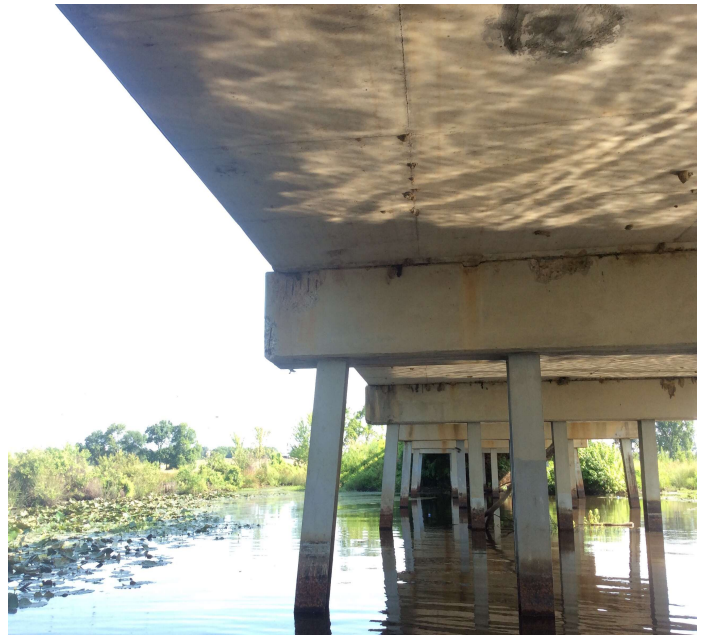
PHOTO 2 Description Bent # 14 Lt cap spalling with exposed reinforcing steel. 12

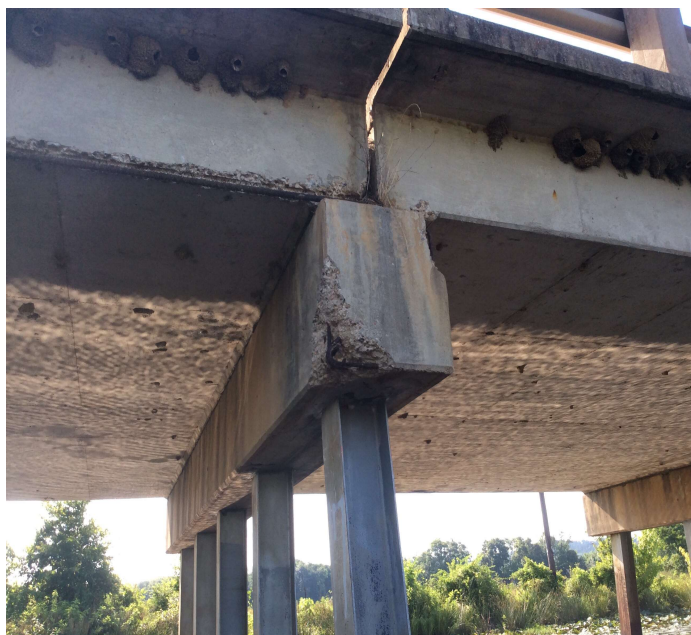
PHOTO 3 Description Bent # 17 Lt end of the cap spalling with exposed reinforcing steel.

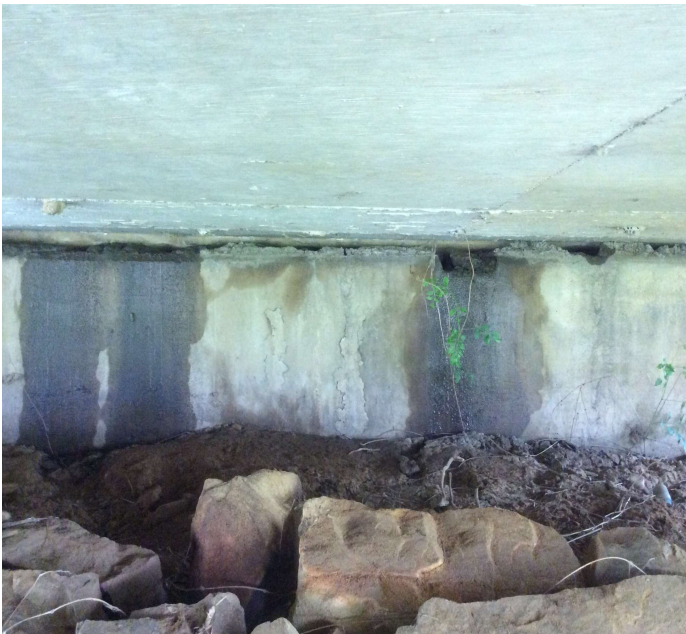
PHOTO 1 Description

Span # 1 has moved 5 1/2" on the Right and 4 3/4" on the Left past the face of Bent # 1 since original construction. Span # 18 has moved 3 1/2" (measured on the Left side) past the face of Bent # 19 since original construction.

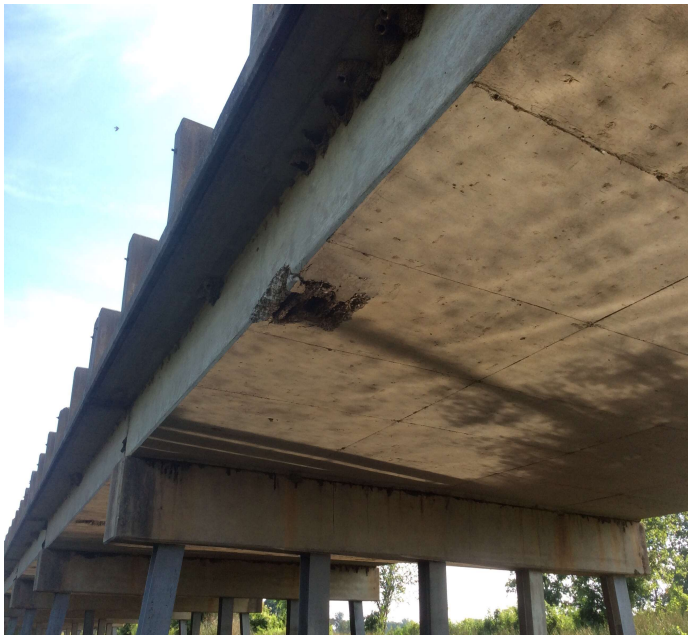
Gutters have heavy scale with deteriorated epoxy repairs. Edges of the deck have spalls over the expansion joints. There are sealable longitudinal cracks on the driving surface of the deck. There are Spalls with exposed reinforcing steel visible from the undersurface of the deck

PHOTO 1 Description Span # 4 Lt spalling with exposed reinforcing steel.

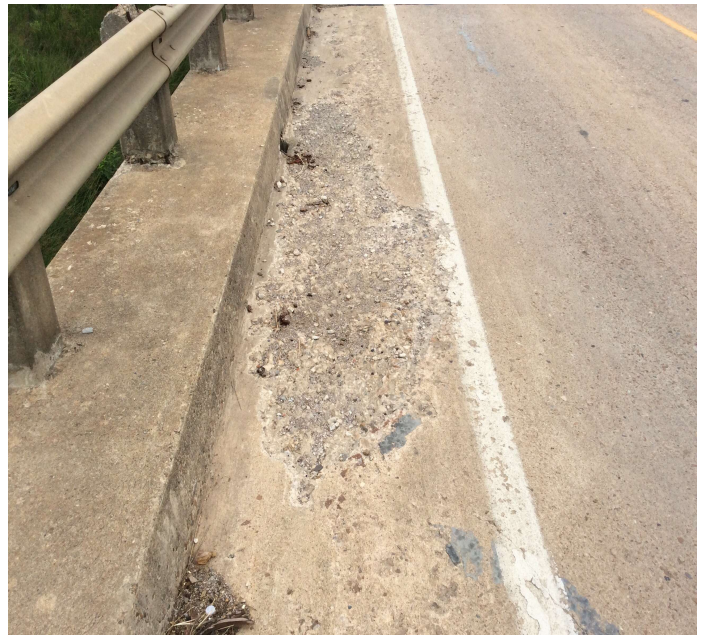
PHOTO 2 Description Span # 5 Lt gutter concrete deterioration.
