# Bridge Inspection Report

**05387**

**SH 23-Logan Co.**

**Little Six Mile Creek**

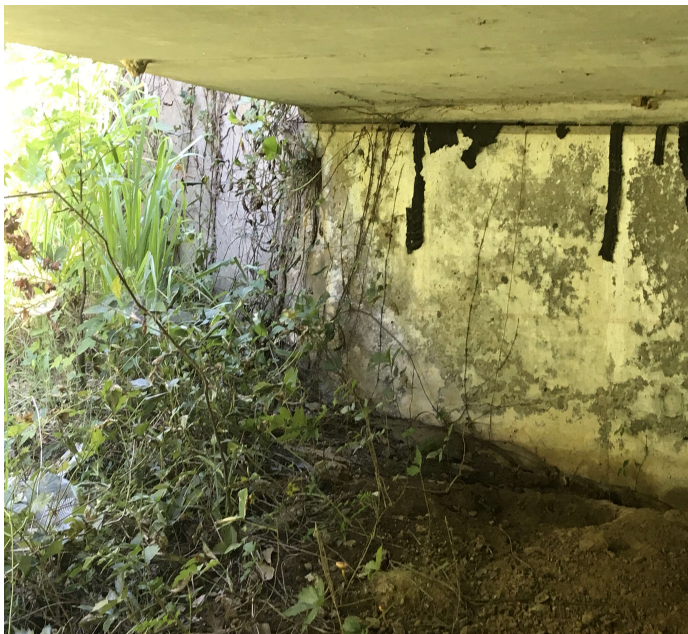
The Rt side of the South abutment stem has shallow spalling with exposed reinforcing steel. Bents 2 and 3 have spalling in the bearing areas. The undersurfaces of the caps have isolated areas of spalling with exposed reinforcing steel.

PHOTO 1      Description      Bent 1 Rt spalling with exposed reinforcing steel in the end of the abutment.

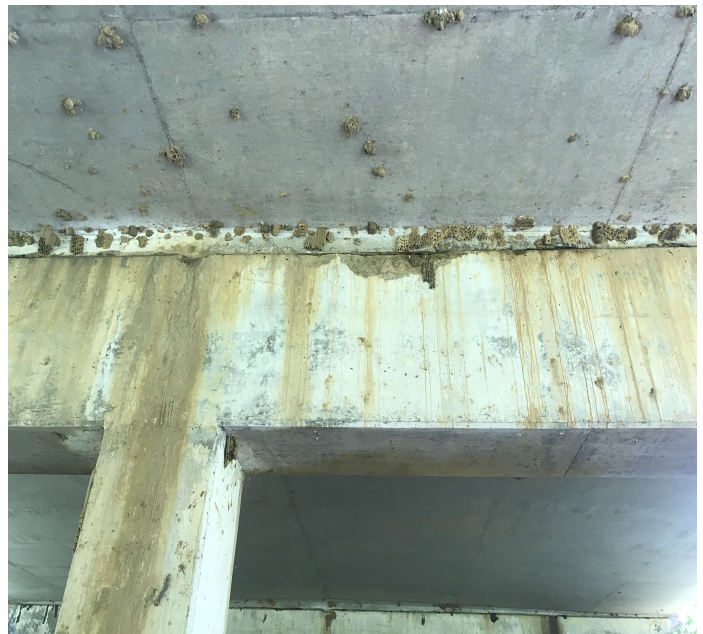
PHOTO 2      Description      Bent 2 Span 2 shallow spalling in the bearing area.

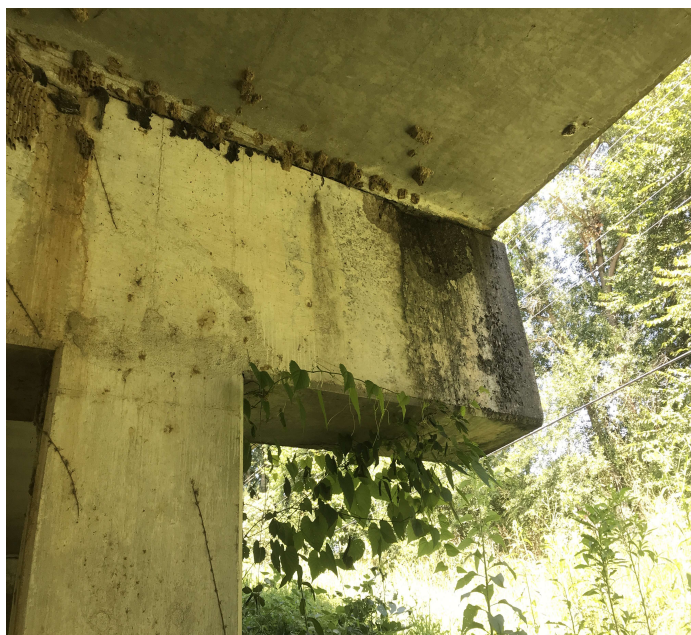
PHOTO 3      Description      Bent 3 Rt spalling with exposed reinforcing steel.

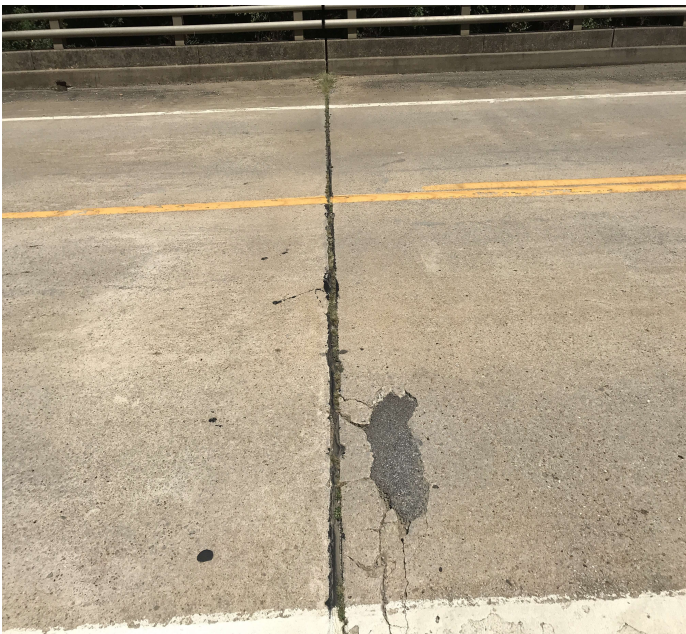
The deck joint sealant over Bents # 2 & 3 is failing and leak water and incompressible material in the joints. The driving surface of the deck has sealable cracking in all spans.

PHOTO 1      Description      Bent 2 failing joint seal.

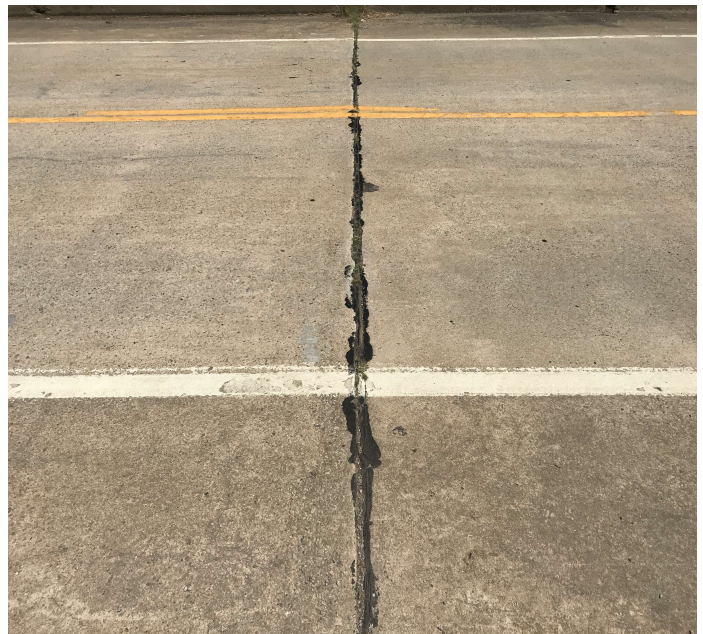
PHOTO 2      Description      Bent 3 failing joint seal.

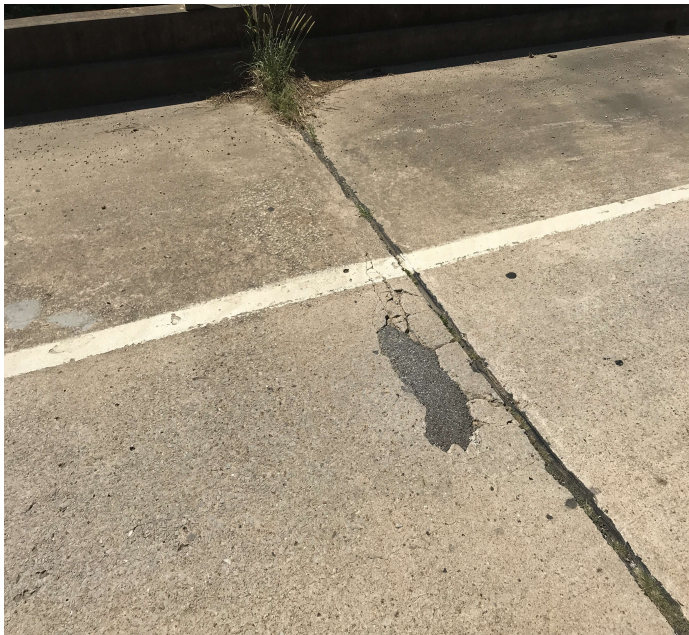
The concrete slab has vertical fractures visible in the Rt and Lt exterior vertical faces of the slab over Bent 2. The fracture on the Lt side propagates into the concrete parapet and continues transversely into the Lt driving lane of the deck adjacent to Bent 2. The deck has spalling adjacent to Bent 2 expansion joint assembly as a result of the cracking.

PHOTO 1      Description      Span 1 Lt spalling and delaminated concrete adjacent to the deck joint.

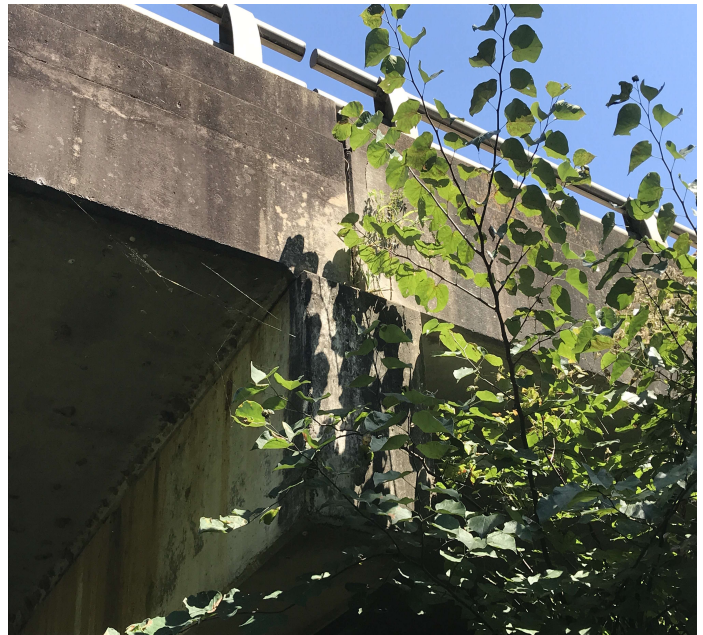
PHOTO 2      Description      Span 1 @ Bent 2 Lt Vertical crack in the edge of the slab.

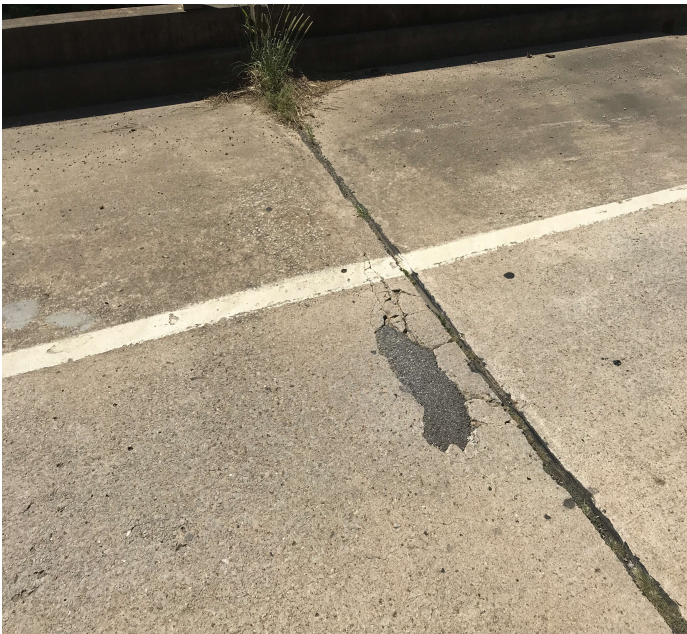
There is a 1' X 12' spalled / delaminated area In the Left side of Span 1 adjacent to the expansion joint over Bent 2.

PHOTO 1      Description      Span 1 Lt spalling and delaminated concrete adjacent to the deck joint.
