Bridge Inspection Report

01789
SH 23-Franklin Co
over
Mulberry River

11/29/2018 - JCJ & TJL -Special Recurring Inspection removed this date. Maintenance forces have replaced the bearings at the North Abutment. The Superstructure has an NBIS rating of 4 based upon the active corrosion and section loss in the bottom chord of the truss spans. Most significant areas of concern are located in the Boxed in areas of the lower chord where dirt and debris have accumulated for years. Fracture Critical Inspections are conducted annually to monitor these fracture critical areas.

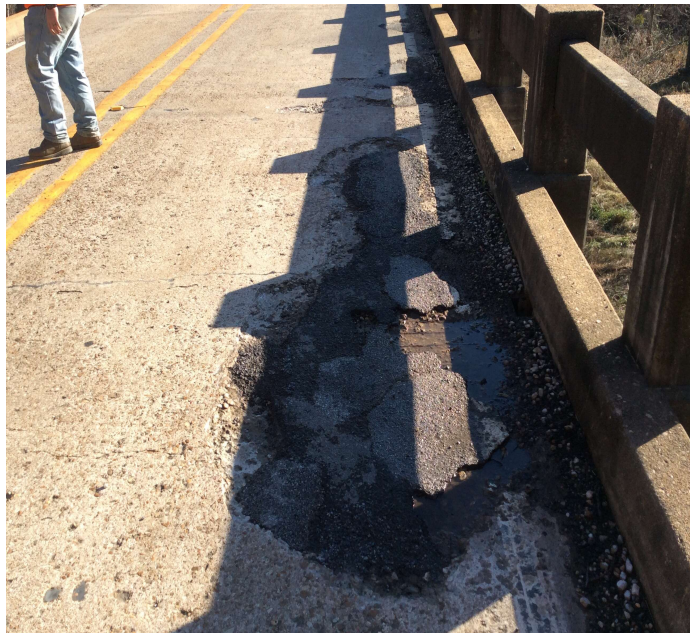
The driving surface of Span # 1 has partial depth failures that expose the top mat of reinforcing steel in the gutters and edges of the wheel paths. There is heavy scale with soft deteriorated concrete in the gutters of all spans with some asphalt patches. Spans # 1, 2, and 3 have a full depth sealable longitudinal crack near centerline. Spans # 4 and 5 have full depth sealable transverse cracks at approximately 6' centers and large areas of heavy scale / concrete deterioration that exposes reinforcing steel. Span # 4, Bay # 2 next to top flange of beam has one softball sized spall near mid span.

PHOTO 1 Description Span # 5 spalling with exposed reinforcing steel.

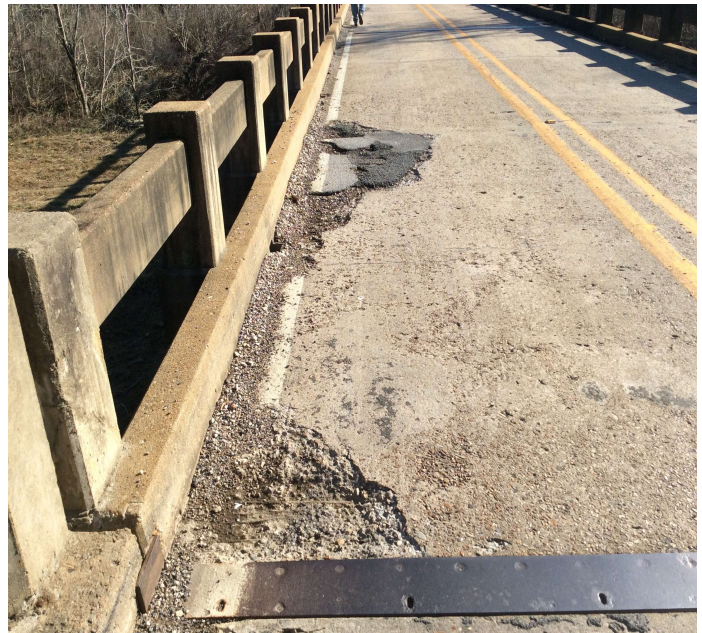
PHOTO 2 Description Span # 5 spalling with exposed reinforcing steel.

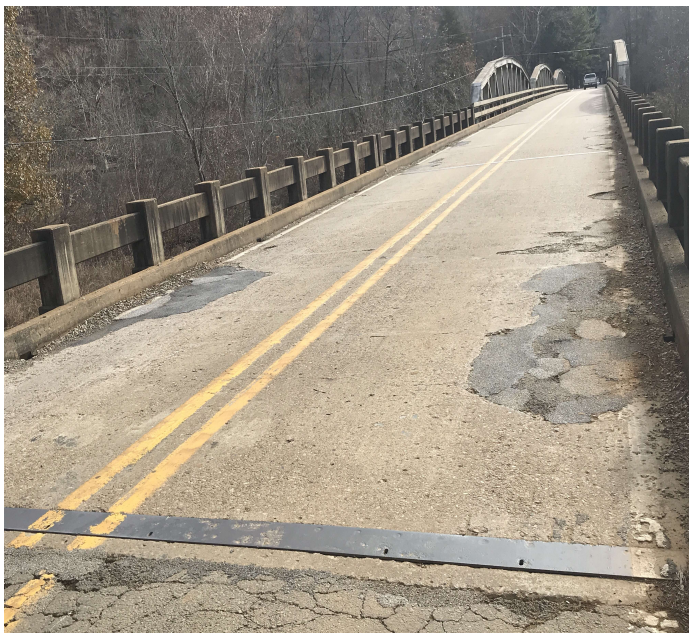
PHOTO 3 Description Deck. Span # 5.

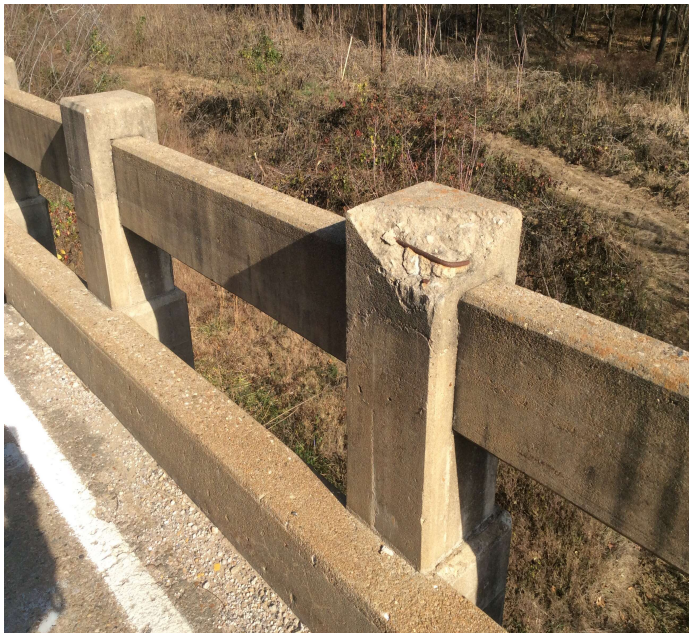
Concrete bridge railing post on the Rt side of Span # 5 at the North bridge end is fractured due to collision damage.

PHOTO 1 Description Span # 4 Rt. Post # 7 has collision damage.

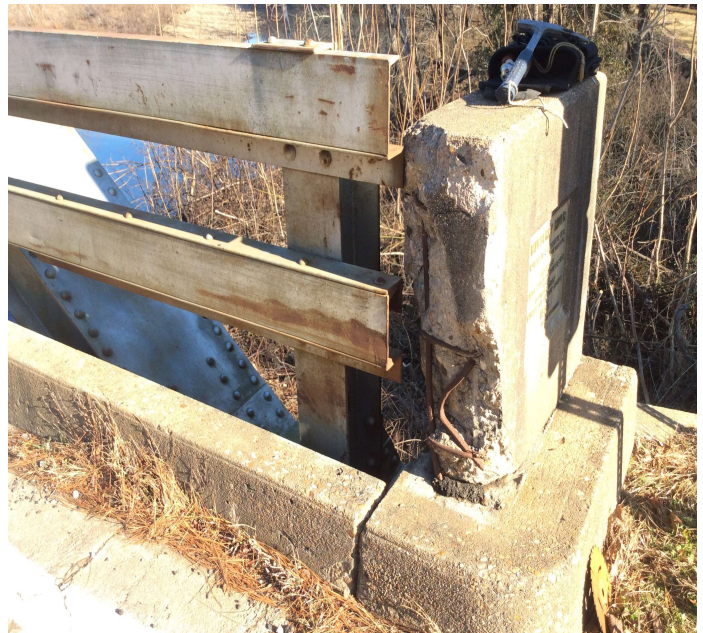
The concrete end post at Bent # 1 Rt side of structure has Collision damage that has fractured it at the base and caused spalling with exposed reinforcing steel.

PHOTO 2 Description End post at Bent 1 Rt has collision damage with exposed rebar.

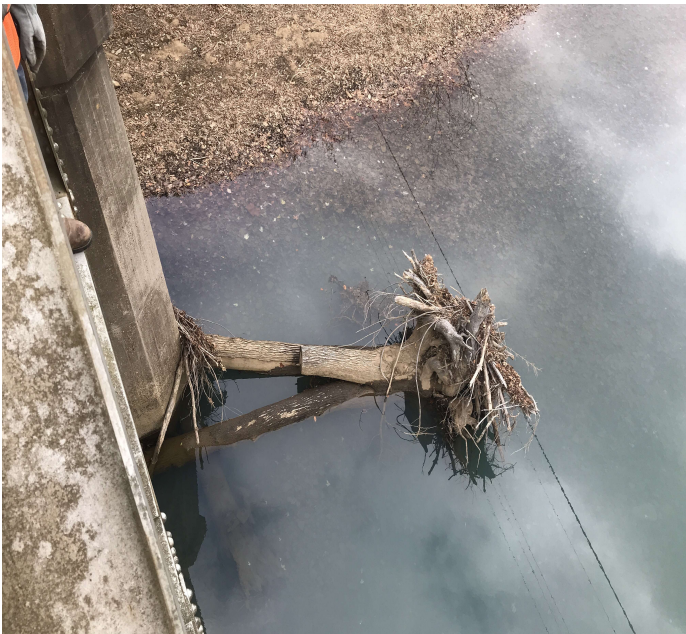
Drift has accumulated in channel against Bent # 2.

PHOTO 1 Description Inlet Bent # 2. Drift.

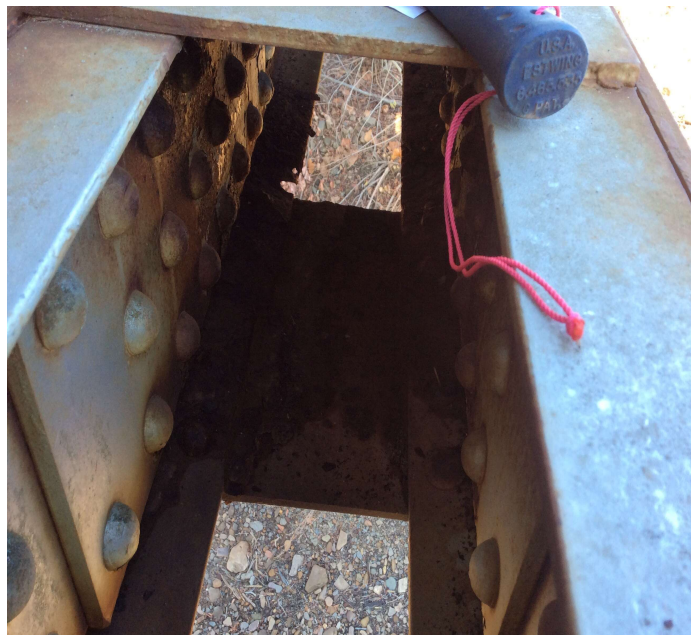
The lower chords and the floor beams have active corrosion, layers of flaking rust and section loss. The section loss in the lower chords range from initial to knife edge with a 3/4" diameter hole rusted through the bottom flange in Span # 2 at L1 - L2 Rt. The majority of the active corrosion and section loss in the lower chords is located in the area of the splice plates of the lower chords with rivet heads that have up to approximately 90% section loss.

PHOTO 1 Description Span # 2 L1-L2 Right with a 3/4" & a 1/4" hole rusted through the interior lower chord.

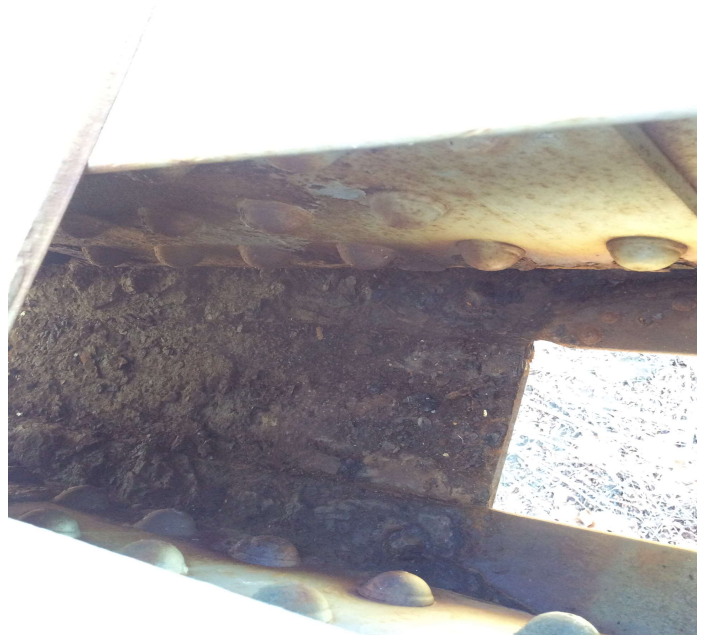
PHOTO 2 Description Span # 2 L3-L4 Right section loss in the lower chord splice.

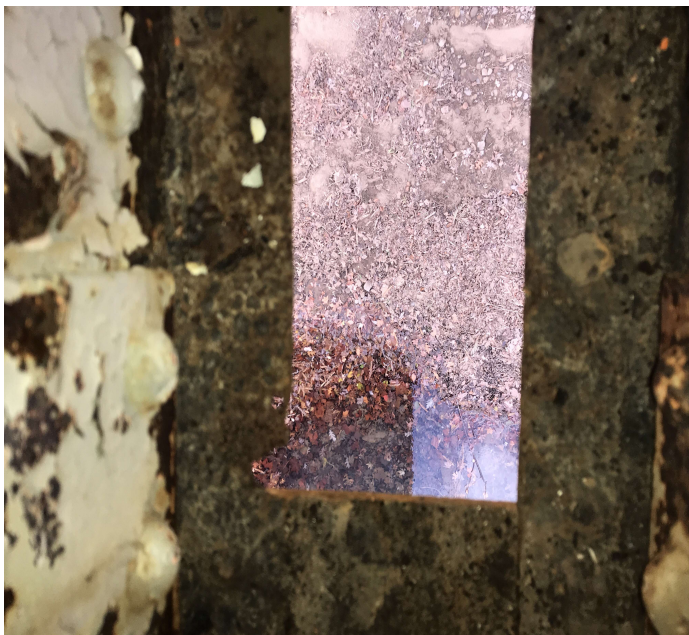
PHOTO 3 Description Span # 2. Right side. 3/4" hole; Section loss. Interior Channel. Splice; L1-L2 Bottom chord.

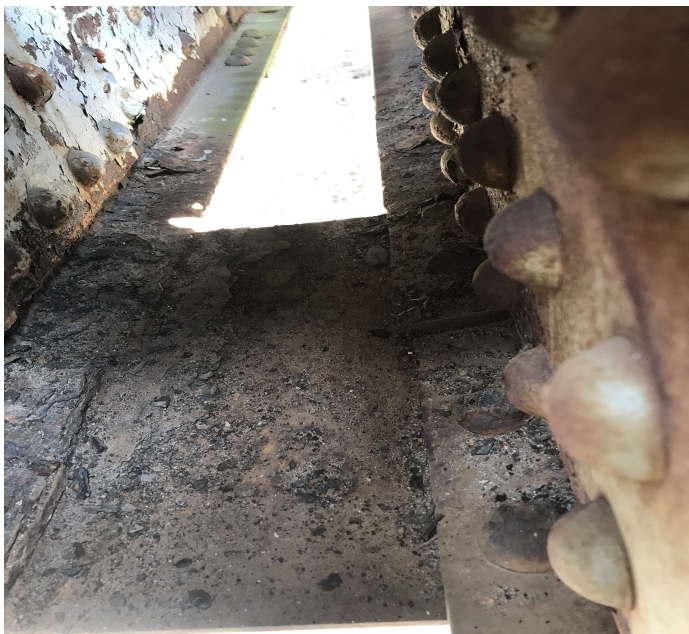
PHOTO 4 Description Span # 2 right. L1-L2. Lower chord. Corrosion.

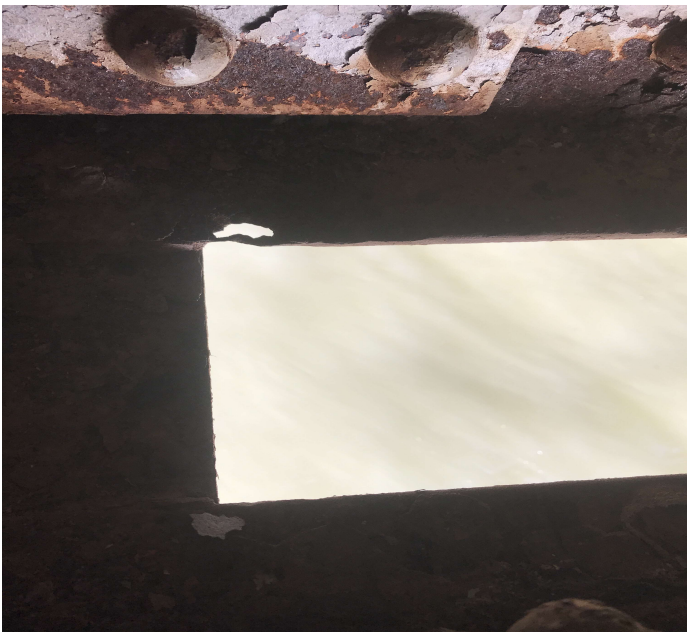
PHOTO 8 Description 1" hole L9-L10 splice.

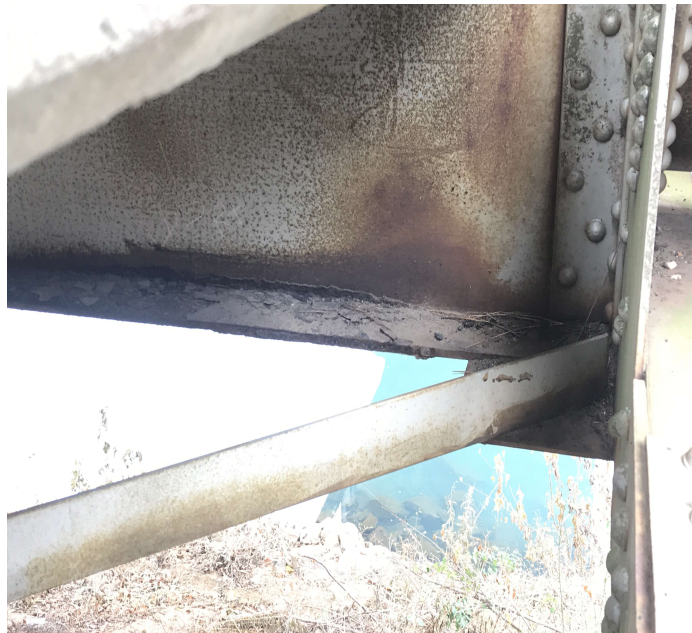
PHOTO 1 Description Span # 1 Right. L2 floor beam corrosion.

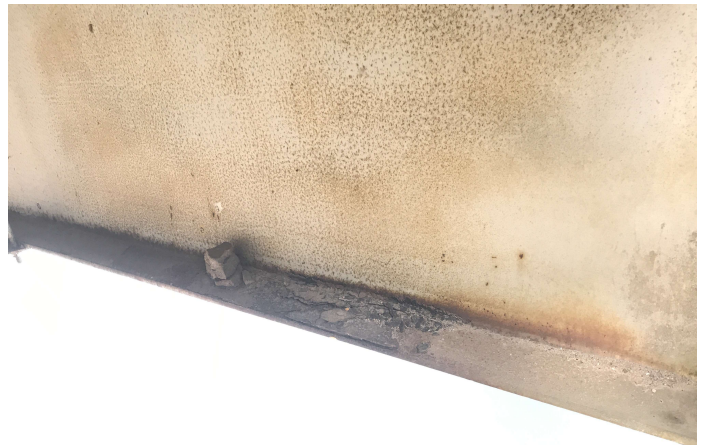
PHOTO 2 Description Span # 1. L6. Right side floor beam corrosion.

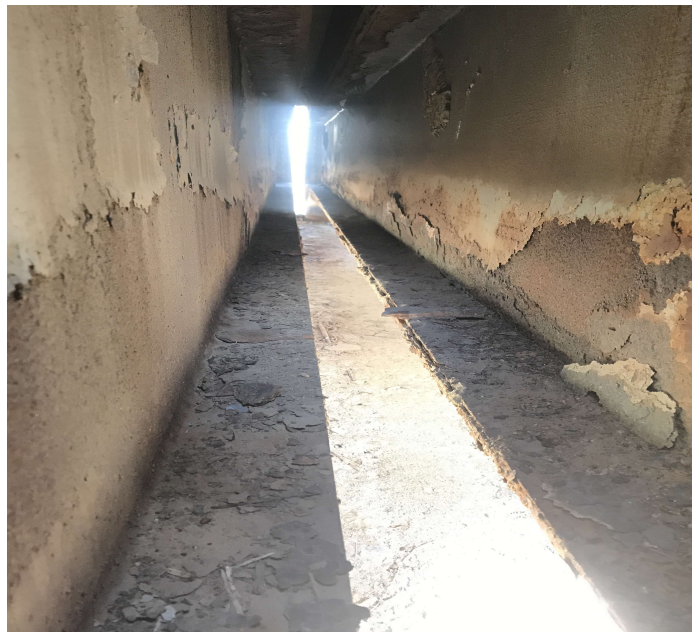
PHOTO 4 Description Floor beams over Bent # 3. Left side. Active corrosion.

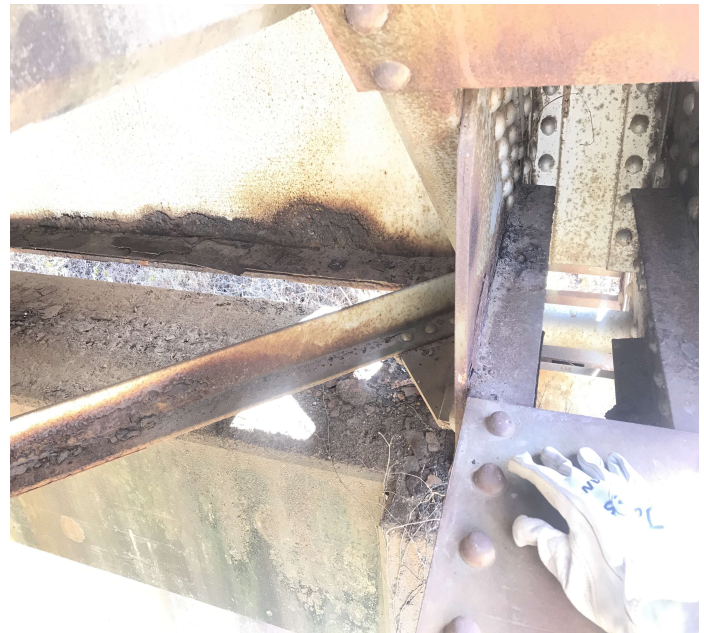
PHOTO 5 Description Span # 3 Left. L0 Corrosion in connection and in the bottom flange of the floor beam.

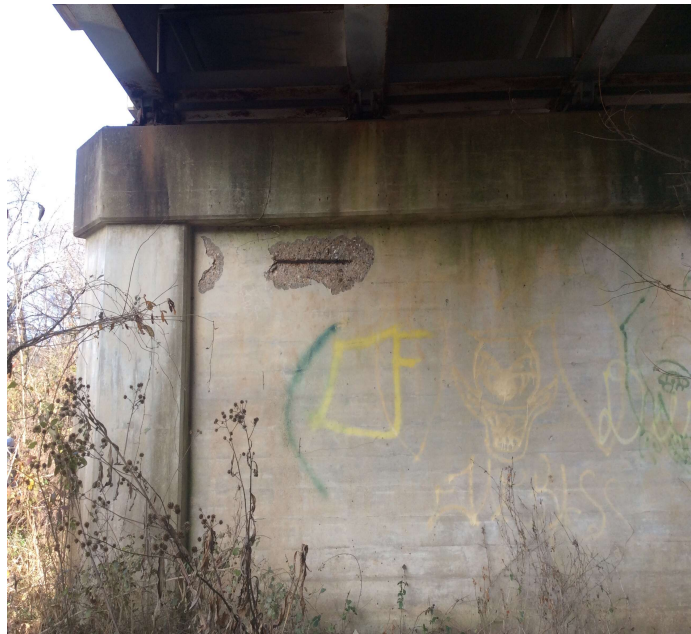
Substructure has spalls with exposed reinforcing steel.

PHOTO 1 Description Bent 5 Span 4 has a 3' spall with exposed reinforcing steel and initial section loss in the web wall

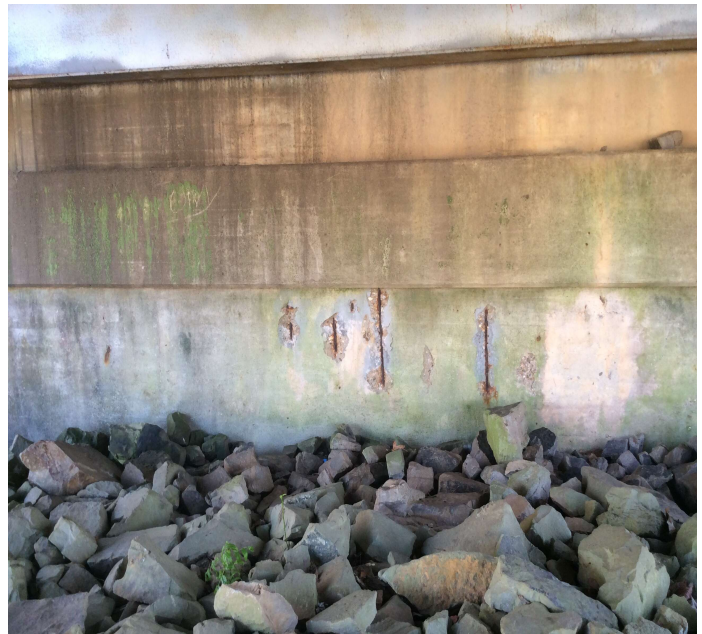
PHOTO 2 Description Bent 1 has 4 vertical spalls with exposed reinforcing steel. Exposed reinforcing steel has initial section loss at this inspection.

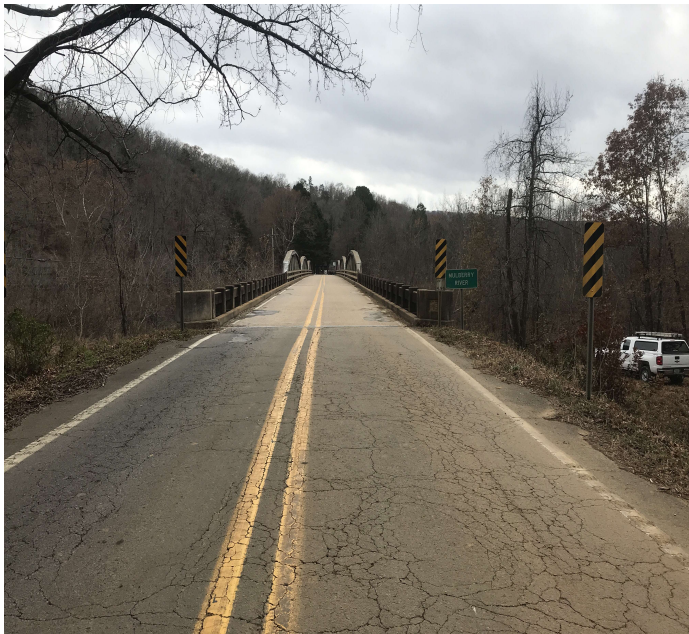
PHOTO 1 Description Approach roadway facing South.

The asphalt in the approach roadway is breaking apart adjacent to the North and South bridge ends.

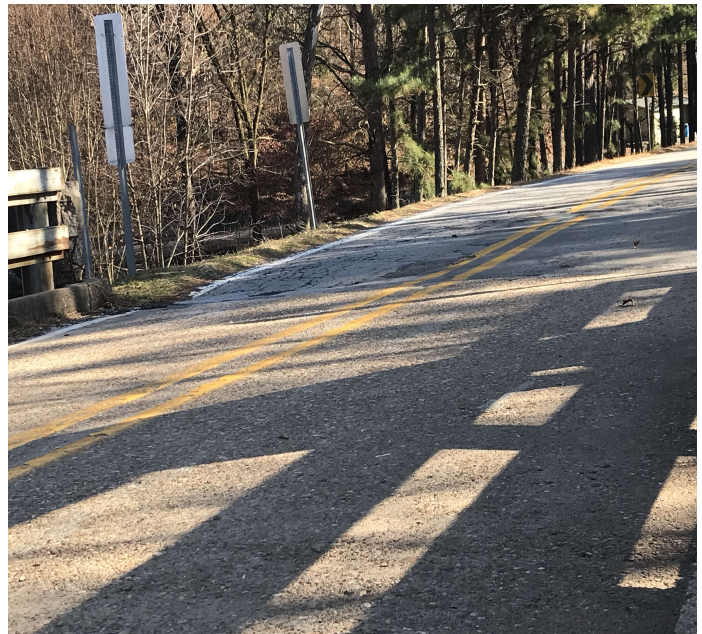
PHOTO 2 Description Asphalt settlement at the South bridge end.

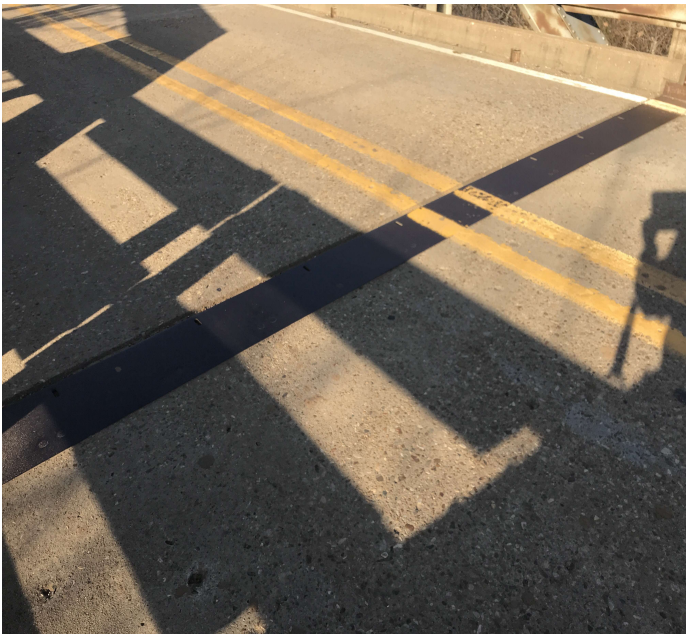
PHOTO 1 Description Sliding plate over Bent # 3.

The sliding plate expansion joints make noise when impacted by heavy loads.
