Bridge Inspection Report

05260
SH 23-Franklin Co.
over
Rock Creek

Structure Number: 05260

Facility Carried: SH 23-Franklin Co.

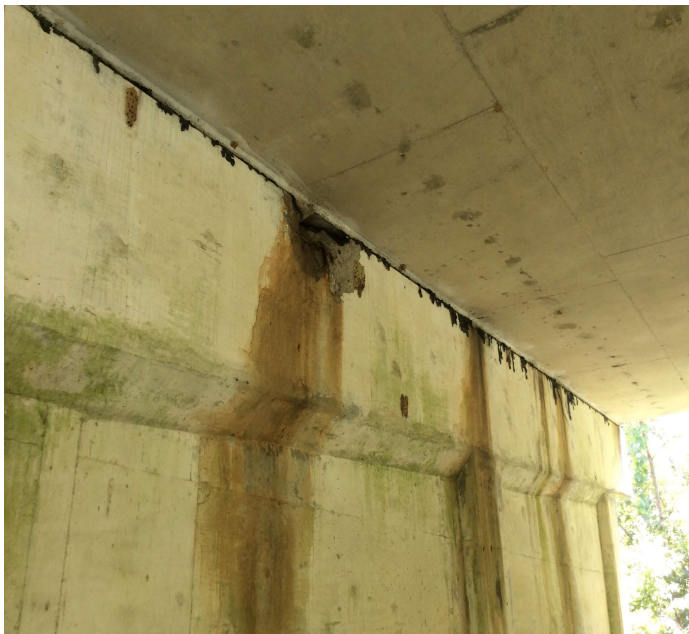
Substructure - Bents # 2, # 3 and # 4

The caps at bents # 2, # 3 and # 4 have spalling at the keyways. The spall at bent # 3 of span # 2 has exposed reinforcing steel.

PHOTO 1 Description Bents 2, 3 & 4 have concrete spalling with exposed reinforcing steel at the keyways. Bent 2 pictured.

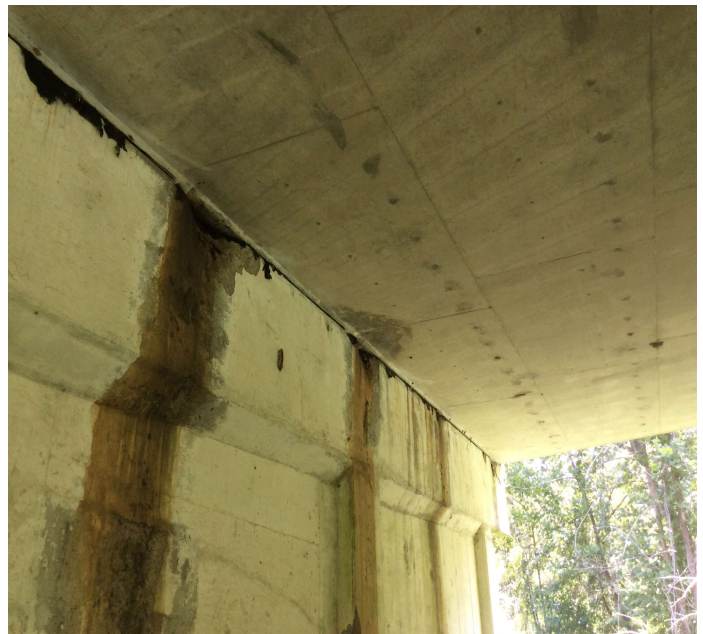
PHOTO 2 Description Bents 2, 3 & 4 have concrete spalling with exposed reinforcing steel at the keyways. Bent 3 pictured.

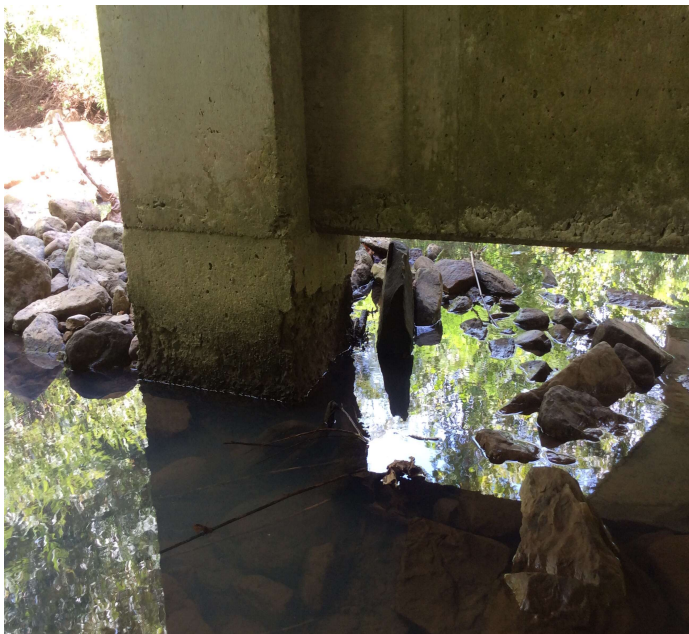
Bent # 4 Columns # 1 & 2 areas of spalling with exposed reinforcing steel. Bent # 2 Column # 1 has concrete deterioration and section loss at the base.

PHOTO 1 Description Concrete spalling and deterioration at the base of Bent 2, Column 1 with no exposed reinforcing steel.

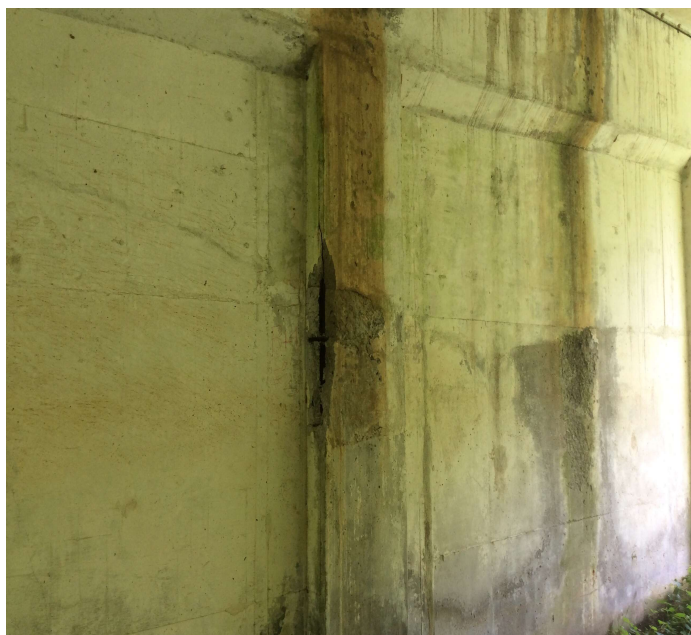
PHOTO 3 Description Bent 4, Column 2 has a 3' long spall with exposed reinforcing steel with initial section loss.

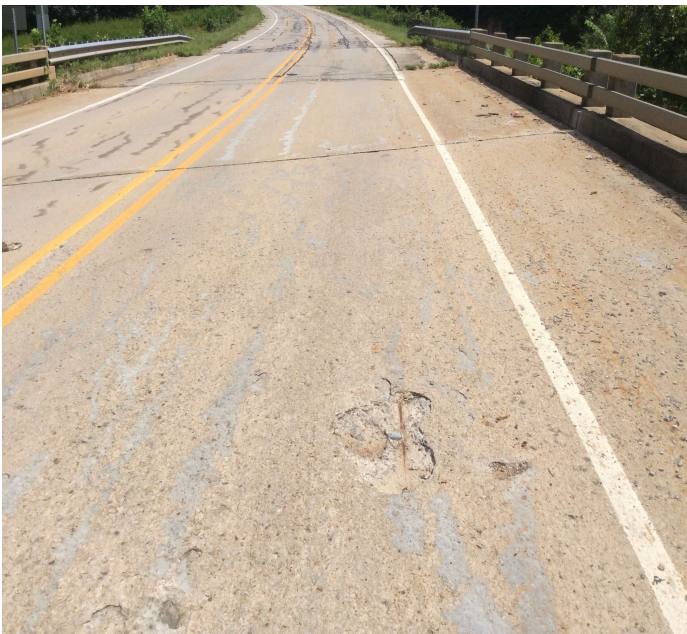
Span 3 Right lane has a 3' x 2' spalled area with exposed reinforcing steel in the wheel path. The exposed reinforcing steel has initial section loss.

PHOTO 1	Description	Span 3 Rt lane has a 2' x 1' spalled area with exposed reinforcing steel in the wheel path.
---------	-------------	---

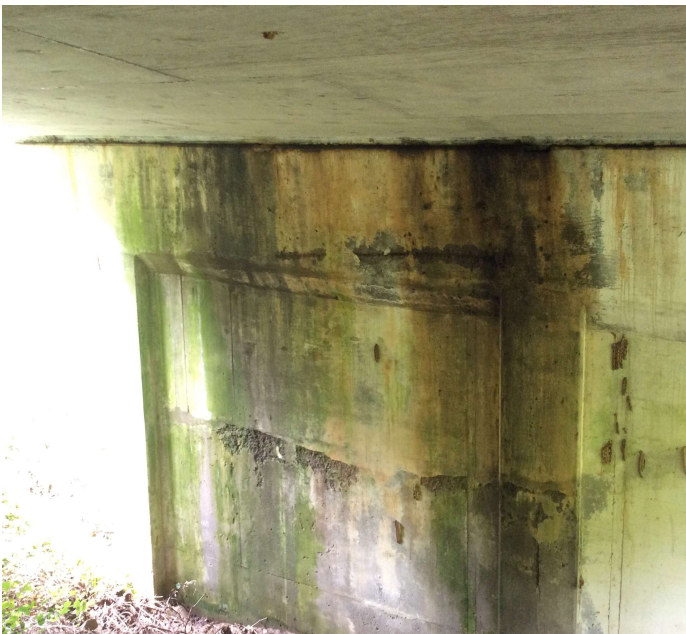
PHOTO 1 Description

Deck Joint Seals

The deck joints seals leak water on the substructure which appears to be contributing to the cracking and spalling in the substructure.

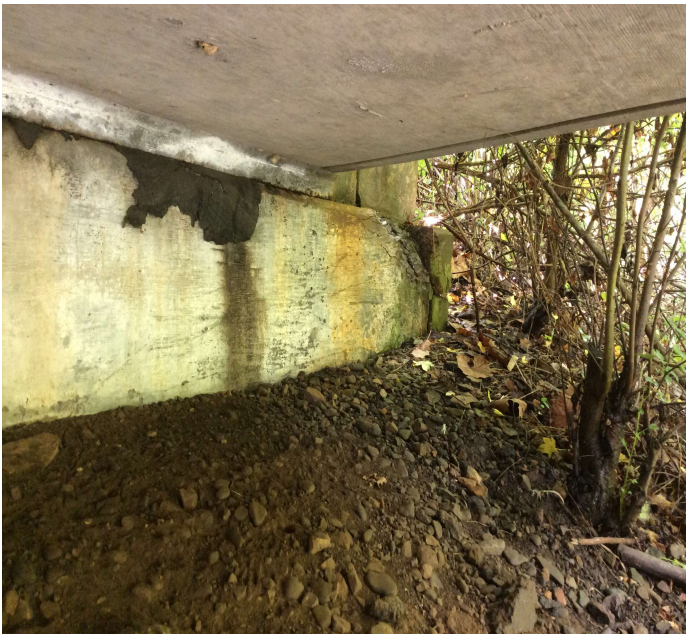
PHOTO 1 Description

The left side of Bent # 1 abutment has a 12" long area of concrete deterioration and section loss.

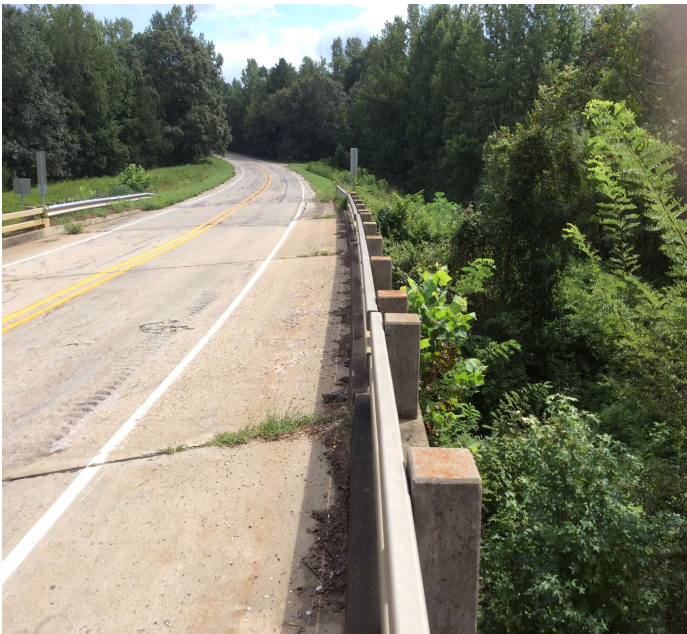
PHOTO 1 Description

The concrete slab spans have several large areas of medium scale / abrasion visible on the driving surface of the deck.
