# Bridge Inspection Report

**05261**  
**SH 23-Franklin Co.**  
**over**  
**Fane Creek**

Structure Number: 05261

Facility Carried: SH 23-Franklin Co.

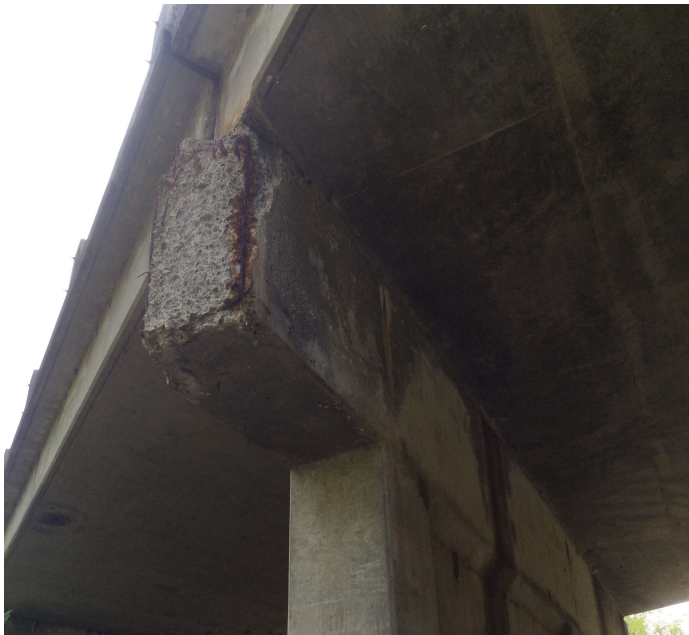
The substructure caps have concrete deterioration and spalling with exposed reinforcing steel in the end of the caps on the left side of Bents # 4 and # 5. The cap of Bent # 2, Span # 2 has spalling in the keyway areas that expose reinforcing steel.

PHOTO 1      Description      -Bent 4 has concrete deterioration with section loss and exposed reinforcing steel on the Lt end of the cap.

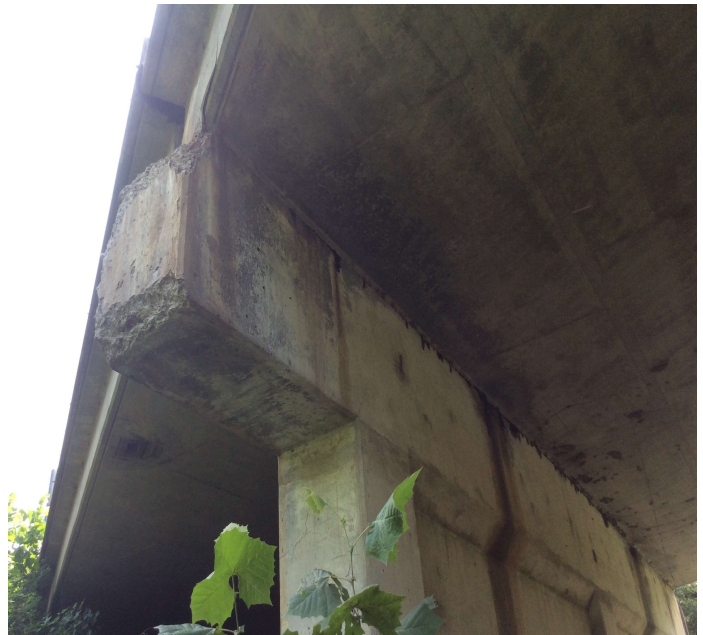
PHOTO 2      Description      -Bent 5 Lt side has concrete deterioration with exposed reinforcing steel.

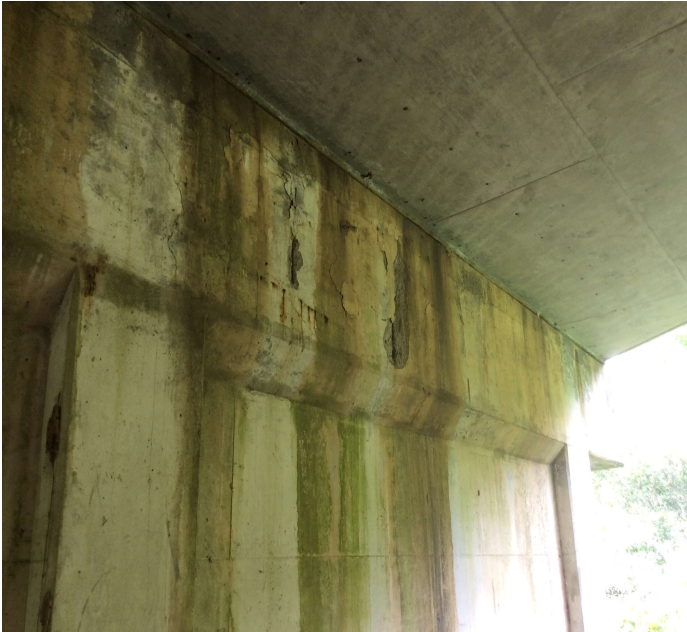
PHOTO 3      Description      -Bent 5 has a large spall with exposed reinforcing steel on the ahead face of the cap near the centerline of the cap.

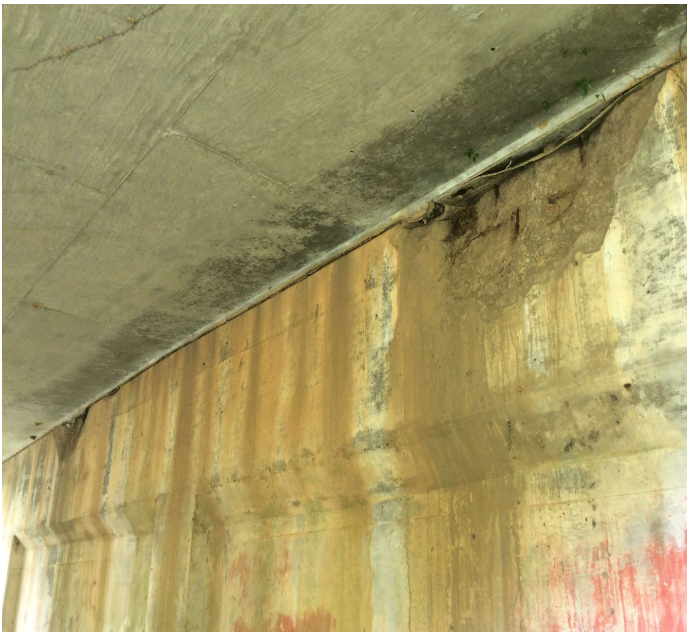
PHOTO 4      Description      -Bent 2 has a 3' wide spalled area on the Rt side of the cap at the keyway.  
-Bent 2 has has a 3' spalled area on the Lt side of the cap with exposed reinforcing steel.

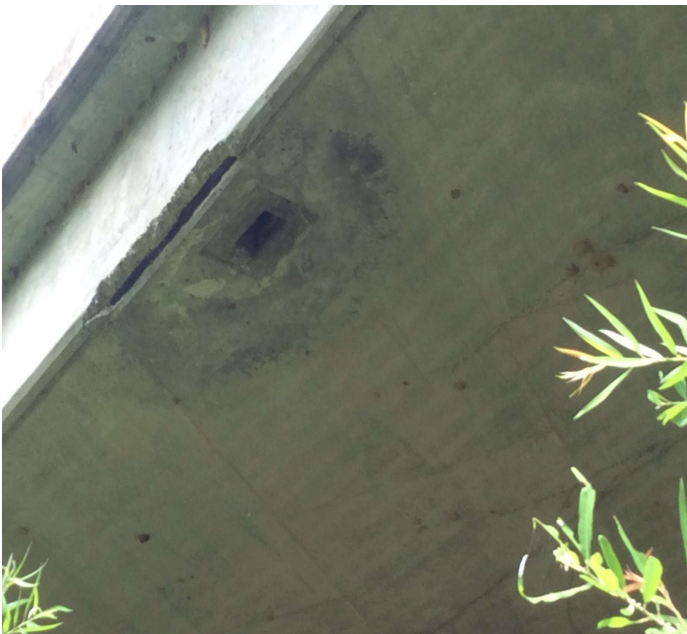
The undersurface of the slab spans on the right side of structure has spalling with exposed reinforcing steel. The exposed reinforcing steel has active corrosion with layers of flaking rust.

PHOTO 1      Description      There is concrete spalling with exposed reinforcing steel around the deck drains visible from the undersurface.

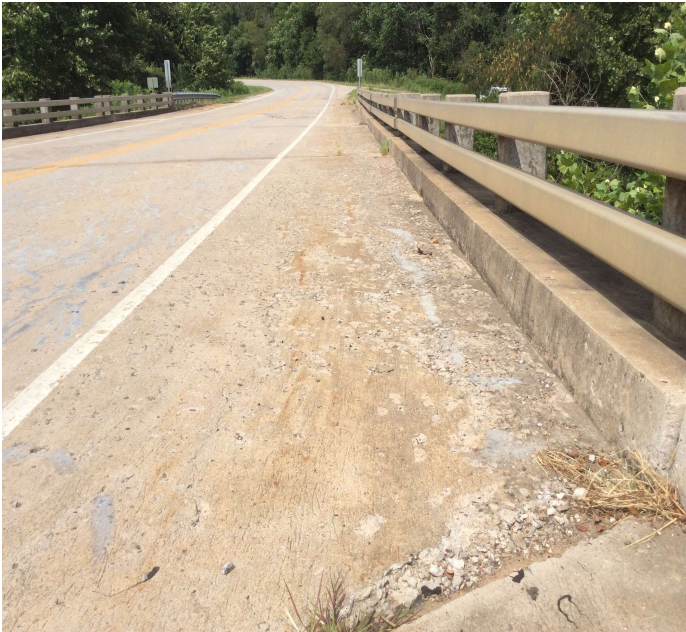
The gutters have light / medium scale typical with a few existing repairs that are failing.

PHOTO 1      Description      Deck  
The gutters have light / medium scale.

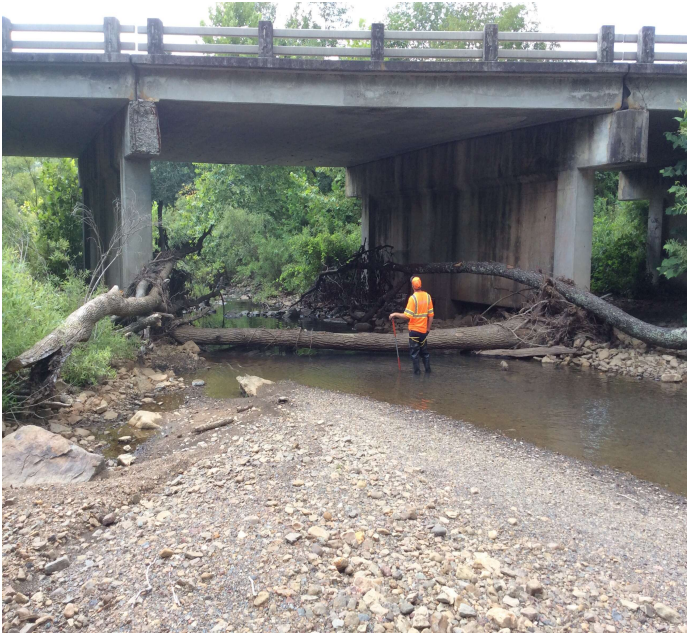
PHOTO 1 Description

The channel has a few large trees that are partially restricting the channel flow.
