# Bridge Inspection Report

**03457**  
**SH 282-SEC 1**  
**over**  
**I 40-SEC 11**

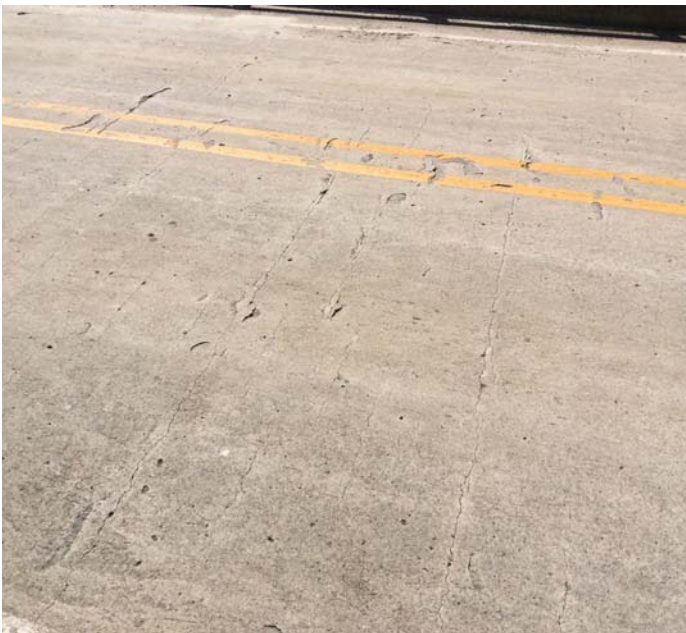
The driving surface of the deck has sealable cracks, delaminated areas, and spalls with exposed reinforcing steel.

PHOTO 1    Description    Span 3

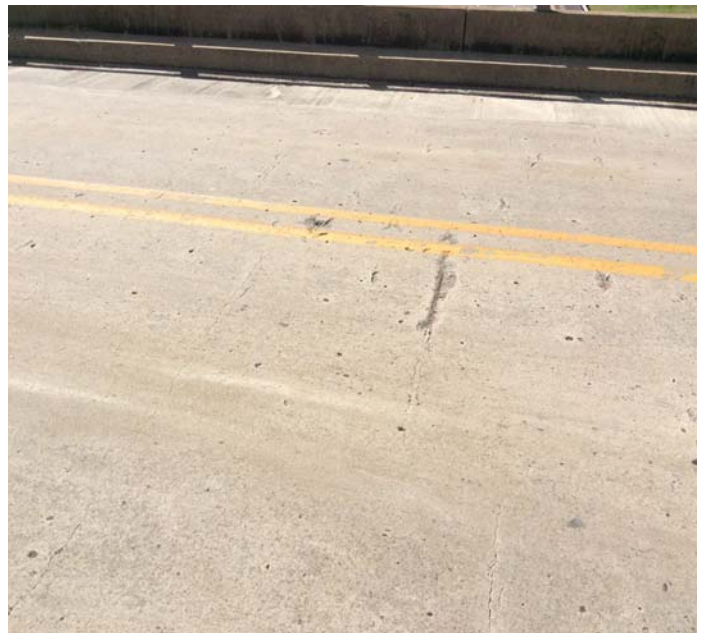
PHOTO 2    Description    Span 2

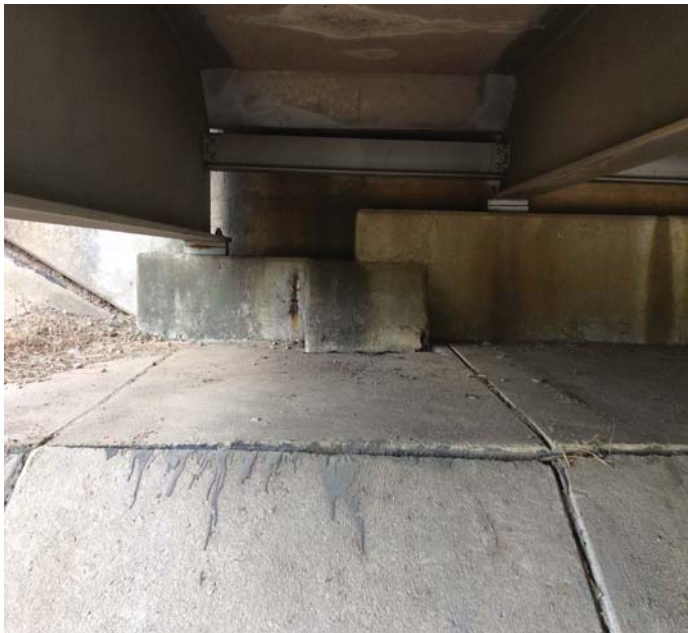
1080 - Delamination/Spall/Patched Area		860			860		
1090 - Exposed Rebar		7			7		
1120 - Efflorescence/Rust Staining		750			750		
1130 - Cracking (RC and Other)		1100			1100		
<b>107 - Steel Open Girder/Beam</b>	1- Ben.	1070	ft.	1062	8	0	0
	09/23/2015 - JCJ & JML - Maintenance forces have painted the superstructure since the last inspection.						
1000 - Corrosion		8			8		
515 - Steel Protective Coating		9005	sq. ft.	8997		8	
<b>205 - Reinforced Concrete Column</b>	1- Ben.	6	each	0	6	0	0
	09/23/2015 - JCJ & JML - Some columns have minor cracks and shallow spalls with no exposed reinforcing steel. Bent 4 Left column has a shallow 12" spall with exposed # 9 wire placed against the forms during the construction process.						
1080 - Delamination/Spall/Patched Area		3			3		
1130 - Cracking (RC and Other)		3			3		
<b>215 - Reinforced Concrete Abutment</b>	1- Ben.	66	ft.	64	2	0	0
	09/23/2015 - JCJ & JML - The Right side of Bent # 1 has a 10" spall with exposed reinforcing steel.

Bent # 2 cap has an 18" vertical delaminated area in the Right side of the cap. Bent # 3 cap has a 24" spall in the undersurface of the cantilever portion of the cap on the right side at the juncture of column # 2 and a 12" long spall under the left side adjacent to column # 1. Bent # 4 cap has a 10" area of concrete section loss at the top Right end of the cap. Bent # 4 cap has 3 spalls with exposed reinforcing steel and two delaminated areas in the North face of cap. Exposed reinforcing steel has initial section loss at this inspection. The right side of the south abutment has an area of spalling with exposed reinforcing steel in the vertical face of the stem wall.

PHOTO 1      Description      Right side of Bent 1.

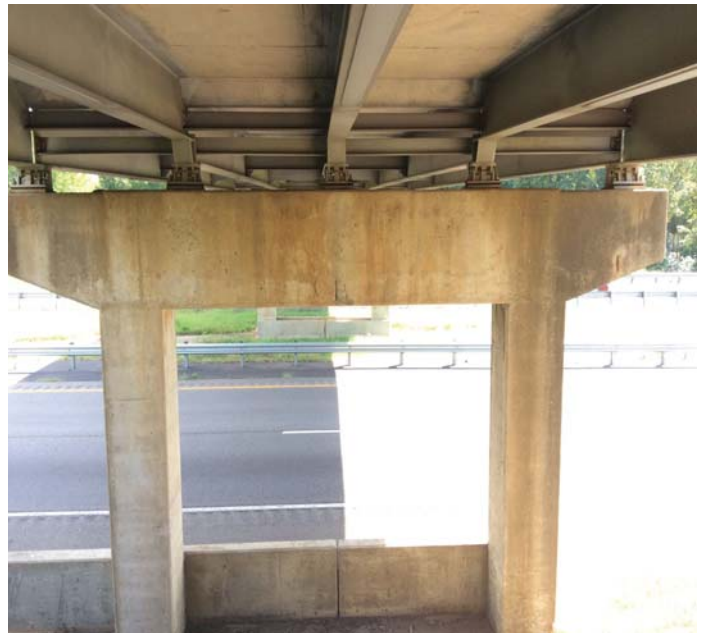
PHOTO 2      Description      Span 4 side of Bent 4.
