Bridge Inspection Report

06044

**SH 282-Crawford Co
over
FROG BAYOU**

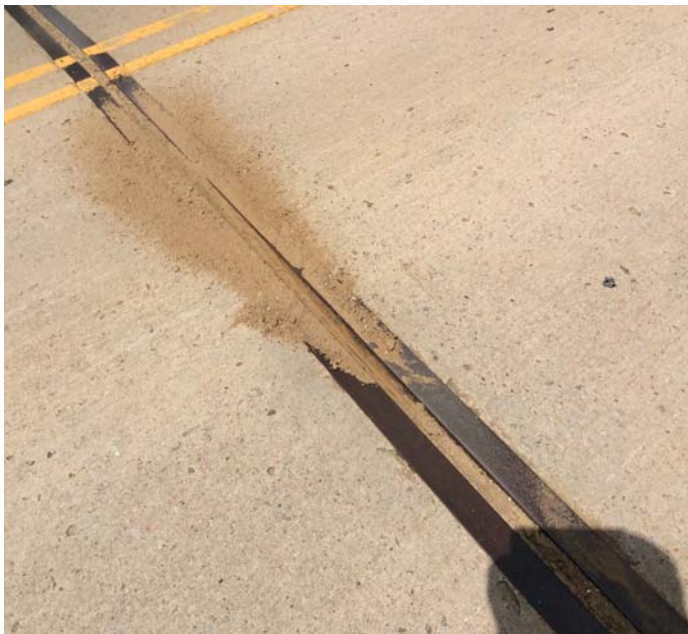
Compression joint seal at Bent # 4 has fallen out of the expansion joint assembly and is resting on the cap. Compression joint seals at Bents # 1, # 2, # 3, and # 5 have pulled away from the assemblies and are leaking dirt and debris on the caps.

PHOTO 1 Description Bent 5. Deck joint seal.

Work Code: Replace

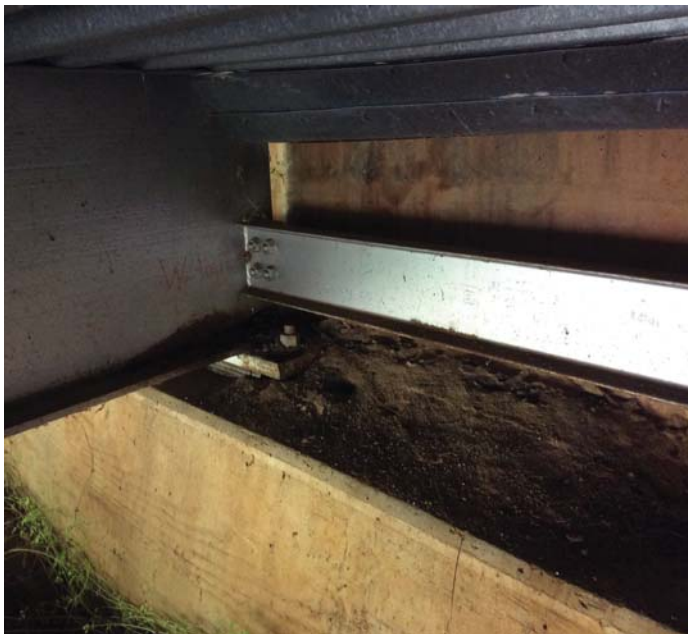
Ends of beams have areas of active corrosion where water leaks onto the beams through the deck joint seals. Ends of beams at Bent # 1 have areas of active corrosion with layers of flaking rust on the bottom flanges where dirt and debris accumulate. The beams in Span # 5 have graffiti with racial slurs.

PHOTO 1 Description Bent 1. Beam 3.

Work Code: Repair

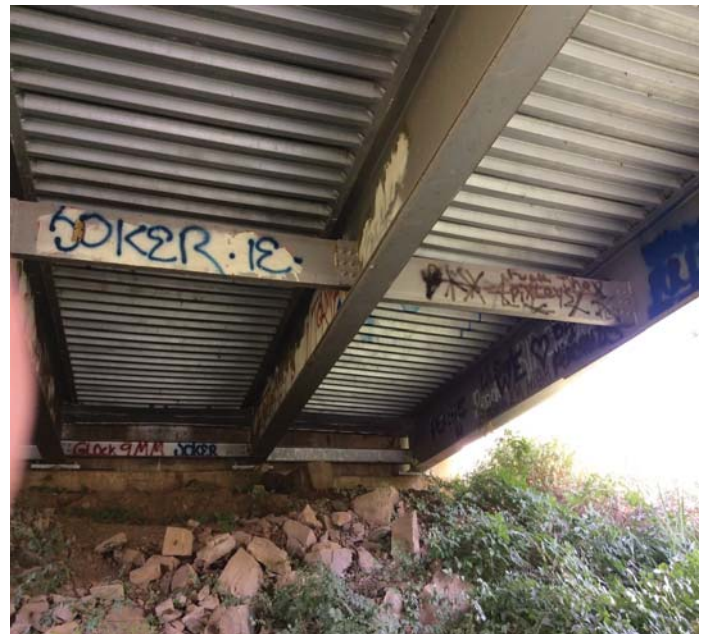
PHOTO 2 Description Span 5 graffiti

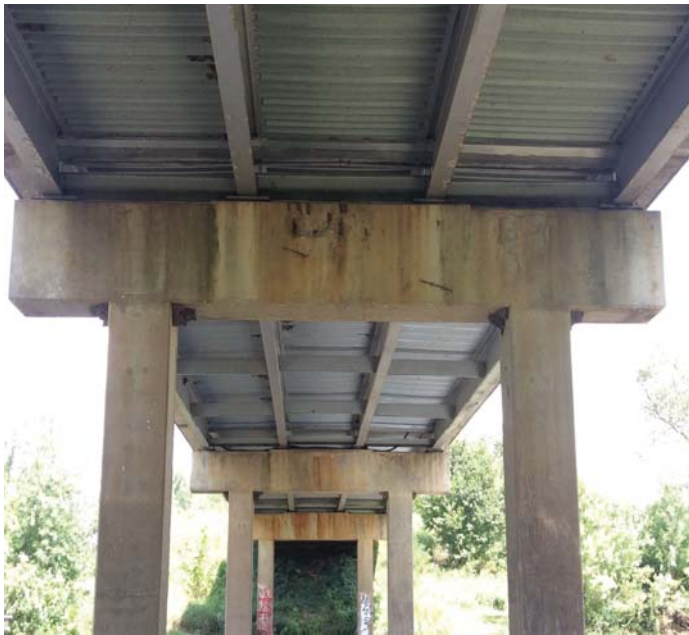
Bents 2, 3 & 4 have horizontal cracking approx. 4" below top of Caps.

PHOTO 1 Description Span 2 side of Bent 3 cap.

Work Code: Repair

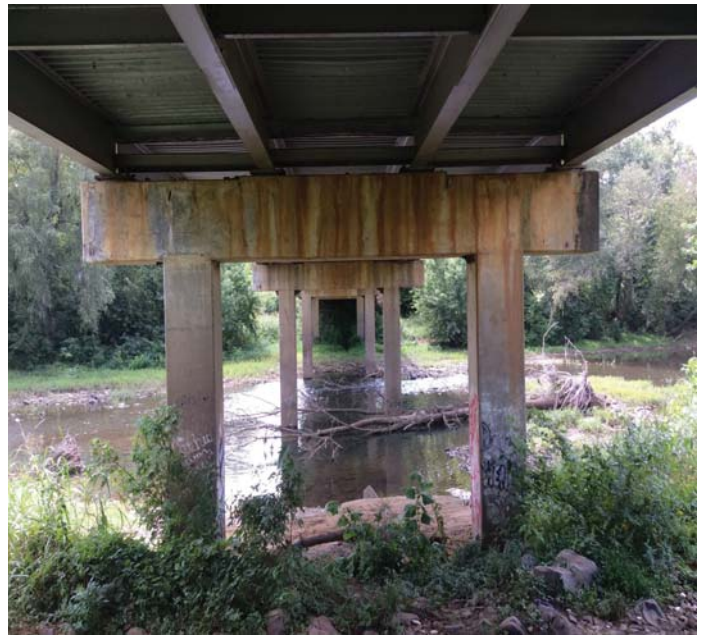
-Bent 5 Cap has delaminated areas and several baseball size spalls with exposed rebar.

PHOTO 2 Description Span 5 side of Bent 5.

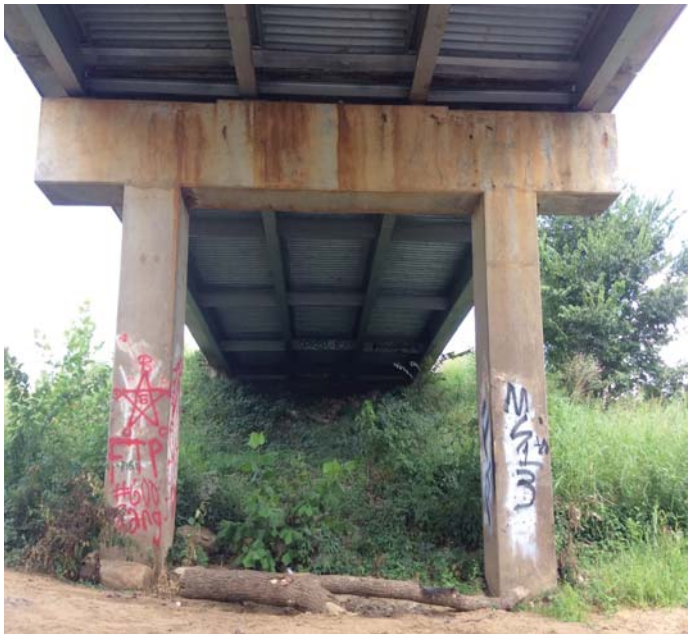
The columns of bent # 5 have graffiti of a racial nature.

PHOTO 1 Description Span 4 side of Bent 5.

Work Code: Clean

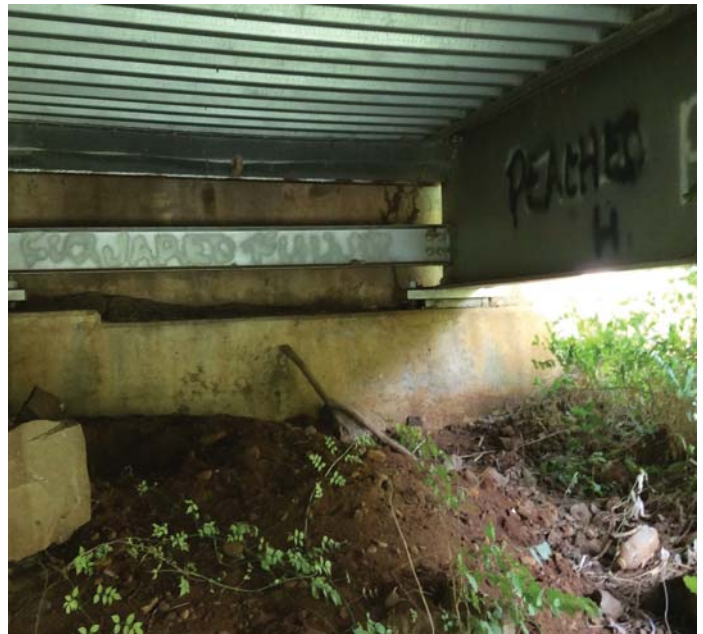
1080 - Delamination/Spall/Patched Area		1			1		
1090 - Exposed Rebar		1			1		
1190 - Abrasion/Wear (PSC/RC)		3			3		
215 - Reinforced Concrete Abutment	1- Ben.	66	ft.	60	5	1	0
	09/16/2015 - JCJ & JML - Bent 6 has a 12" delaminated area under Beam 4. There are vertical hairline cracks in the abutment backwalls and in the face of the stem walls.						
1080 - Delamination/Spall/Patched Area		1				1	
1130 - Cracking (RC and Other)		5			5

PHOTO 2 Description Bent 6. Beam 4.

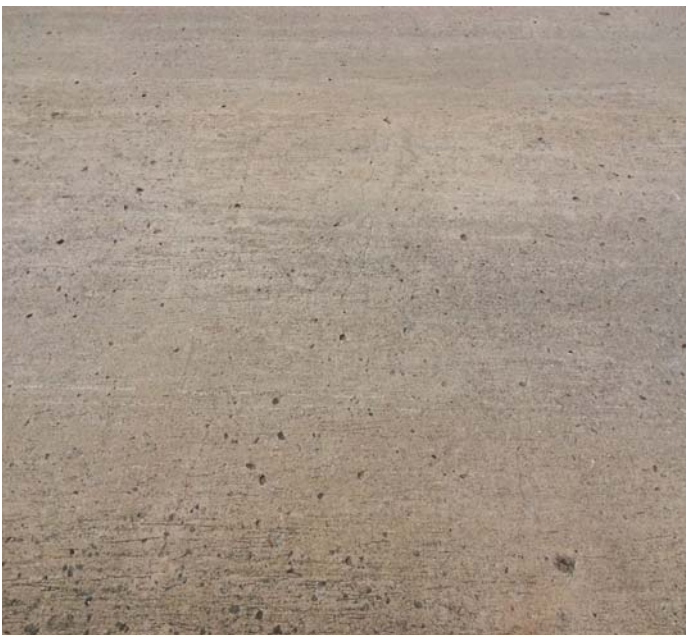
Driving surface of the deck -
The driving surface of the deck has sealable cracking in all spans.

PHOTO 1 Description Sealable deck cracks

Work Code: Repair
