# Bridge Inspection Report

**06235**  
**SH 282-SEC 1**  
**over**  
**I-49**

## Bridge Inspection Report

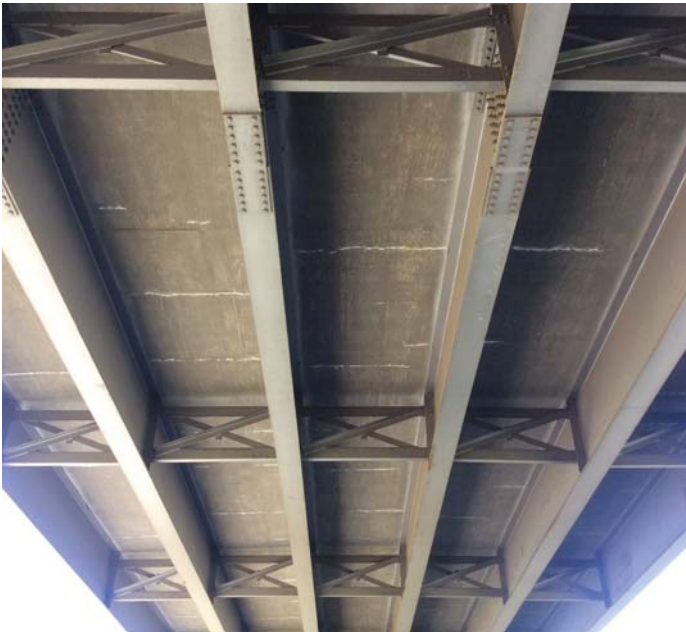
The driving surface of the deck has sealable transverse deck cracks with light efflorescence.

PHOTO 1      Description      Light / medium efflorescence visible in undersurface of all Spans.

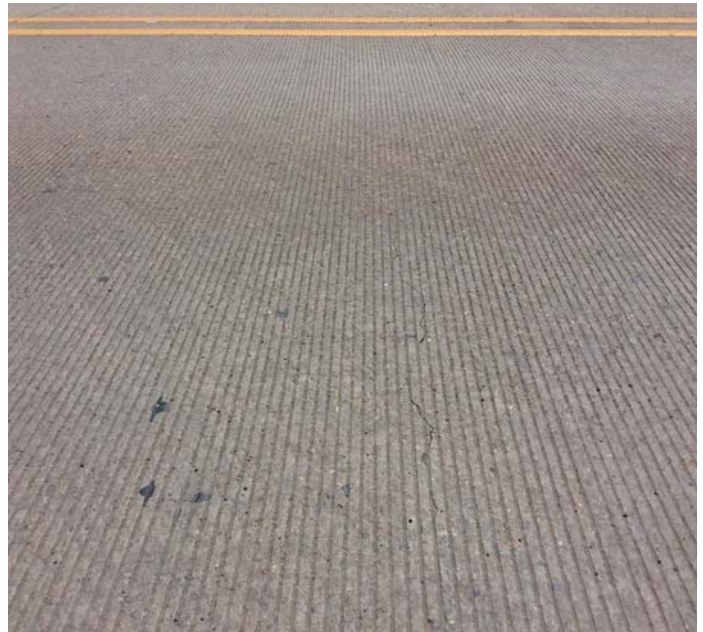
PHOTO 2      Description      The driving surface of the deck has sealable transverse deck cracks with light efflorescence.

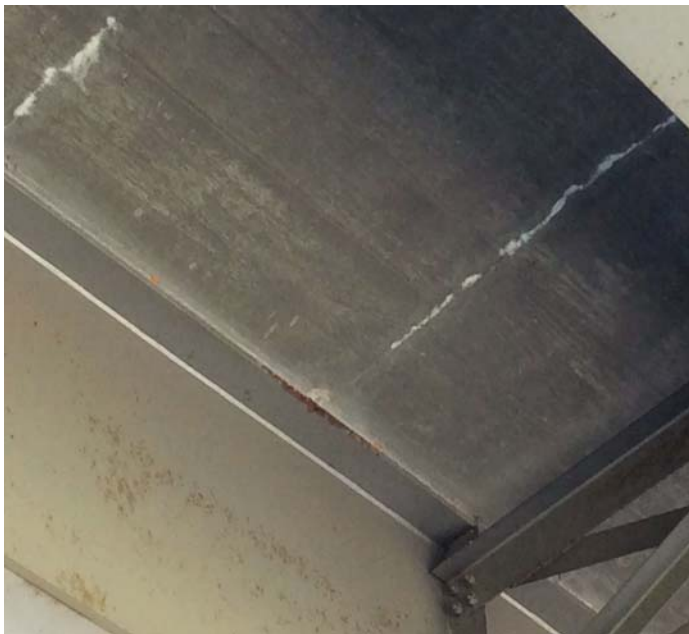
The active corrosion in the top flanges appears to correspond with full depth cracks in the deck.

PHOTO 1      Description      Transverse cracks appear to be full depth with leakage contributing to the active corrosion on the top flanges of the beams.

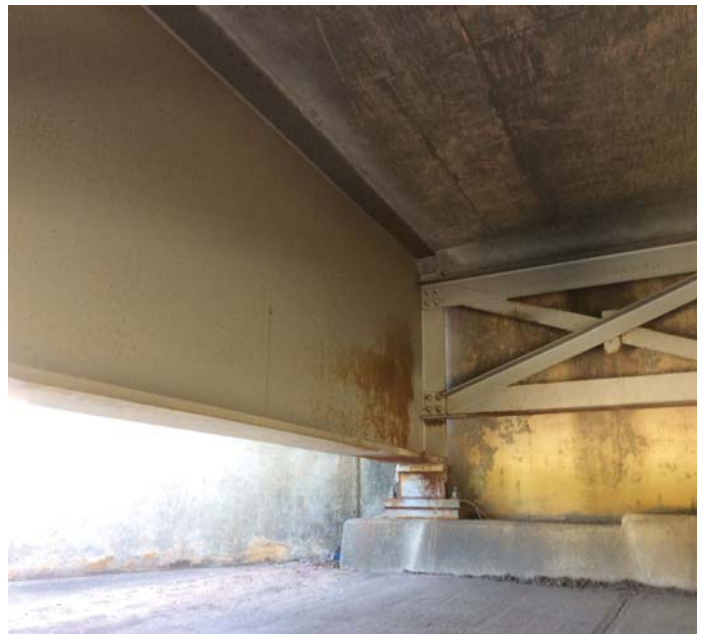
The superstructure has areas of active corrosion in top flanges of the beams and a failing paint system.

PHOTO 2      Description      Superstructure has a failing paint system with freckled rust and active corrosion in the top flanges of the beams and diaphragms with isolated area of flaking rust.

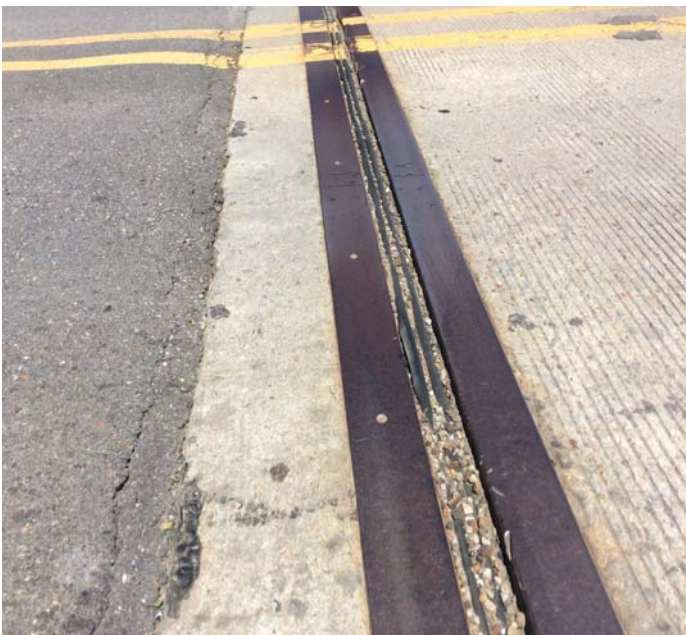
Compression joint seals have adhesion failure and leak water and debris on the caps.

PHOTO 1      Description      The joint seal at Bent 1 has cracks and appears to be deteriorating from weathering.

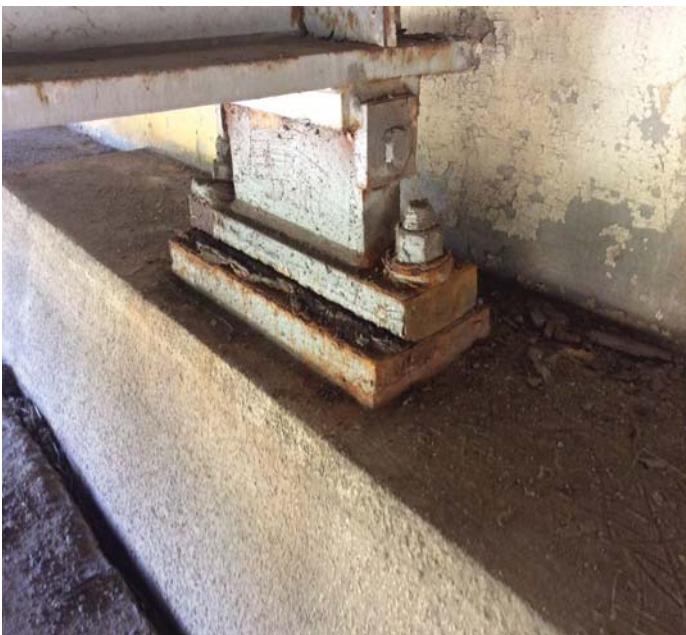
The bearings have active corrosion and flaking rust.

PHOTO 1      Description      Bearings have active corrosion with layers of rust on the masonry plates.
