# Bridge Inspection Report

**M2669**

**SH 282-Crawford Co**

**Trenna Creek**

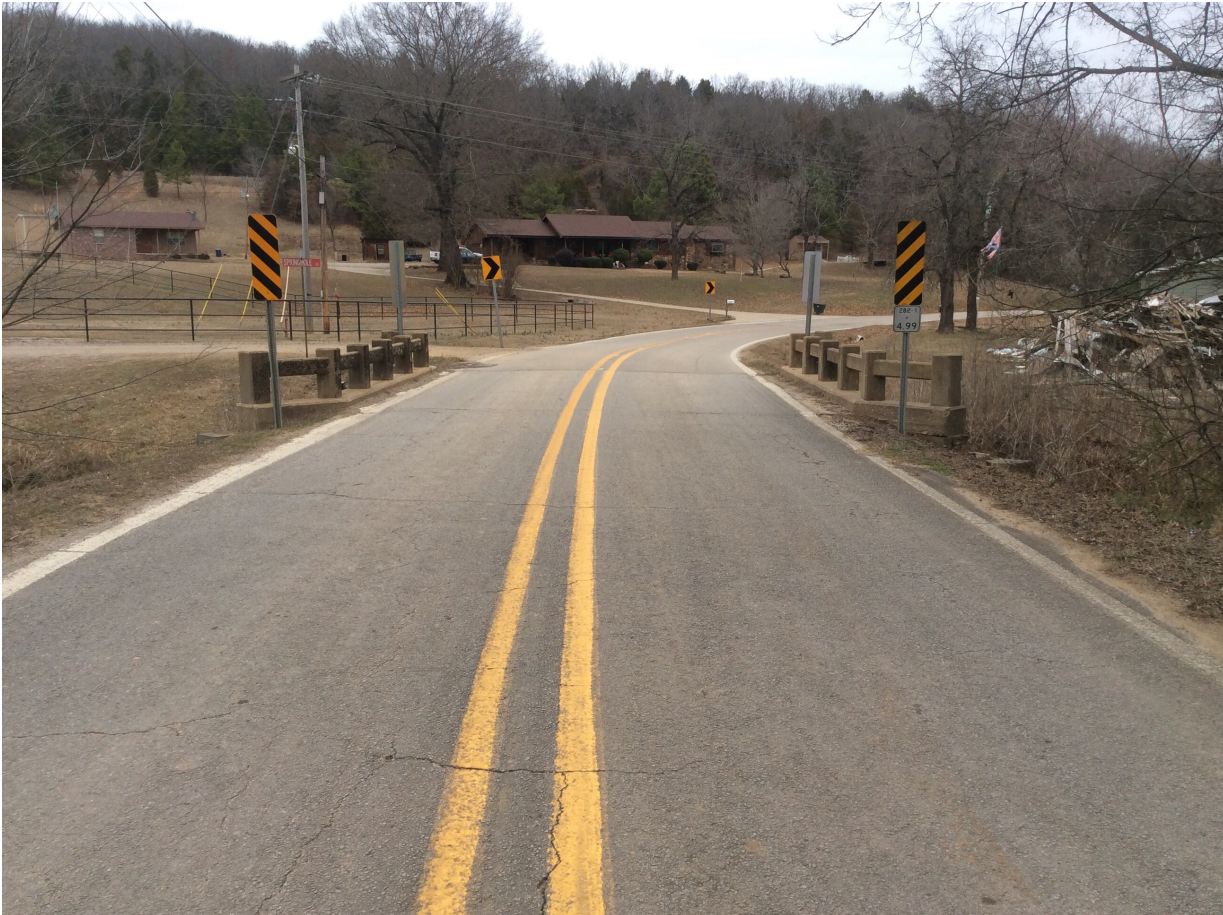
Deck has 2 1/2 inches of asphalt overlay

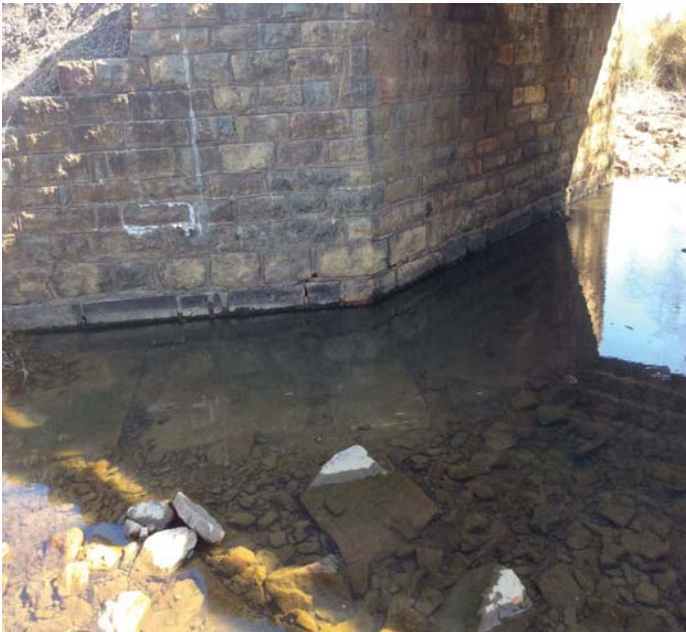
PHOTO 1      Description      Concrete slabs placed at the base of Bent 2 to control scour are in place and functioning as intended. No apparent scour or scour problems at this inspection.

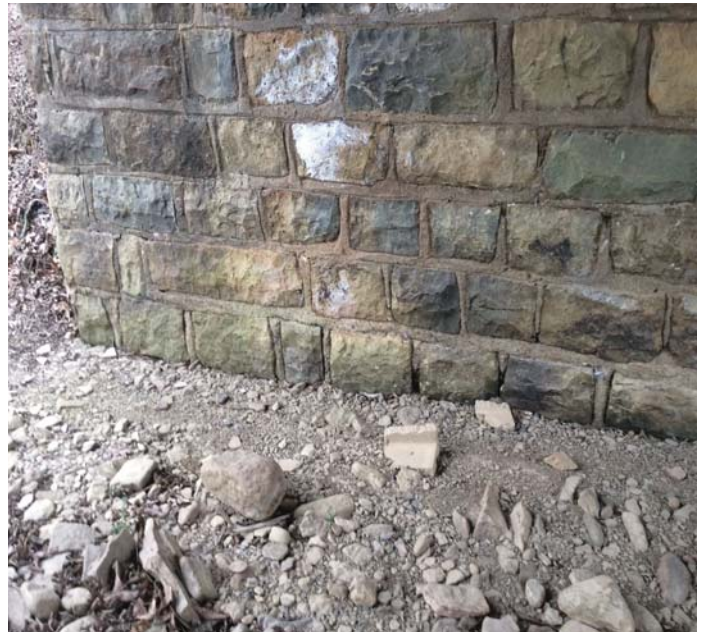
Base of stone masonry abutments -  
Grout deterioration between stones at the base of the abutments.

PHOTO 2      Description      Grout deterioration between the stones at the base of the walls is typical in both abutments.

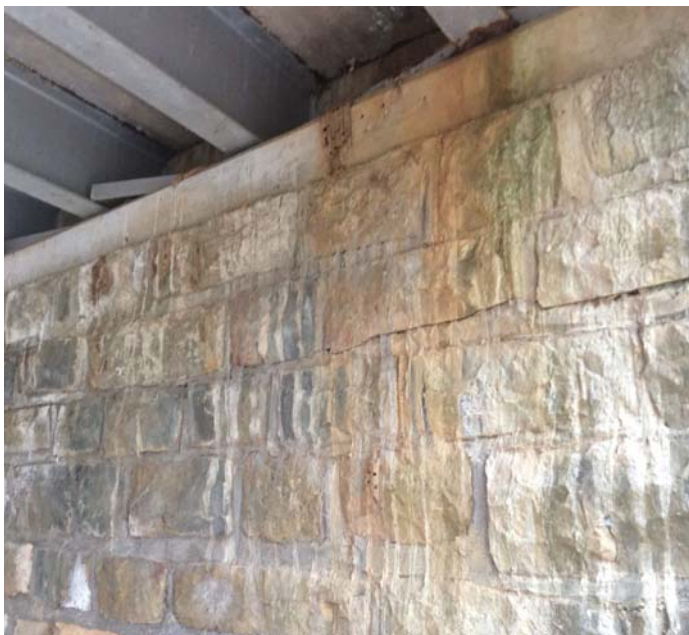
PHOTO 3      Description      Rock masonry substructure with a horizontal hairline crack in grout approx. 18" below cap at Bent 2.

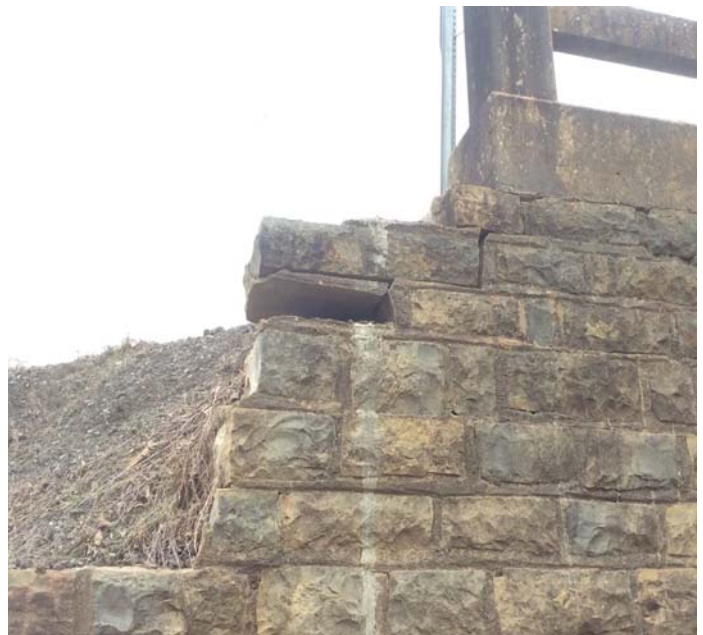
Northwest, Northeast and Southeast wing walls -  
Tops of wing walls have stones displaced and/or missing.

PHOTO 2      Description      A few of the stones have been  
displaced in the top of the Northwest  
wing wall.

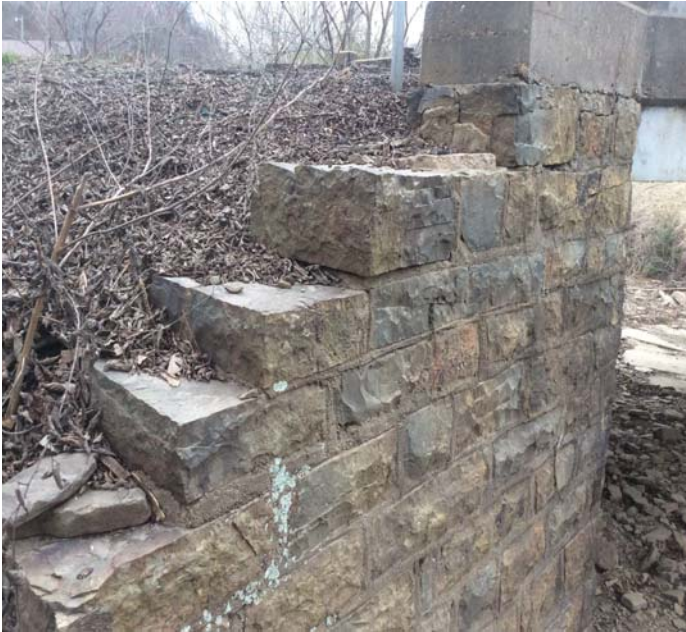
PHOTO 3      Description      A few of the stones have been displaced in the top of the Southeast wing wall.

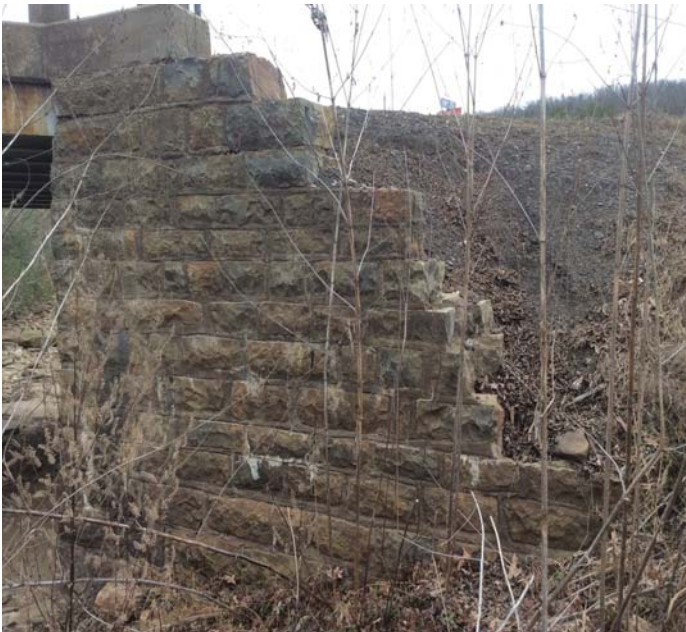
PHOTO 4      Description      A few of the stones have been displaced in the top of the Northeast wing wall.

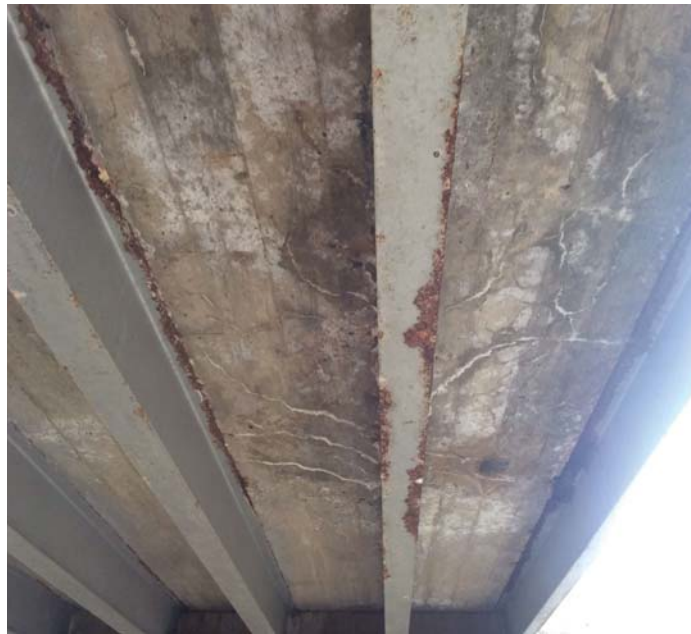
PHOTO 1      Description      Map cracking with light efflorescence visible from the undersurface of the deck in Bays 8 & 9.

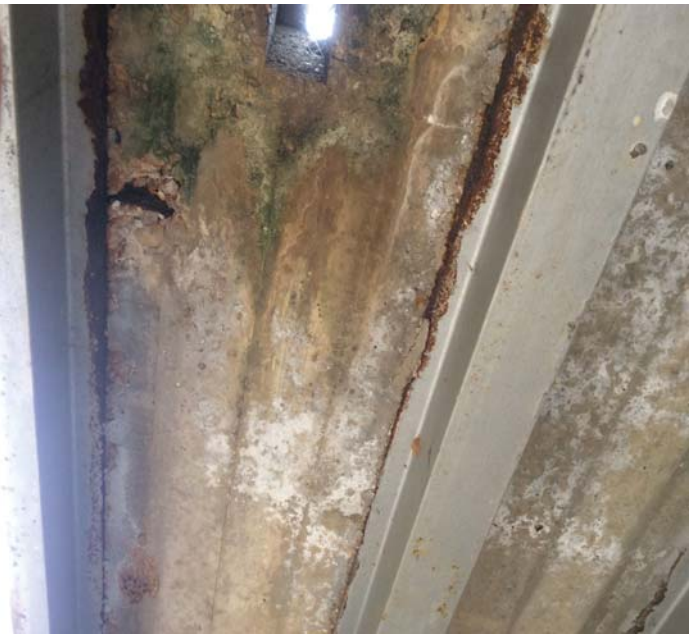
Undersurface of the deck has spalling with exposed reinforcing steel in bays # 1 and # 9 adjacent to the exterior beams. The exposed reinforcing steel has active corrosion with initial section loss.

PHOTO 2      Description      Bay 1 has 1 shallow baseball size spall with exposed reinforcing steel on the undersurface of the deck.

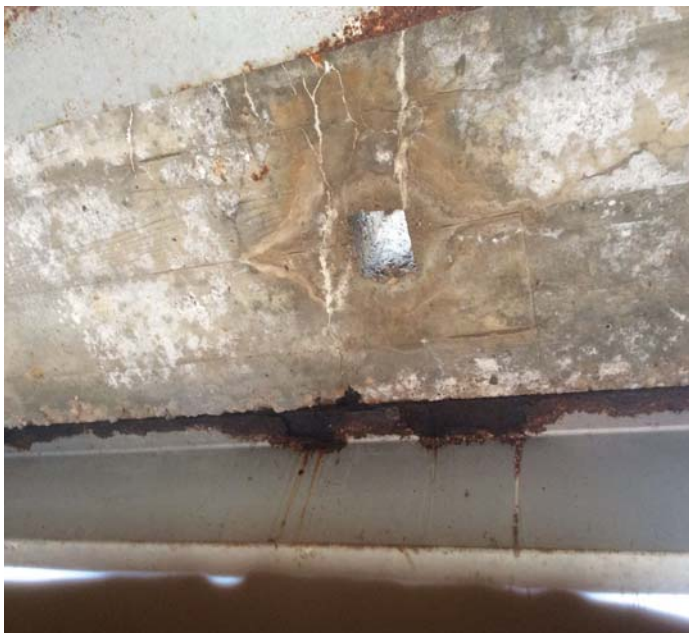
PHOTO 3	Description	Bay 9 has 3 shallow baseball size spalls. Spalls have exposed reinforcing steel that has active corrosion with initial section loss.
---------	-------------	--

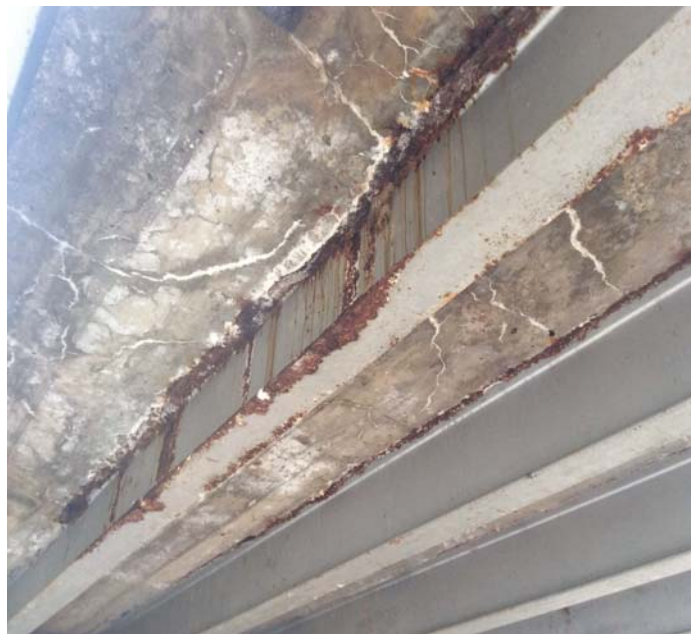
There is active corrosion with flaking rust with up to 1/8" section loss in the top flanges of the beams. Some of the beams have active corrosion with up to 1/8" section loss to the flanges and portions of the webs adjacent to the abutments.

PHOTO 1      Description      Beams 1,2,3, 8,9, & 10 have areas of active corrosion along the top flanges of the beams.

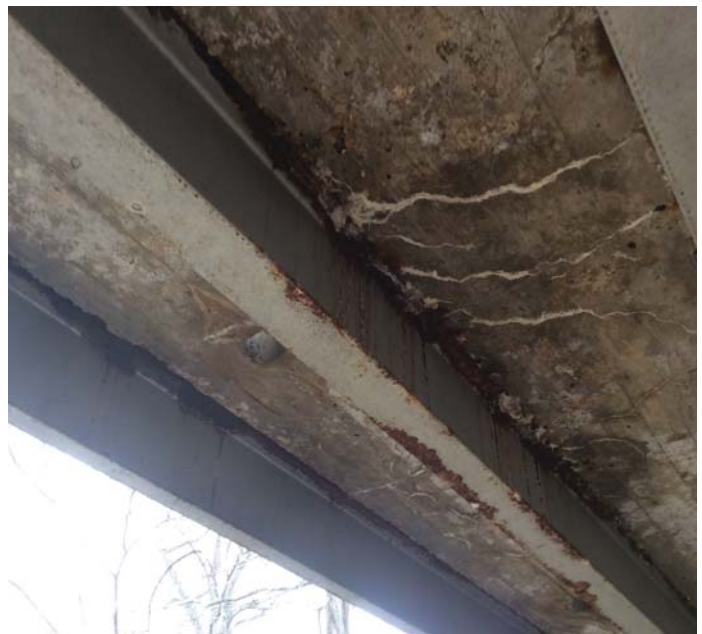
PHOTO 2      Description      Beam 9 has active corrosion with initial section loss adjacent to the deck drain near mid-span.
