Bridge Inspection Report

05464

**State Highway 16
over
Illinois River-Wash Co.**

Executive Summary

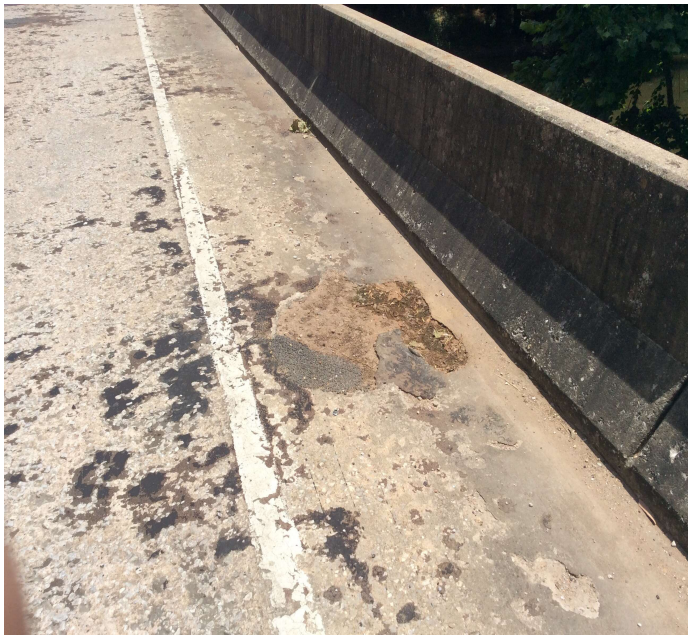
The driving surface of span # 1 has medium abrasion with areas of spalling that has created potholes in the driving surface of the left and right lanes. Exposed reinforcing steel with section loss is visible in one of the spalls. Previous repairs made with asphaltic mix have failed. The gutter on the right side of span # 1 has an area of concrete deterioration and scaling.

PHOTO 1 Description Span # 1 Right gutter pothole.

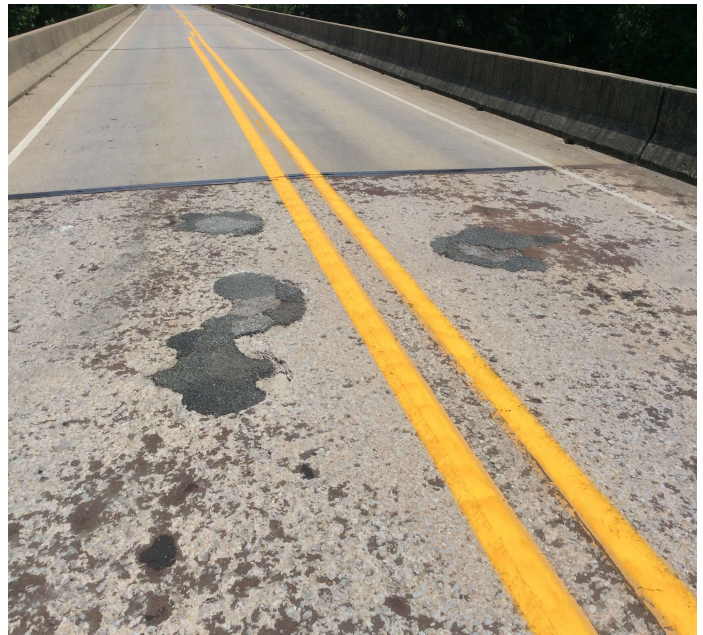
PHOTO 2 Description Span # 1 temporary asphalt repairs.

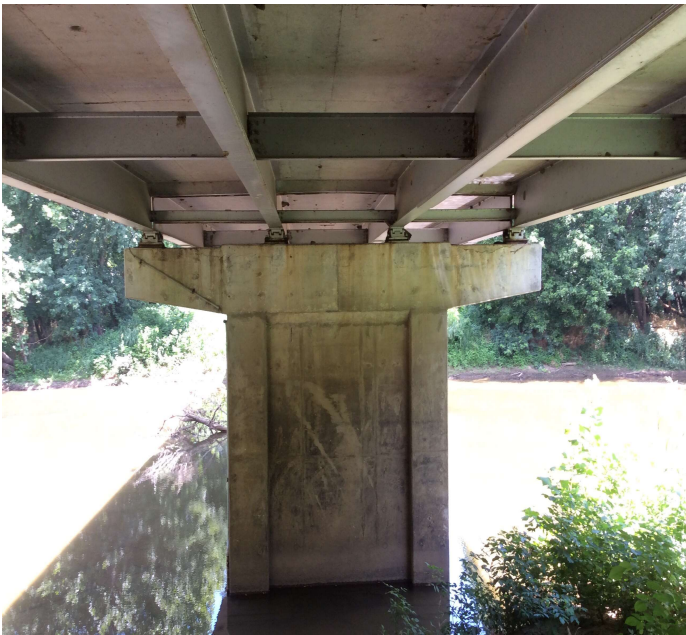
The intermediate bent caps have horizontal cracking approximately 4 inches below the bearing areas and numerous areas of shallow spalling with exposed reinforcing steel. The most extreme case appears to be the exterior vertical face on the Right side of Bent # 2 cap. This area has concrete deterioration with map cracking. The undersurface has spalling with exposed reinforcing steel.

PHOTO 1	Description	Span # 1 Bent # 2 horizontal cracking in cap.
---------	-------------	---

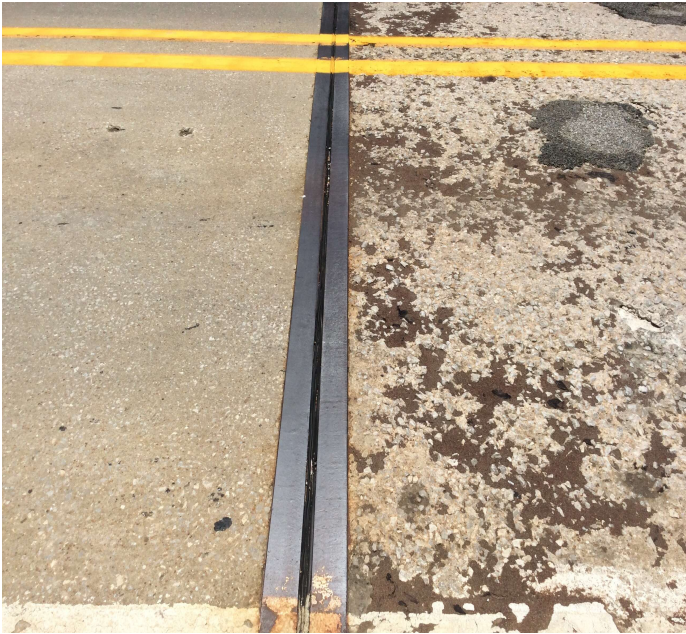
The compression joint seals are deteriorating and have lost their bond to the joint assemblies in locations allowing water to leak onto the bent caps.

PHOTO 1 Description Bent # 2 failing joint seal.
