Bridge Inspection Report

05595

SH 253 Seb. Co.

James Fork Creek

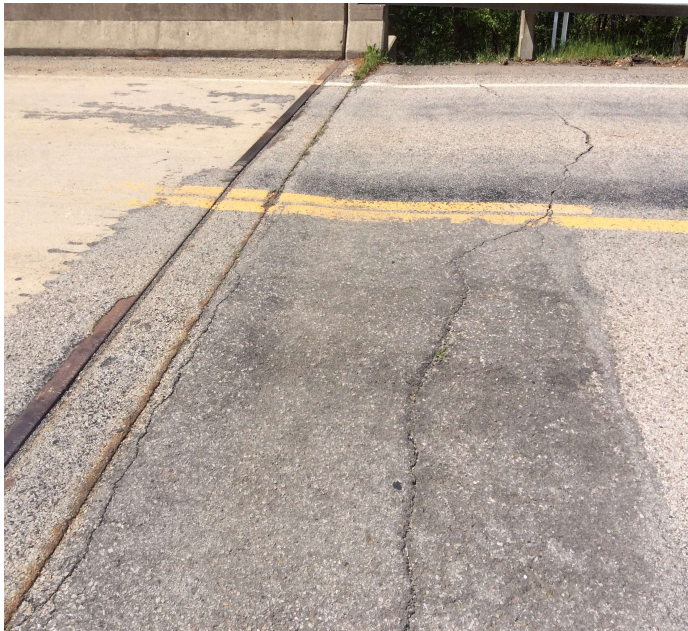
There is asphalt settlement in the approach roadway adjacent to the abutments.

PHOTO 1 Description Asphalt settlement adjacent to Bent 1.

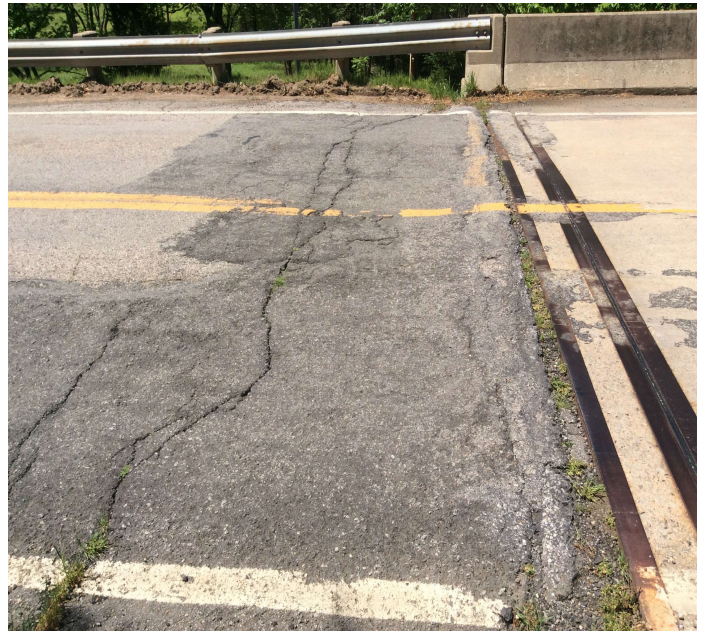
PHOTO 2 Description Approach roadway at Bent 5.

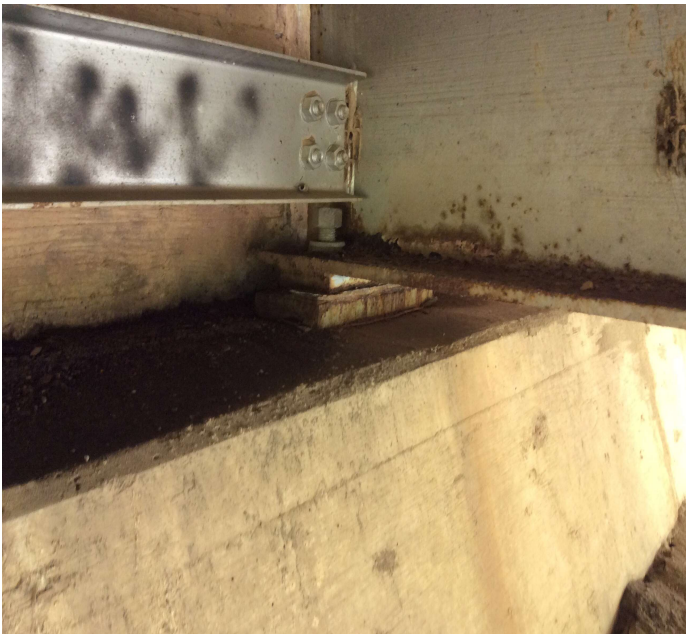
The ends of the beams have a light coating of rust beginning to show through the paint. The paint system is beginning to flake off in locations.

PHOTO 1 Description Bent 1. Beam 2. Bearing

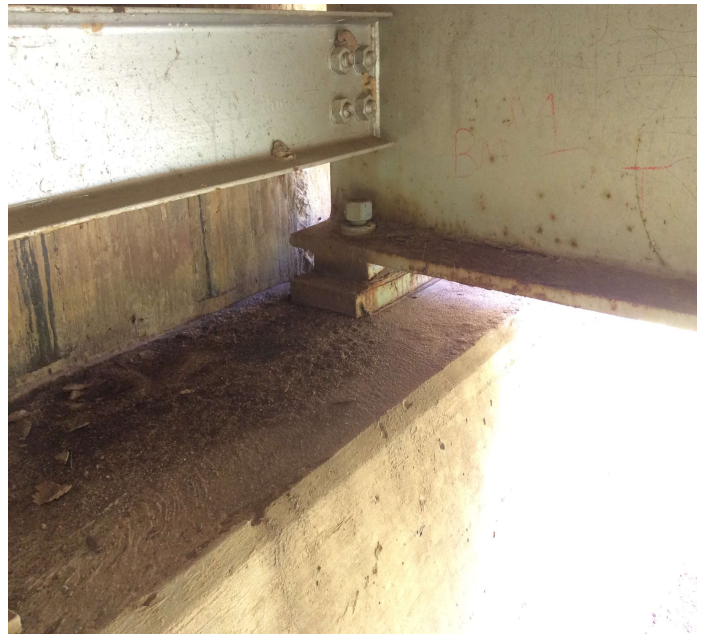
PHOTO 2 Description Bent 1. Beam 1.

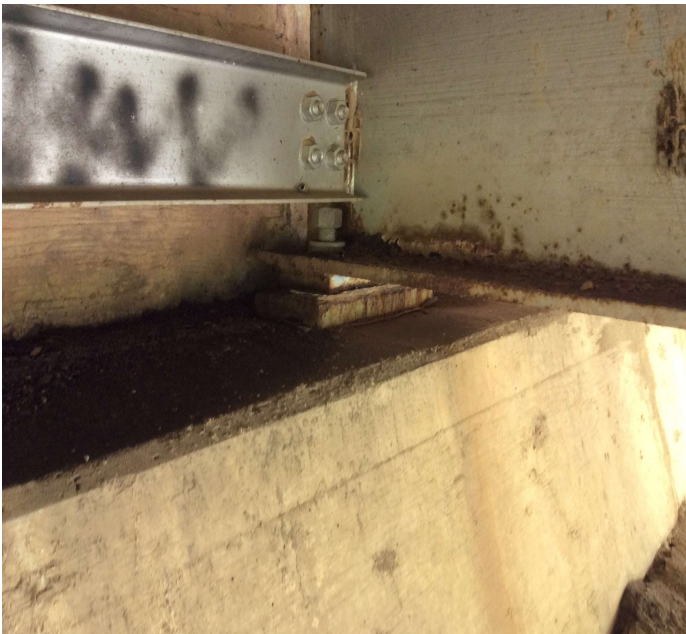
The bearings have areas of active corrosion and pack rust between the bearing devices. Beams # 1 and # 4 at the north abutment are missing a nut from the exterior anchor bolts.

PHOTO 1 Description Bent 1. Beam 2. Bearing

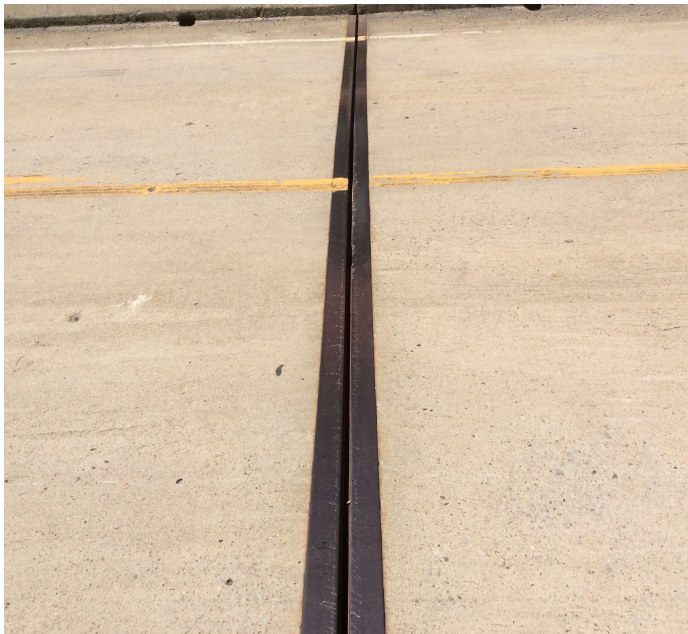
The compression joint seal is missing at Bent # 2 and the compression joint seal at Bent # 4 has adhesion failure. All deck joint seals leak.

PHOTO 1 Description Missing deck joint seal over Bent 2.

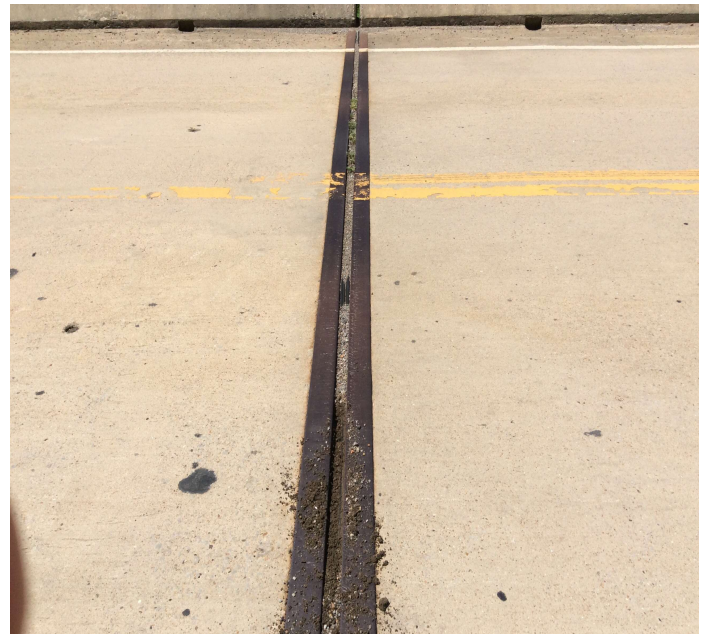
PHOTO 2 Description Bent 3 deck joint seal.

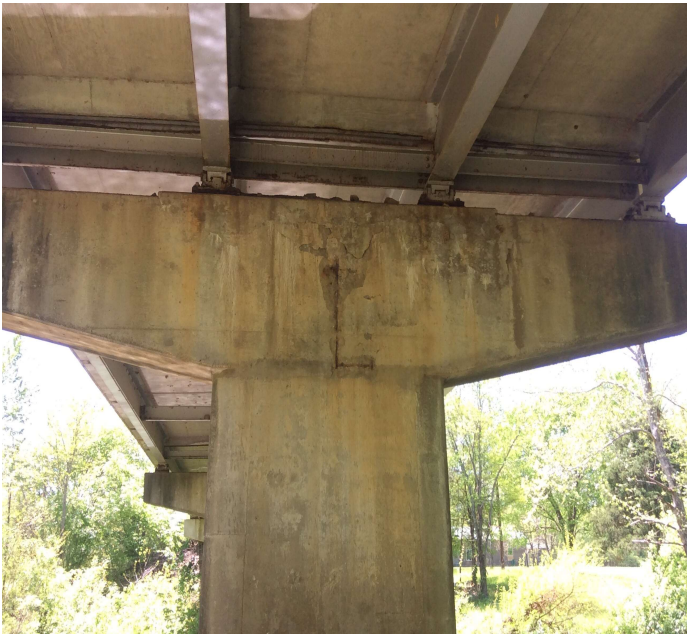
The caps of Bents # 2, # 3 and # 4 have spalling with exposed reinforcing steel.

PHOTO 1 Description Span 1 side of Bent 2 cap.

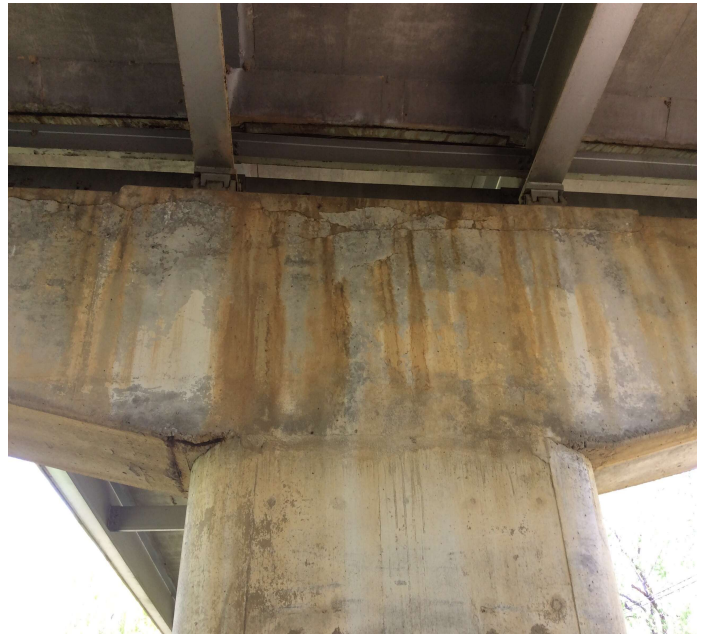
PHOTO 2 Description Bent 4 cap

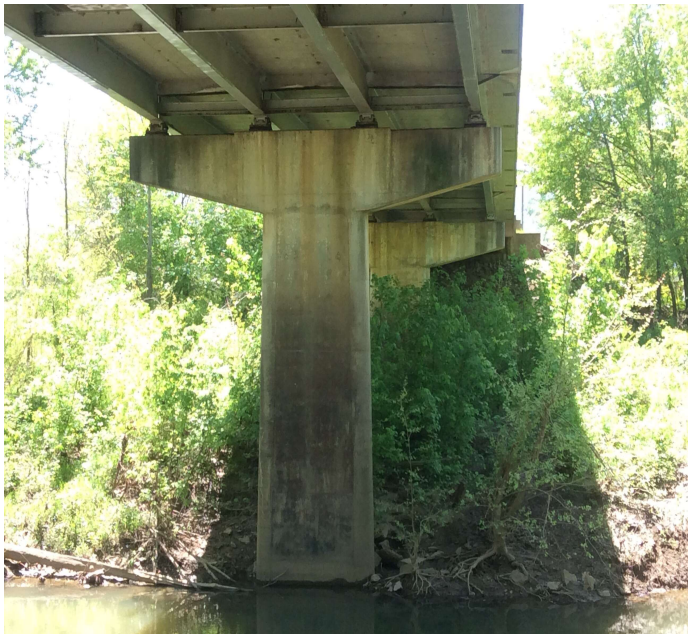
The overhang portion of the deck on the right side of span # 4 has a 12" long spall with exposed reinforcing steel adjacent to deck drain # 3. The exposed reinforcing steel has active corrosion.

PHOTO 1 Description Span 2 side of Bent 3.

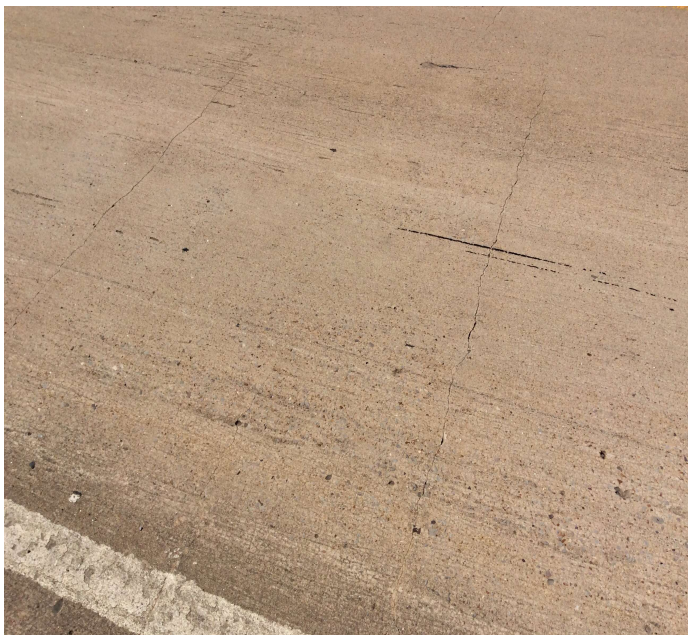
The driving surface of the deck has sealable transverse and random cracking in all spans.

PHOTO 1 Description Sealable deck cracks

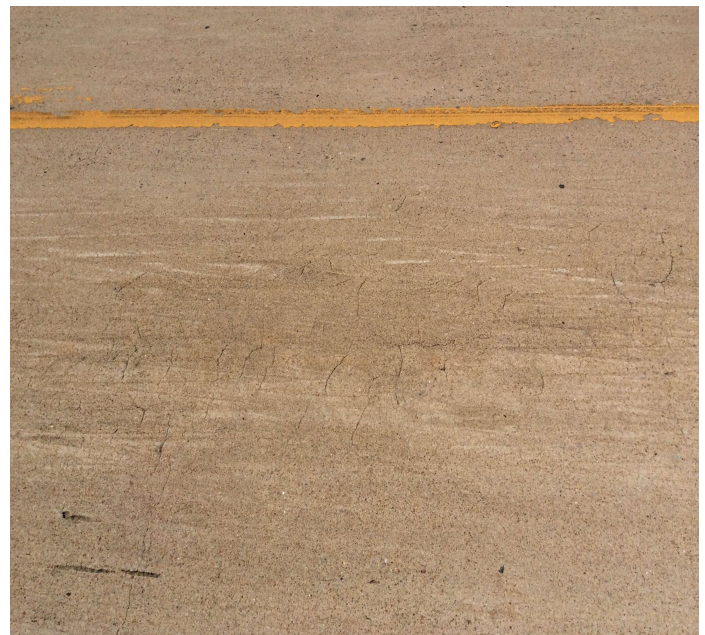
PHOTO 2 Description Span 2 map cracking
