Bridge Inspection Report

05651

State Highway 253

Mackenay Creek Seb. Co.

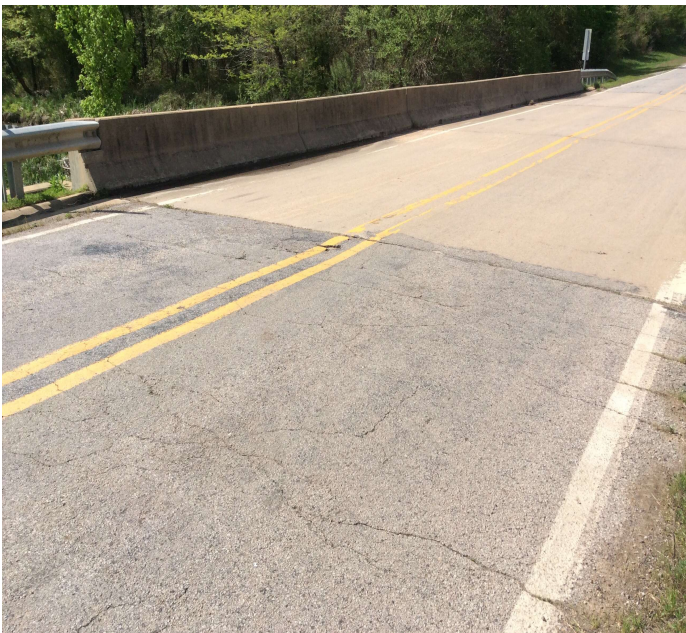
There is minor asphalt settlement in the approach roadway adjacent to the abutments.

PHOTO 1 Description South approach roadway

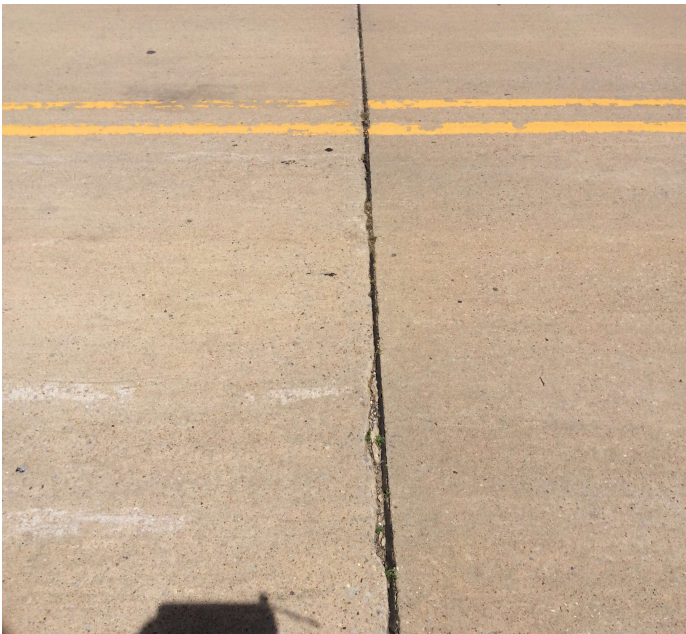
Expansion joints -

The pourable type joint material at the intermediate bents has deteriorated and is missing in locations allowing water to leak onto the substructure and incompressible materials to enter the joints.

PHOTO 1 Description Deck joint sealant

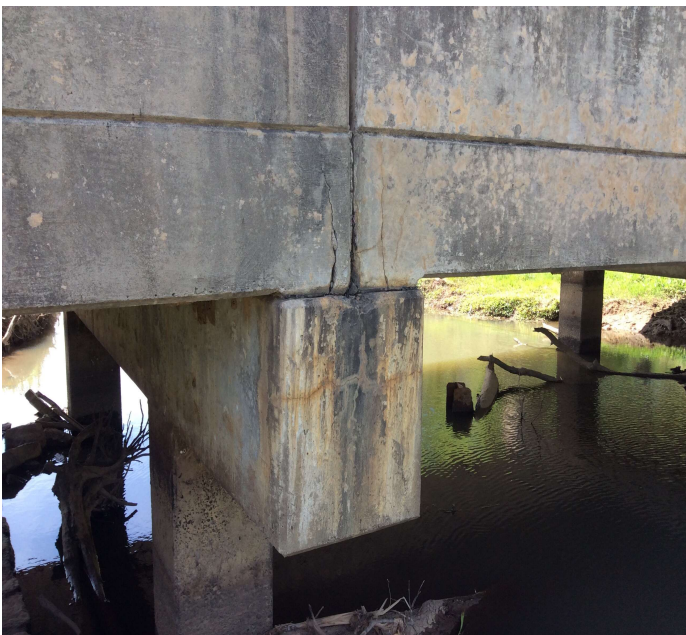
Deck / superstructure -

The left edge of the deck / superstructure in Spans # 2 and # 3 has delaminated areas over Bent # 3.

PHOTO 1 Description Bent 3. Left

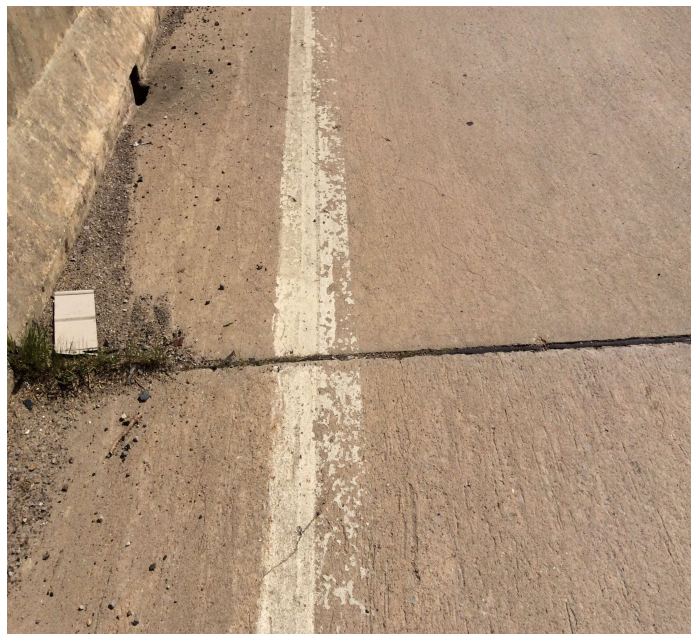
Driving surface of the deck -

The driving surface of the deck has sealable diagonal cracking at both ends of all spans on the left and right sides of structure.

PHOTO 1 Description Left side of deck over Bent 2.

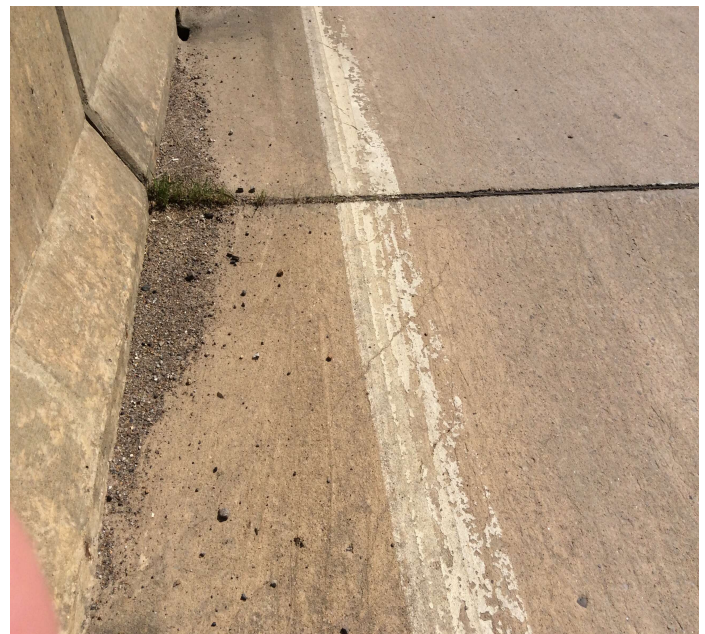
PHOTO 2 Description Diagonal cracking over Bent 3.
