Bridge #07048(Routine, Underwater type 2)

State Highway 22-1 over Little Vache Cr Seb. Co.

Team Lead: Eric West Inspection Date: April 02, 2020

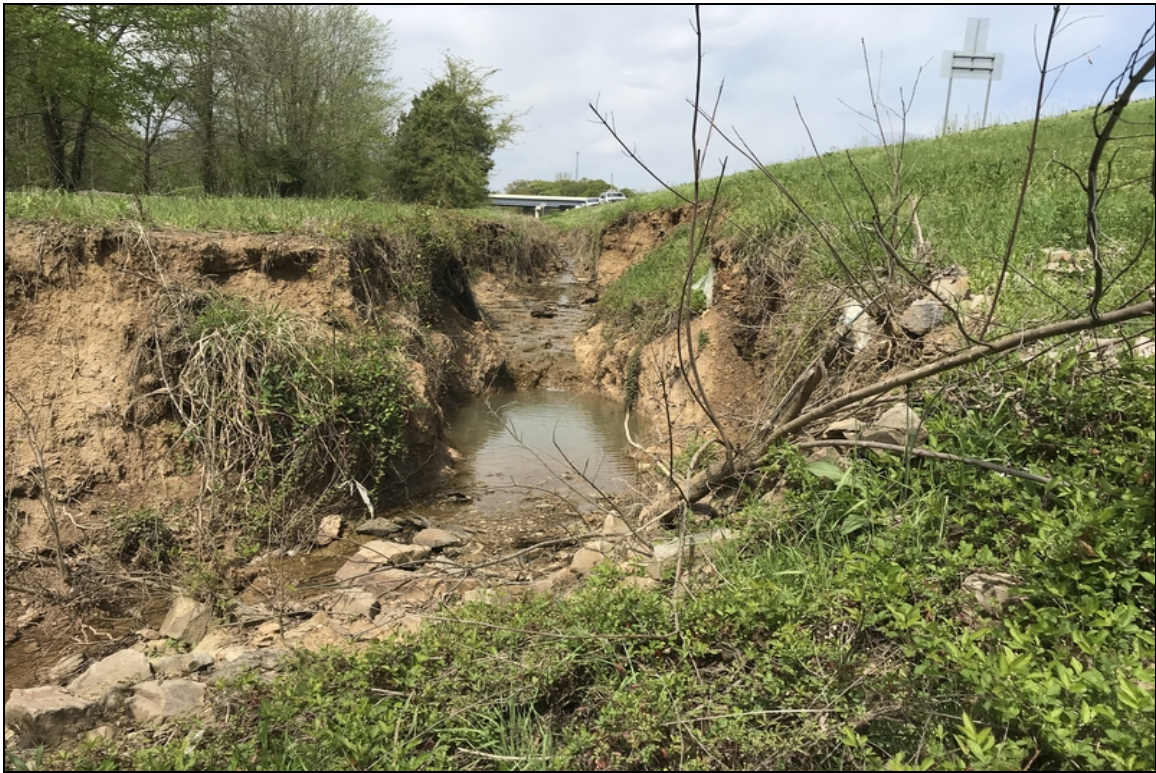
Southwest bridge end with approximately 7' of head cut scour.

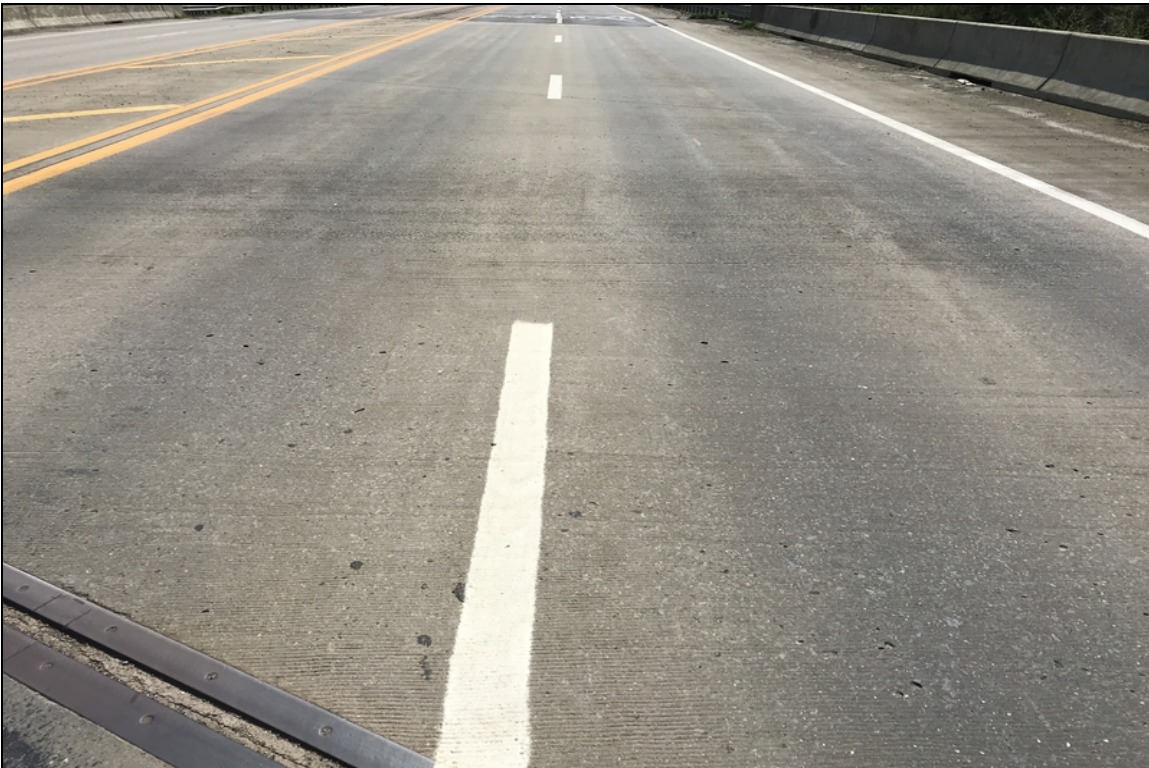
Typical driving surface of the deck.

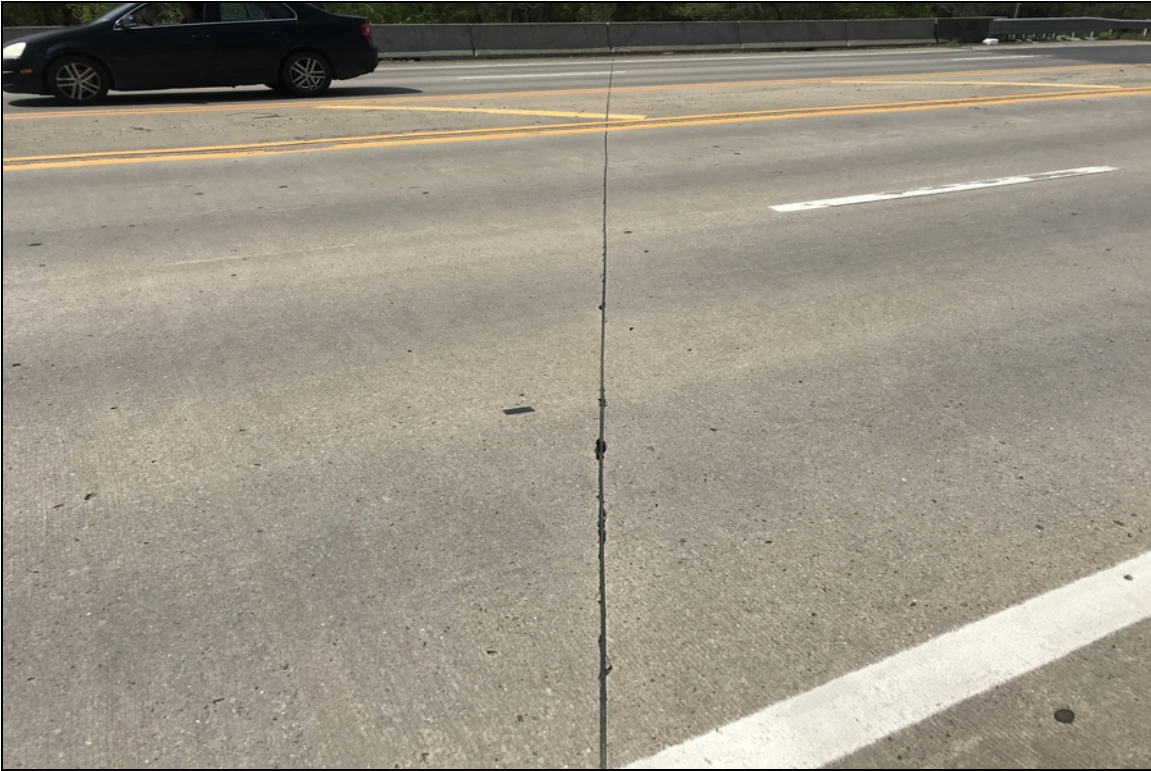
Deteriorating poured joint sealant.

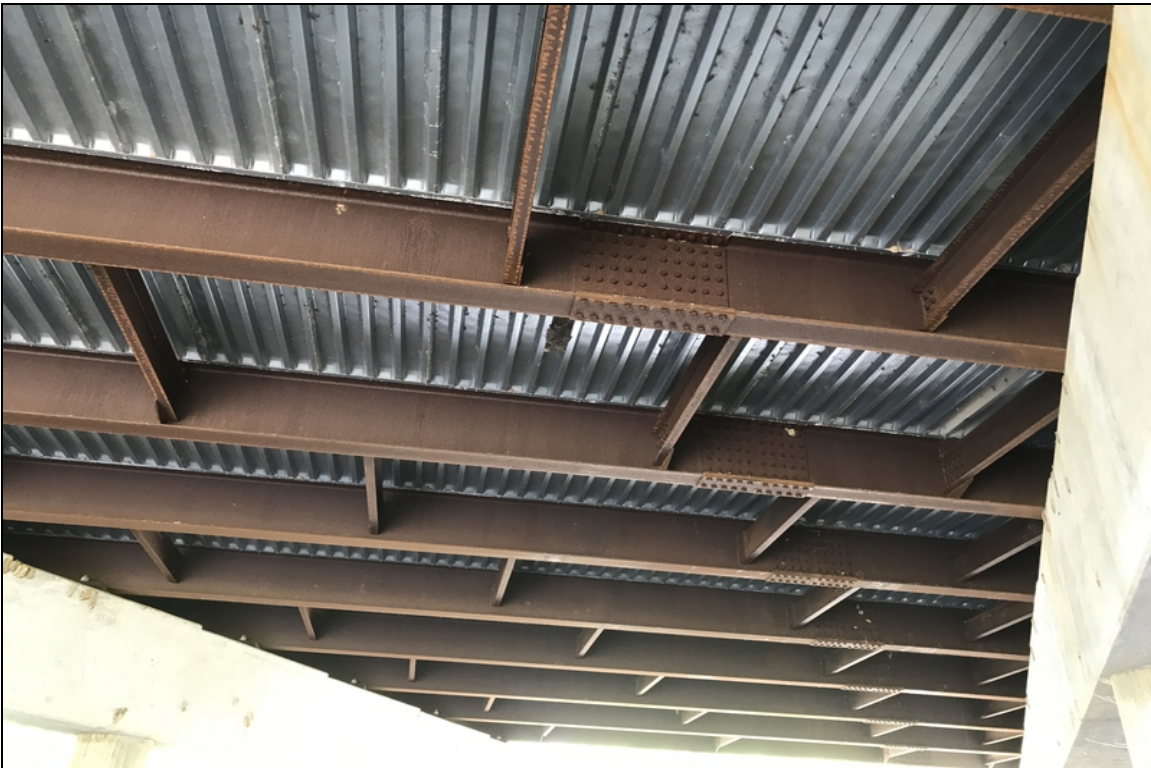
(12)							
-The gutters have hairline transverse cracks on spacing that ranges from 2' to 4'.							
-Span 2 has isolated areas with hairline map cracking and a full length longitudinal crack in the left inside lane near centerline.							
-Random transverse cracks in the overhangs with light efflorescence.							
107	Steel Open Girder/Beam	LF	1221	1209	12	0	0
1000	Corrosion	LF	12	0	12	0	0
515	Steel Protective Coating	SF	7427	7409	6	12	0
3440	Effectiveness (Steel Protective Coatings)	SF	18	0	6	12	0

Typical undersurface of the deck

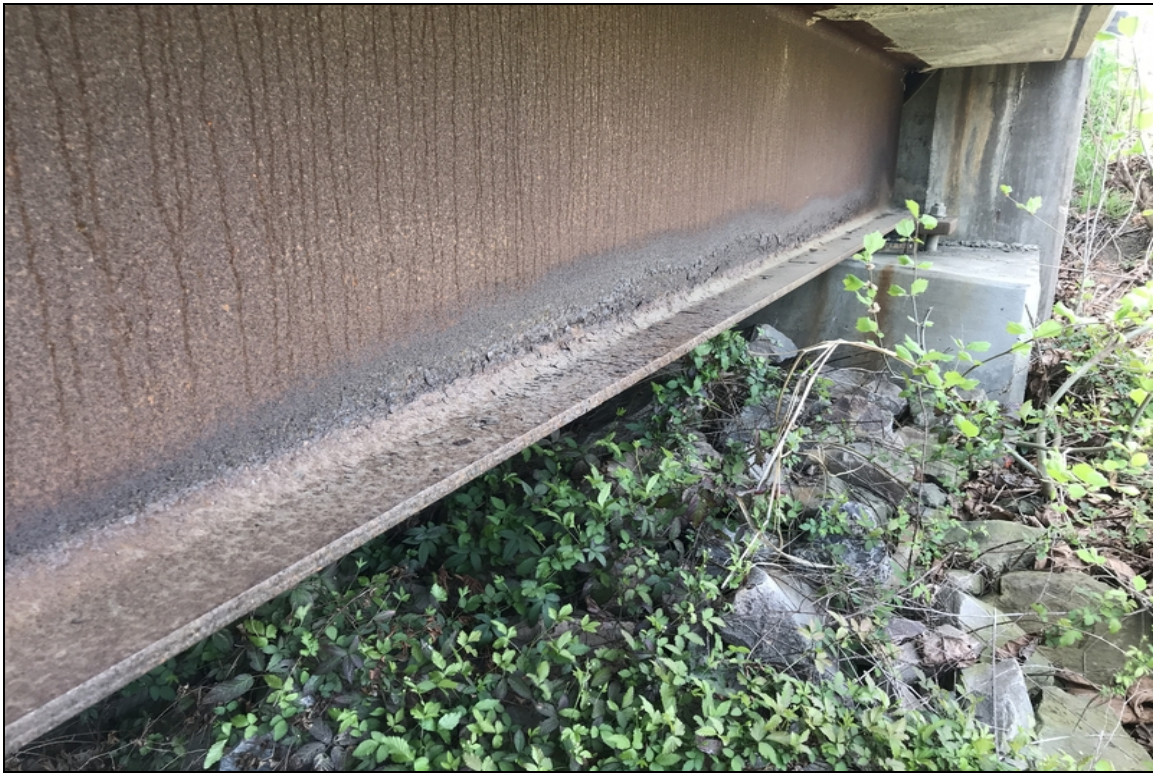
(107)							
-Beam #1 at abutment #1 has corrosion with flaking rust to the bottom flange and base of web on the interior and exterior sides in an area approximately 12' long.							
205	Reinforced Concrete Column	EA	8	7	1	0	0
1080	Delamination/Spall/Patched Area	EA	1	0	1	0	0

Bent # 1 Beam # 1 exterior base of web and bottom flange with flaking rust

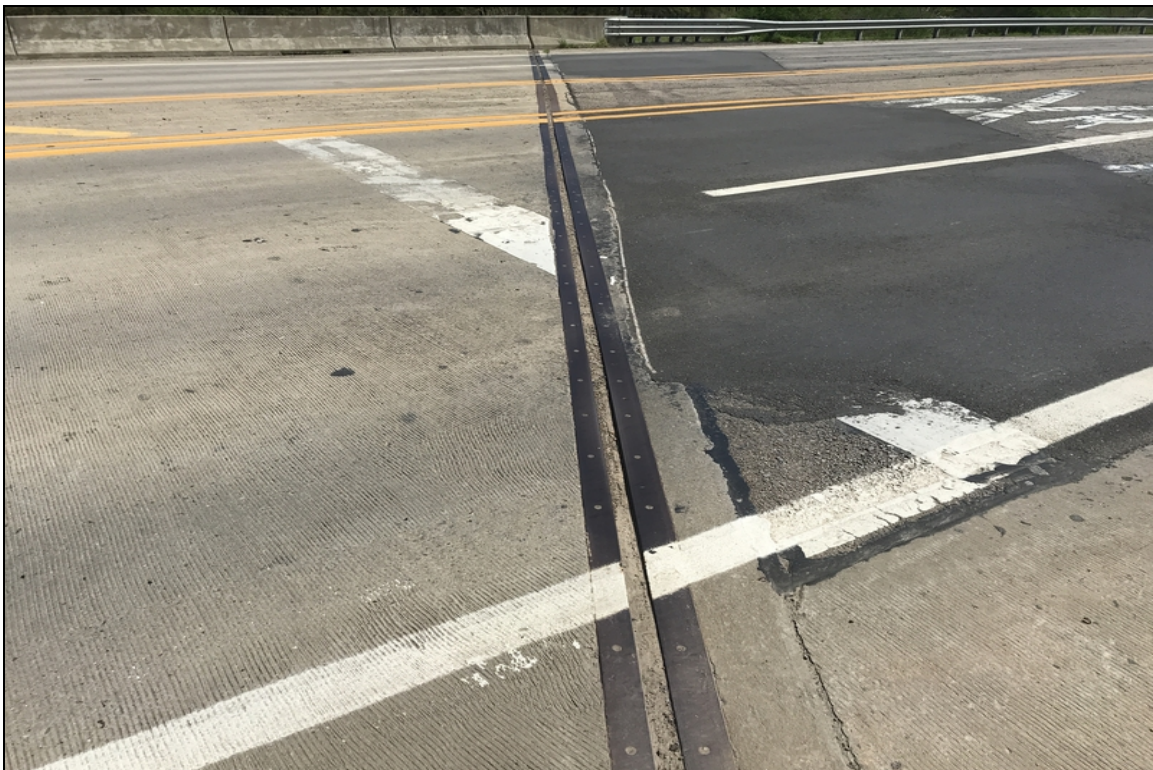
(215)							
-Both abutments have transverse cracking on approximately 2' spacing visible in the top of backwalls. The cracking in locations is full height with efflorescence and is visible from the undersurface.							
-The stem wall of abutment #2 has a few shallow spalls on the right side that appear to be from impact damage during the construction process.							
234	Reinforced Concrete Pier Cap	LF	157	155	2	0	0
1080	Delamination/Spall/Patched Area	LF	2	0	2	0	0

East abutment mention loss to the back wall.

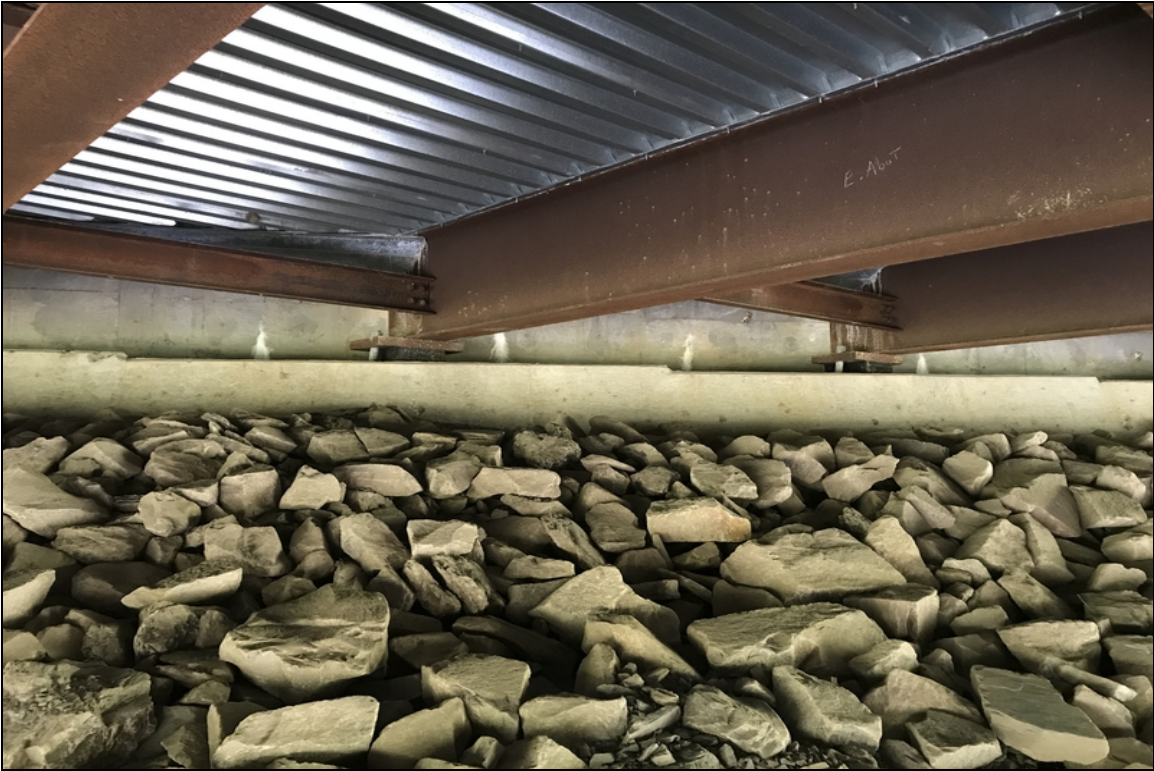
Bent # 4 vertical cracks with efflorescence buildup.

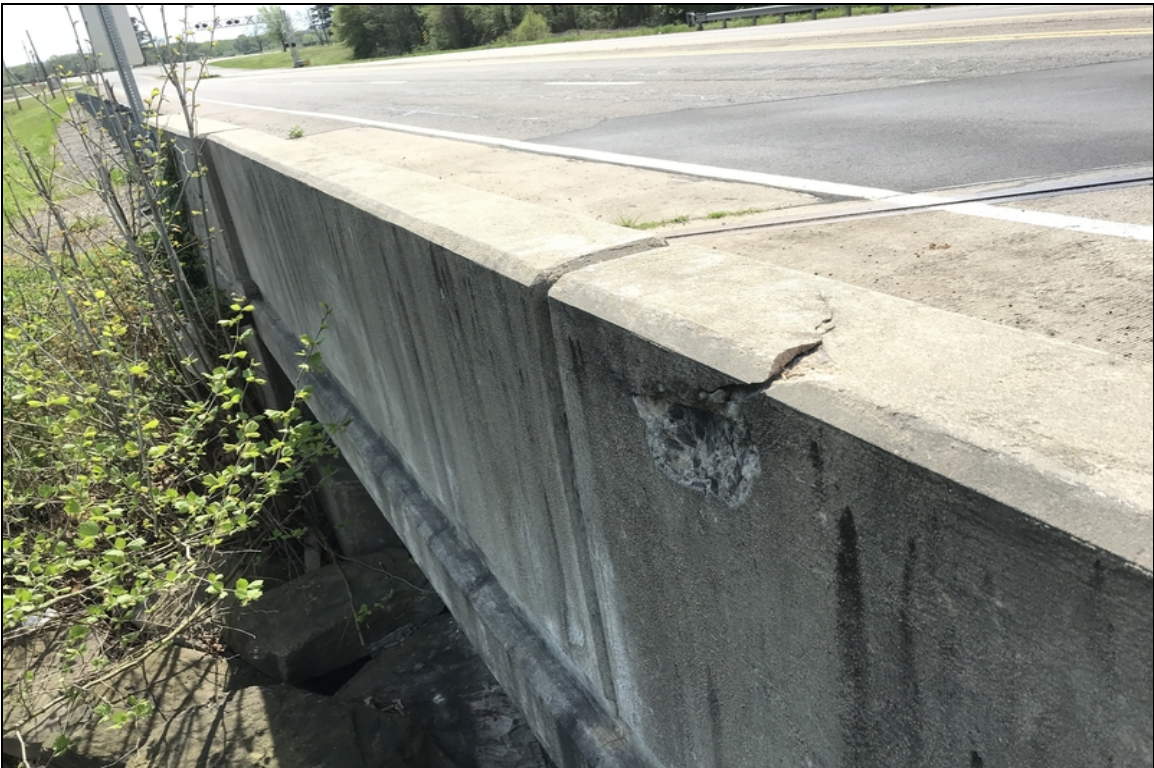
Span # 3 Lt concrete spalling/ delamination.

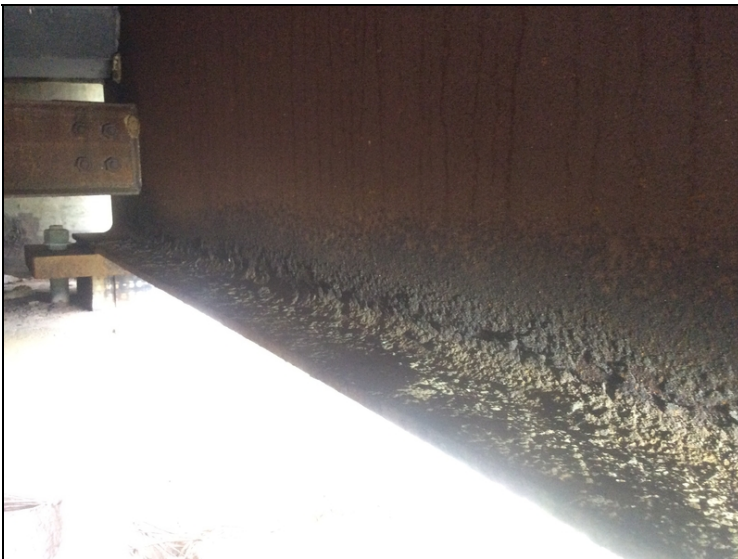
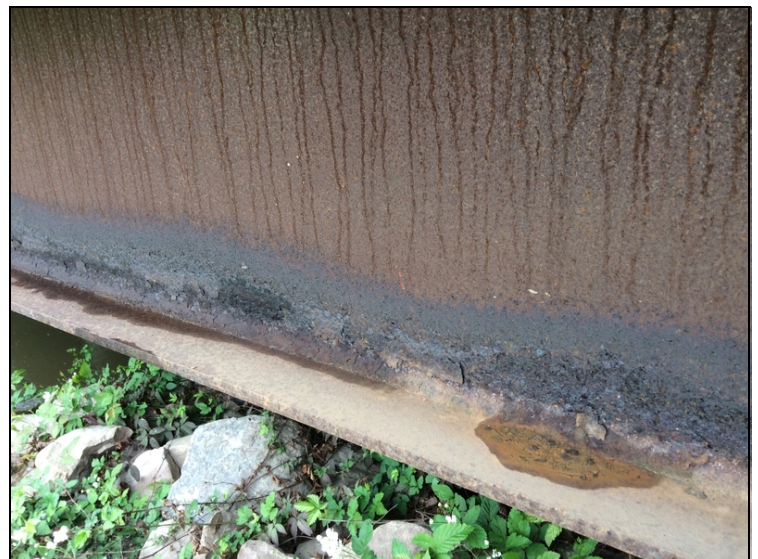
Span 1, Beam 1 has active corrosion with flaking rust to the bottom flange and base of web on the interior and exterior sides of beam adjacent to Bent 1.

Span #1, beam #1-Corrosion with flaking rust on bottom flange and base of web at abutment #1.

Beam 1 at Bent 1.

Date Reported: 04/19/2016
Priority: D- Routine
Type of Work: Repair
Status: Monitor
Component: Superstructure

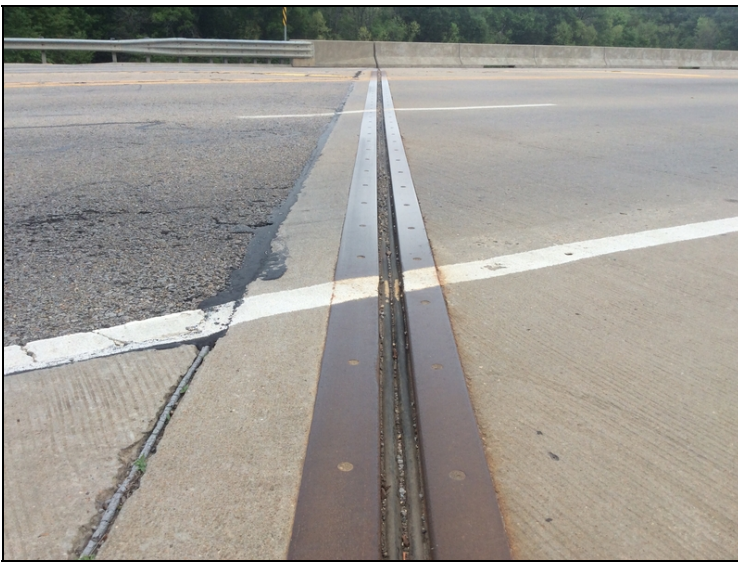
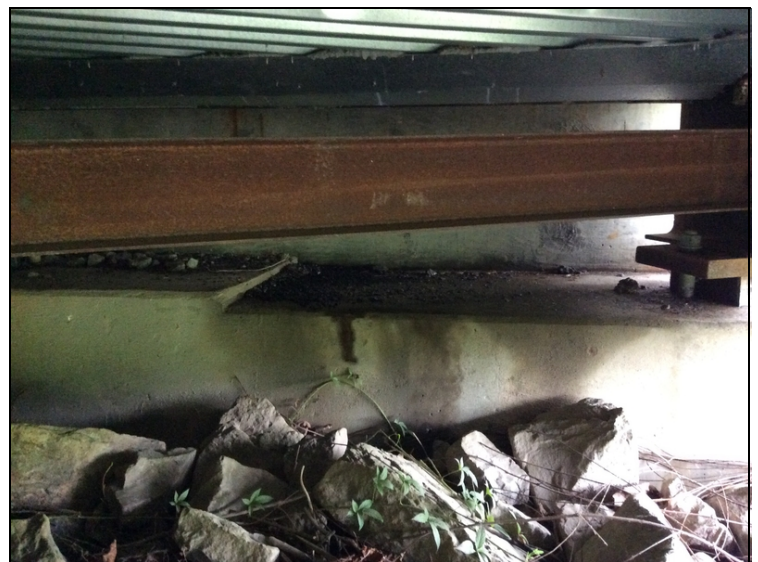
Substructure-
Stains and debris on the abutment caps indicate that the deck joint seals leak in areas.

General view of abutment #1 expansion joint.

Debris on bent 1 seat.

Date Reported: 04/19/2016
Priority: G - General/ Preventive maintenance
Type of Work: Clean
Status: Monitor
Component: Substructure
