Bridge Inspection Report

07154

State Highway 22

Big Vache Grasse Creek

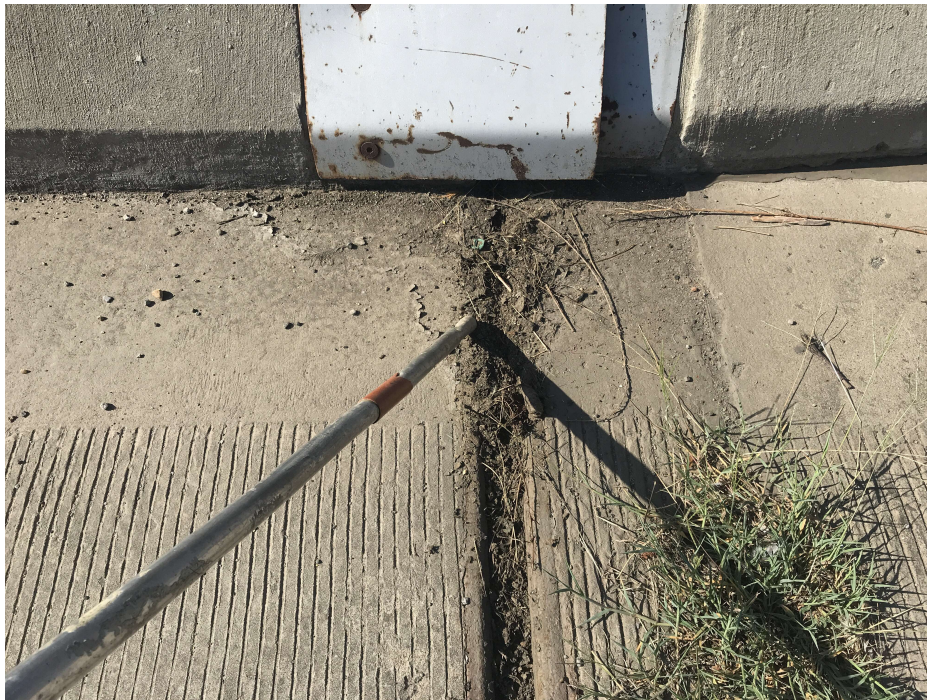
PHOTO 6

Description Dirt and debris expansion joint assembly.

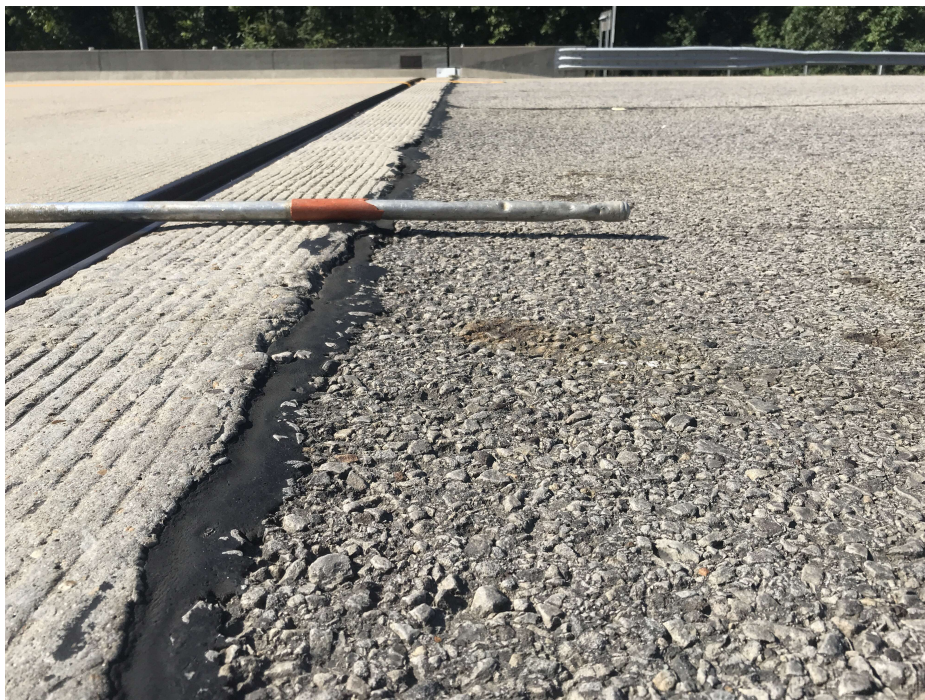
PHOTO 9 Condition

Description West approach roadway-Minor settlement at bridge end.

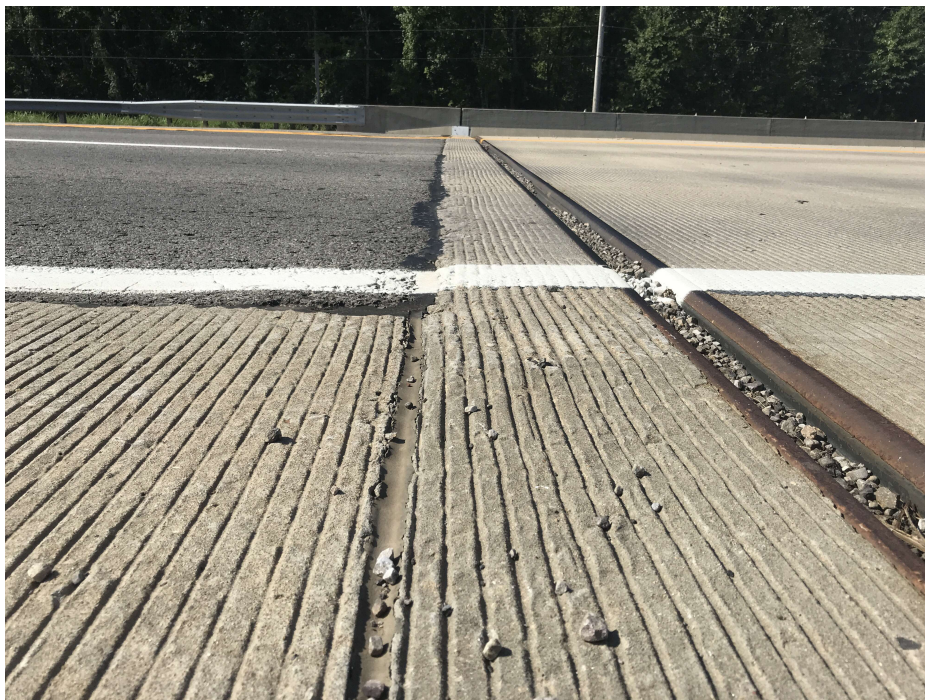
PHOTO 15 Condition

Description East approach roadway-Minor settlement.

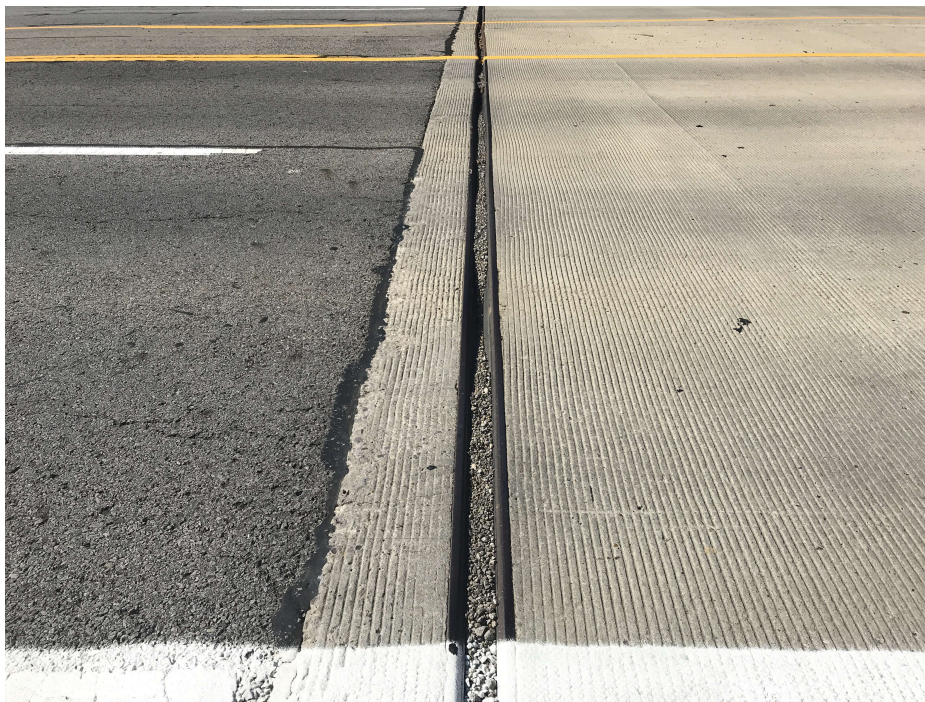
PHOTO 16

Description East abutment expansion joint assembly-Dirt and debris.

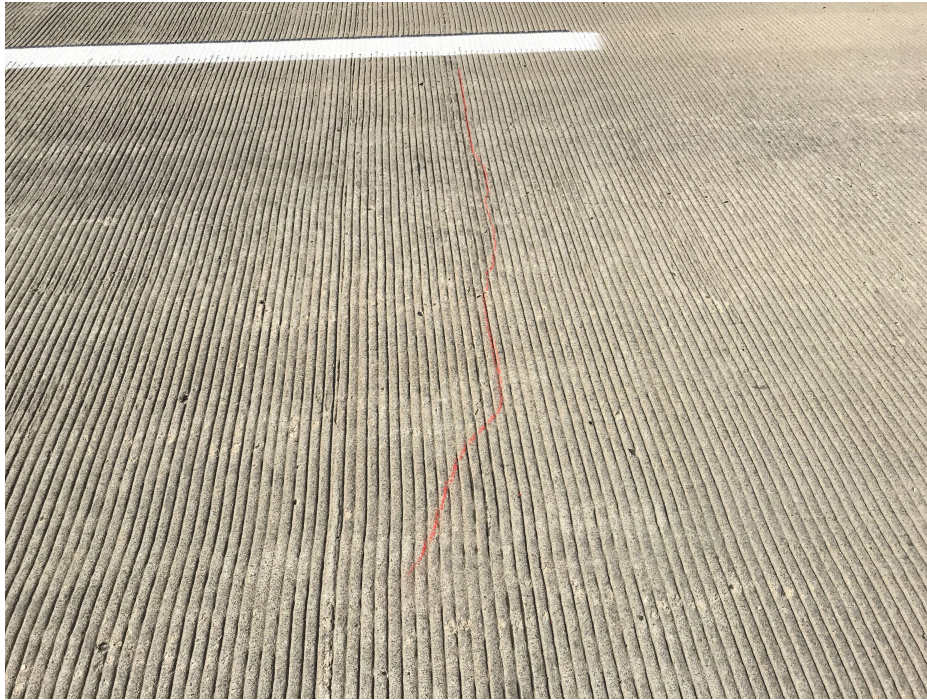
PHOTO 19 Condition

Description Transverse deck cracking.

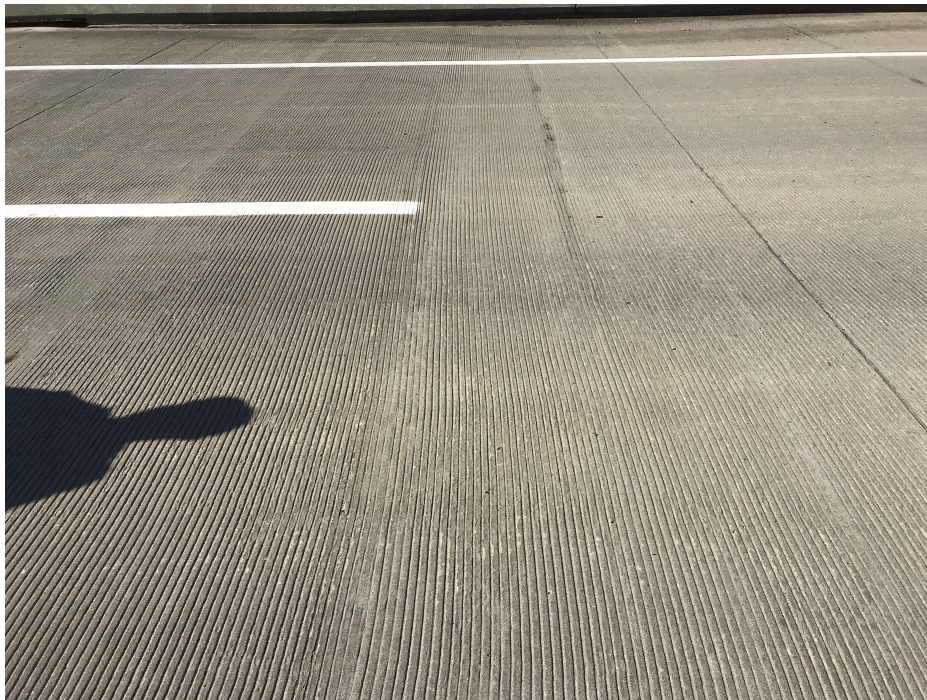
PHOTO 20 Condition

Description Transverse deck cracking.

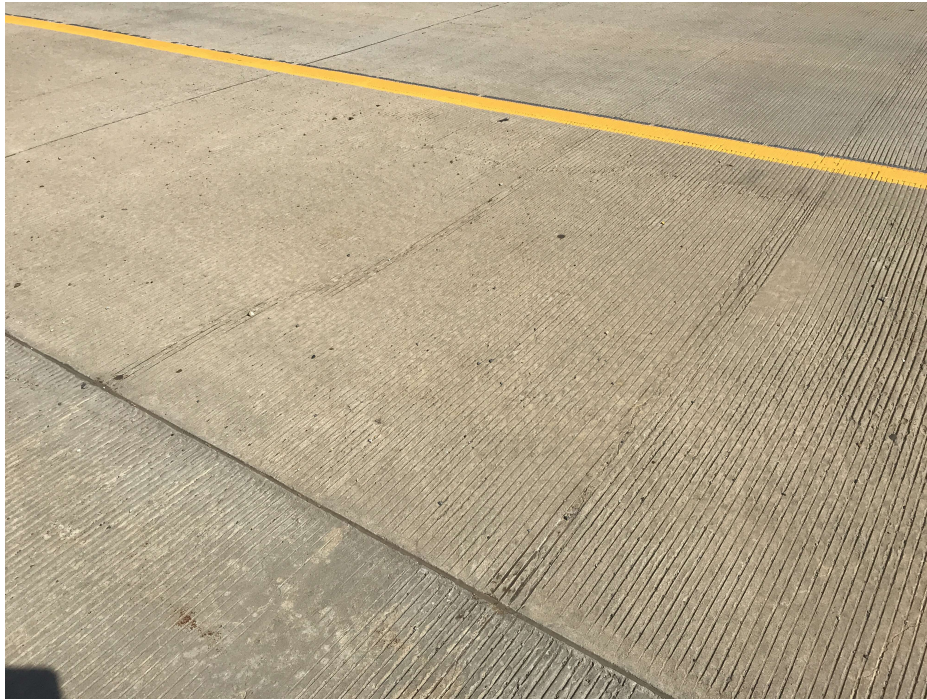
PHOTO 21 Condition

Description Crack sealant has failed.

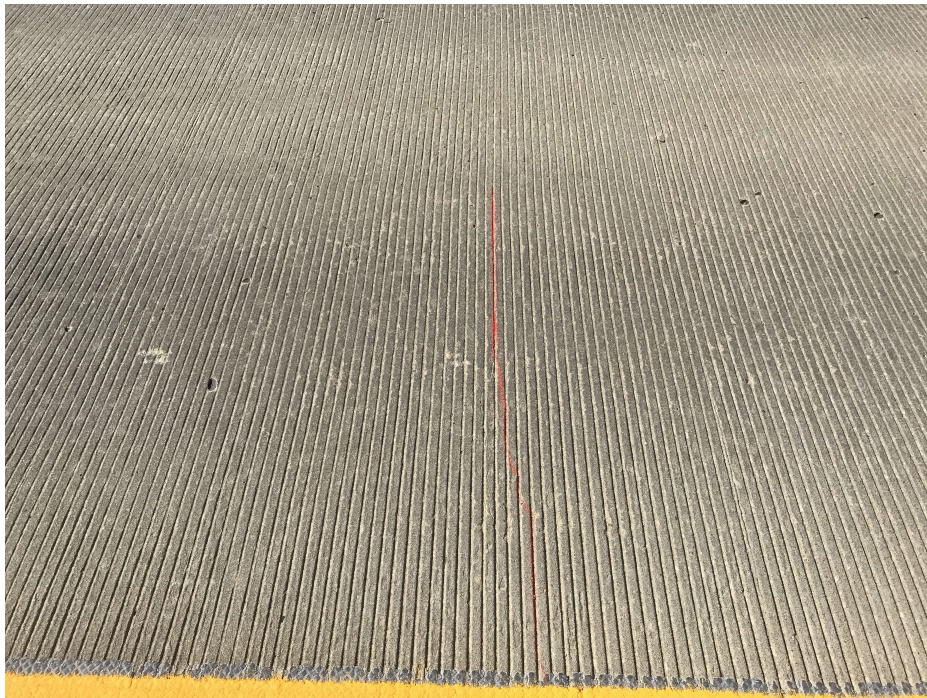
PHOTO 22 Condition

Description Transverse deck cracking.

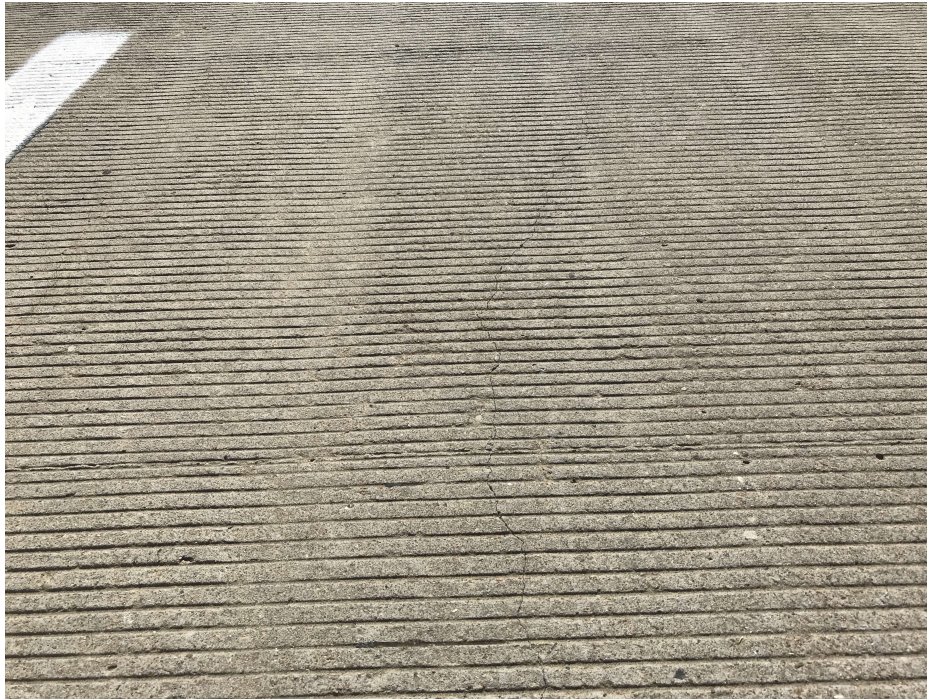
PHOTO 23 Condition

Description Longitudinal deck cracking.

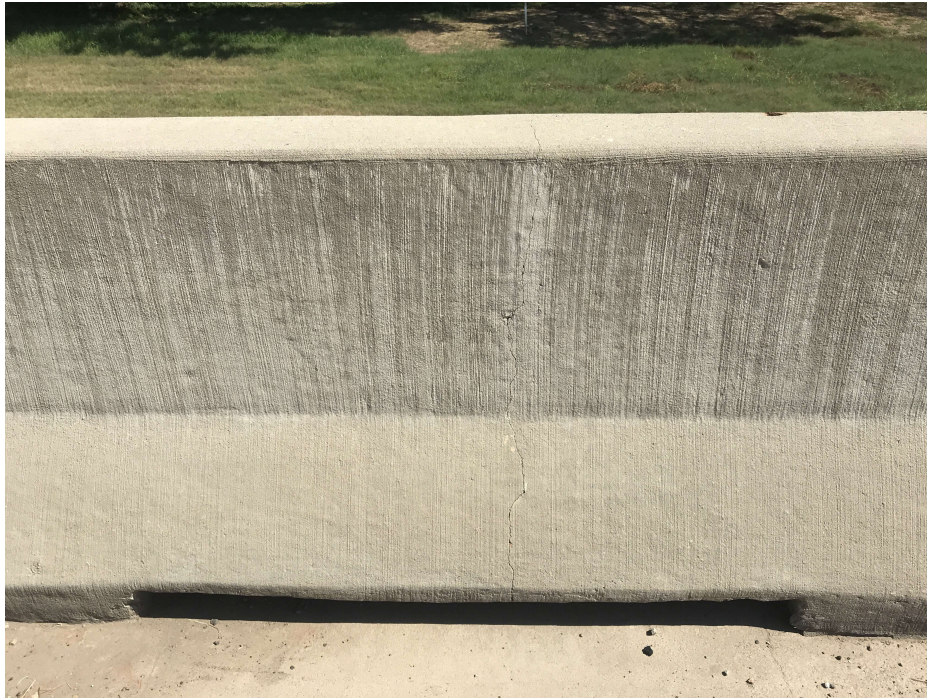
PHOTO 25 Condition

Description Vertical cracking in parapets.

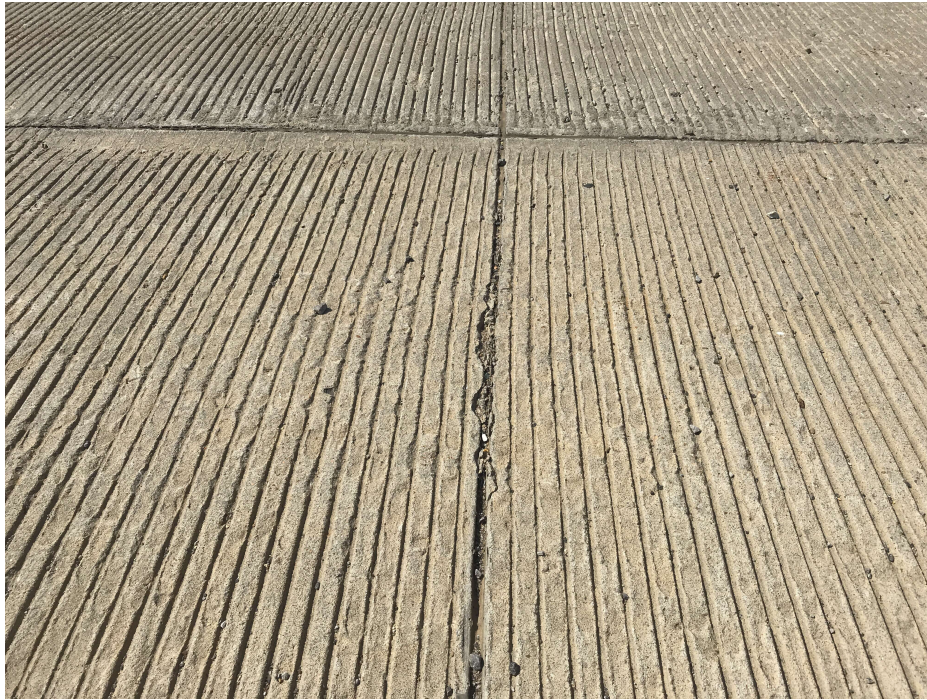
PHOTO 27

Description Saw joint sealant.

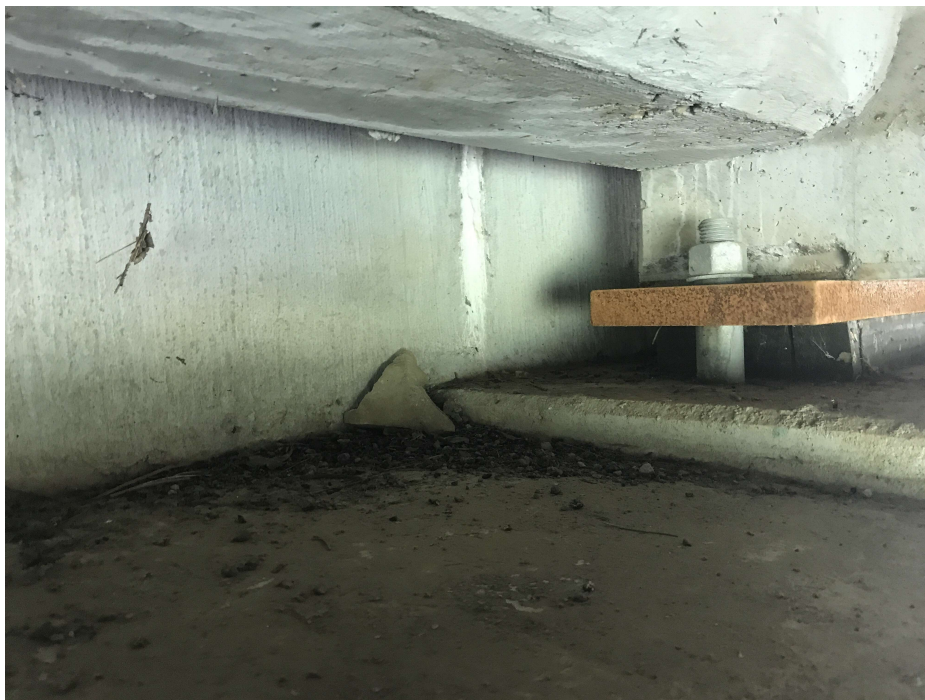
PHOTO 31

Description Vertical cracking with efflorescence in abutment backwall.

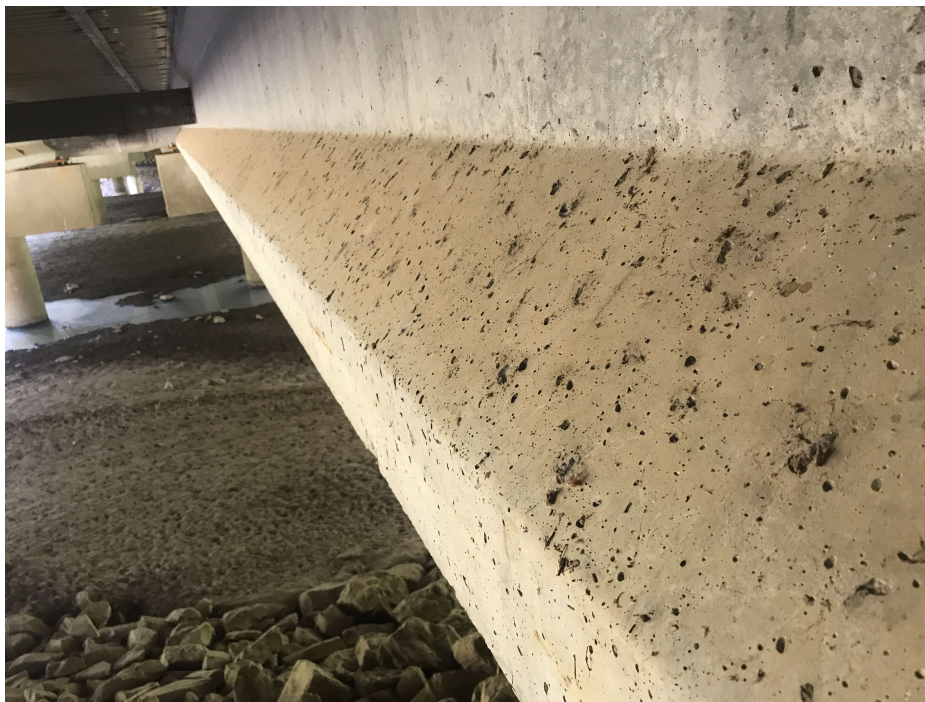
PHOTO 32

Description Honeycombing in bottom flanges typical.

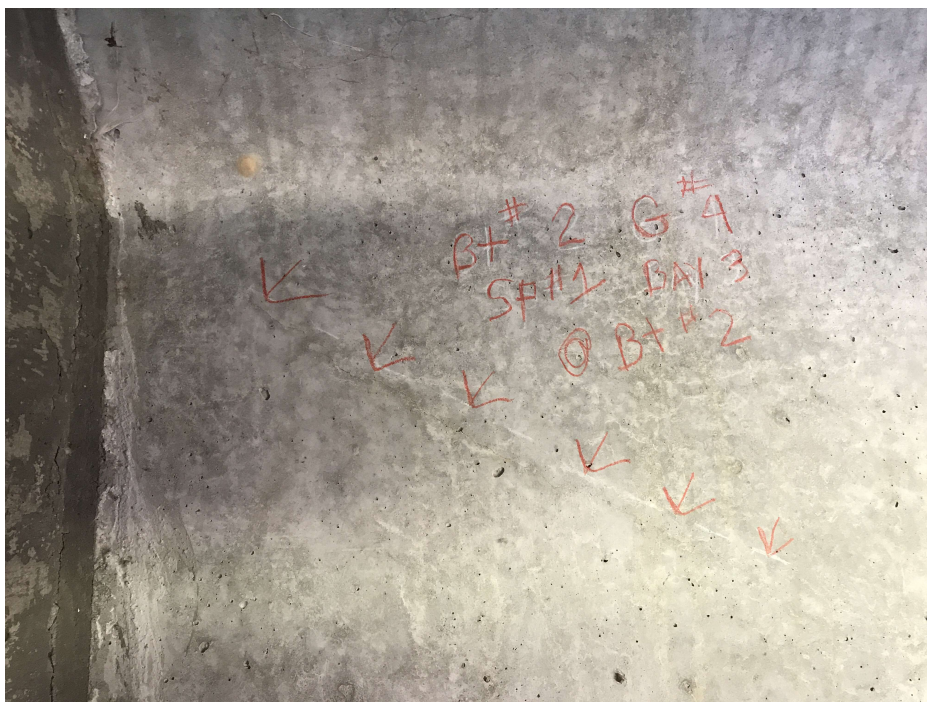
PHOTO 36 Condition

Description Diagonal cracking in girder web.

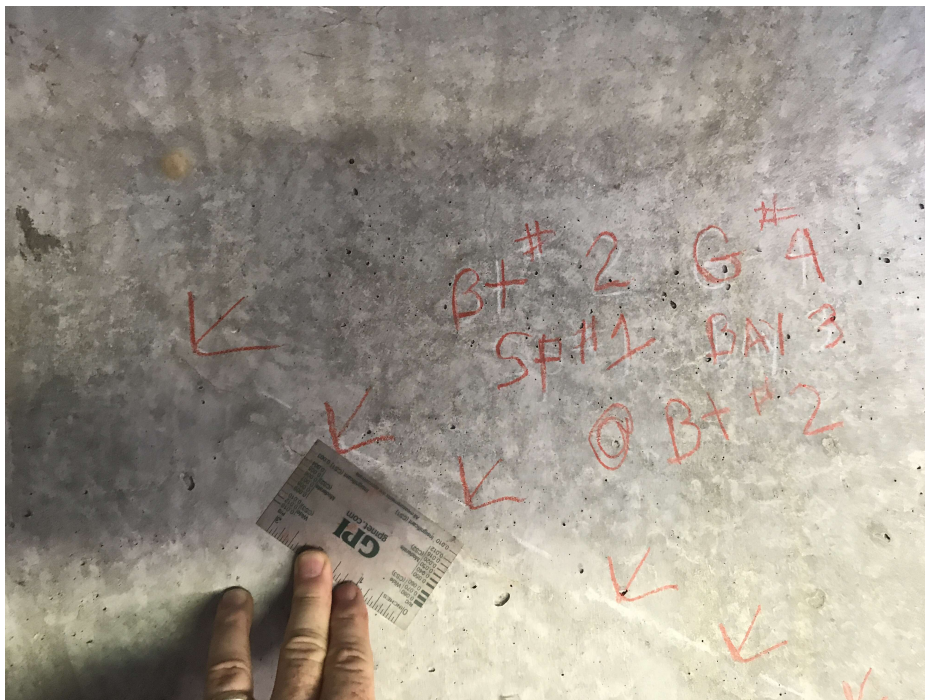
PHOTO 37 Condition

Description Diagonal cracking in girder web.

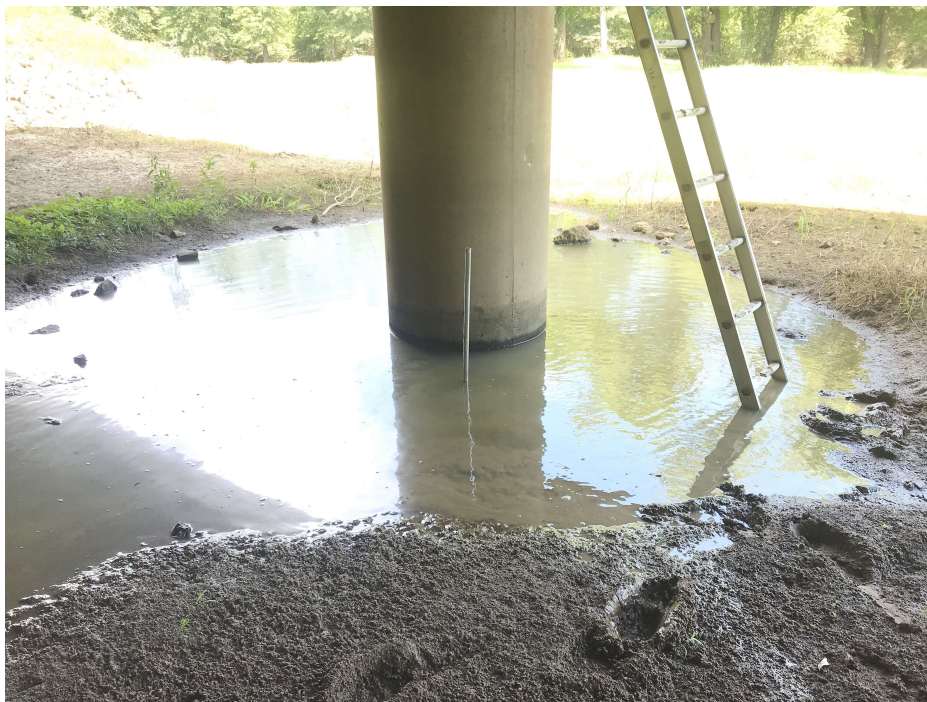
PHOTO 42

Description Minor scour hole.

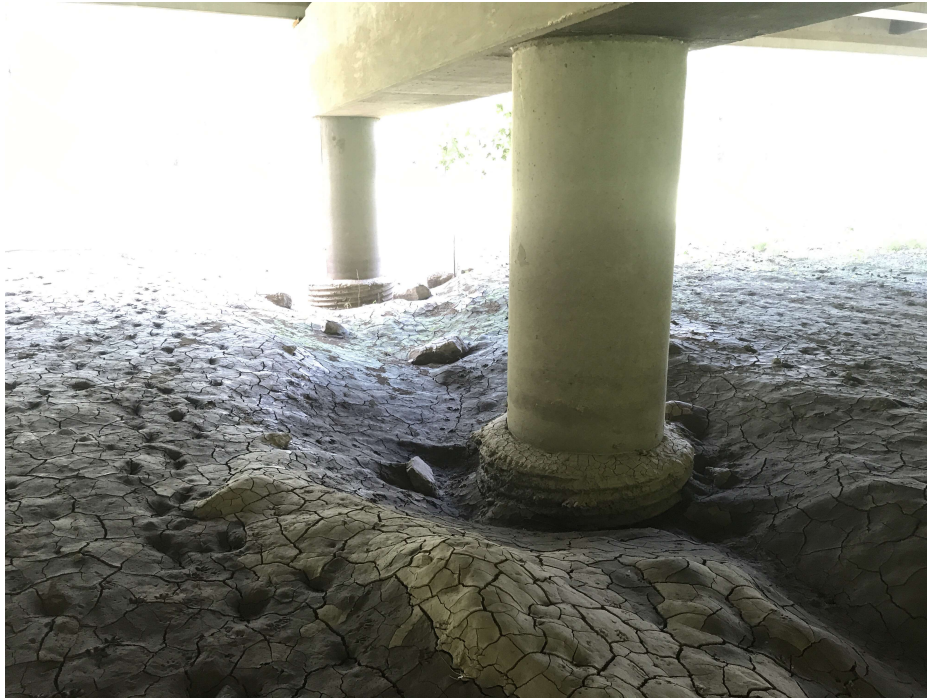
PHOTO 43

Description Tops of drilled shafts exposed.

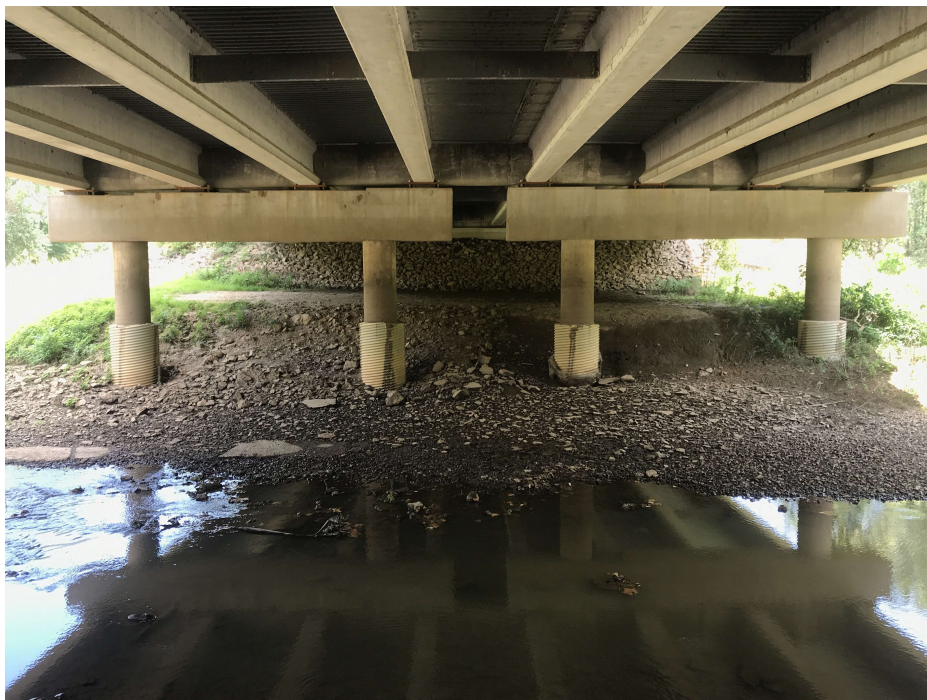
PHOTO 47

Underwater Type II inspection: Visual observation in low water conditions revealed that the drilled shafts are visible in several locations. Bents #4 and #5 are the most notable case with up to approximately 8' of the drilled shafts exposed at some of the columns. A review of the plans indicate that the shafts are 26 feet in length with a minimum of 8 feet socketed in medium hard shale. No apparent scour problems at this inspection.

Description Bent #5-Drilled shafts exposed.

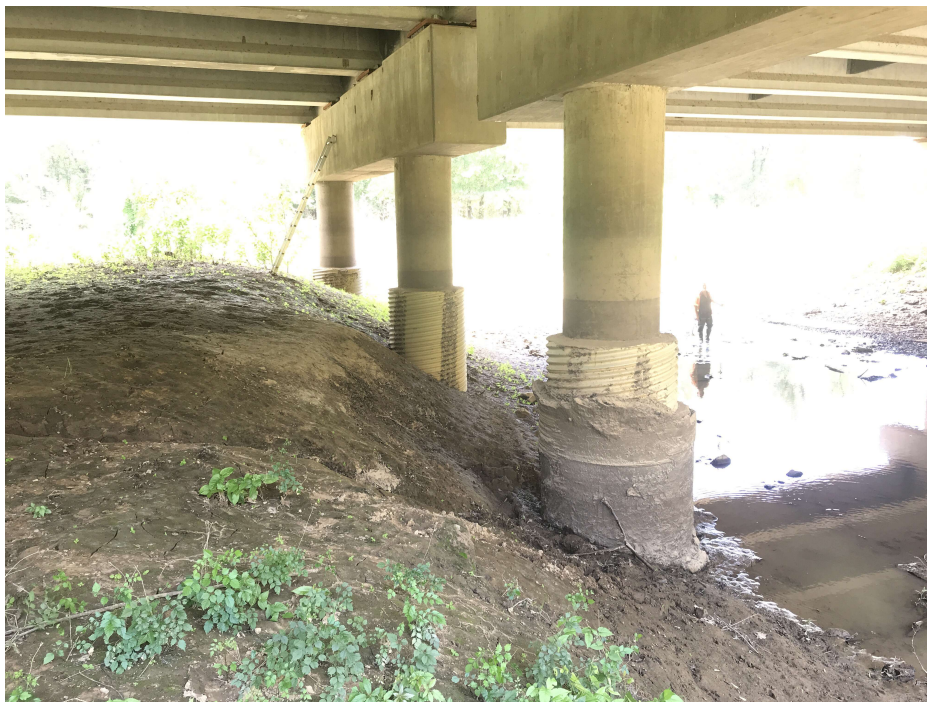
PHOTO 48

Description Bent #4-Drilled shafts exposed.

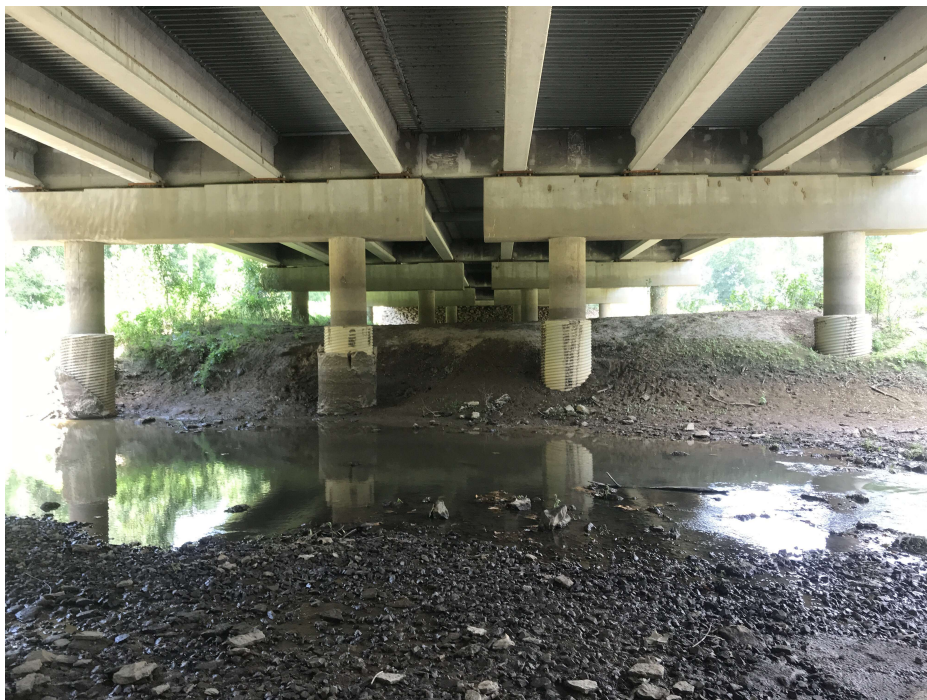
PHOTO 53

Description Bent #4-Drilled shafts exposed. Photo #2.

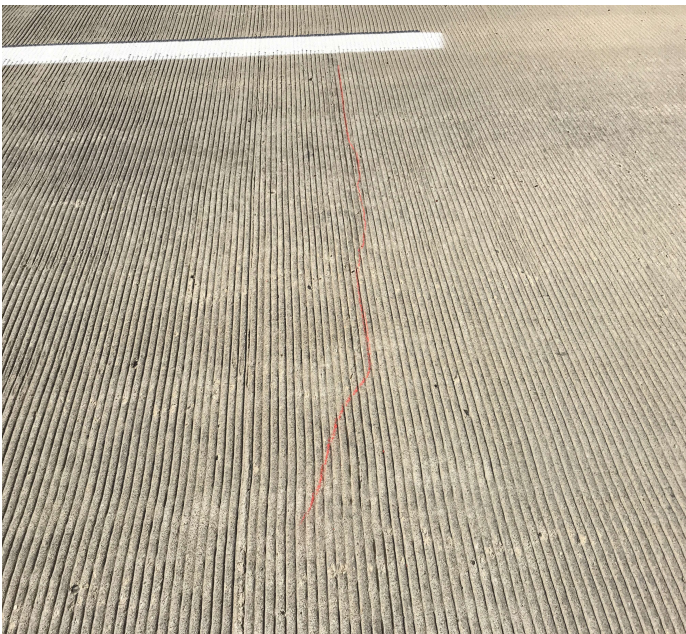
Deck and Top of Back Walls -
Driving surface of the deck has sealable longitudinal, transverse and map cracks. The cracks sealant used in the past has failed in most locations with numerous unsealed cracks visible in all spans. The tops of the back walls have numerous unsealed transverse cracks.

PHOTO 1 Description Transverse deck cracking.

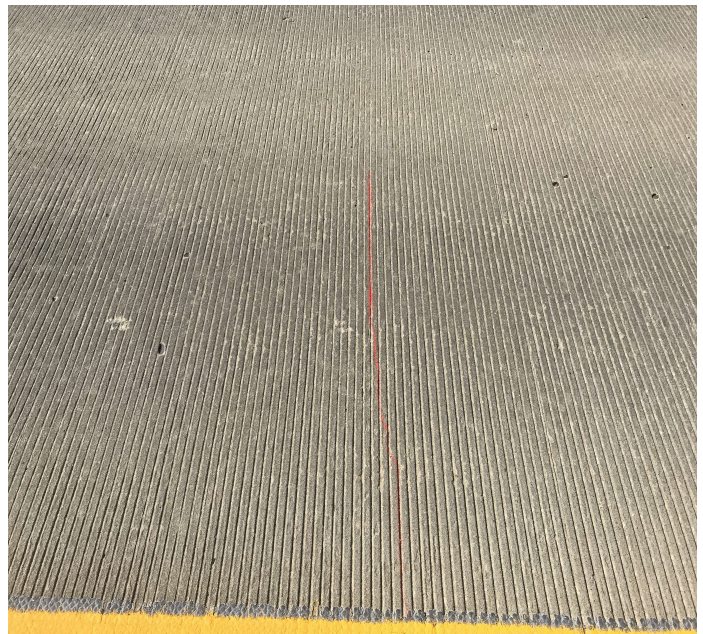
PHOTO 2 Description Transverse deck cracking.

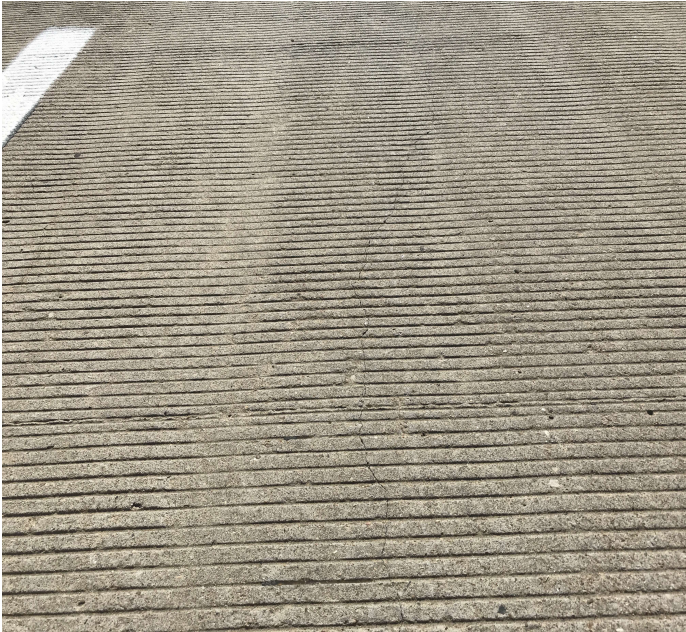
PHOTO 3 Description Longitudinal deck cracking.

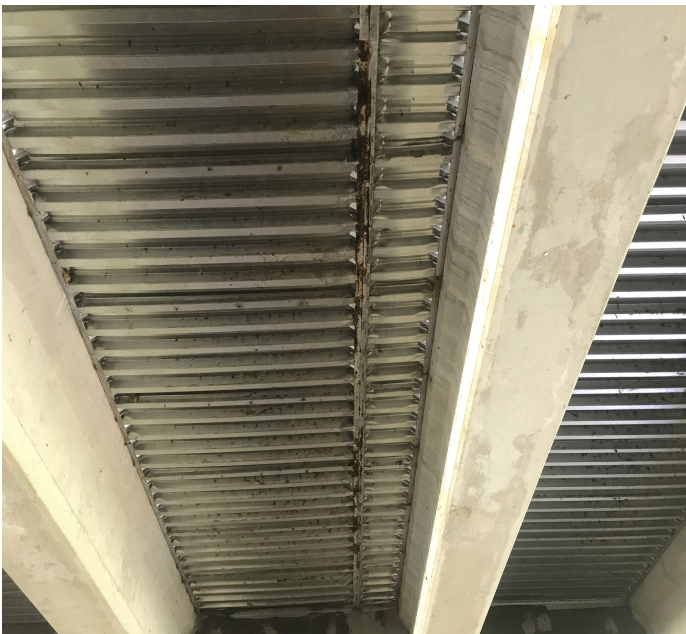
The deck sawn joints and the centerline construction joint sealant appears to have adhesion failure allowing water to penetrate the joints. Active corrosion is forming on the stay in place forms along the centerline of the structure. Joint sealant is in place at the time of the inspection.

PHOTO 1 Description Corrosion to SIP forms along construction joint.

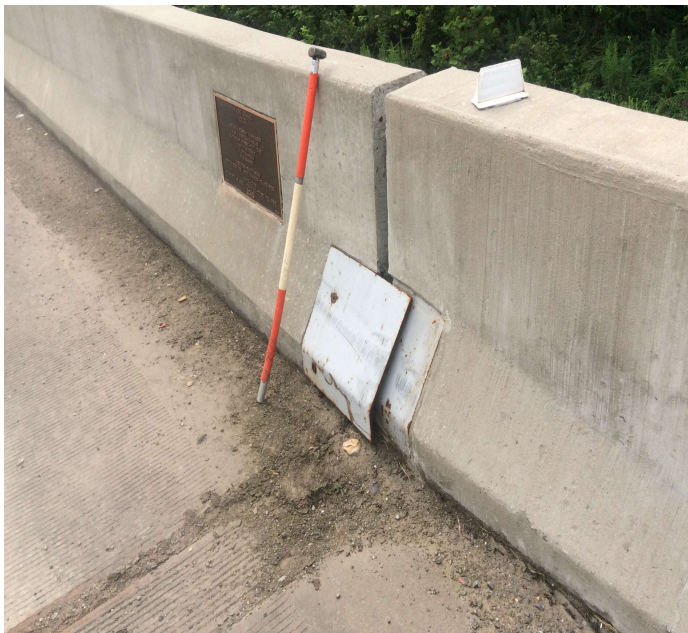
The steel cover plates attached to the right parapet wall have out of plane bending at Both abutment expansion joints.

PHOTO 1 Description South sliding plate at Bent 1.

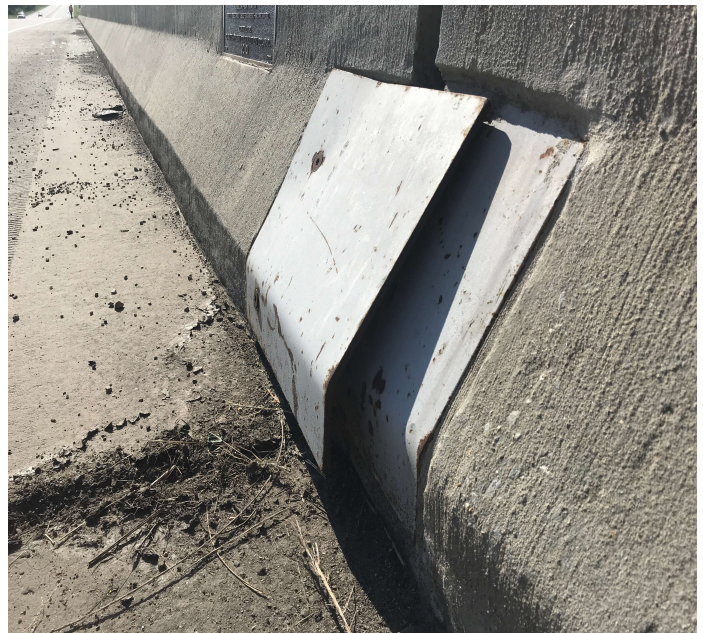
PHOTO 1 Description The steel cover plates attached to the right parapet wall have out of plane bending at Both abutment expansion joints.

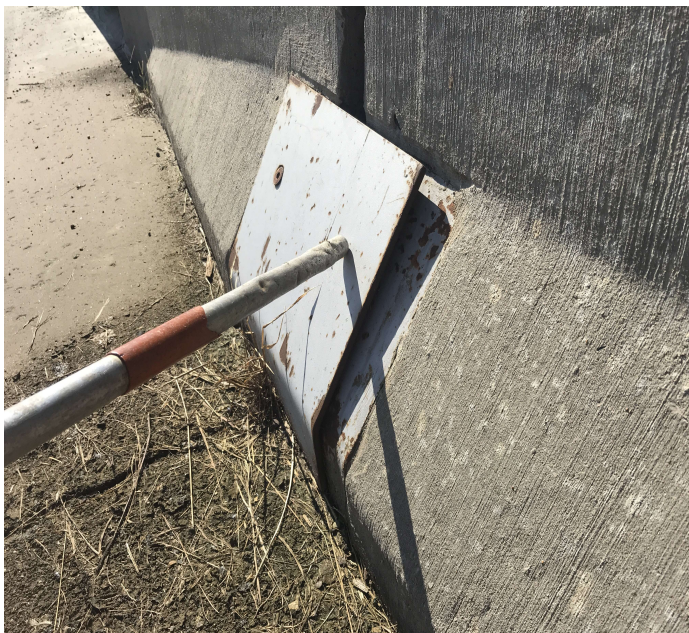
PHOTO 2 **Description** The steel cover plates attached to the right parapet wall have out of plane bending at Both abutment expansion joints.

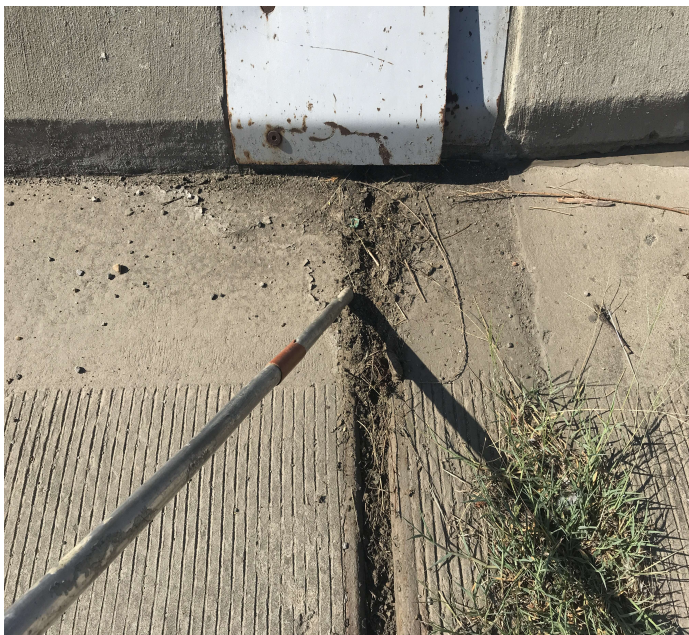
Expansion joints - The expansion joints at both abutments have dirt, debris and gravel accumulation in the gutters and in portions of the driving lanes.

PHOTO 1 Description Dirt and debris expansion joint assembly.

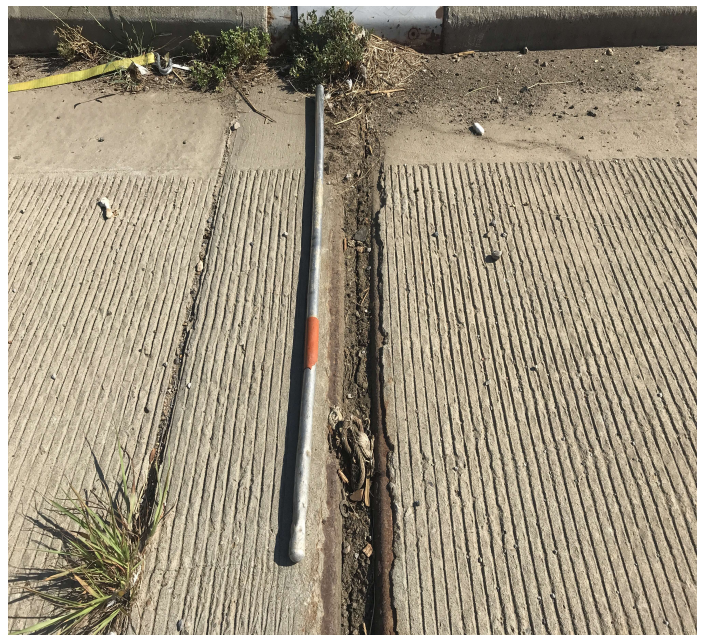
PHOTO 2 Description The expansion joints at both abutments have dirt, debris and gravel accumulation in the gutters and in portions of the driving lanes.

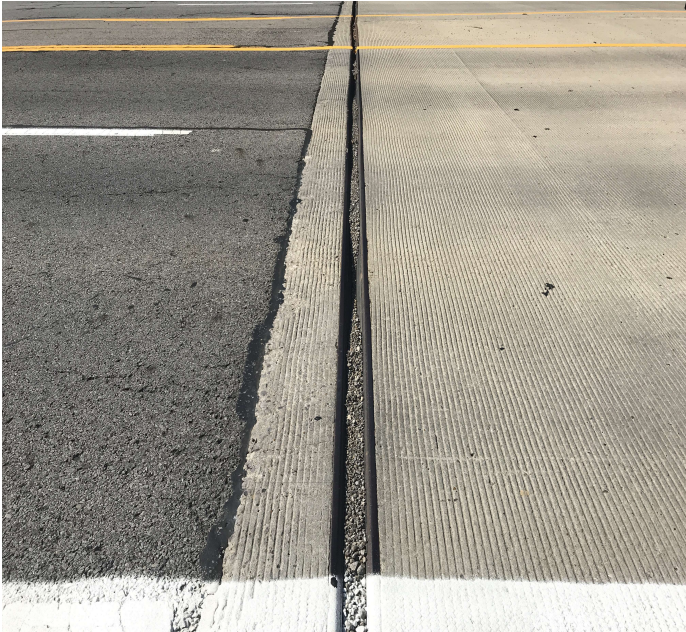
PHOTO 3 Description East abutment expansion joint assembly-Gravel accumulation.
