Bridge #A0350(Routine, Underwater type 2)
State Highway 22 over Massard Creek Seb. Co.
Location: 1.35 MI SE MASSARD, ARK.

Team Lead: Eric West **Inspection Date:** September 30, 2020

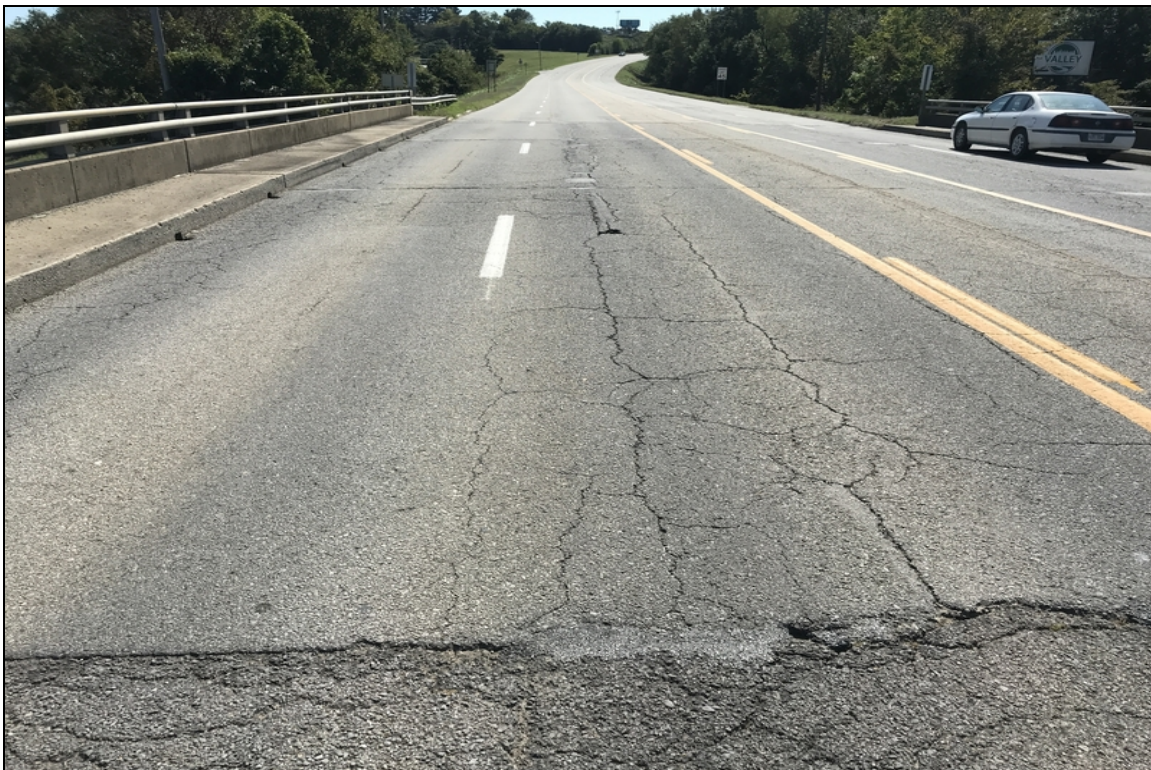
Typical driving surface of the deck westbound.

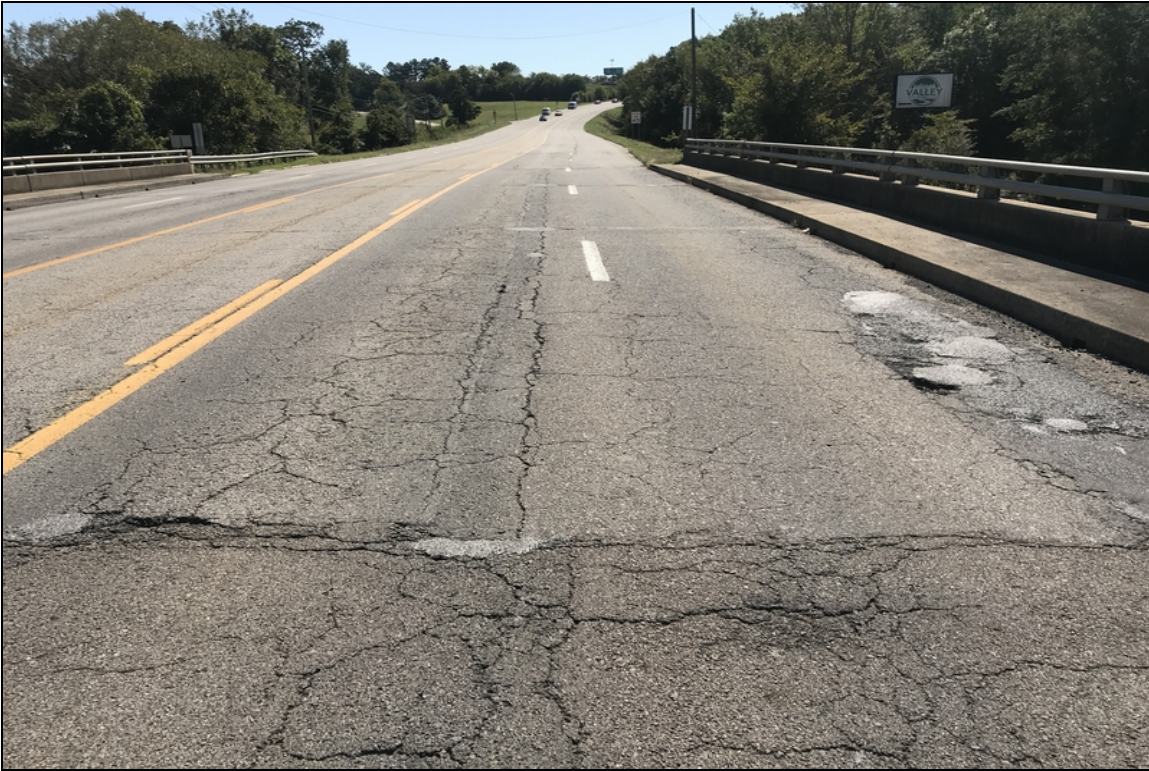
Typical driving surface of the deck eastbound.

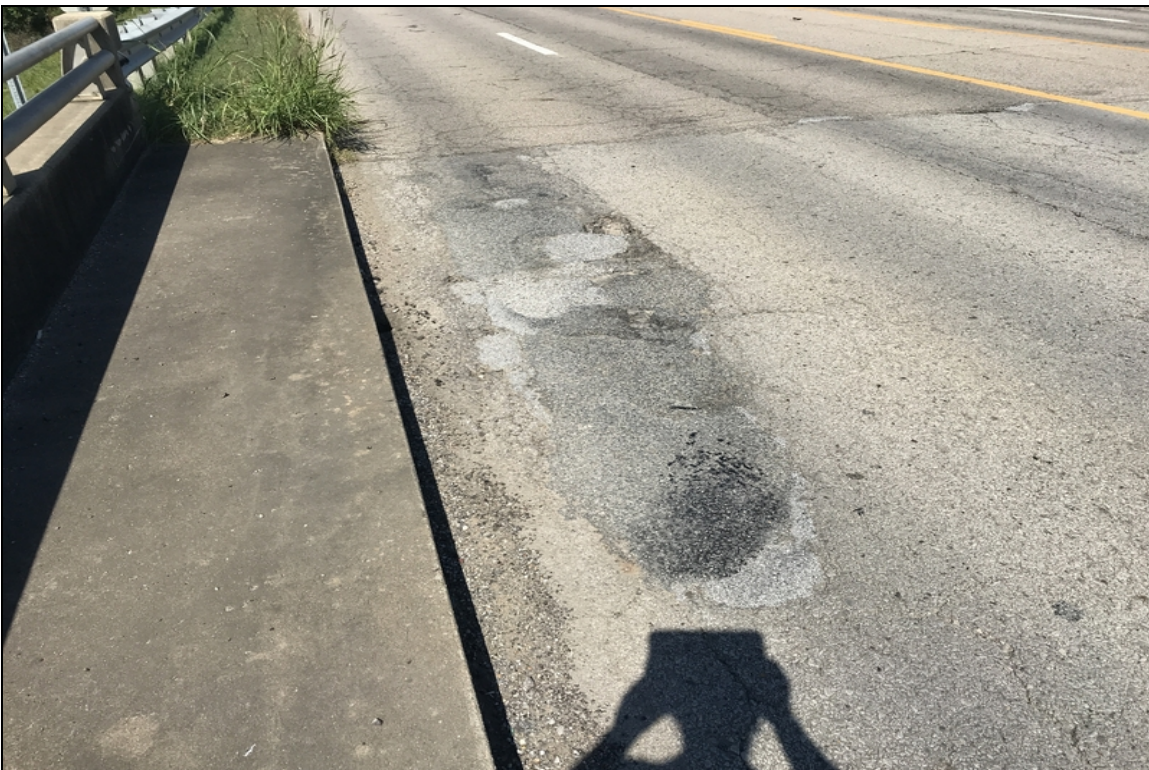
Span #1 Rt with failing asphalt patches.

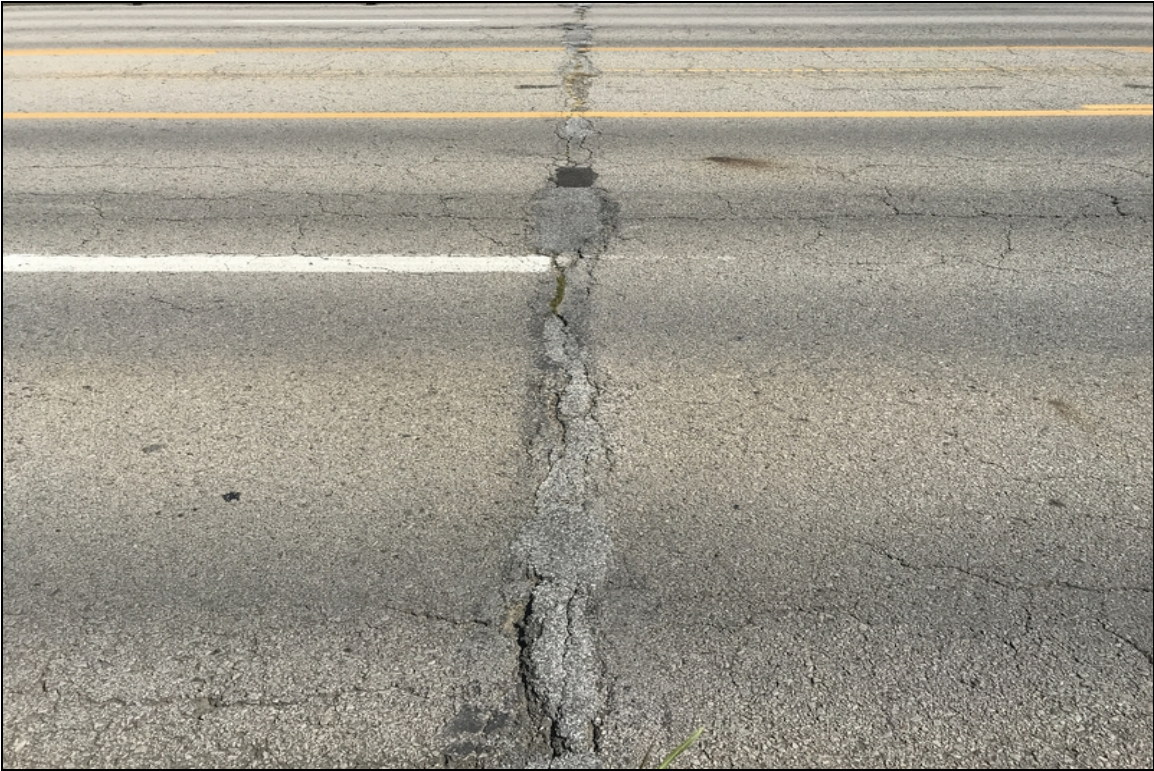
Bent #3 asphalt breaking apart over the deck joint.

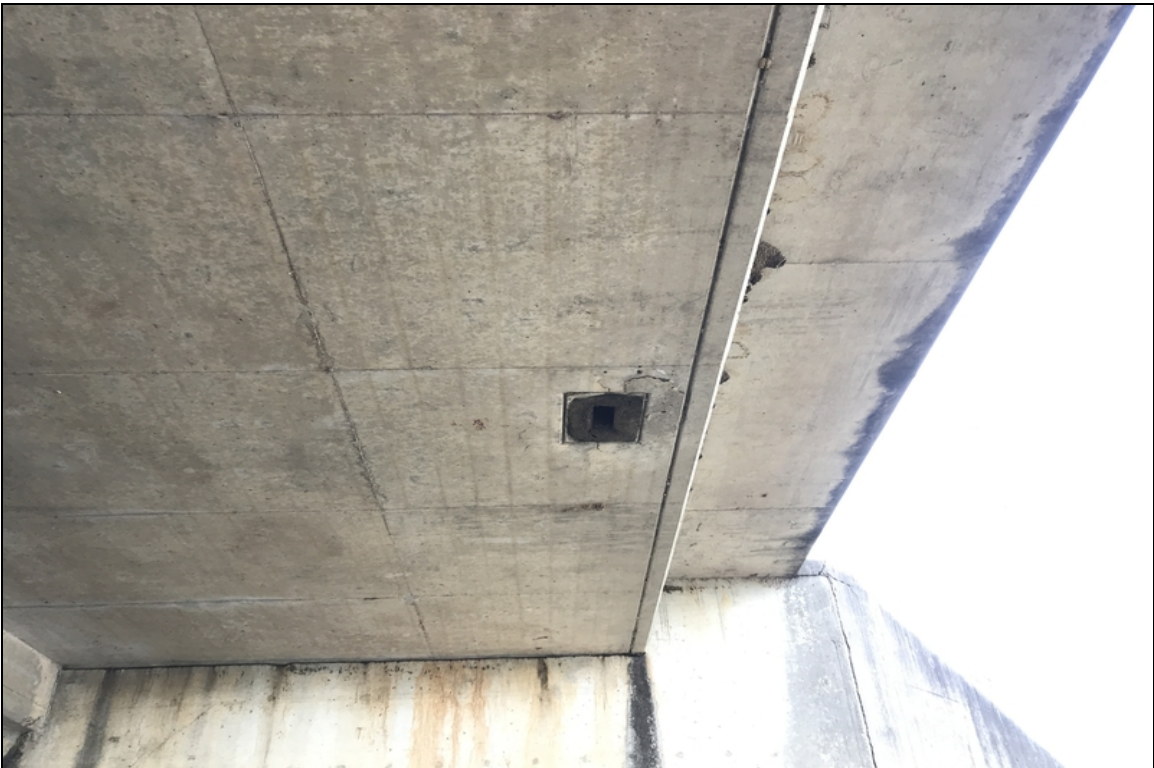
Span #1 Lt concrete delamination's at the deck drain.

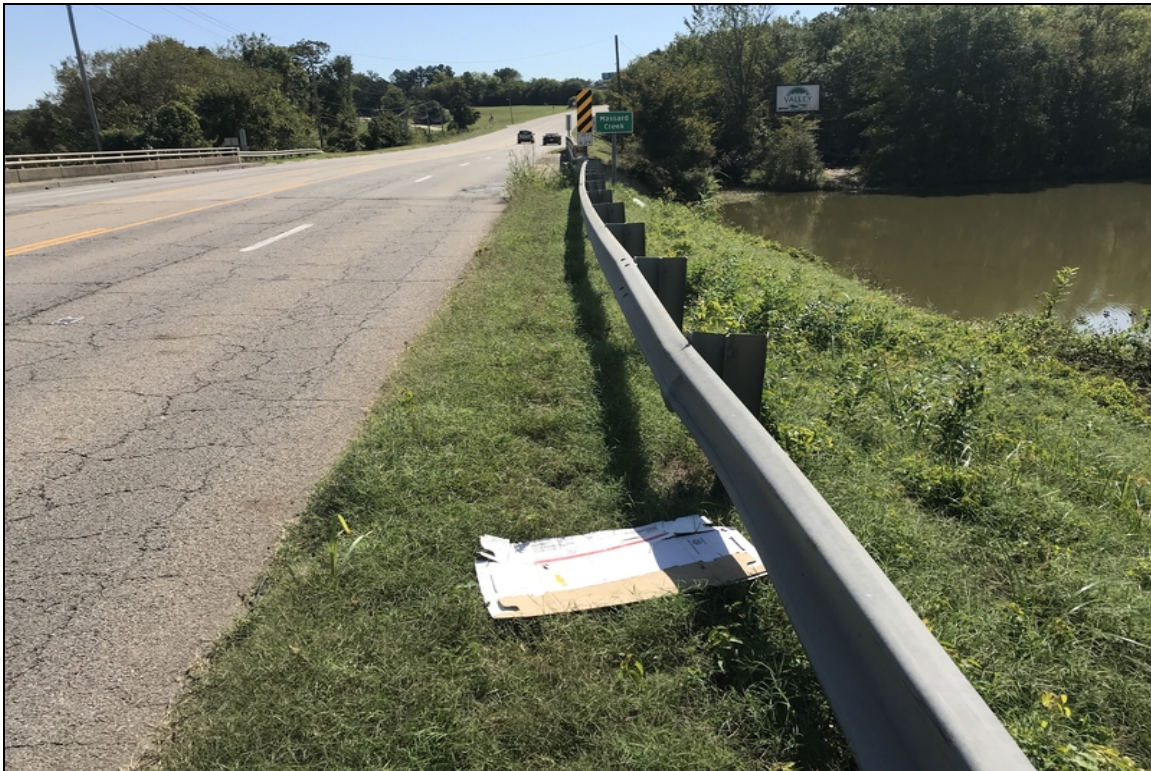
Southwest approach rail collision damage.

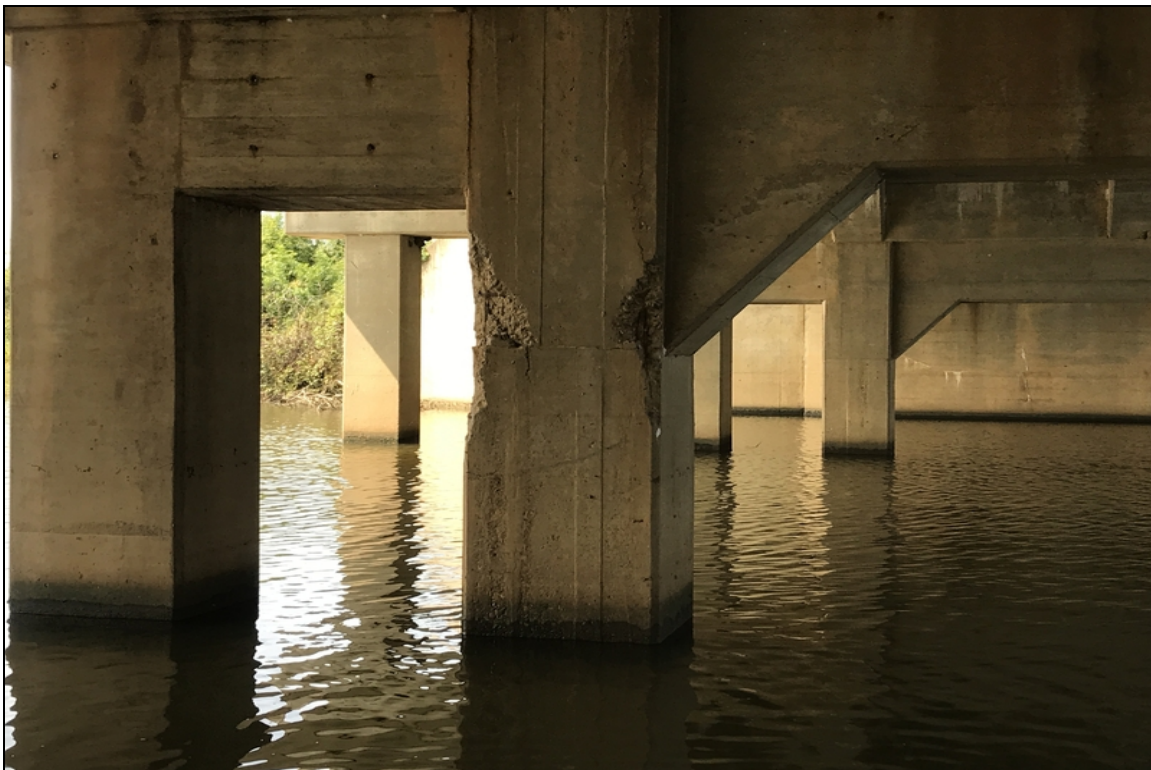
Bent #3 column #5 spalling with exposed reinforcing steel.

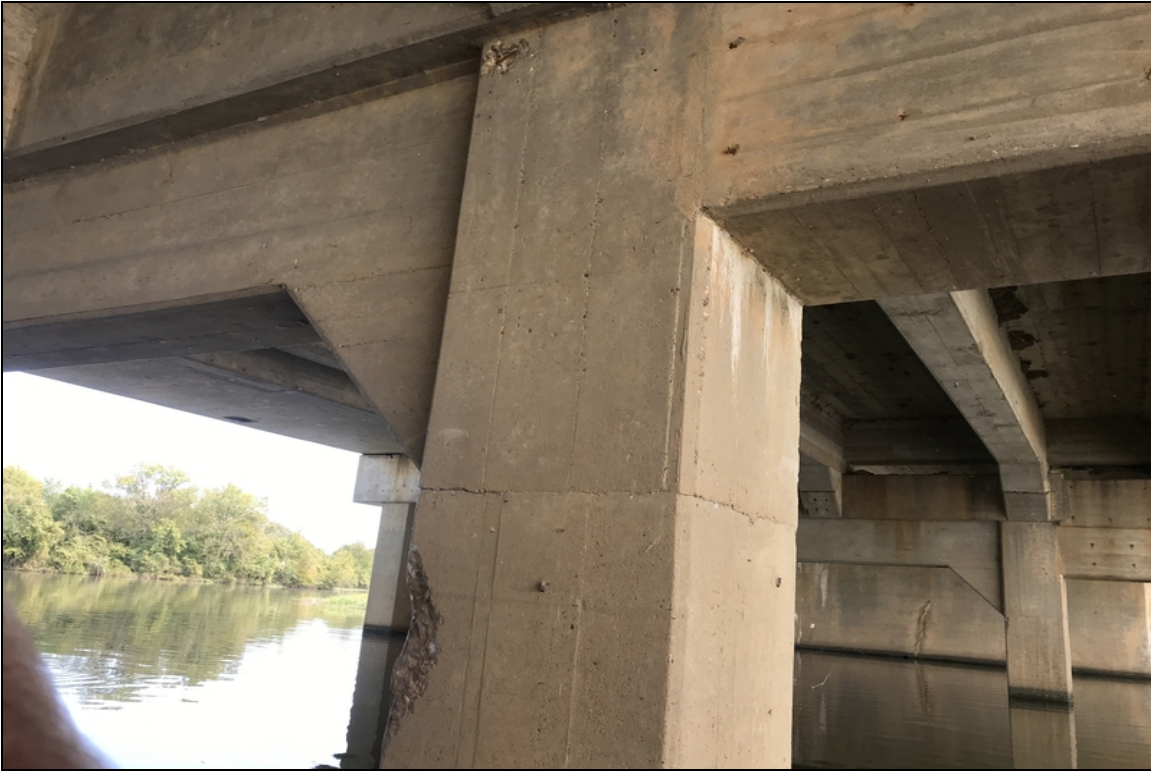
Bent #2 column #5 spalling with exposed reinforcing steel and a concrete spall near the water elevation.

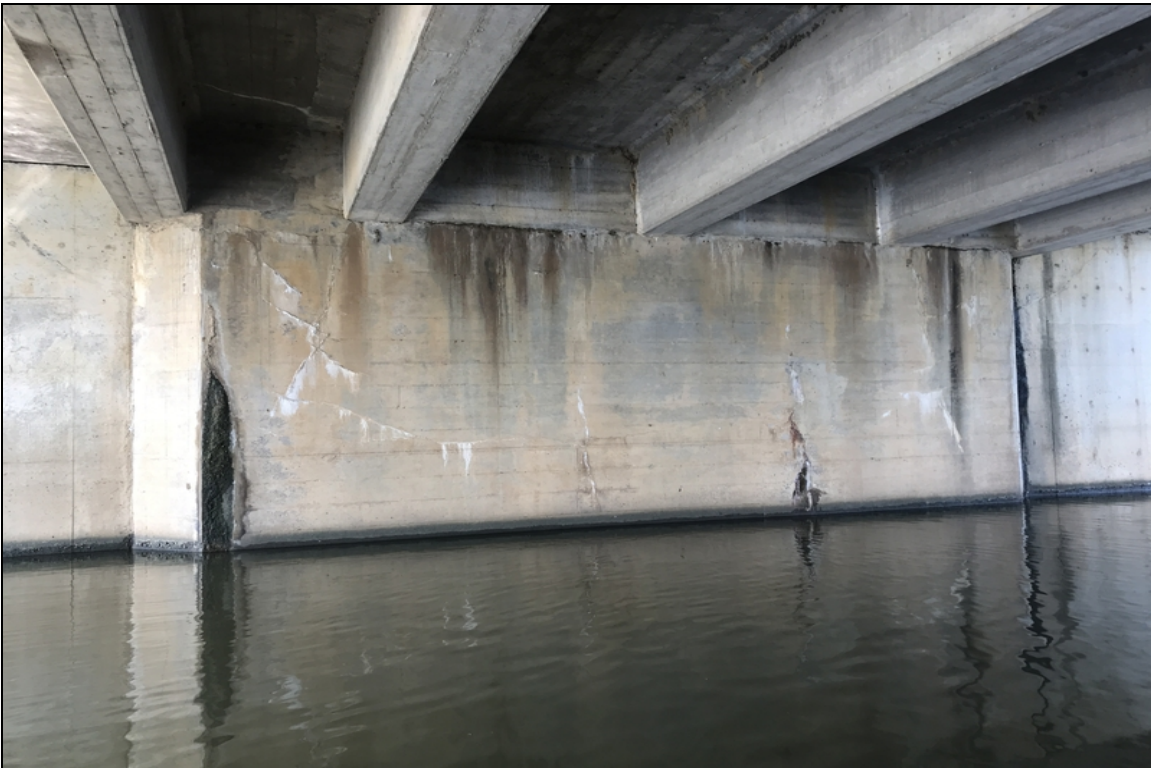
Abutment #1 cracking in the original portion of the abutment stem.

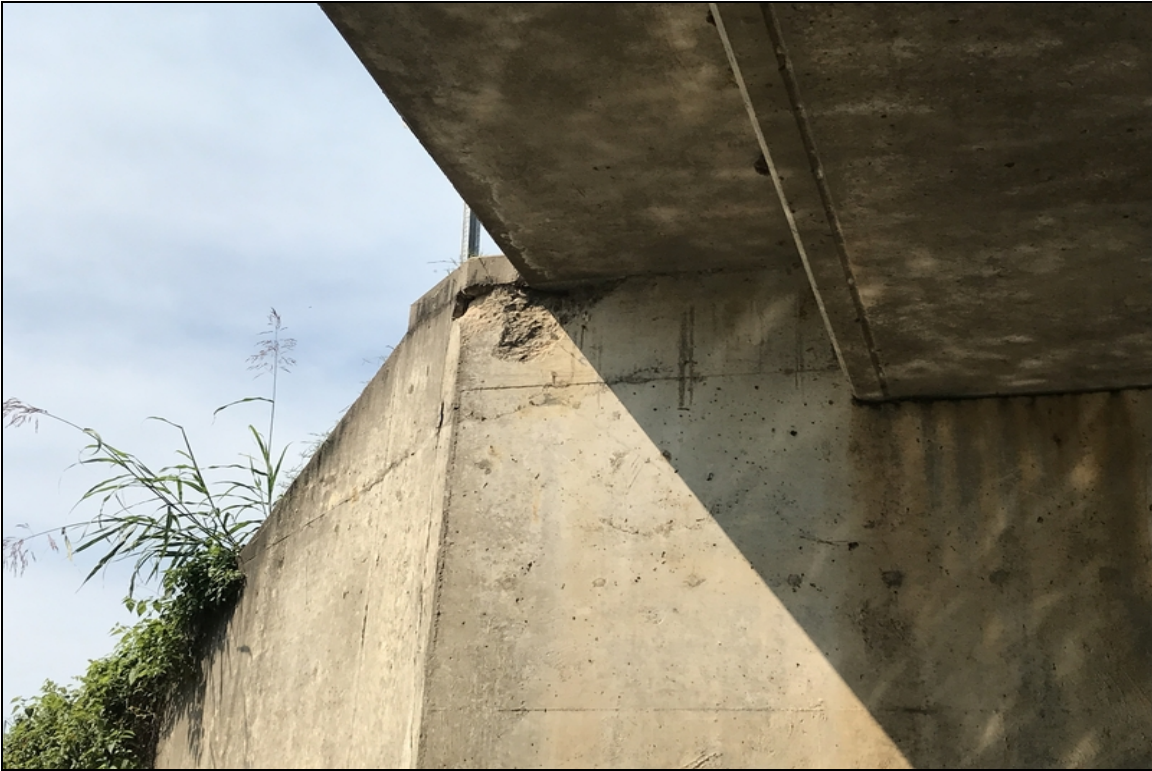
Abutment #1 Rt spalling in the abutment at the wingwall juncture.

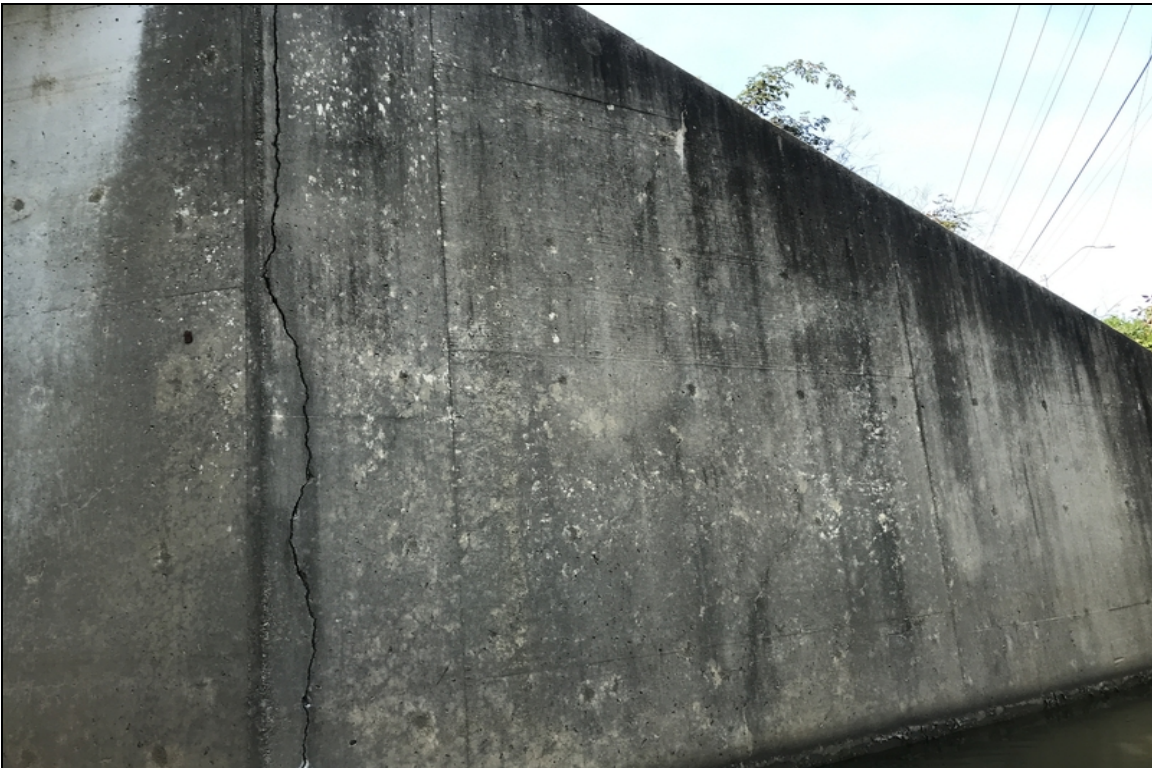
Abutment #1 Lt wing wall cracking.

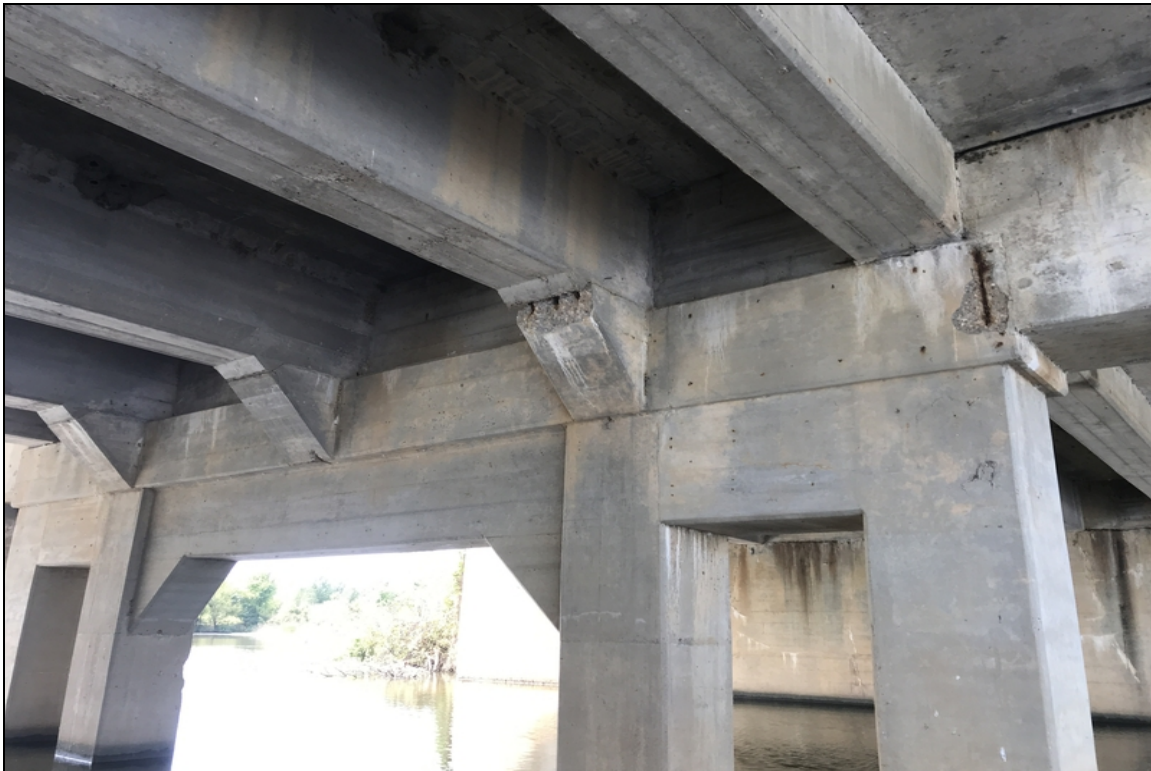
Bent #2 Span #2 girders # 1,2 & 3 spalling with exposed reinforcing steel.

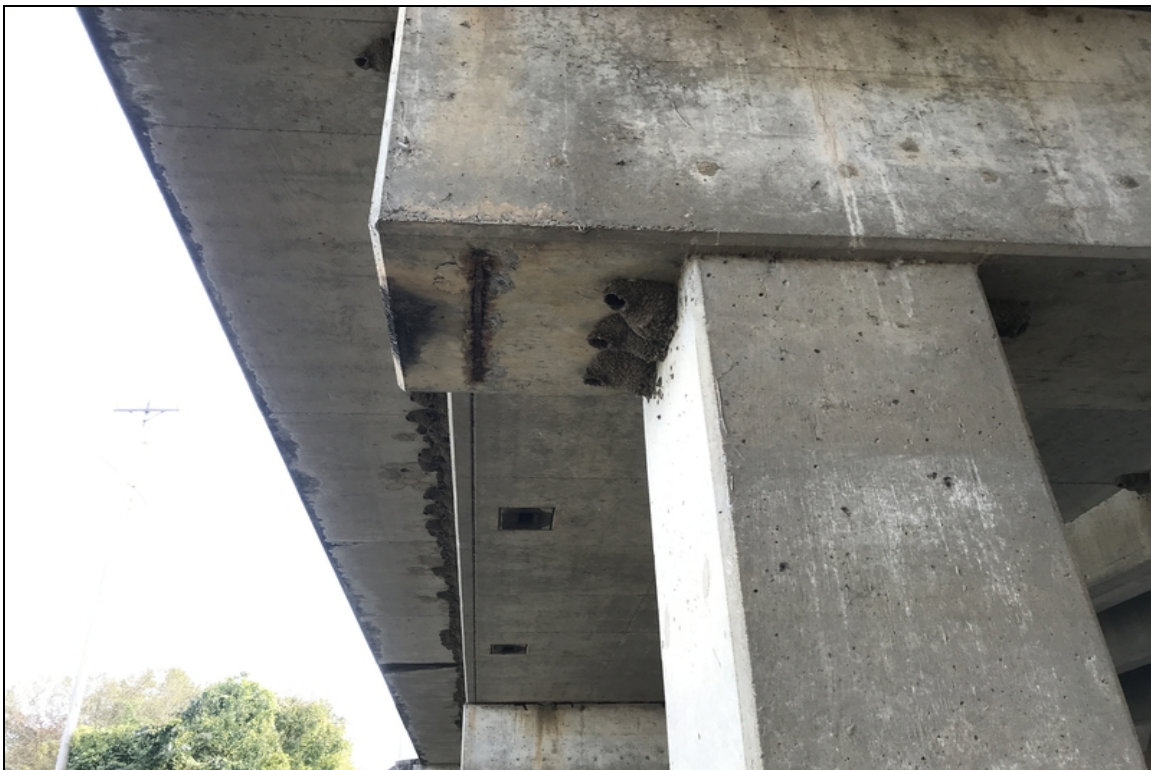
Bent #2 Lt shallow spalling with exposed reinforcing steel.

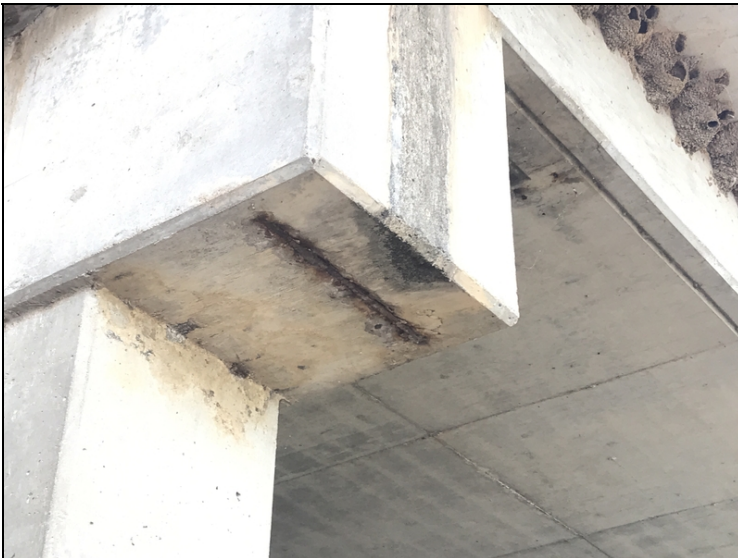
The substructure caps have spalling that exposes reinforcing steel in the cap haunches and other random areas of the caps. The ahead face of column #5 of bent #3 has large spalls with exposed reinforcing steel. The exposed reinforcing steel has an estimated 30% section loss.

Bent #2 cap, left side-Spalling with exposed reinforcing steel.

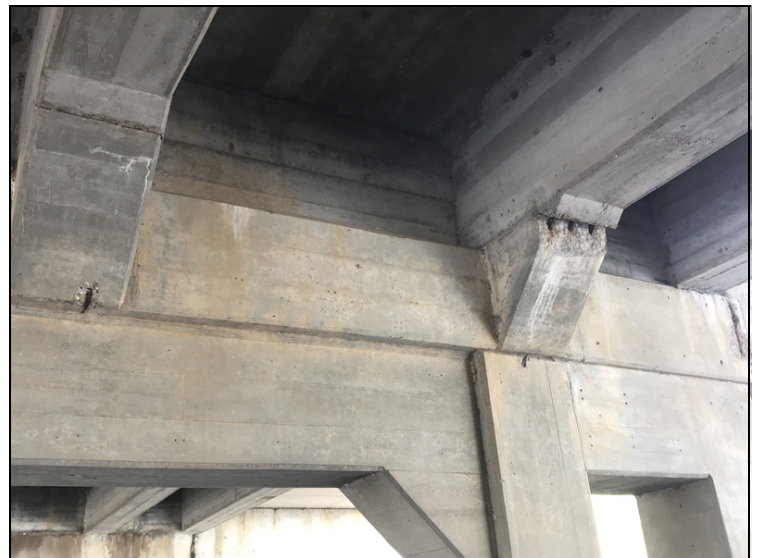
Bent #2 cap-Spalling with exposed reinforcing steel.

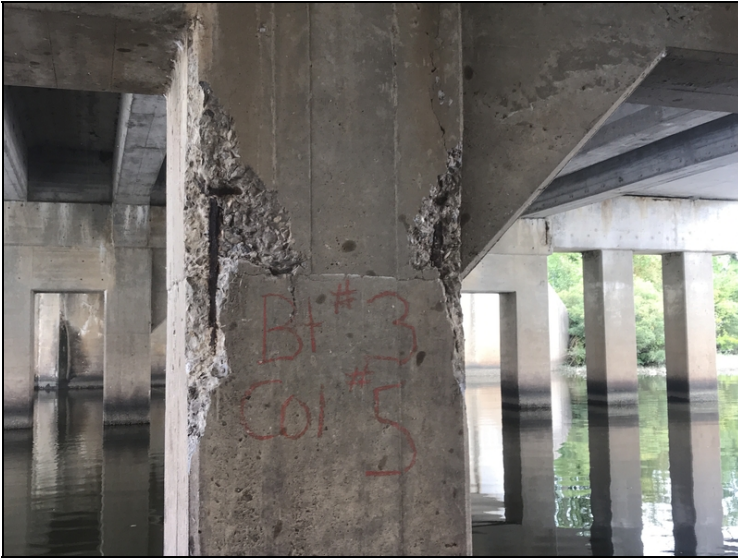
The ahead face of column #5 of bent #3 has large spalls with exposed reinforcing steel. The exposed reinforcing steel has an estimated 30% section loss.

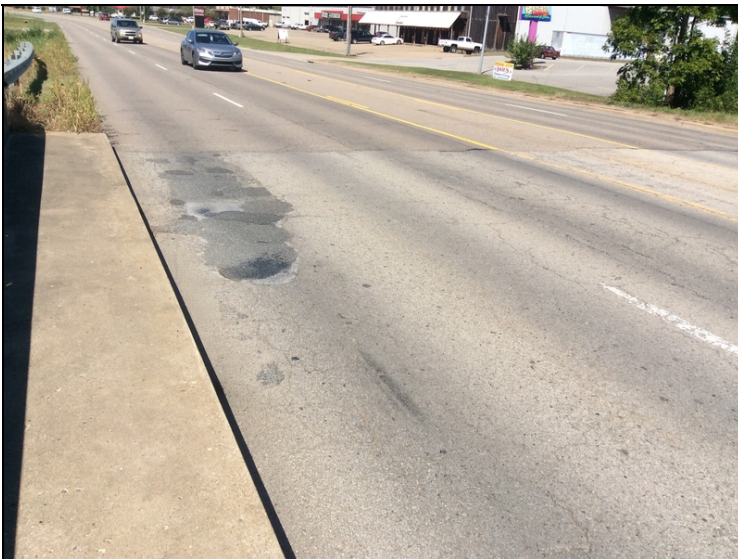
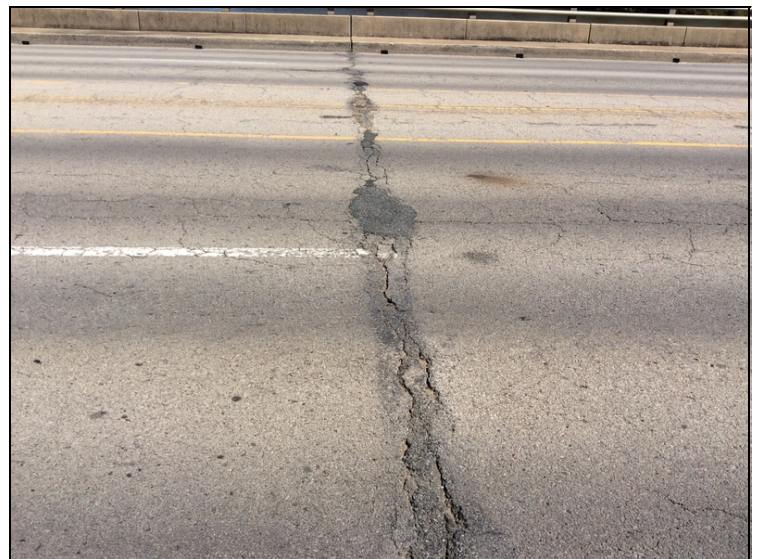
The asphalt on the driving surface of the deck has map cracking, minor rutting and is breaking up over the deck joints allowing potholes to form in the driving surface.

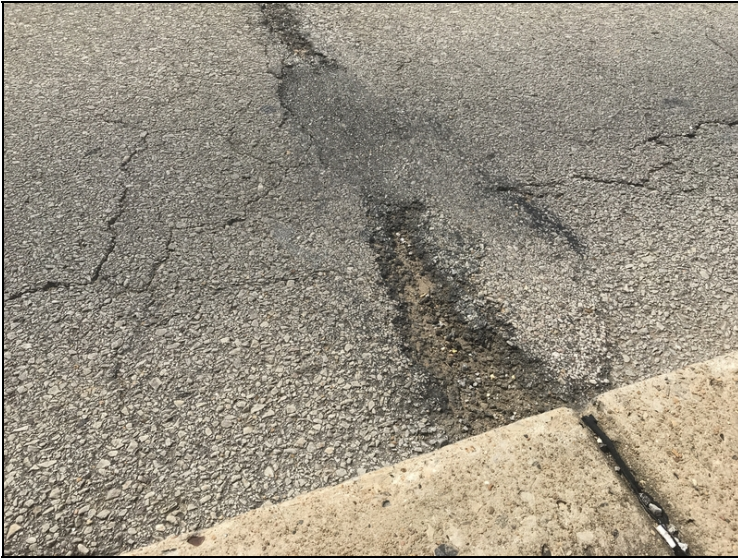
Asphalt breaking up over bent #3, left side.

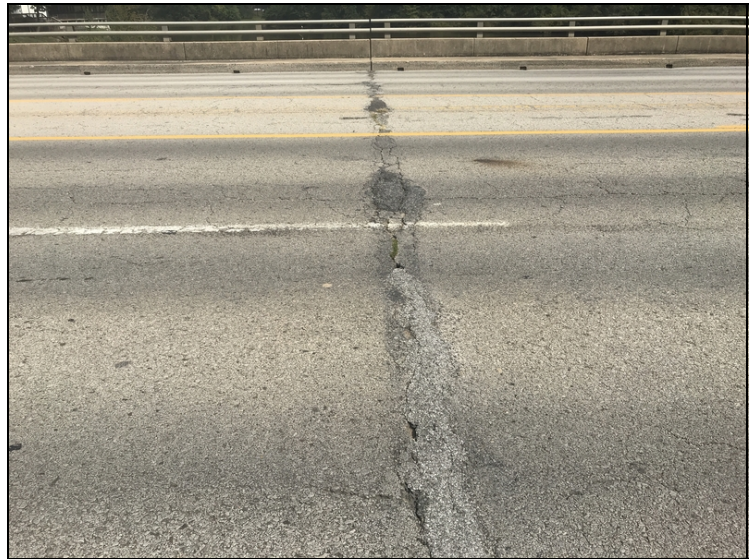
Asphalt breaking up over bent #3.

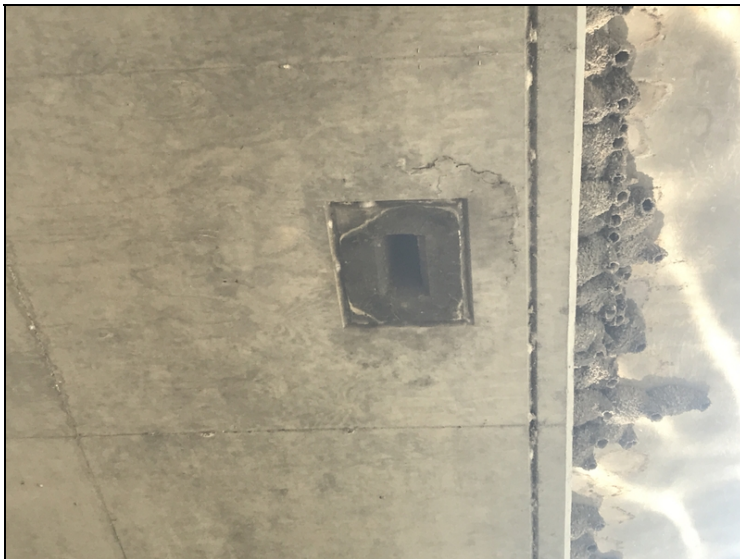
The undersurface of the deck has delaminated areas adjacent to the deck drains on the left and right sides of the structure. The undersurface has a baseball sized spall with exposed reinforcing steel on the right exterior side of span #1 and in bay #4 of span #3 adjacent to abutment #2.

Span #2, right side-Delaminated area at deck drain.

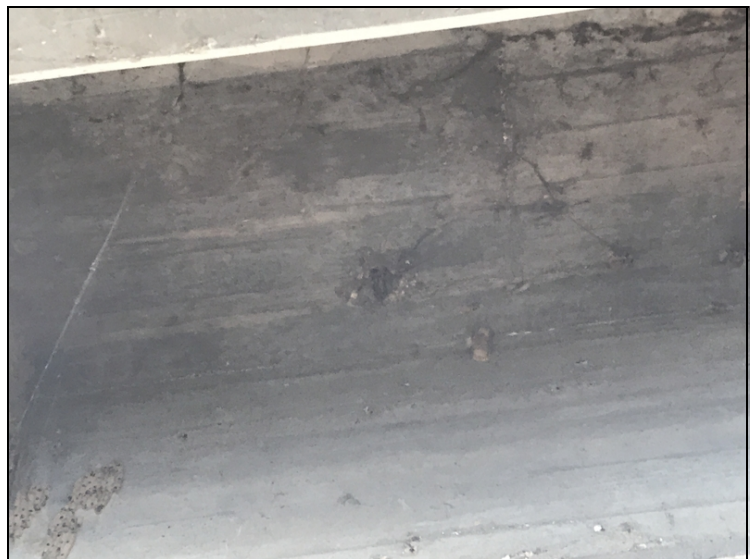
Span #3, bay #4-Spall with exposed reinforcing steel near abutment #2.

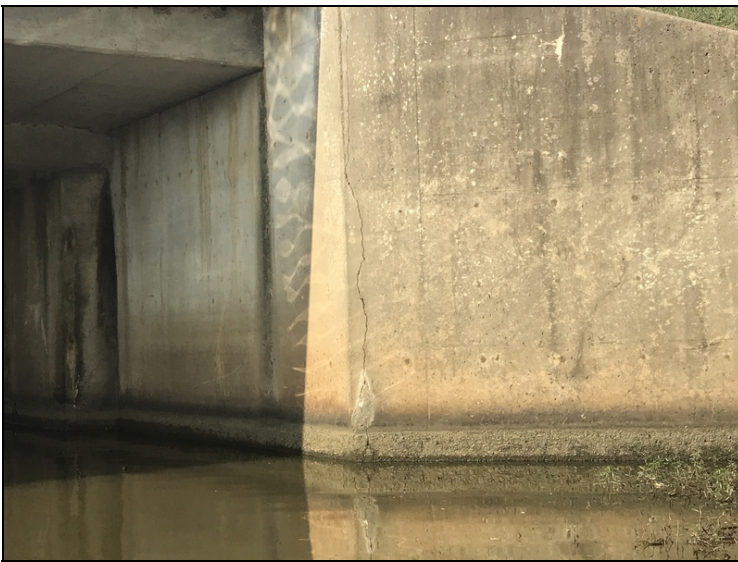
The Northwest wing wall has a wide vertical crack at the abutment interface and has rotated slightly toward the channel.

Northwest wing wall-Wide vertical cracking.

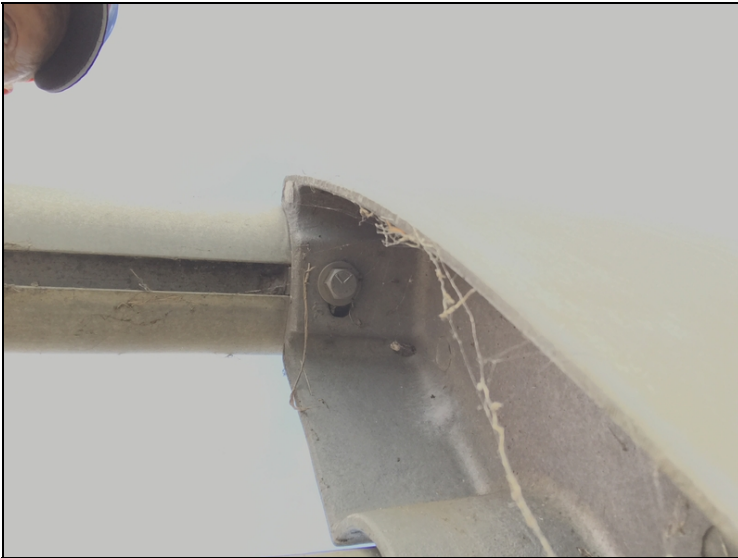
The metal portion of bridge railing on the right side of structure has loose connections at post # 1 and # 2 of span # 3 adjacent to bent # 3.

Span #3, right bridge railing at post #1-Loose connection.

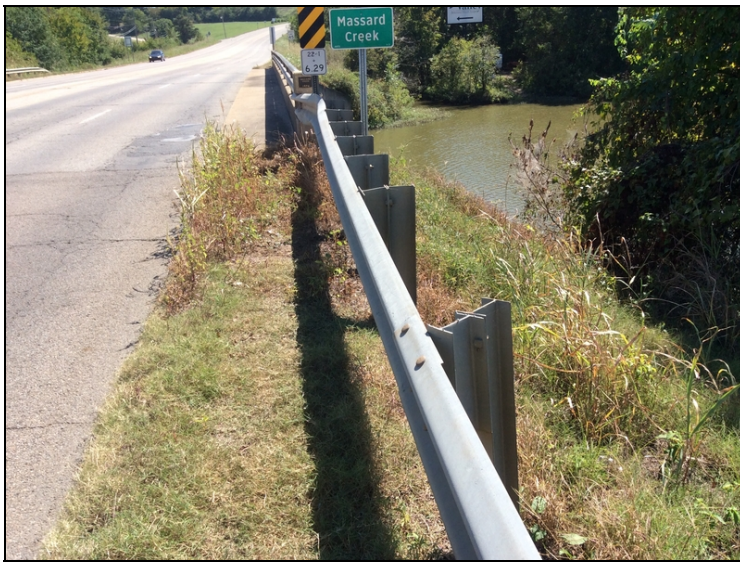
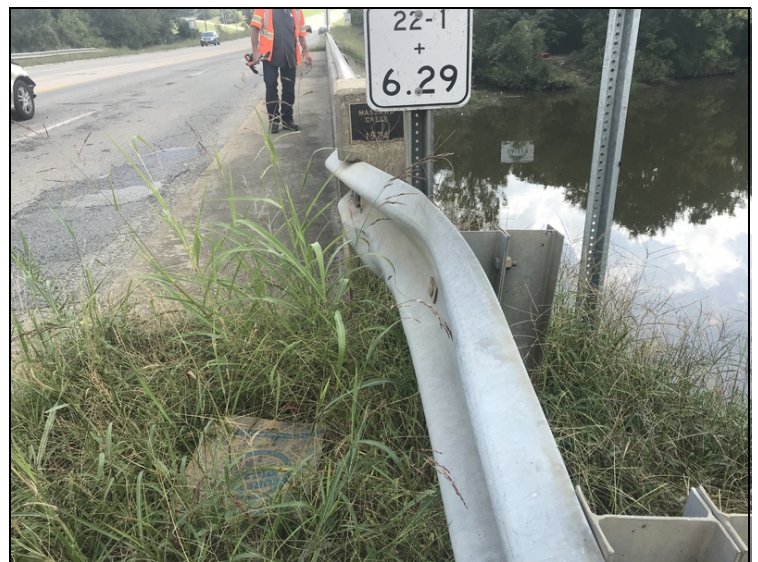
Approach Guardrail-
The approach guardrail at the Southwest bridge end has collision damage.

The Southwest approach railing has collision damage at the bridge end that has created a "Pocket" in the railing.
