Bridge #A0351 (Routine)

SH 22 Seb. Co. over Little Massard Creek

Location: 5.44 MI E JCT US 71

Team Lead: Eric West, Inspection Date: July 23, 2020

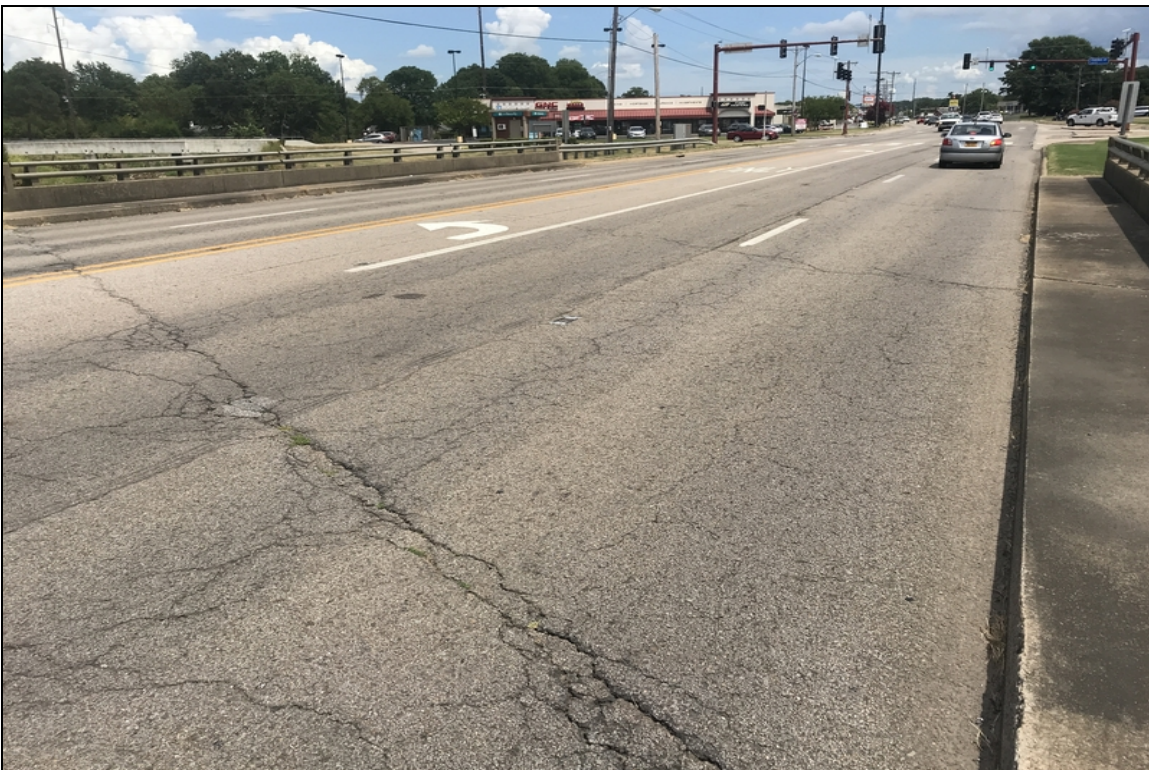
Typical driving surface of the slab.

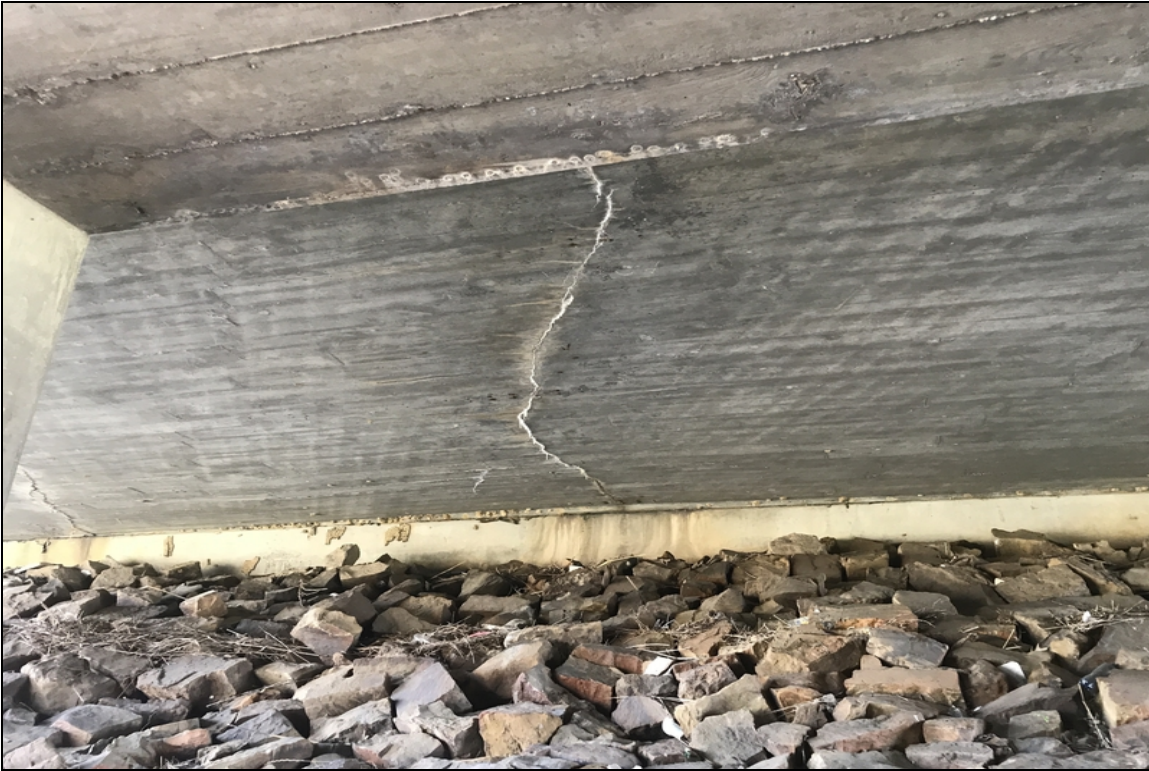
Typical undersurface of the deck.

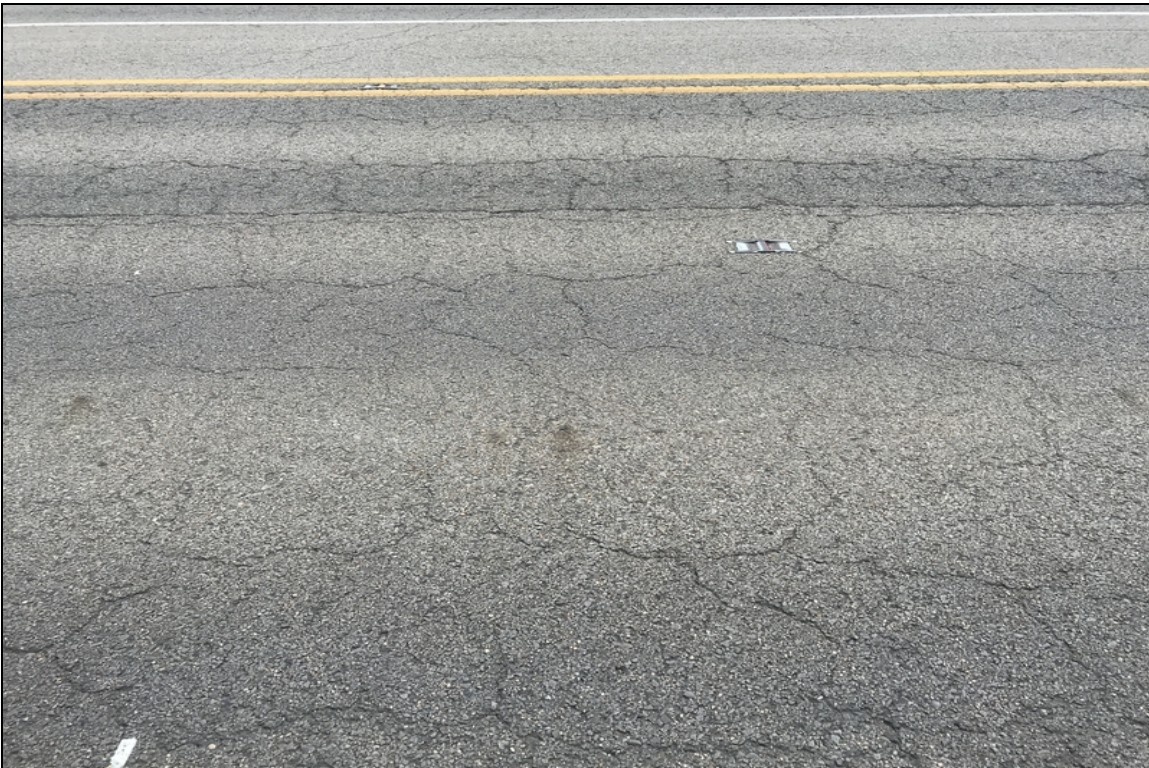
Typical cracking on the driving surface of the slab.

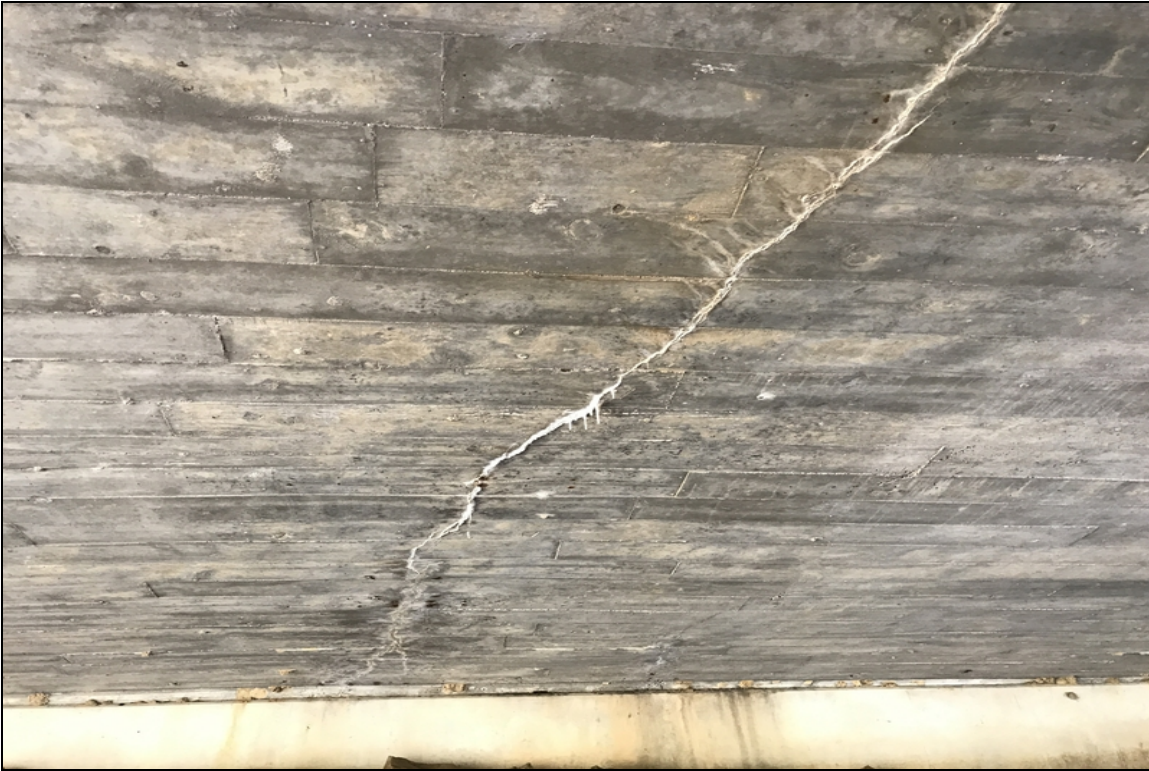
Span #1 concrete cracking with efflorescence buildup.

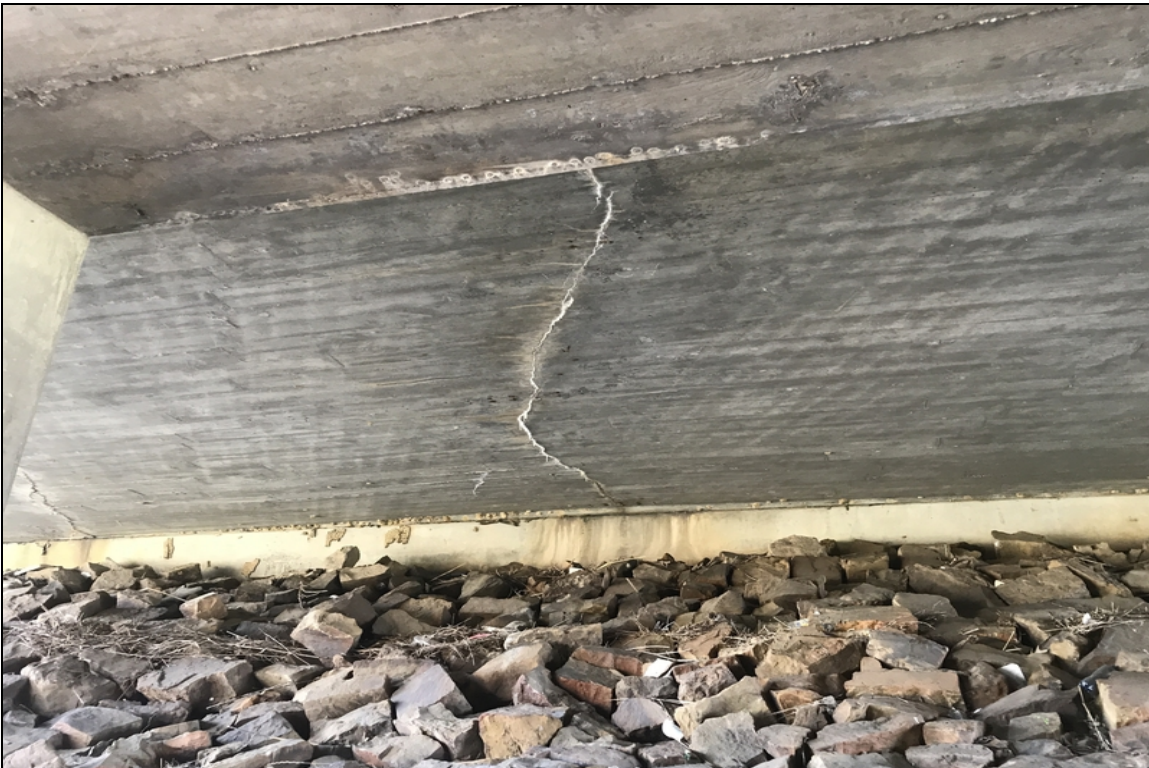
Span # 3 cracking with efflorescence buildup.

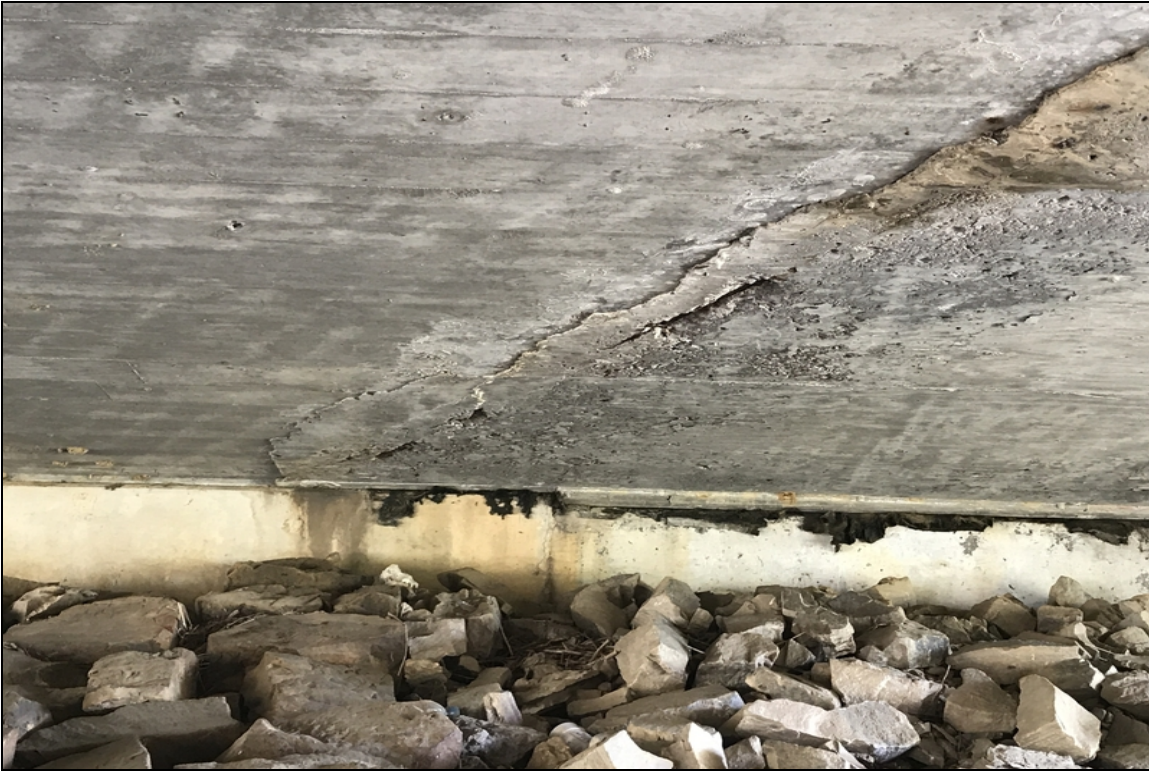
Span #3 Rt spalling with exposed reinforcing steel on the undersurface of the slab.

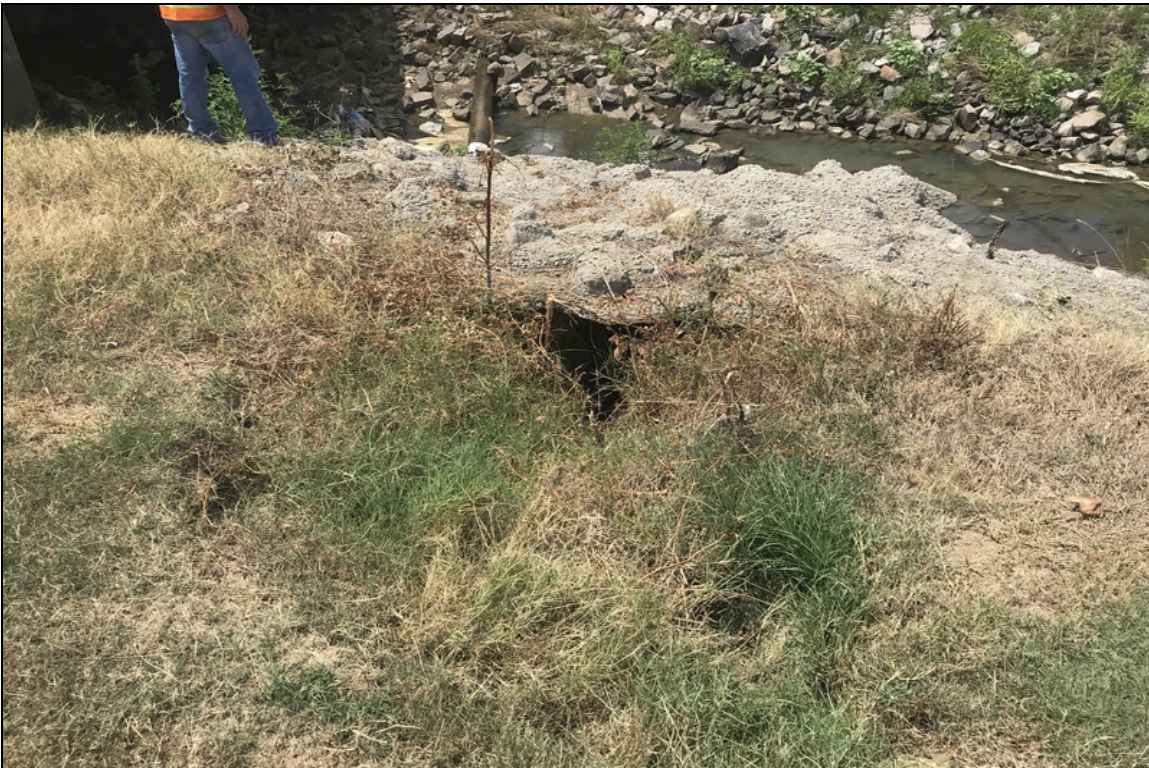
Northeast embankment with erosion under the grouted rip rap.

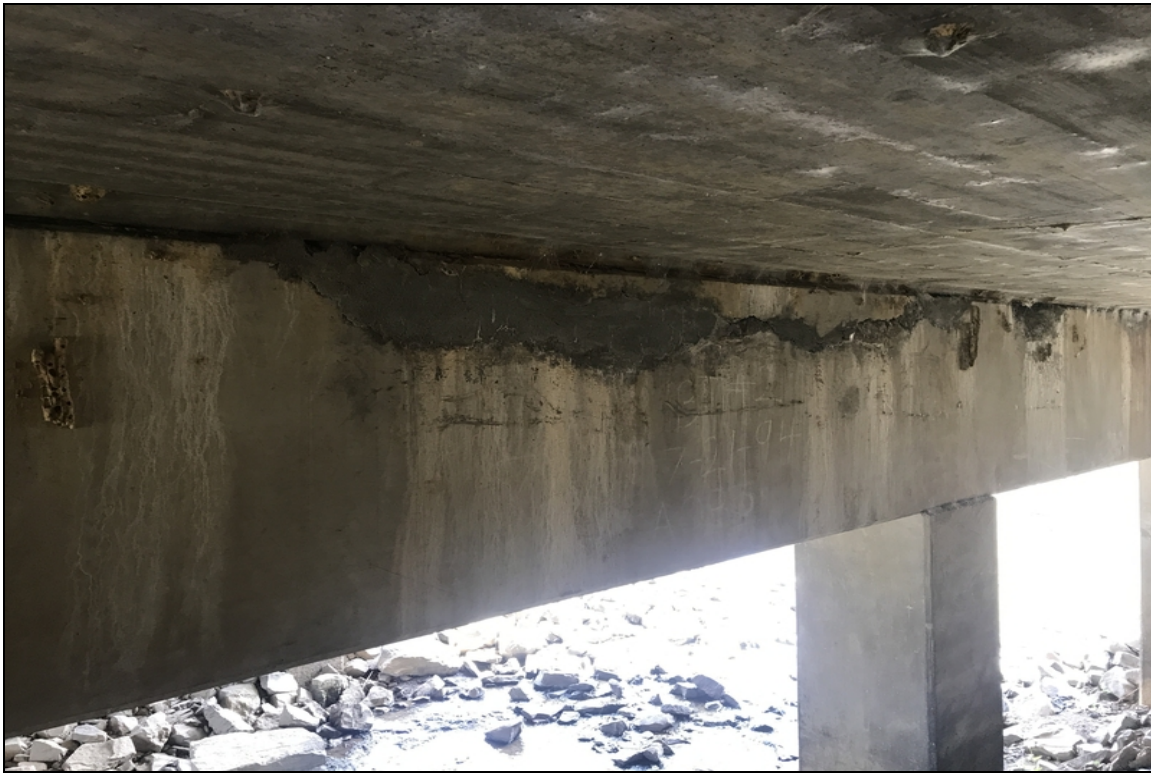
Bent #2 concrete delamination's and spalling over column #3.

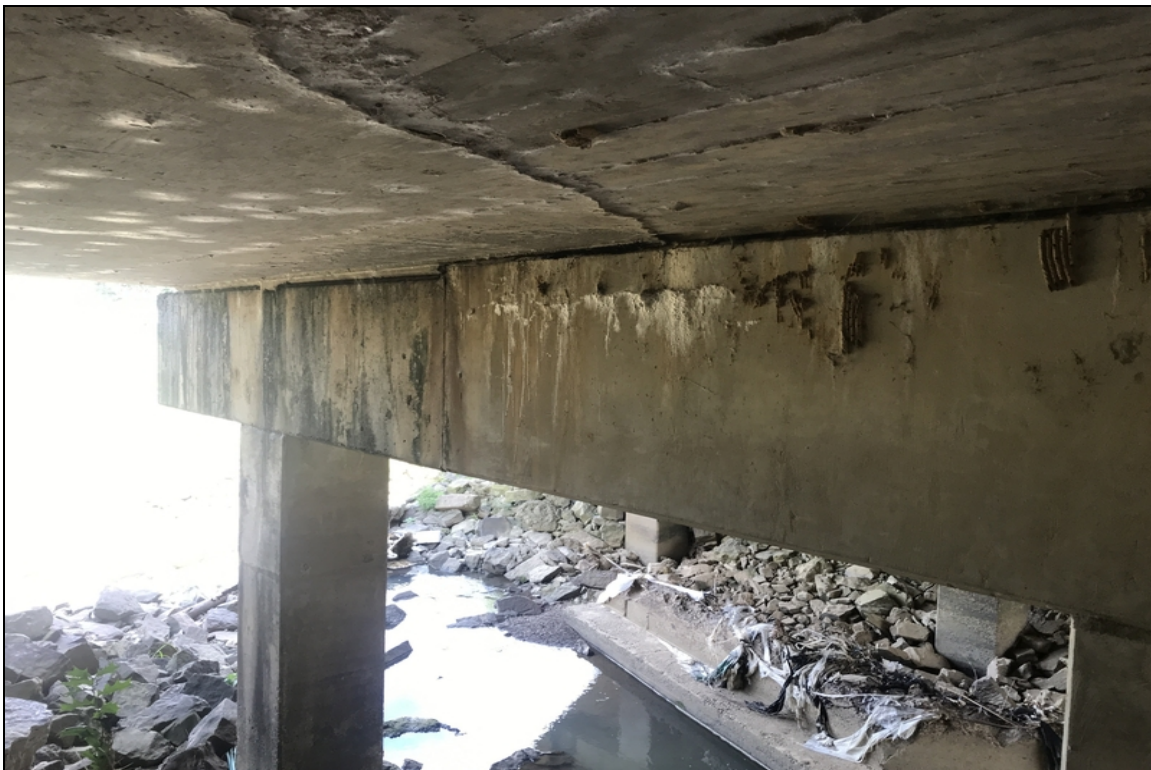
Bent #2 Lt concrete cracking with efflorescence buildup.

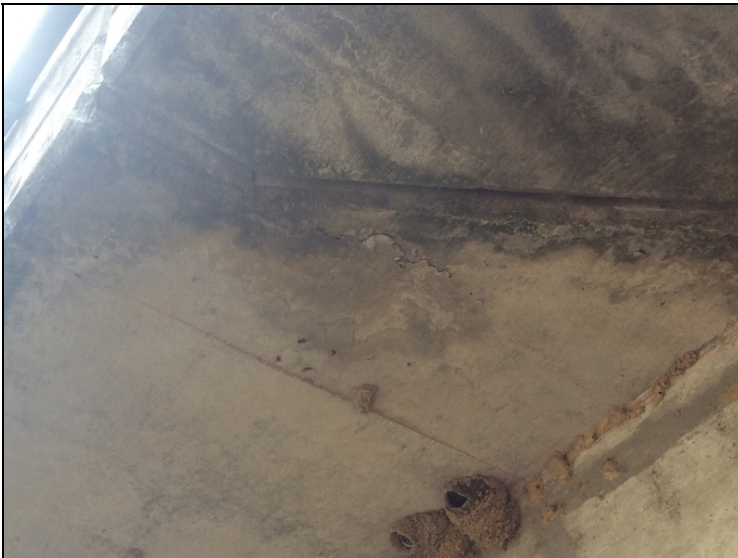
Superstructure -
The undersurface of the deck / superstructure in Spans 2 and 3 have spalls with exposed reinforcing steel.

The undersurface of the right pedestrian sidewalk has a 24" delaminated area with spalling that exposes reinforcing steel over bent #3.

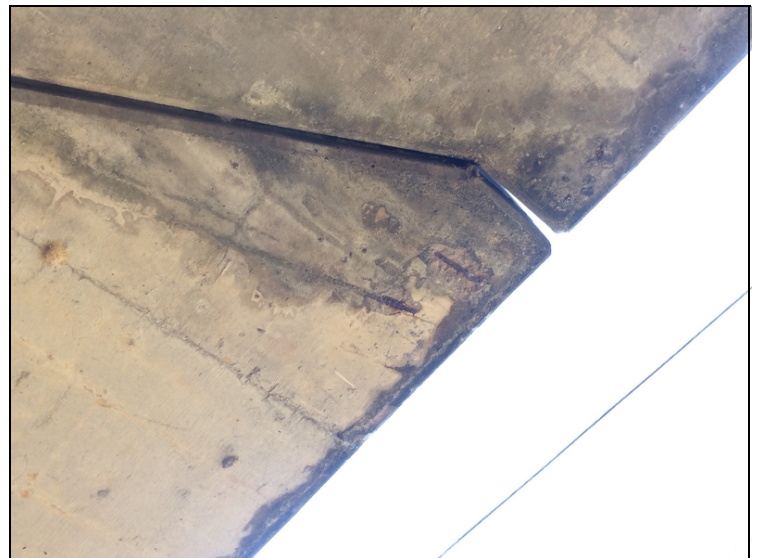
Span #2, left pedestrian sidewalk-Exposed reinforcing steel in undersurface.

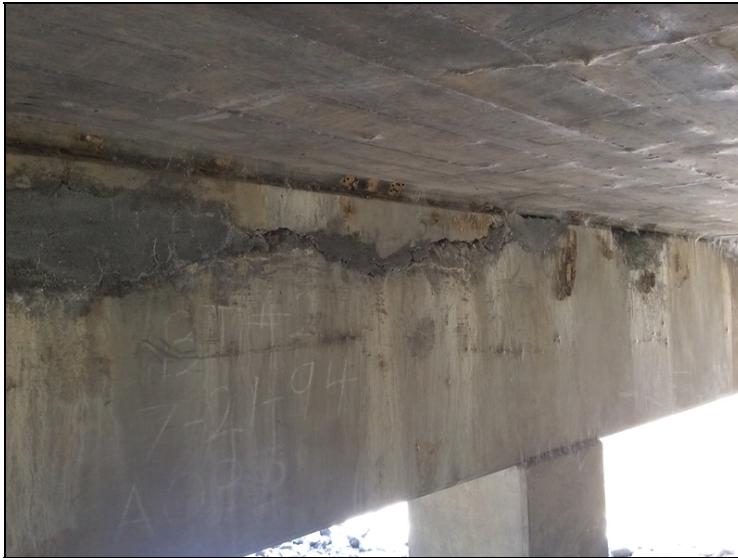
The span #1 side of bent #2 has a 10' long delaminated area with a large spalled area in the upper portion of cap in bay #2.

Bent #2 cap-Spalling / delaminated area in back face.

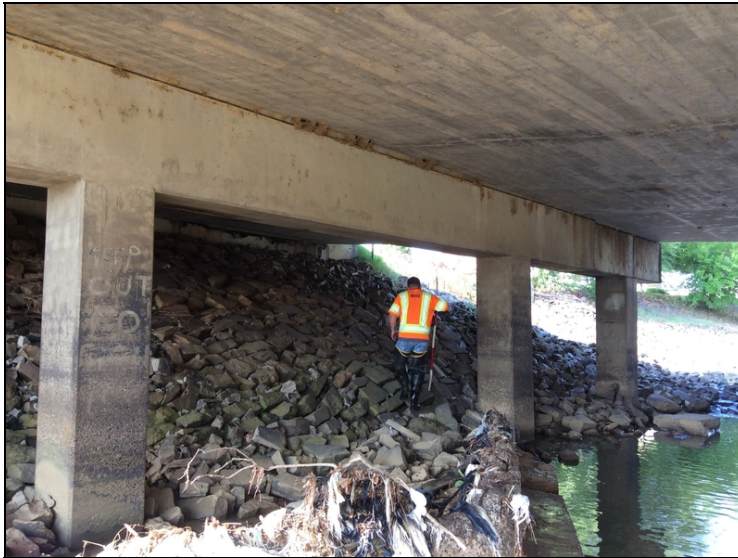
Bent 3. Typical

Stains and scale visible from the undersurface of the structure indicates that the deck joint sealant over the intermediate bents leak.

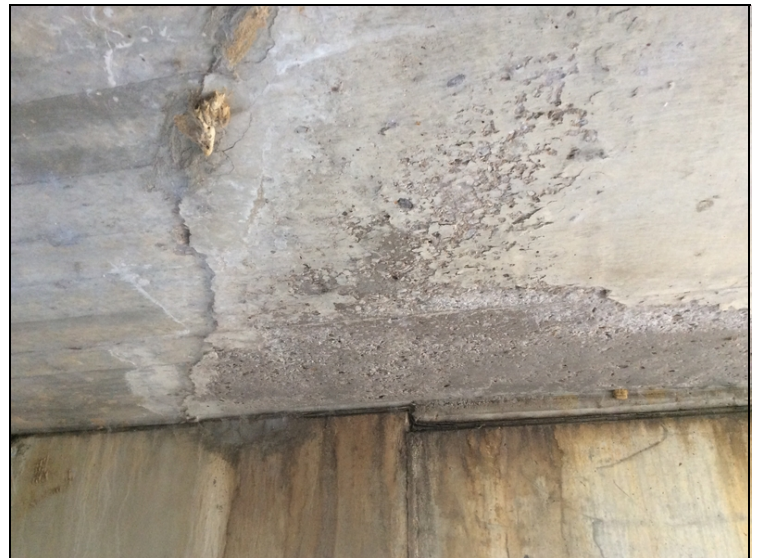
Span #1 undersurface-Scaling adjacent to bent #2.

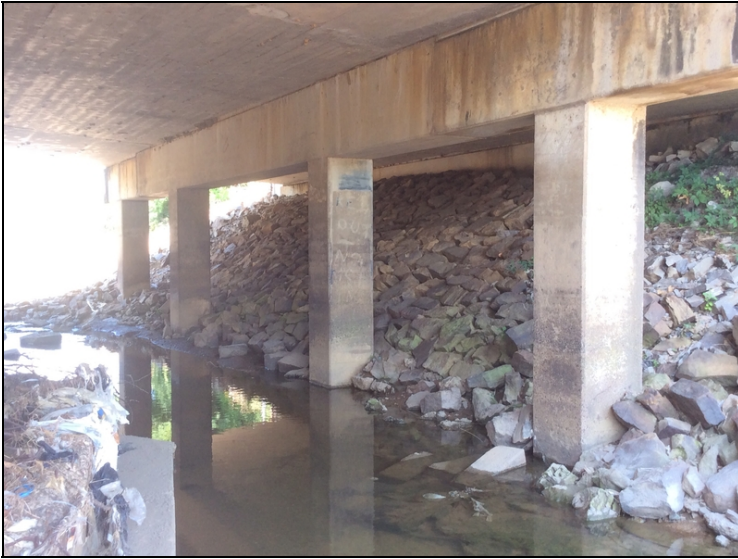
Staining due to leaking deck joints.
