# Bridge Inspection Report

**A6458**

**US 412 Sec 2, WB L**

**Wildcat Creek-Washington**

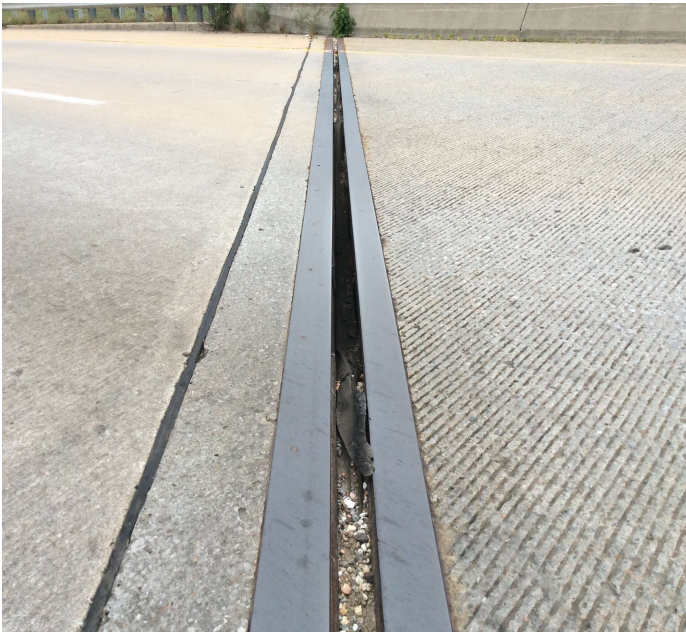
Poured Silicone Joint Seals

The poured silicone joint seals have failed at the east and west abutments. They leak water and dirt on the abutments.

PHOTO 1      Description      Compression joint seals have failed at the East and West abutments. They leak water and dirt on the abutments.

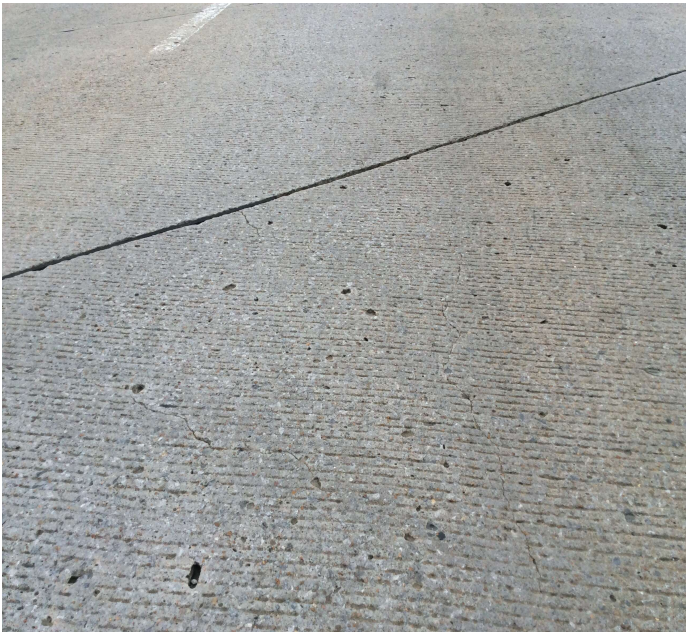
Deck

Deck has sealable cracking.

PHOTO 1      Description      Deck has sealable cracking.

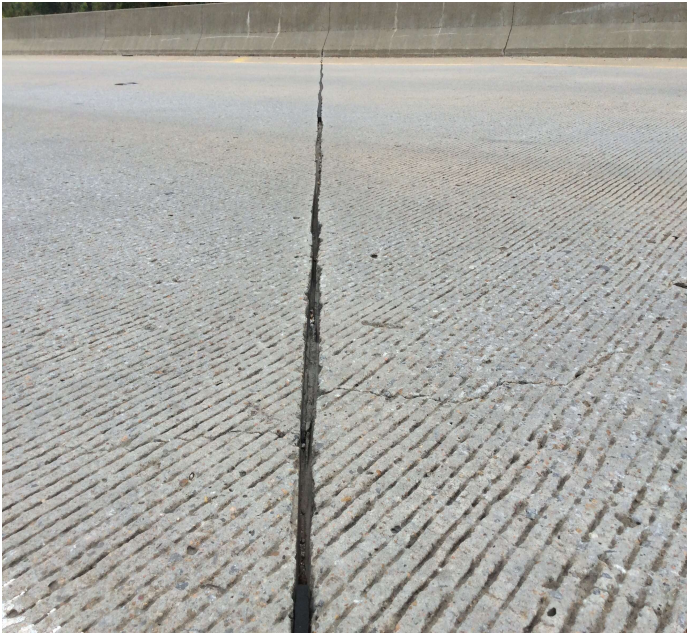
Deck Joints

The deck saw joints are deteriorating and leak water that appears to be causing active corrosion in the metal stay in place forms.

PHOTO 1      Description      The deck saw joints are deteriorating and leak water that appears to be causing active corrosion in the metal stay in place forms.
