Bridge Inspection Report

B6458
US 412 Sec 2, EB L
over
Wildcat Creek-Washington

Structure Number: B6458

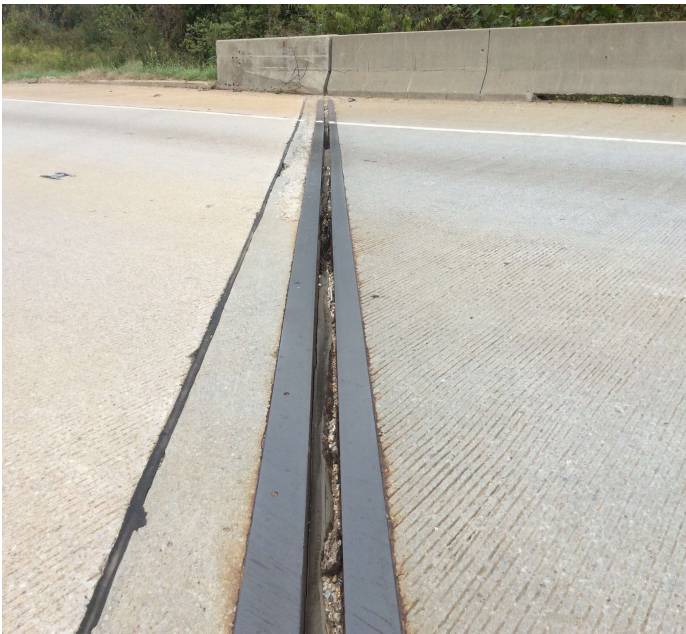
| | Environment | Total Quantity | Units | Condition State 1 | Condition State 2 | Condition State 3 | Condition State 4 |
|---|--|---|---|---|---|---|---|
| | The joint seals have failed and leak water and debris on the caps. No apparent repairs since the last inspection. The joint anchorage appears solid at this inspection. | | | | | | |

Poured Silicone Joint Seals

The poured silicone joint seals have failed at the east and west abutments. The leak water and dirt on the abutments.

PHOTO 1 Description Compression joint seals at the abutments and the poured joint material at the intermediate expansion joints have deteriorated and are failing.

Work Code: Repair

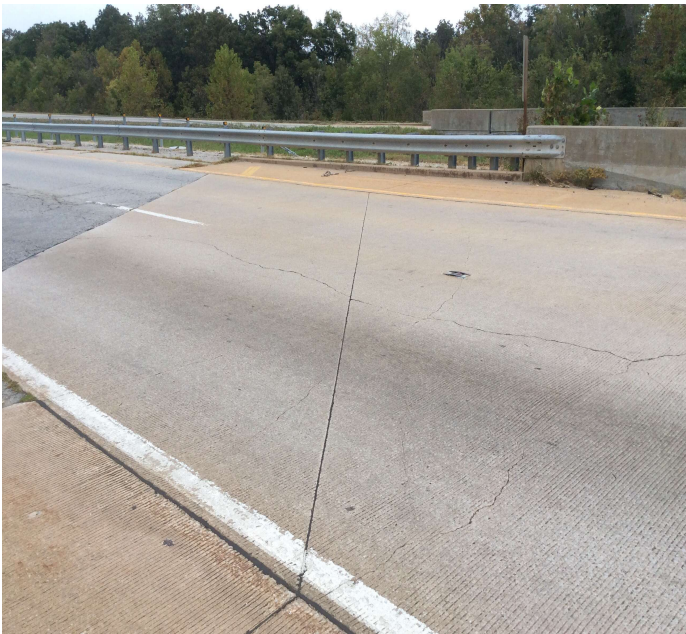
| Sealable cracking at both slabs. | | | | | | | |

PHOTO 1 Description Sealable cracking at both slabs.

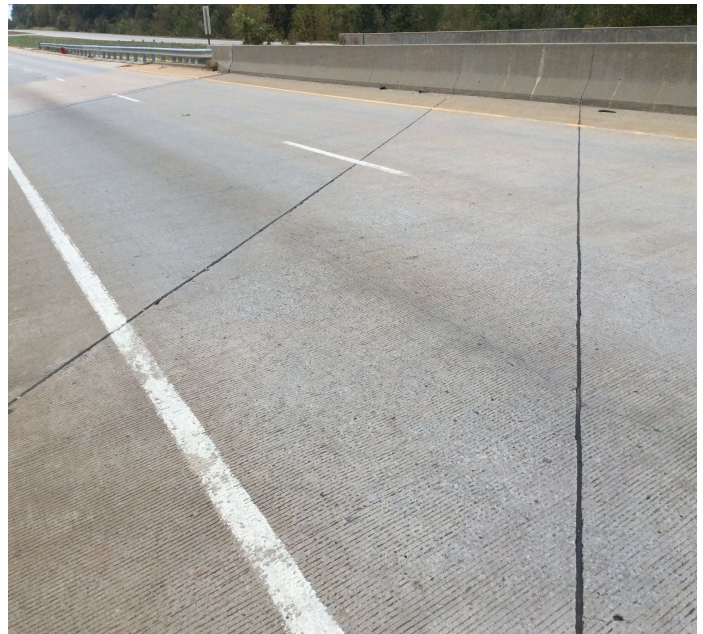
Deck has sealable cracking in all spans.

PHOTO 2 Description Deck has sealable cracking in all spans.

Work Code: Repair

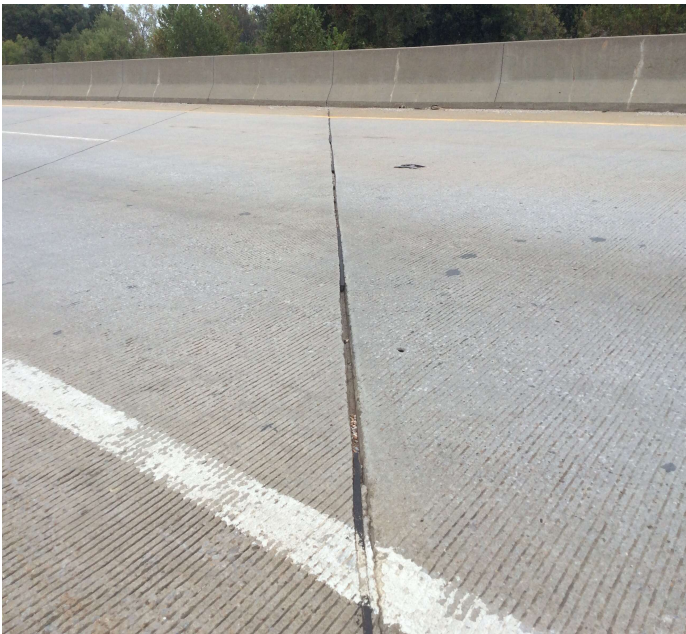
Poured Sawn Joint Sealant

The poured saw joint sealant is deteriorated and missing in locations.

PHOTO 1 Description The poured saw joint seals are deteriorated and missing in locations.

Work Code: Replace
