Asset #02240(Routine)

US 71 - Seb. Co. over Prairie Creek

Location: 0.1 M N OF SH 252

Team Lead: Jeff Jones, Inspection Date: 08/17/2023

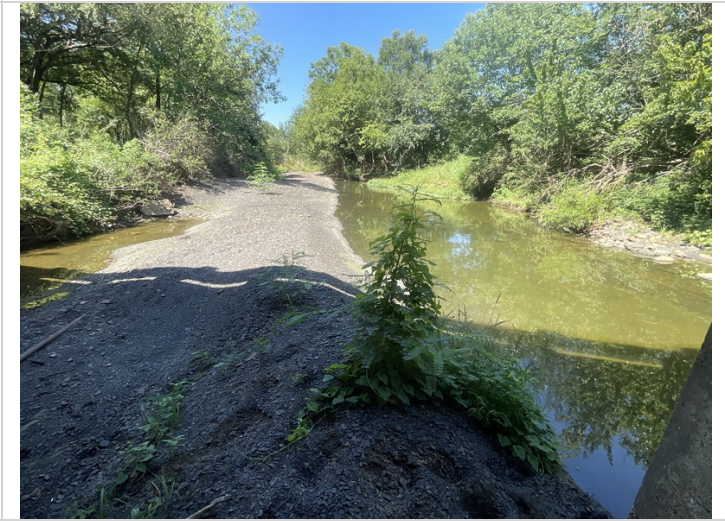
Channel. Typical.

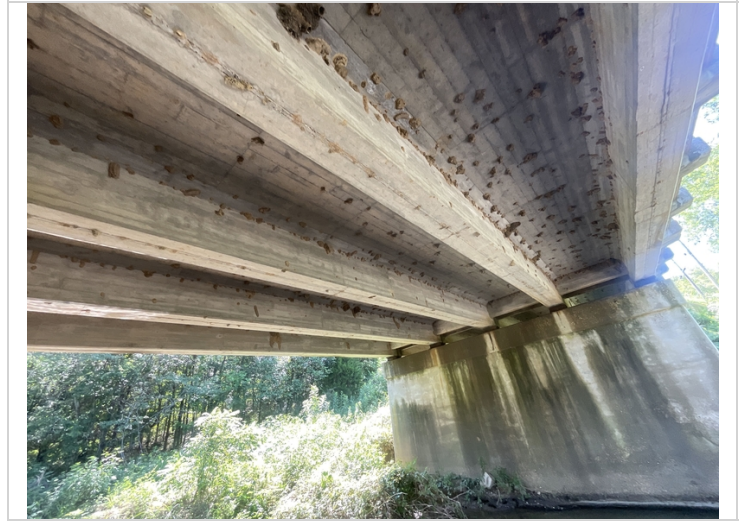
Span # 2 superstructure. Typical.

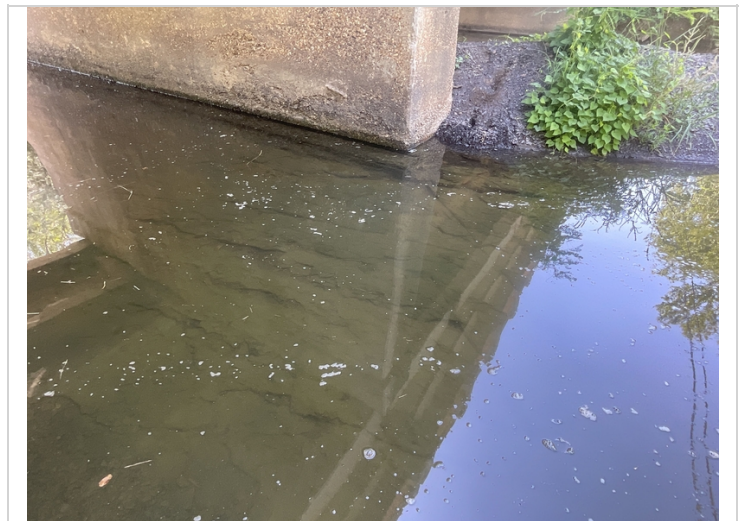
Bent # 3 footing exposed. Solid shale channel.

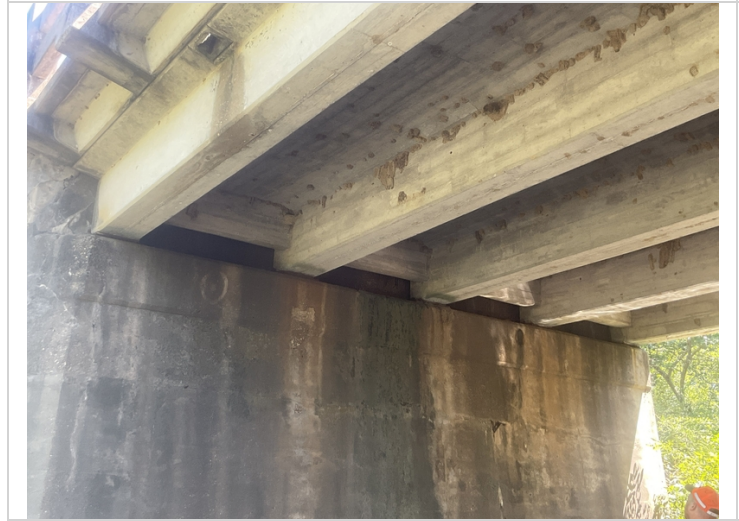
Span # 3 beam ends over Abutment # 2.

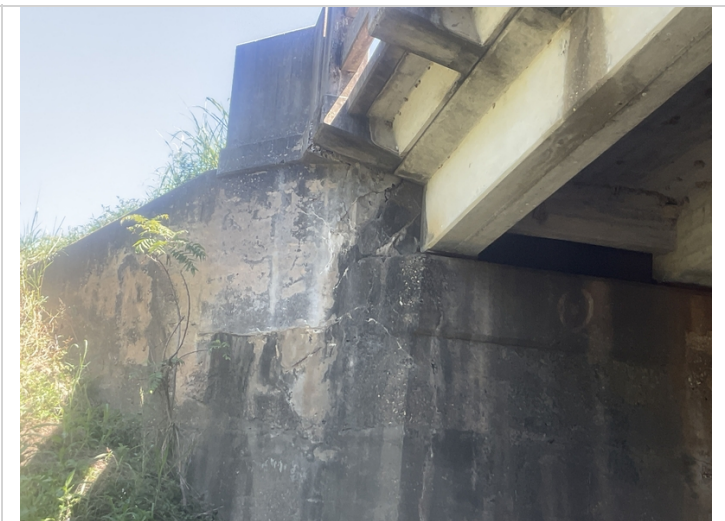
Abutment # 2 - There are delaminated areas and map cracking in the exterior edges of the back walls adjacent to the wing wall connection.

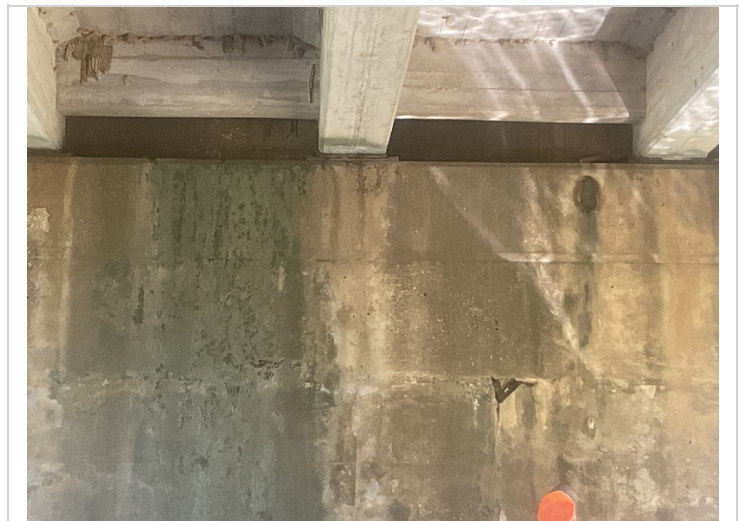
Abutment # 2 cap. Centerline. Spall with exposed reinforcing steel.

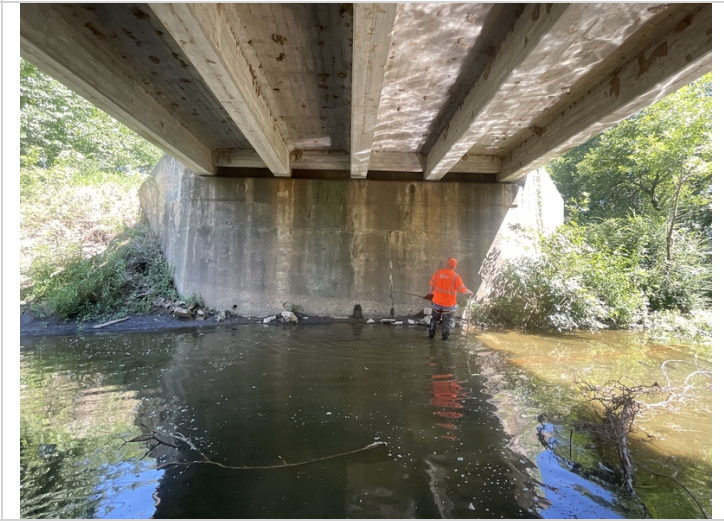
Abutment # 2. Typical.

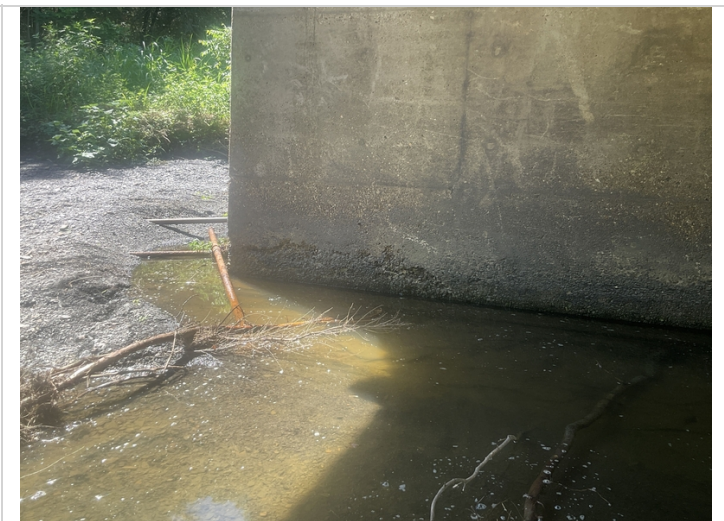
Concrete deterioration at the base of Bent # 3. Ahead face.

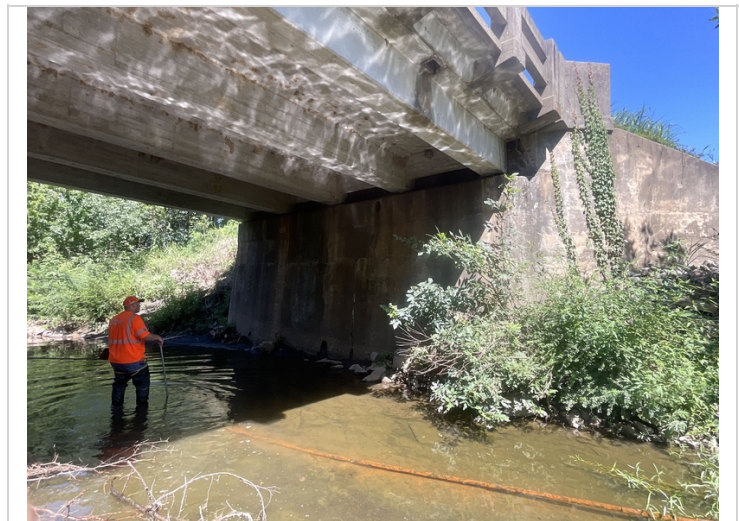
Abutment # 2. Typical.

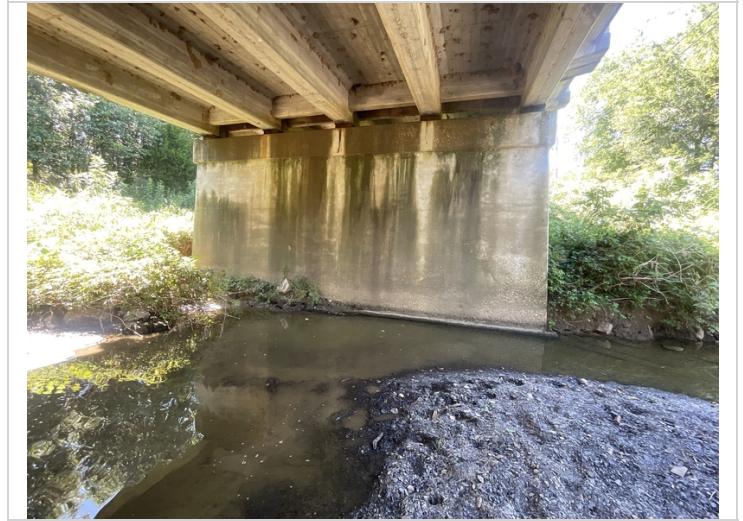
Bent # 2 ahead face. Typical.

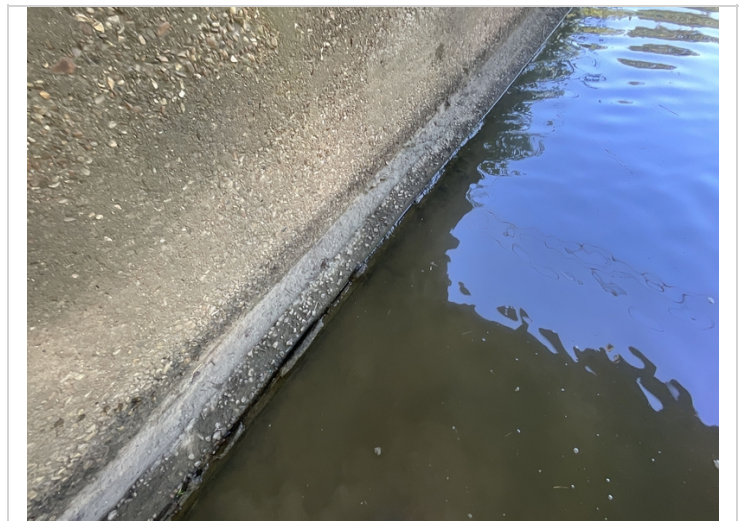
Bent # 2 footing is exposed on the ahead face of the bent.

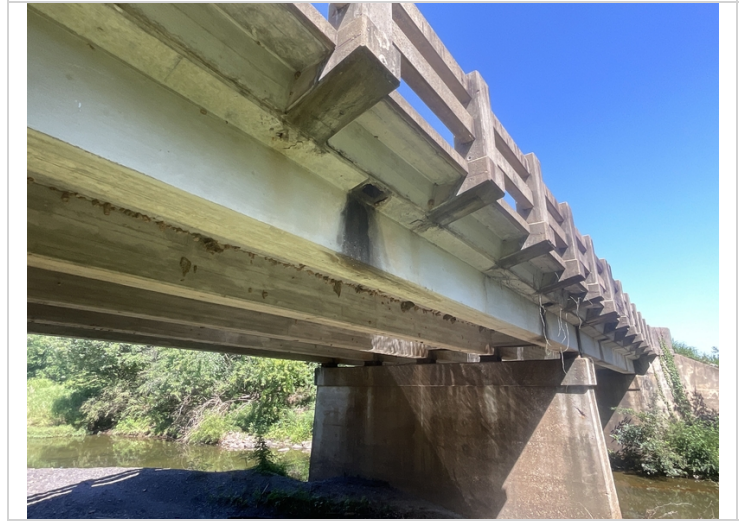
Right overhang of Span # 2.

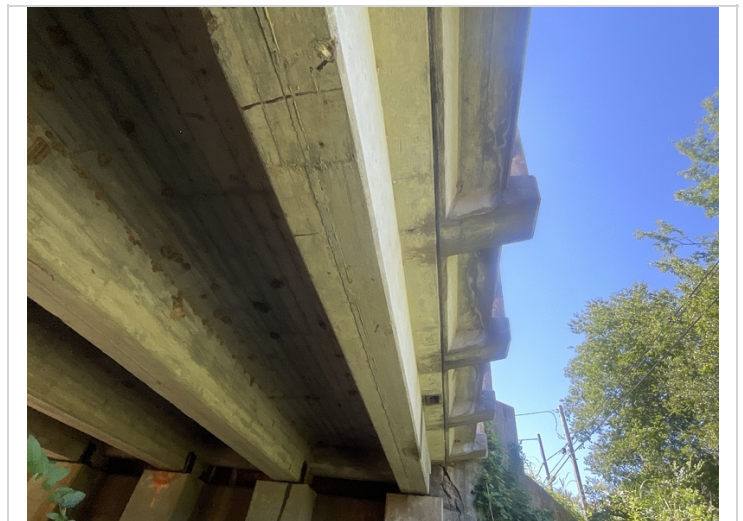
Left overhang of Span # 1 deck soffit.

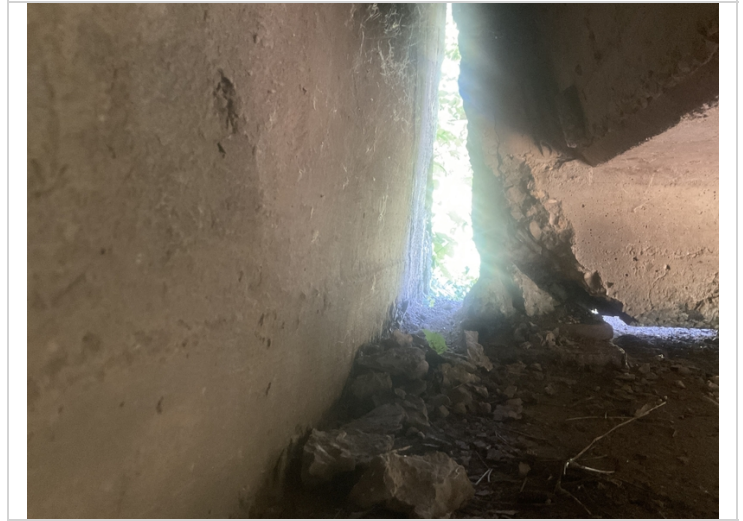
(110) 08/17/2023 - JCJ & TJL - -The ends of the concrete deck girders in Span # 1 at Abutment # 1 are rubblized with exposed reinforcing steel over the bearings. There is additional deterioration since the last inspection. -The ends of the girders over Abutment # 1 are in the process of shearing off the fixed bearings due to lateral movement of the superstructure towards Bent # 2. -No significant movement was detected in the Substructure since the last inspection. -Actual field verified measurements were taken from a documented painted location at Abutment # 1, Beam # 3 and Bent # 2 pier cap. -Span # 2 Beam # 5 has a 6" shallow spall adjacent to the deck drain near Bent # 3 with exposed reinforcing steel. Exposed reinforcing steel has active corrosion with initial section loss. -There are no apparent changes in Span # 1 measurements since the last inspection. History Notes: 08/17/2022 - JCJ & TJL - Special Recurring Inspection - Special Recurring Inspection was conducted this date to monitor Span # 1 Superstructure and Substructure for any additional excessive movement. Actual field measurement indicates that there are no apparent noteworthy changes since the last inspection. Field measurements are consistent with previous measurements taken over the past 10 years. There have been no apparent repairs to Span # 1 girders or Bent 1 backwall since the 08/30/2016 inspection. -Maintenance Forces have removed the PCCP adjacent to the South abutment in the past relieving the pressure against the South abutment backwall. -See Documentation of measurements associated with this inspection for additional information.

Girder # 1 at Abutment # 1. Spalling with exposed reinforcing steel.

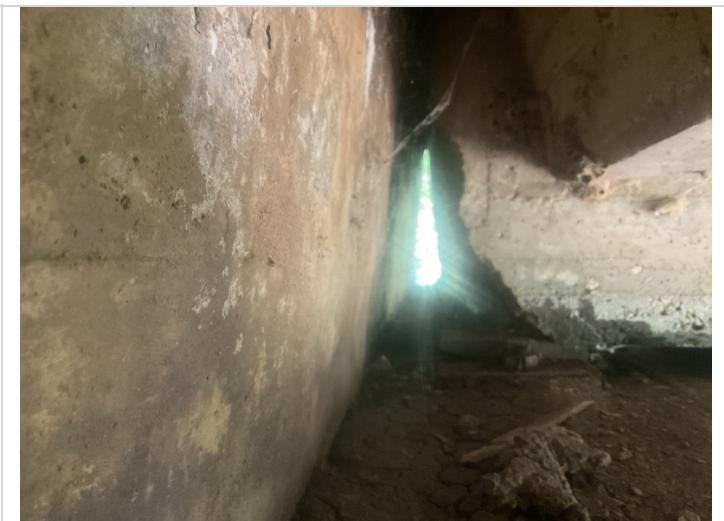
Girder # 2 at Abutment # 1. Spalling with exposed reinforcing steel.

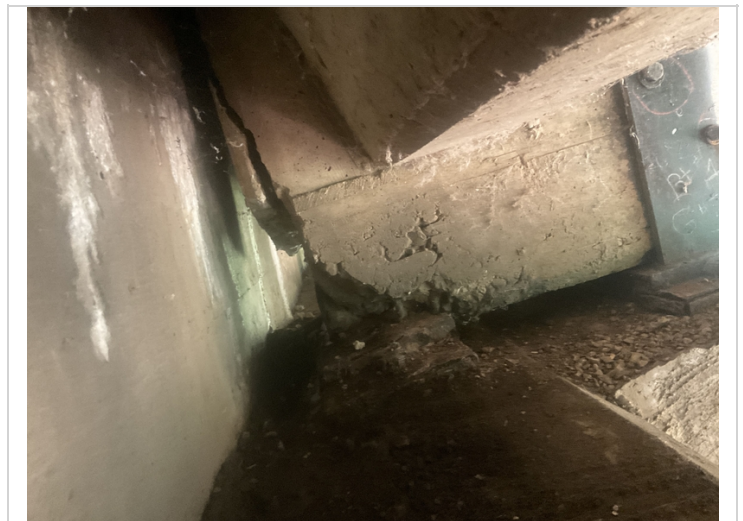
Girder # 3 at Abutment # 1. Spalling with exposed reinforcing steel.

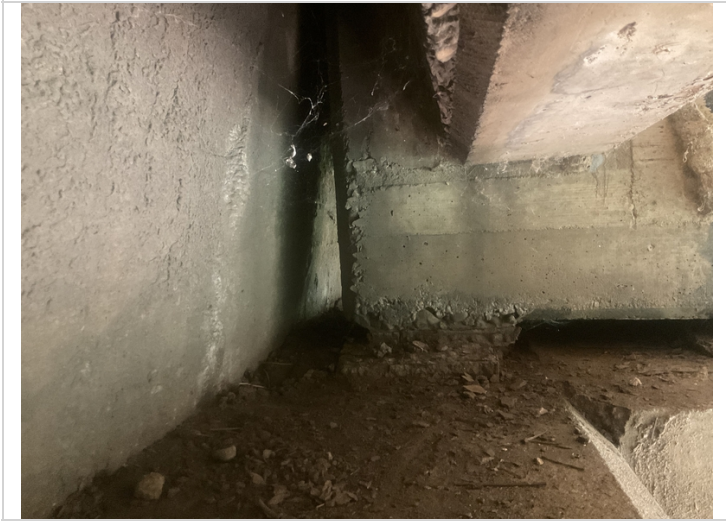
Girder # 4 at Abutment # 1. No apparent problems during this inspection.

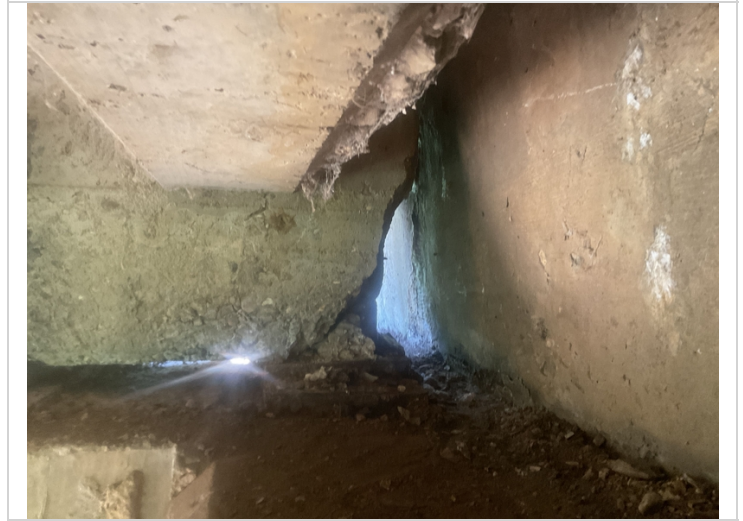
Girder # 5 at Abutment # 1. Spalling with exposed reinforcing steel.

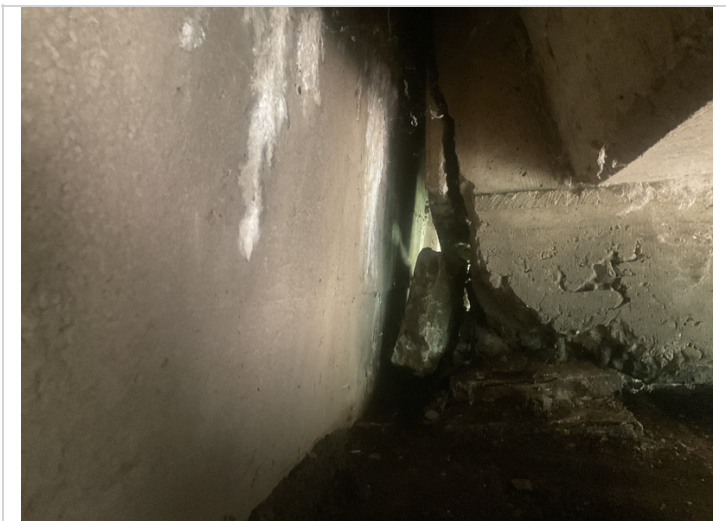
Girder # 3 at Abutment # 1. Spalling with exposed reinforcing steel.

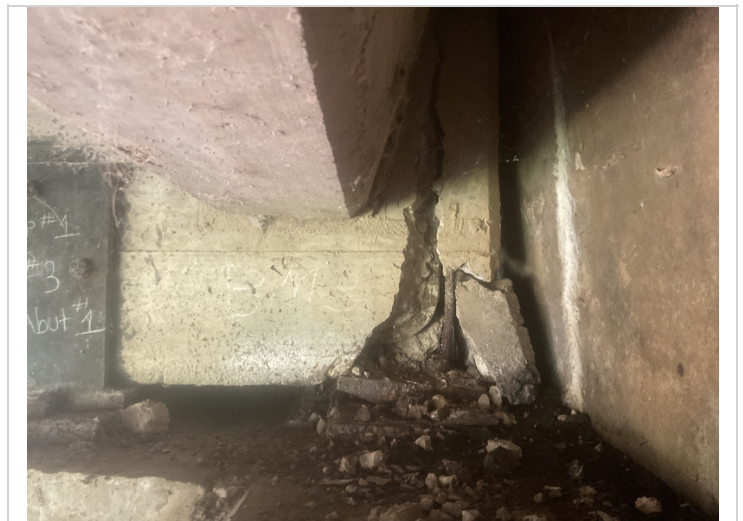
Girder # 3 at Abutment # 1. Spalling with exposed reinforcing steel.

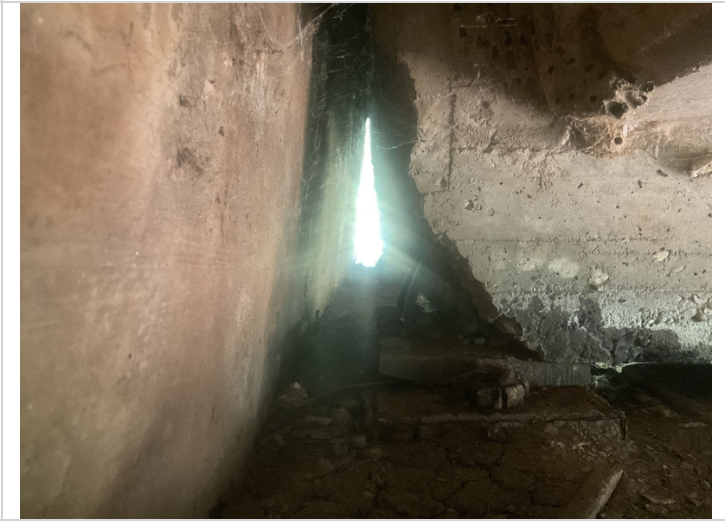
Girder # 2 at Abutment # 1. Spalling with exposed reinforcing steel.

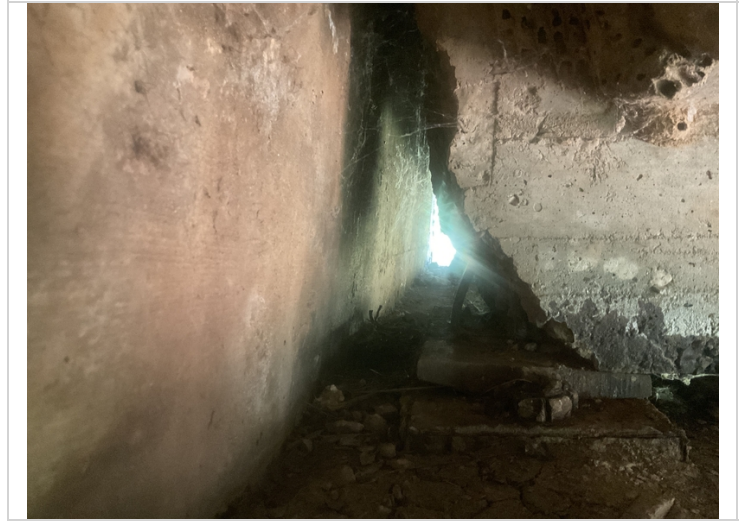
Fixed bearing at Abutment # 1. Girder # 2.

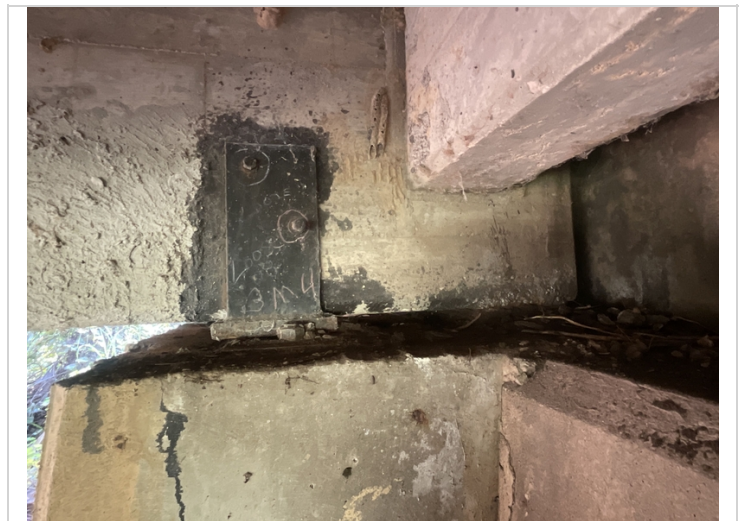
Fixed bearing at Abutment # 1. Girder # 4.

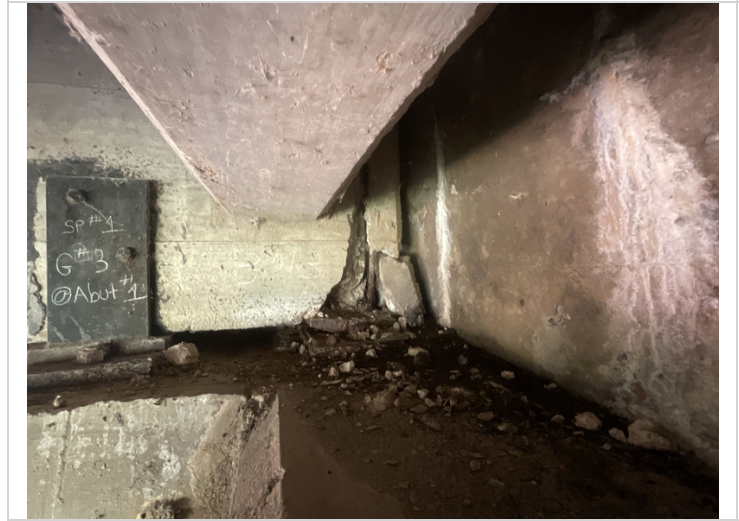
Girder # 3 at Abutment # 1. Spalling with exposed reinforcing steel.

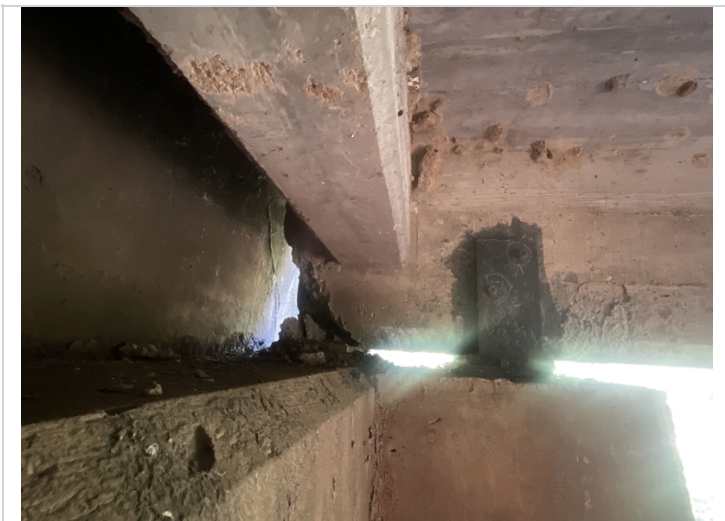
Girder # 1 at Abutment # 1. Spalling with exposed reinforcing steel.

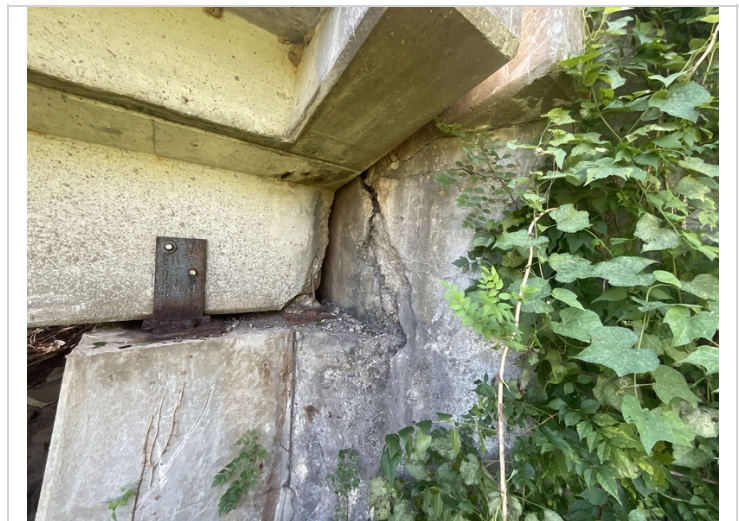
(215) 08/17/2023 - JCJ & TJL - Routine Inspection: -The additional shoring placed by maintenance forces in the past is functioning as intended. The top of the backwalls at both abutments are fractured and leaning towards the channel. The South abutment backwall has exposed reinforcing steel and is jammed-up tight against the deck. The ends of Span # 1 "Tee" beams are rubblized with exposed reinforcing steel. The backwall has several vertical cracks with efflorescence. No apparent repairs since last inspection. See documentation in media and history files for additional information. -Abutment # 2 has vertical and horizontal cracks in the stem wall. -There are delaminated areas and map cracking in the exterior edges of the back walls adjacent to the wing wall connection. -Abutment # 2 cap has a 10" spall with exposed reinforcing steel at the centerline. -See documentation of measurements for Abutment 1 associated with this inspection for additional information. History Notes: 08/17/2022 - JCJ & TJL - Special Recurring Inspection - Special Recurring Inspection was conducted this date to monitor Span # 1 Superstructure and Substructure for any additional excessive movement. Actual field measurement indicates that there are no apparent noteworthy changes since the last inspection. Field measurements are consistent with previous measurements taken over the Past 10 years. There have been no apparent repairs to Span # 1 Girders or Bent # 1 backwall since the 08/30/2016 inspection. Maintenance Forces have removed the PCCP adjacent to the South abutment in the past relieving the pressure against the South abutment backwall.

Abutment # 1. Left side. Backwall is fractured and rotated towards the channel.

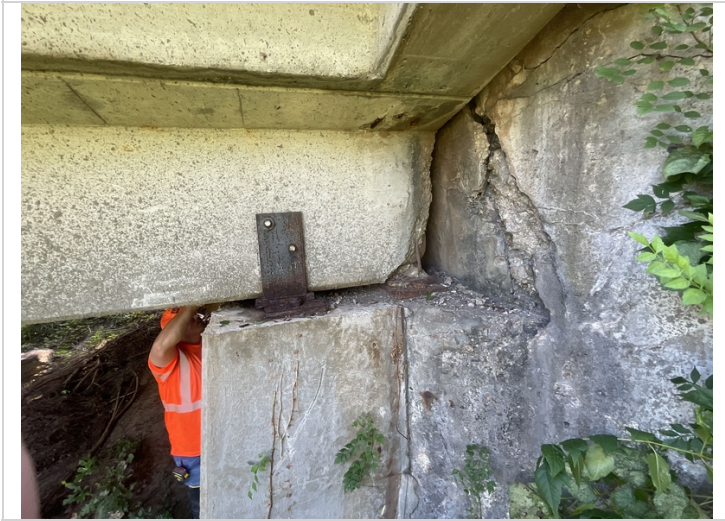
Girder # 1 at Abutment # 1. Spalling with exposed reinforcing steel.

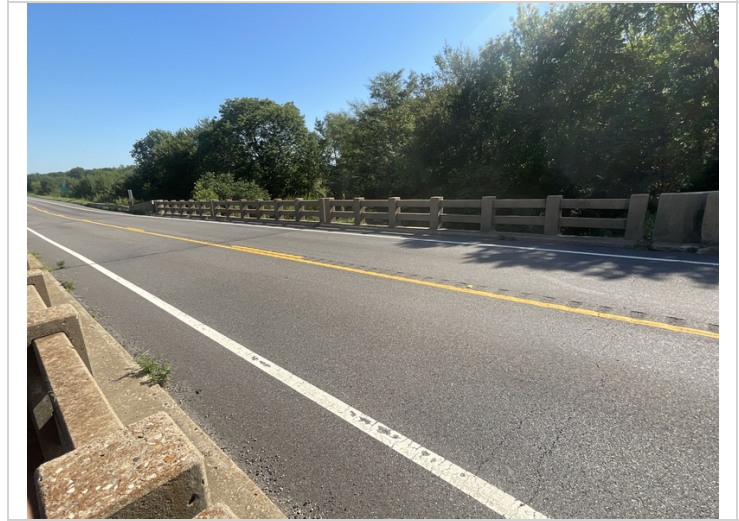
Bridge railing. Typical.

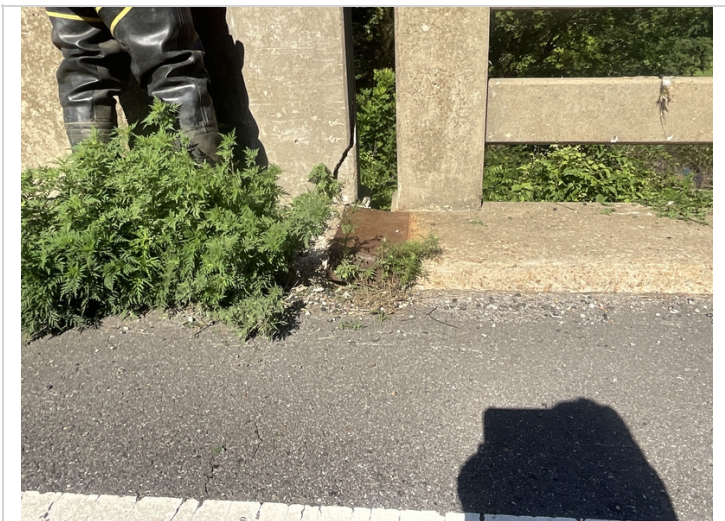
- Asphalt driving surface has transverse cracks over the expansion joints.
- The exposed edges of the sliding plate at the curbs over the South abutment and Bent # 2 Right side are not level and appear to be pushed up beyond the original design gradient.

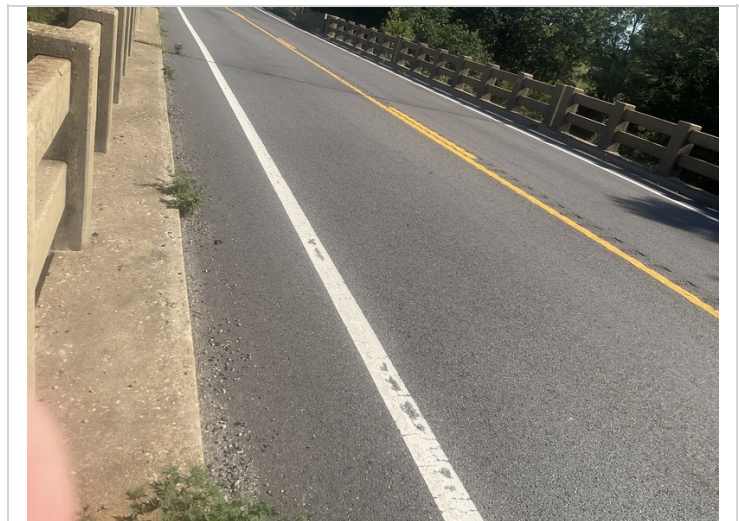
Deck. Typical.

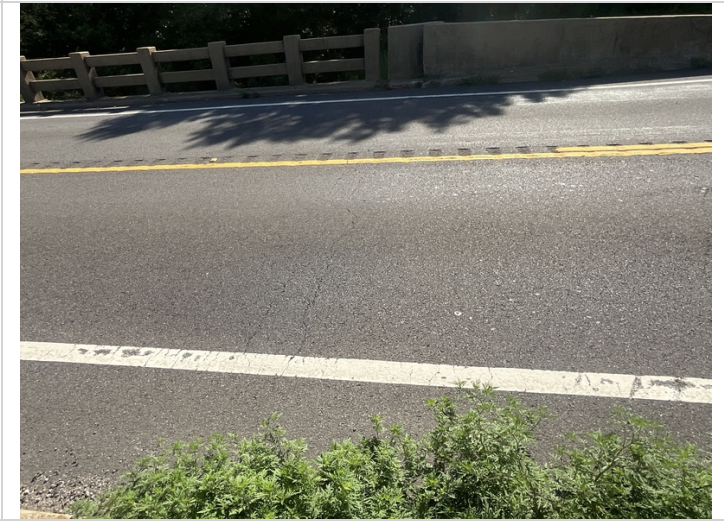
Transverse cracks in the asphalt over Abutment #2 expansion joint.

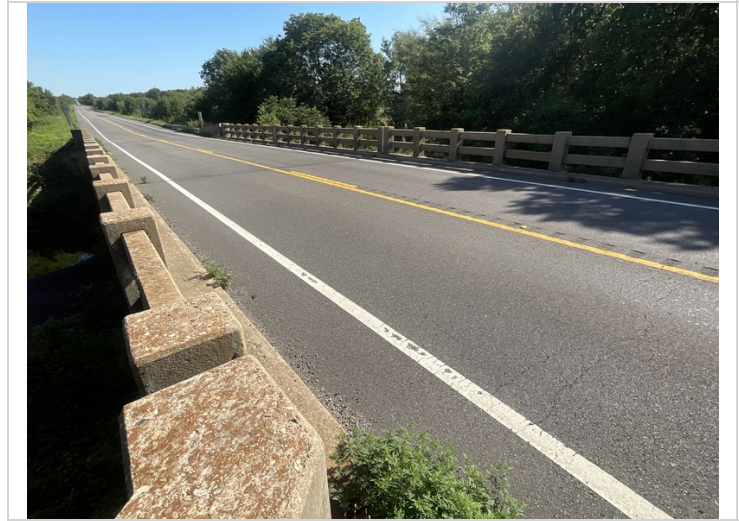
Deck. Typical.

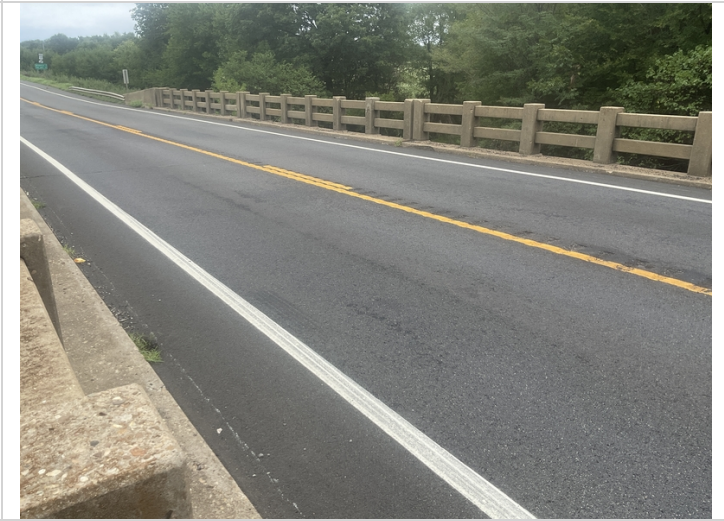
New asphalt wearing surface

08/17/2022 - JCJ & TJL - The deck has a new asphalt wearing surface since the last inspection. Actual field measurement along the left side of Span # 1 indicates approximately 5 3/4" of asphalt on the deck.

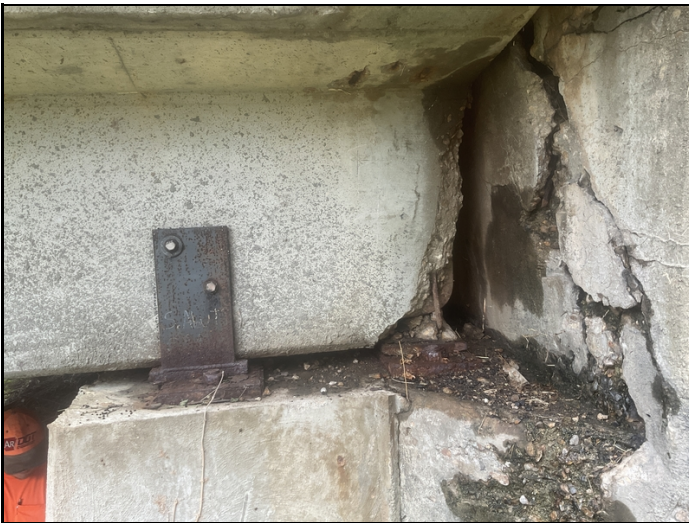
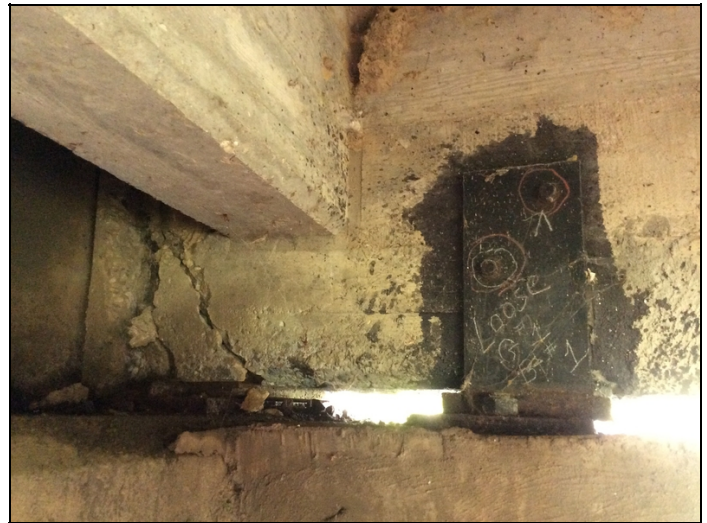
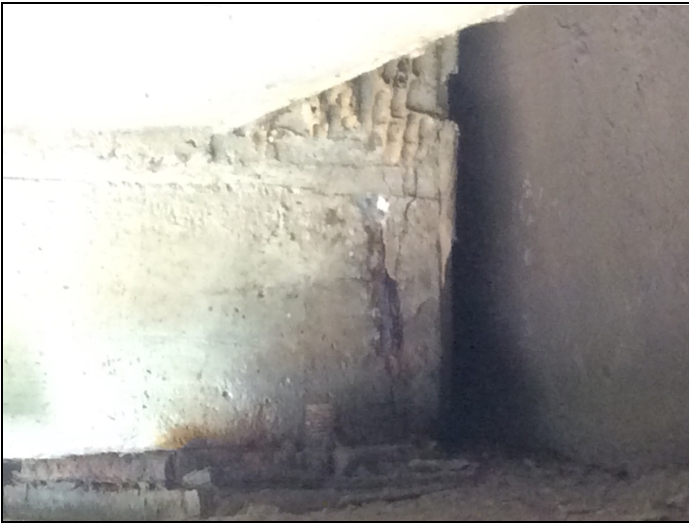
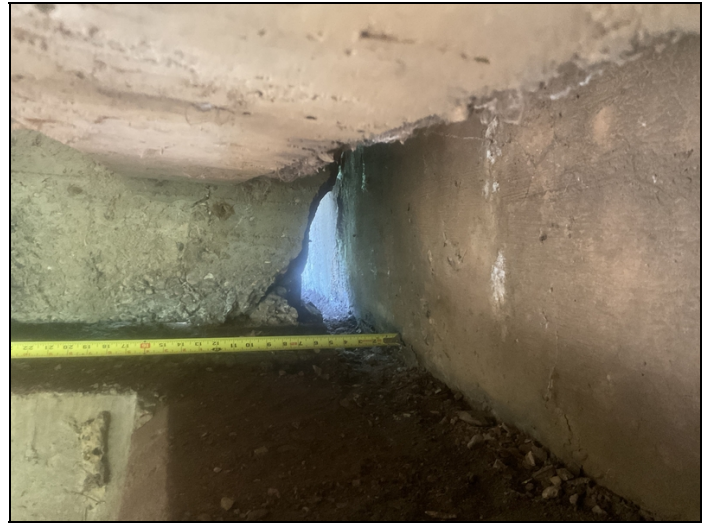
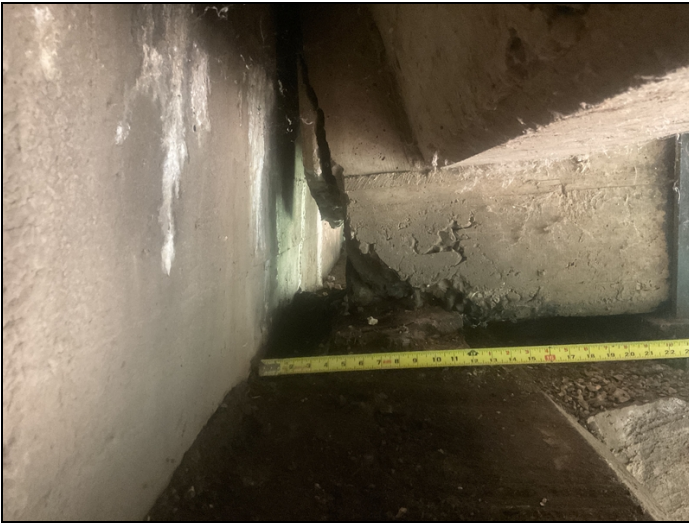
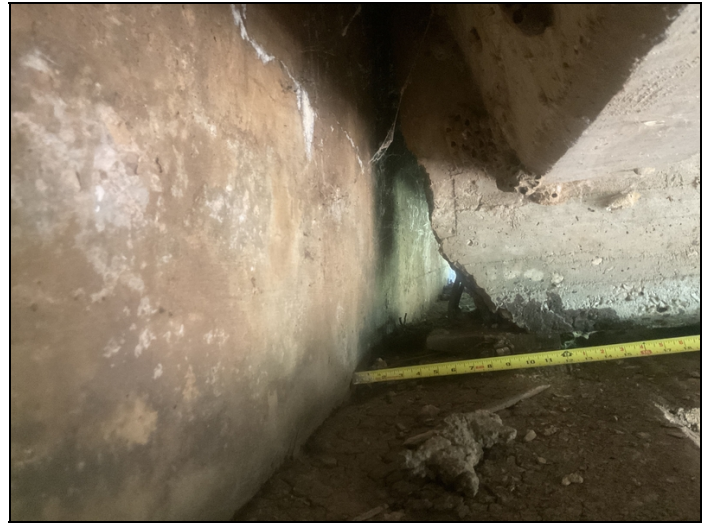
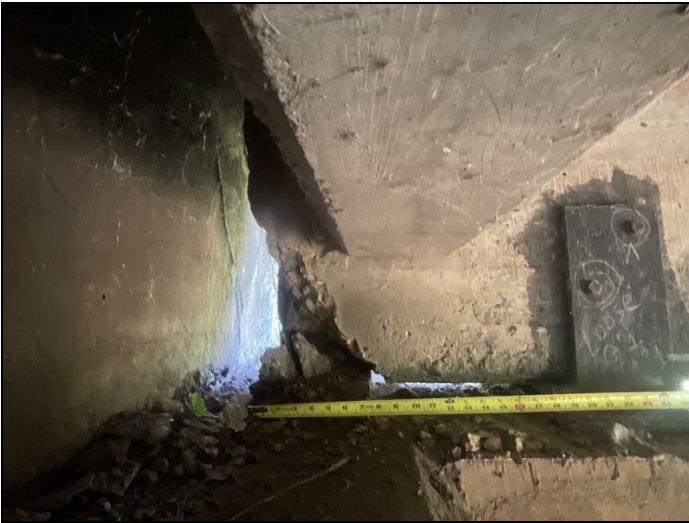
The ends of concrete T-beams have spalls with exposed reinforcing steel over abutment # 1 where the sole plate is incorporated into the ends of the concrete girders (Fixed Bearings). The ends of the girders appear to be in the process of being sheared off of the fixed bearings. Reference measurements were taken at Span # 1 to monitor substructure. Expansion bearings for Span # 1 at Bent # 2 are fully expanded. See sketches with actual field measurements and photos for additional information.

08/17/2023 - JCJ & TJL - The priority code for this deficiency is raised to a B during this inspection. The ends of the girders over Abutment # 1 continue to rubblize with reduced concrete area over the bearings.

Girder # 1 at Bent # 1. Spalls with exposed reinforcing steel.

Bent # 1 Girder # 1.

Span # 3, girder # 3 at abutment # 2- Spall with exposed reinforcing steel.

Girder # 1 at Bent # 5. Spalls with exposed reinforcing steel.

Girder # 1 at Bent # 3. Spalls with exposed reinforcing steel.

Girder # 2 at Bent # 1. Spalls with exposed reinforcing steel.

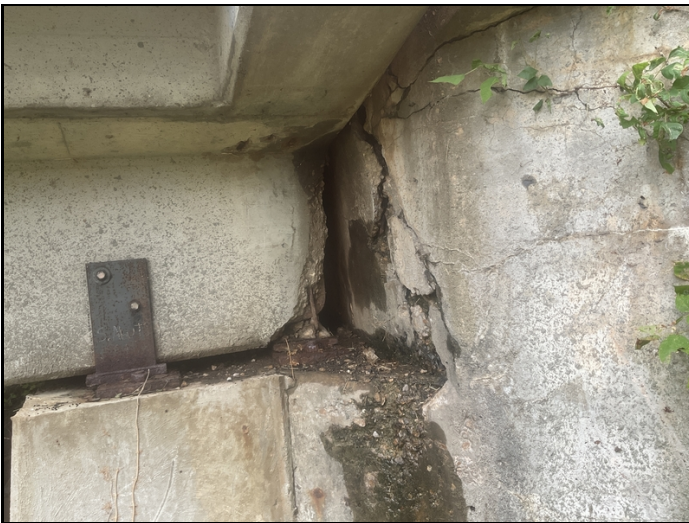
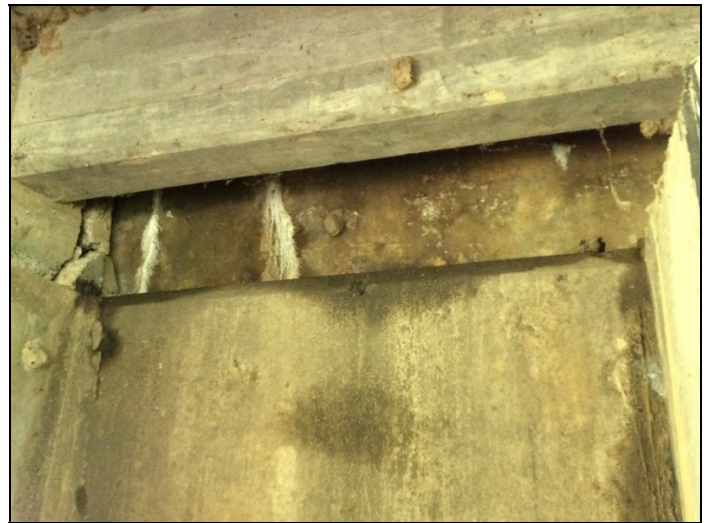
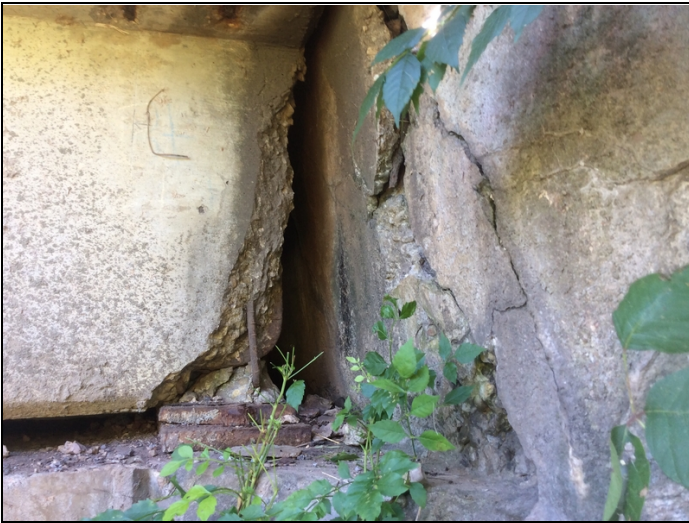
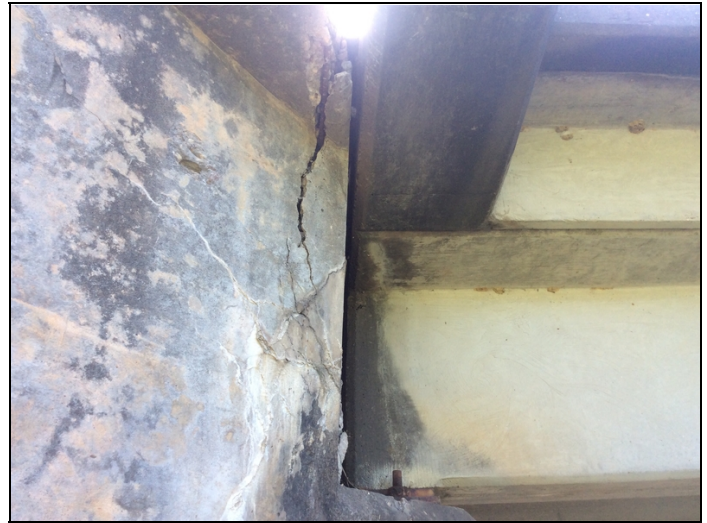
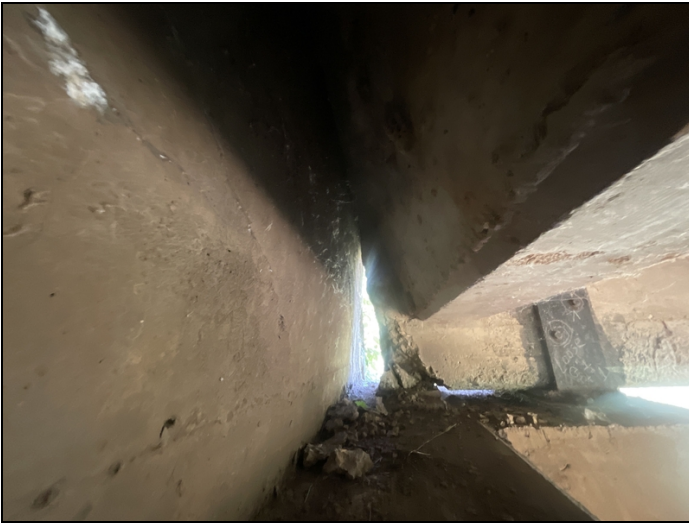
Abutment back walls are leaning towards the channel and have map cracking (Appears to be crushing / rubbelized) where it makes contact with the top of the concrete deck girders and edge of deck. The backwall at abutment # 1 appears to be pushing Span # 1 North.

Bent # 1 backwall is leaning towards the channel.

Bent # 1 Back wall cracking. With efflorescence.

Abutment #1, left side- backwall fractured and rotating.

Abutment # 2 backwall, left side- fractured and leaning towards the channel.

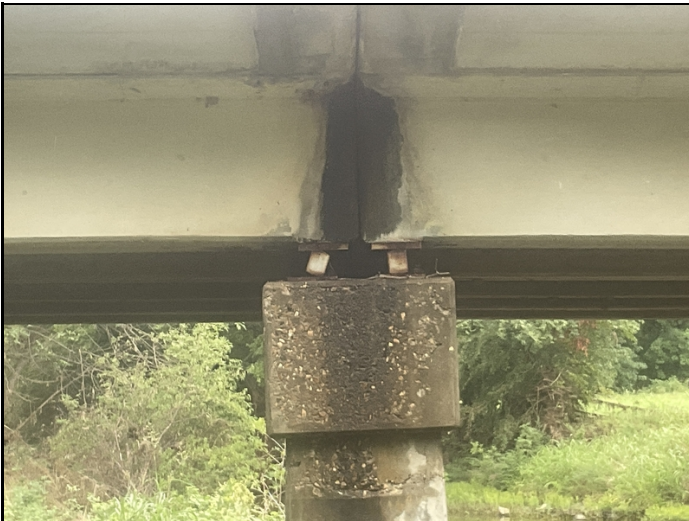
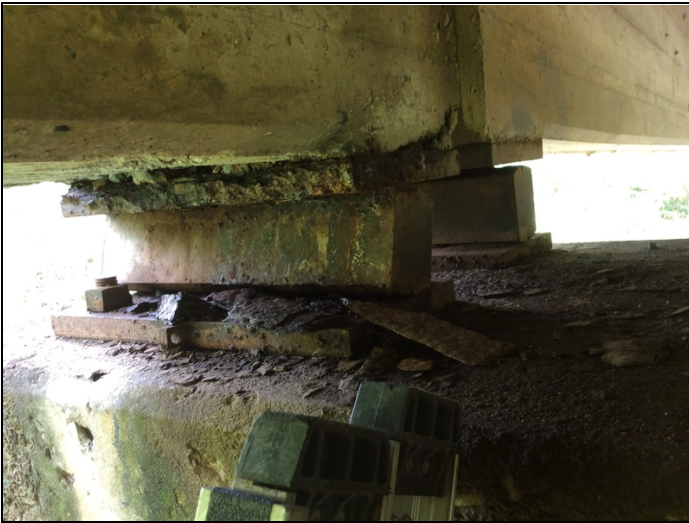
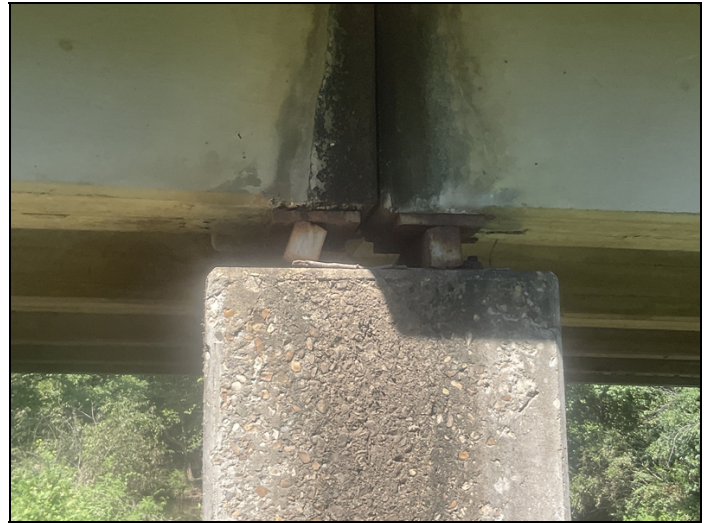
Bearing have active corrosion and flaking rust.

Span # 1, Bent # 2 bearing leaning. Girder # 5. No apparent change since the last inspection.

Bent # 2 Girder # 1 Active corrosion with flaking rust in the bearing.

The bearings for Span # 1 over bent # 2 are fully expanded with excessive rotation. Bearing have active corrosion and flaking rust.

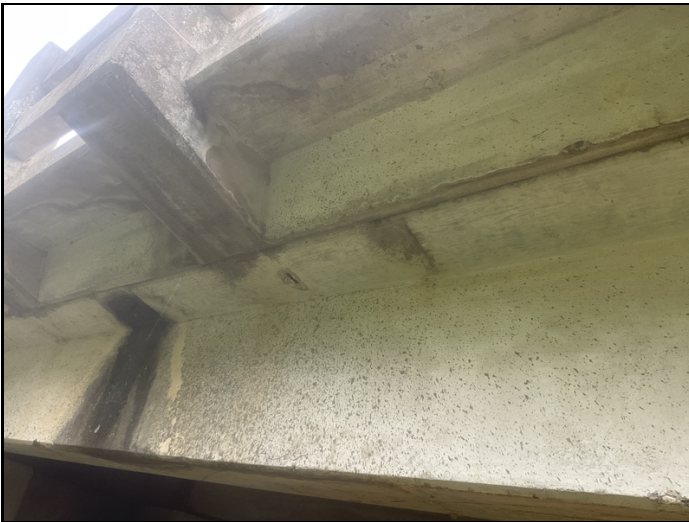
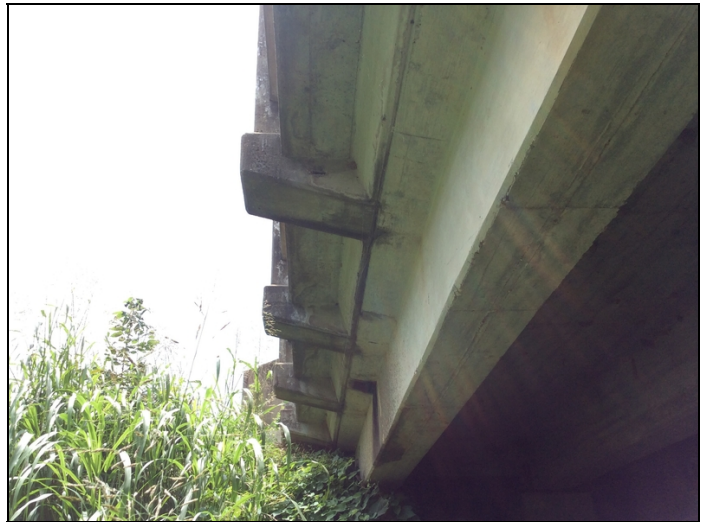
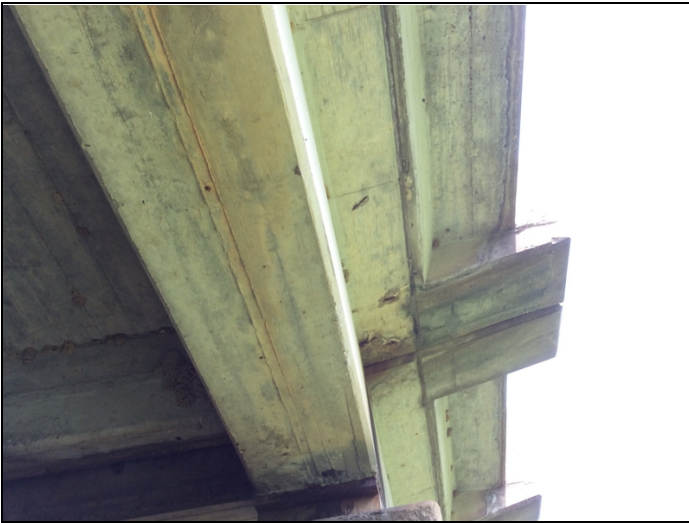
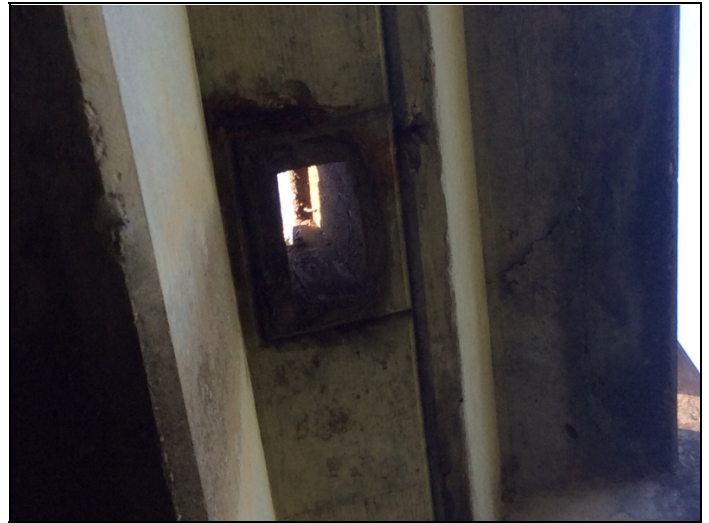
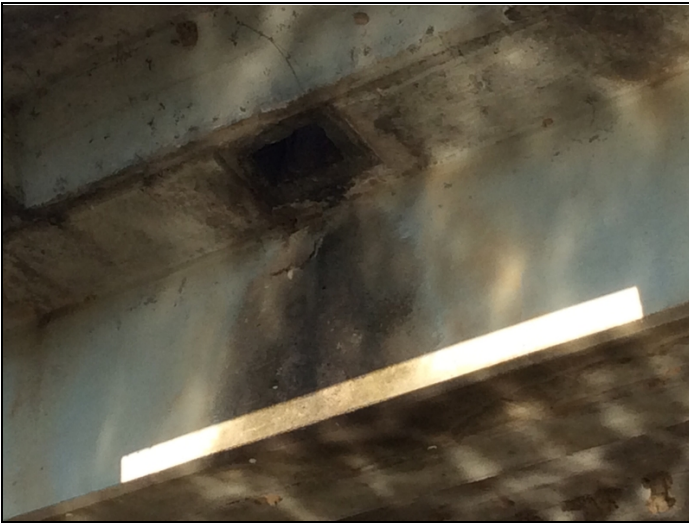
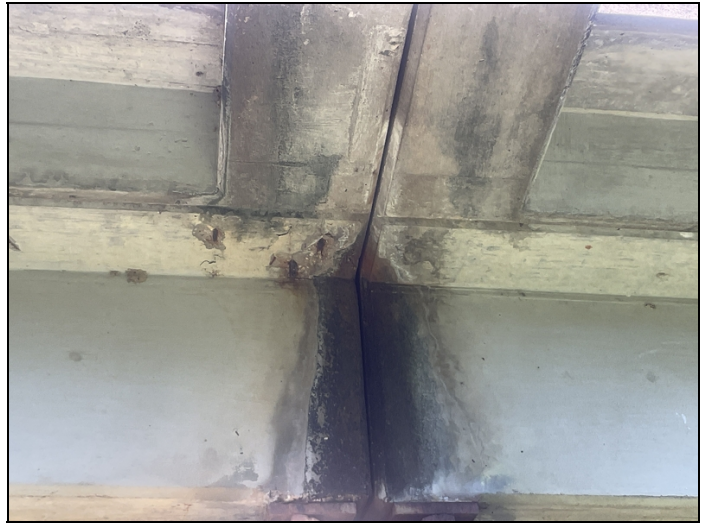
Deck has shallow spalls with exposed reinforcing steel on the undersurface of the deck overhang.

Right overhang of Span # 1. Spall with exposed reinforcing steel.

Span # 1 Right Spalling with exposed reinforcing steel in the bridge rails.

Span # 1 Right Spalling with exposed reinforcing steel.

Span # 1, left side-Spalling with exposed reinforcing steel adjacent to deck drain.

Span # 3, left side of girder # 5- softball sized delaminated area.

Right overhang of Span # 1 over Bent # 2. Spall with exposed reinforcing steel.
