Asset #02240(Routine)

US 71 - Seb. Co. over Prairie Creek

Location: 0.1 M N OF SH 252

Team Lead: Jeff Jones, Inspection Date: 08/17/2023

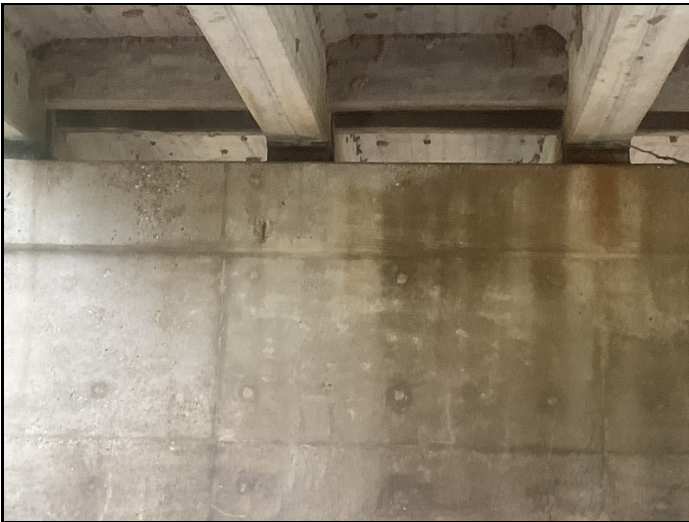
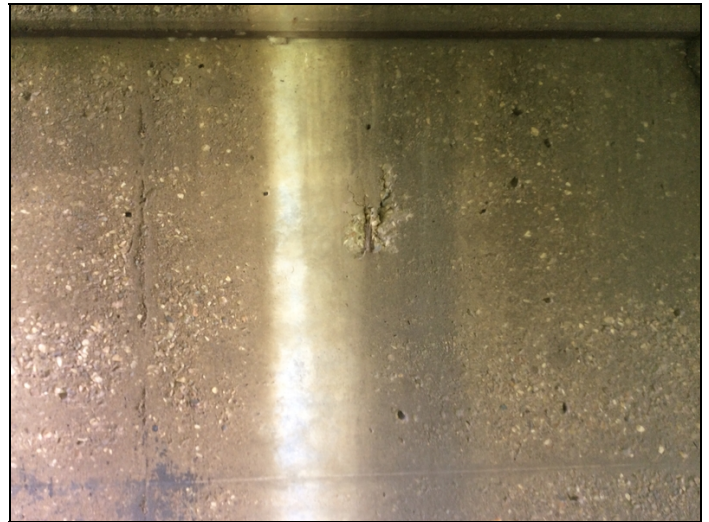
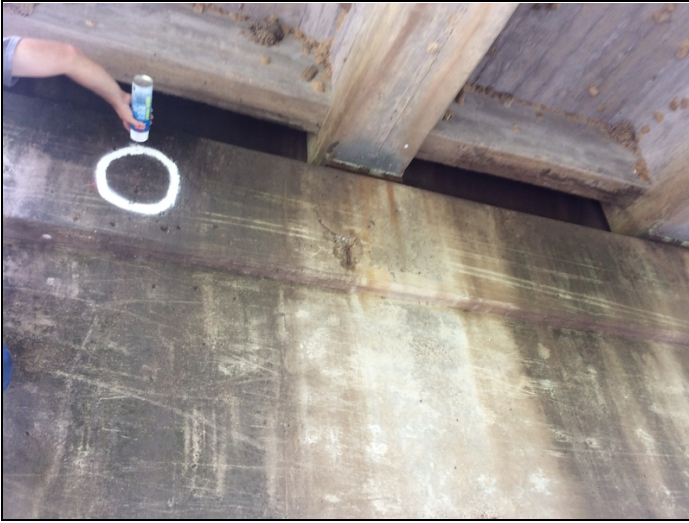
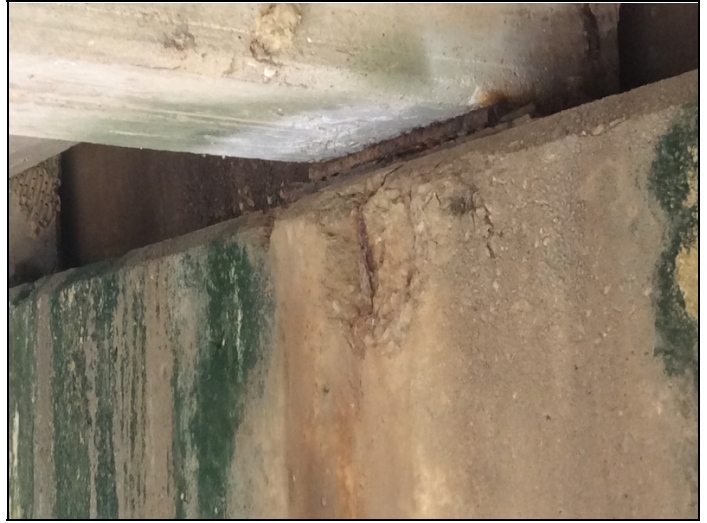
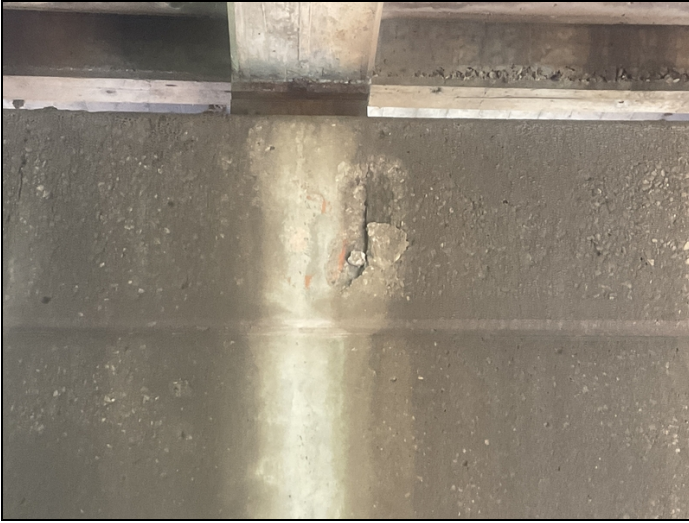
Substructure -
Bent caps have a few shallow spalls with exposed reinforcing steel.

Bent # 3 cap. Ahead face. Spall with exposed reinforcing steel.

Span # 1 Bent # 2 Spalling with exposed reinforcing steel.

Bent # 3 Span # 3 Spalling with exposed reinforcing steel.

Abutment # 2 spall with exposed reinforcing steel.

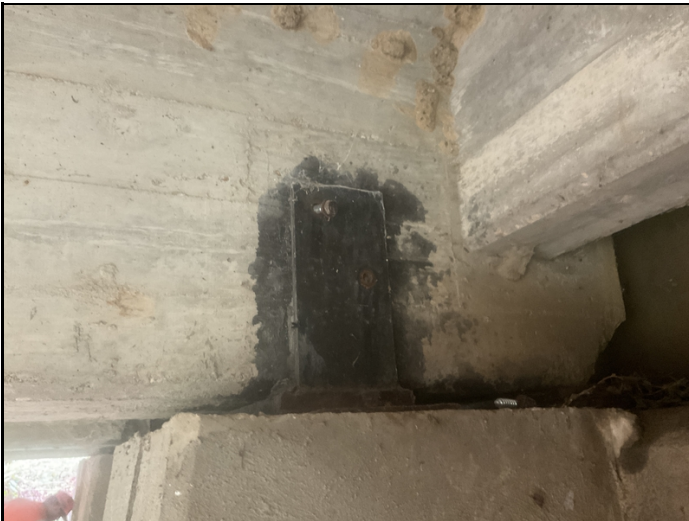
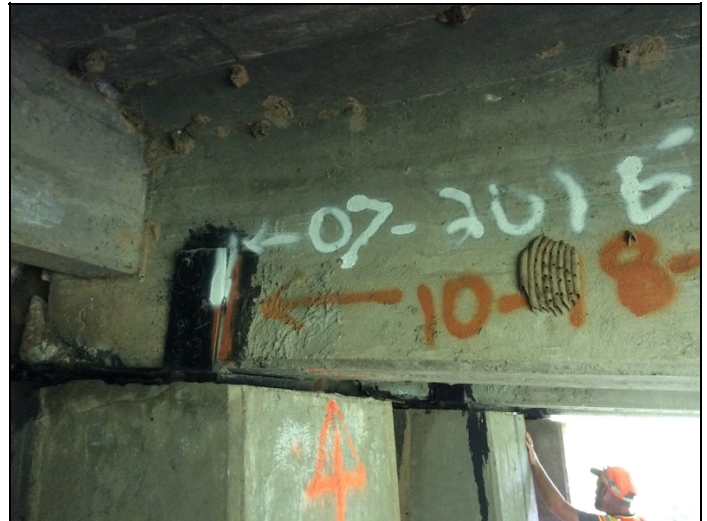
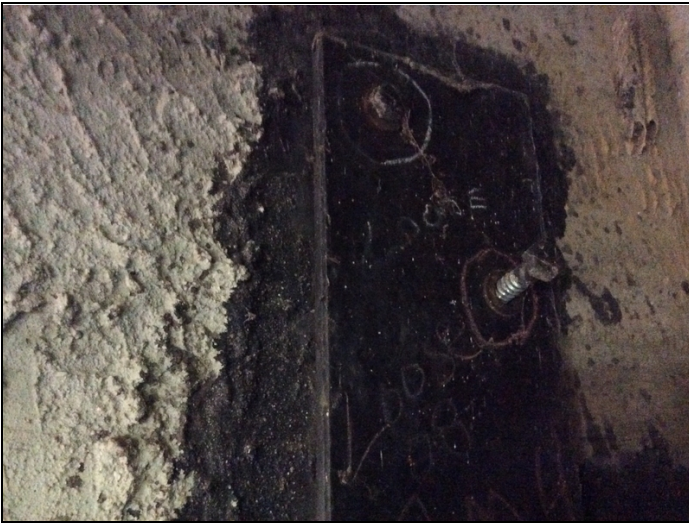
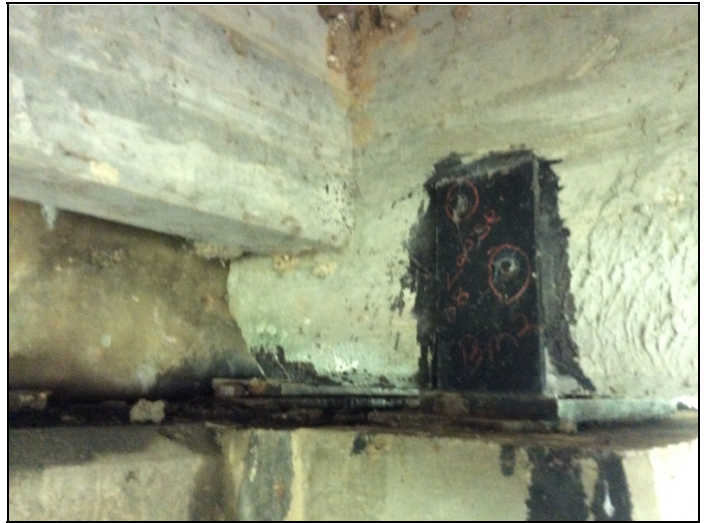
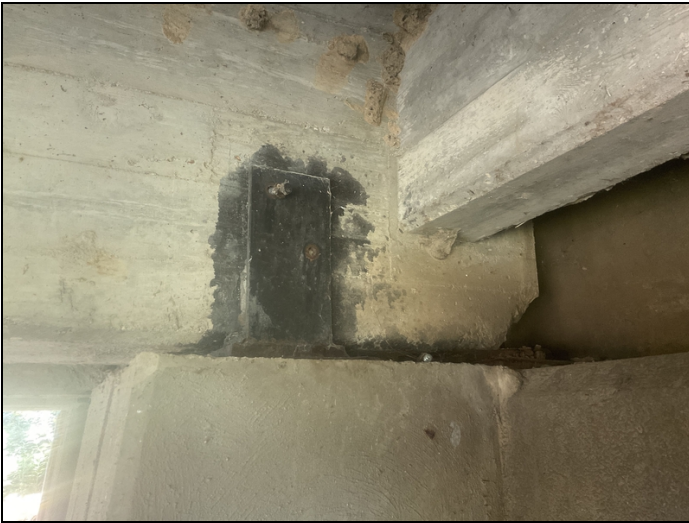
The retrofit bearing devices at the south abutment have loose / fractured bolts / nuts where they attach to the sides of the concrete girders.

Bent # 1. Girder # 2. Retrofit bearing has fractured and missing bolts.

Bent # 1 Girder # 3.

Span # 1, girder # 3- loose bolt.

Bent # 1 Girder # 2.

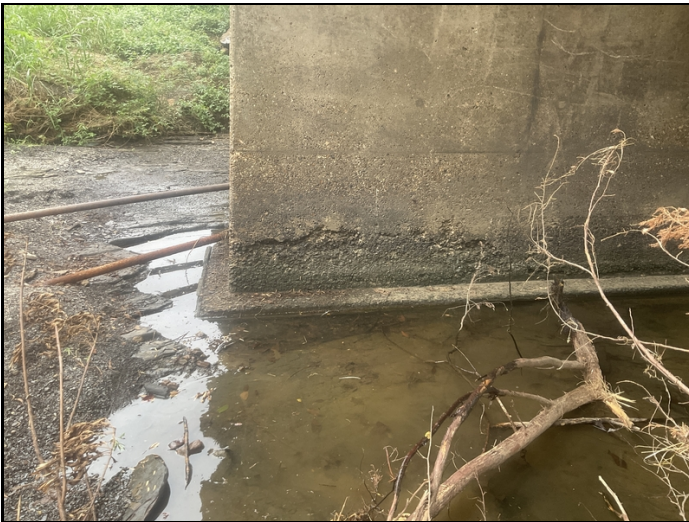
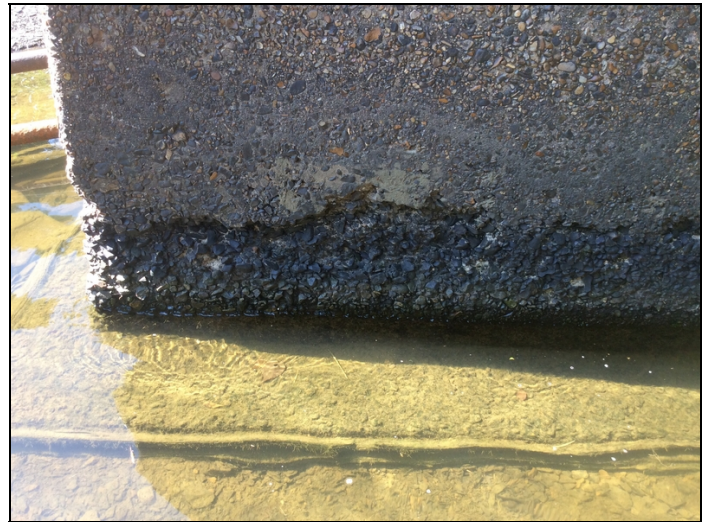
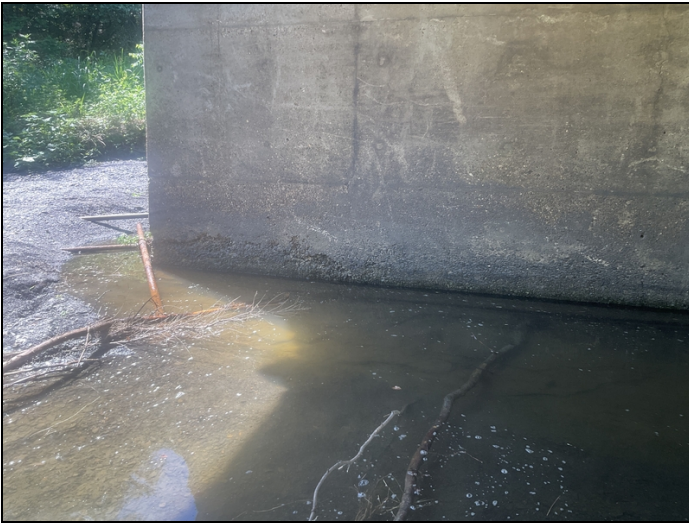
Substructure -
Base of bent # 3 has heavy abrasion with up to 2" of section loss.

Concrete deterioration at the base of Bent # 3.

Base of bent # 3 has heavy abrasion with up to 2" of section loss.
