Bridge #05662(Routine, Underwater type 2)

State Highway 255 over Mill Creek

Location: 1.54 SO OF US 64

Team Lead: Eric West Inspection Date: April 29, 2020

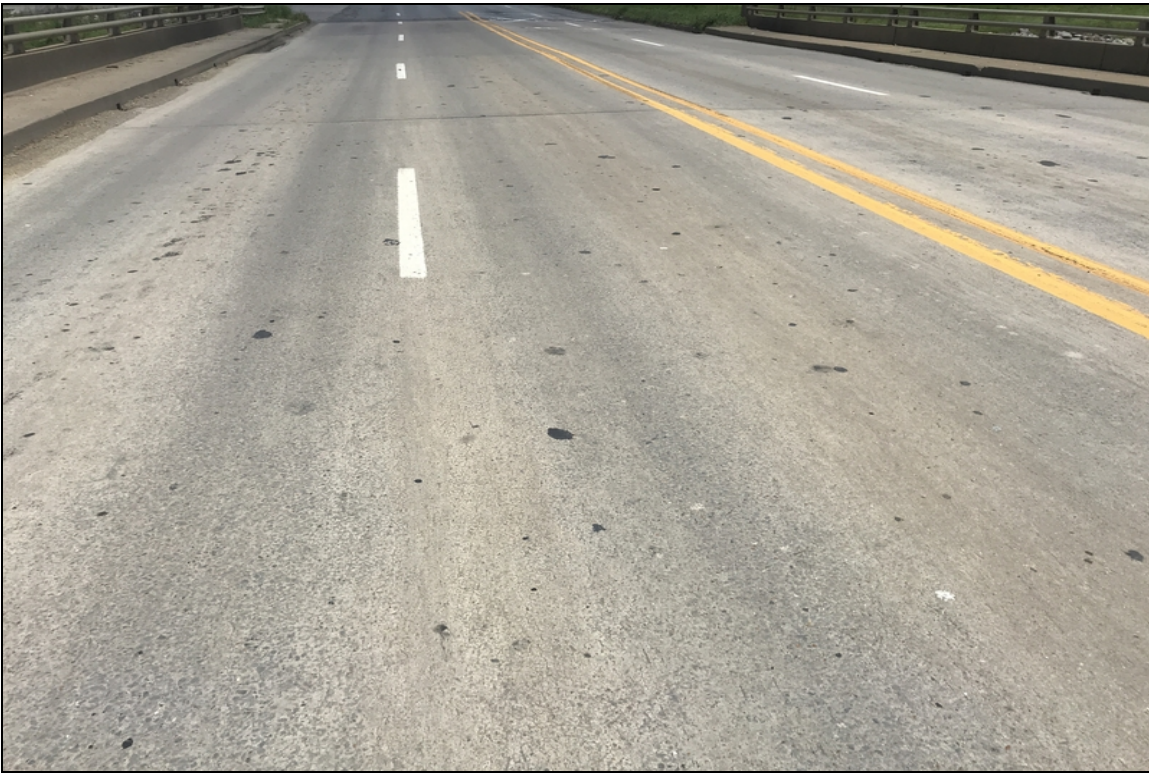
Typical driving surface of the slab.

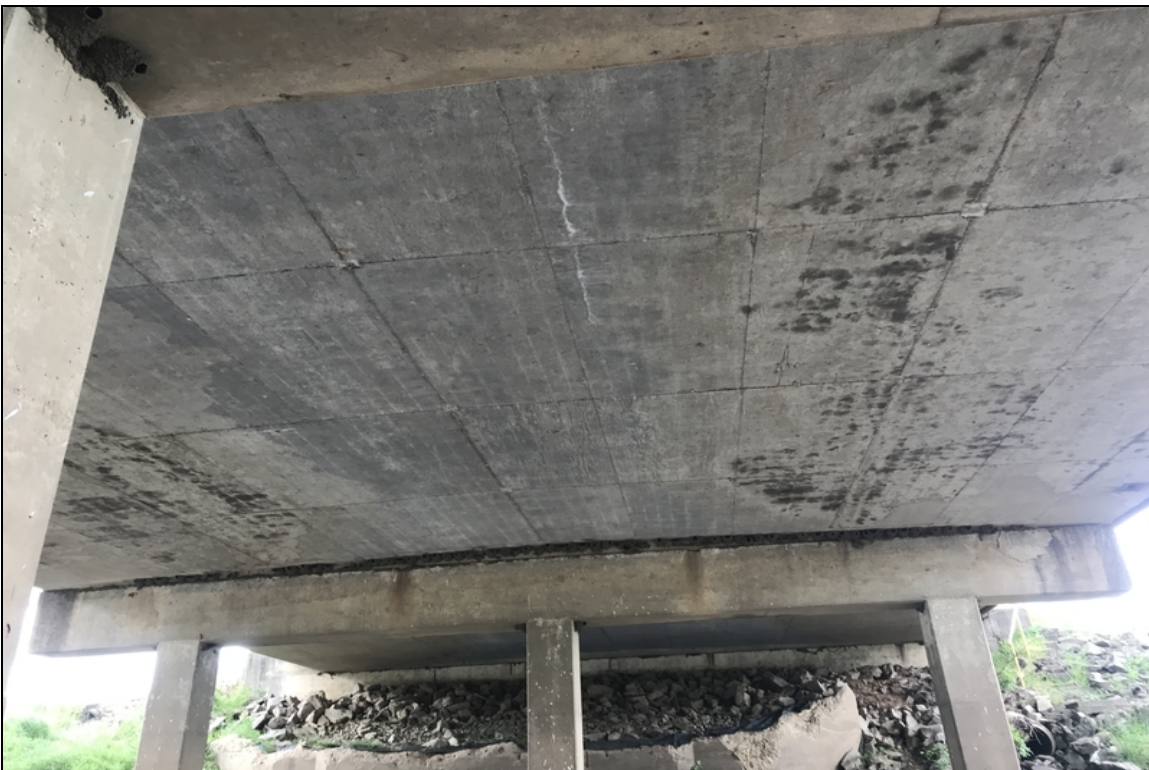
Typical undersurface of the slab.

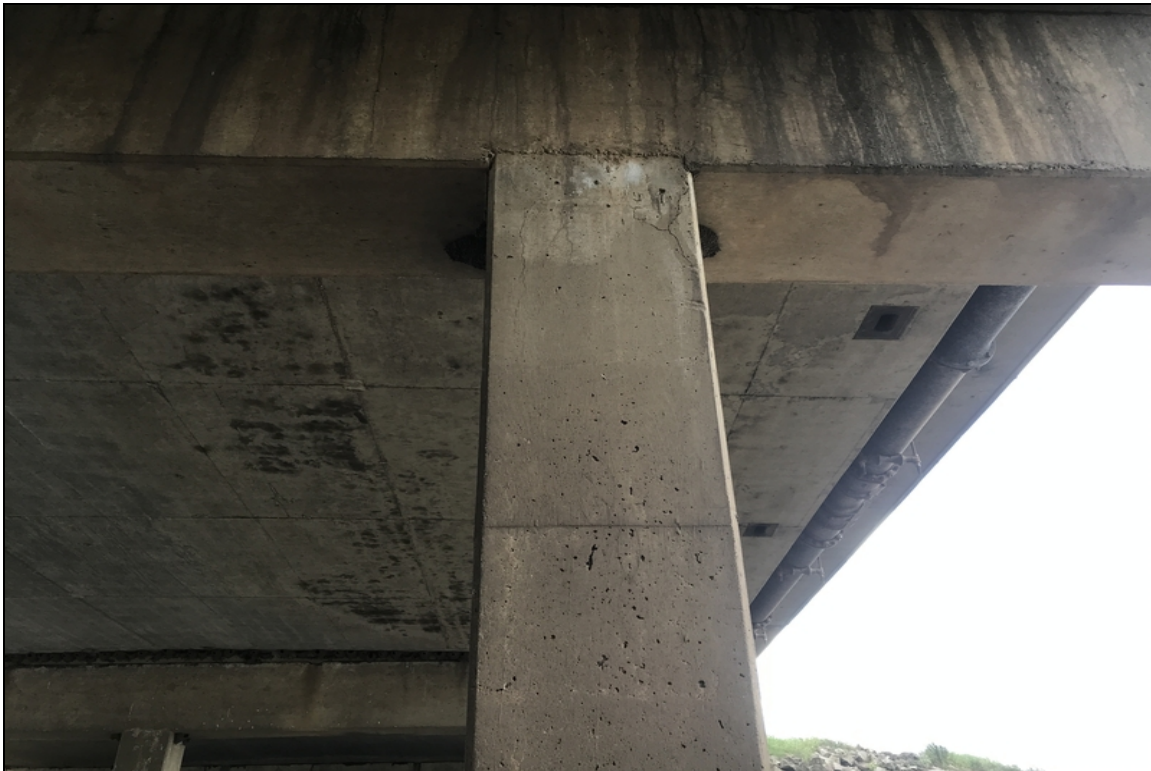
Bent # 3 Column # 1 vertical cracking at the cap juncture.

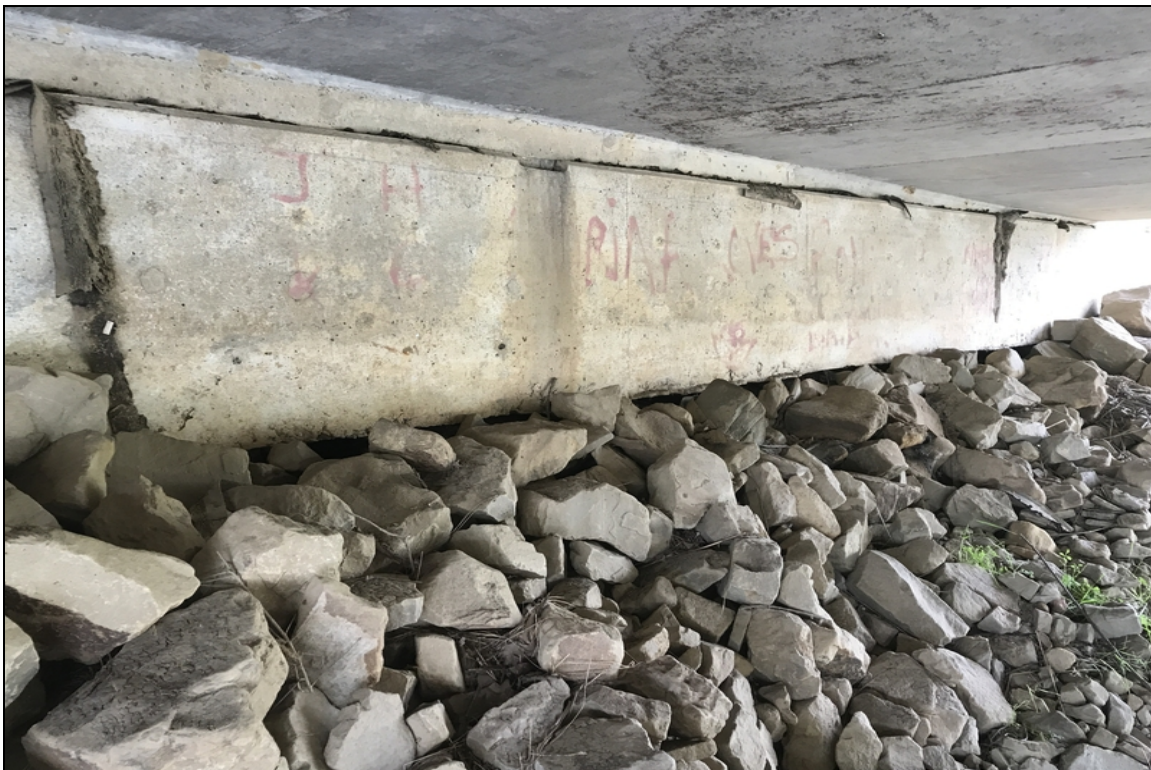
(215)							
End Bents:							
-The abutment caps have staining where the failed joint seals allow water to leak onto the substructure.							
-Bent # 4 has minor earth settlement under the abutment cap.							
220	Reinforced Concrete Pile Cap/Footing	LF	30	30	0	0	0

Bent # 4 earth settlement under the abutment cap.

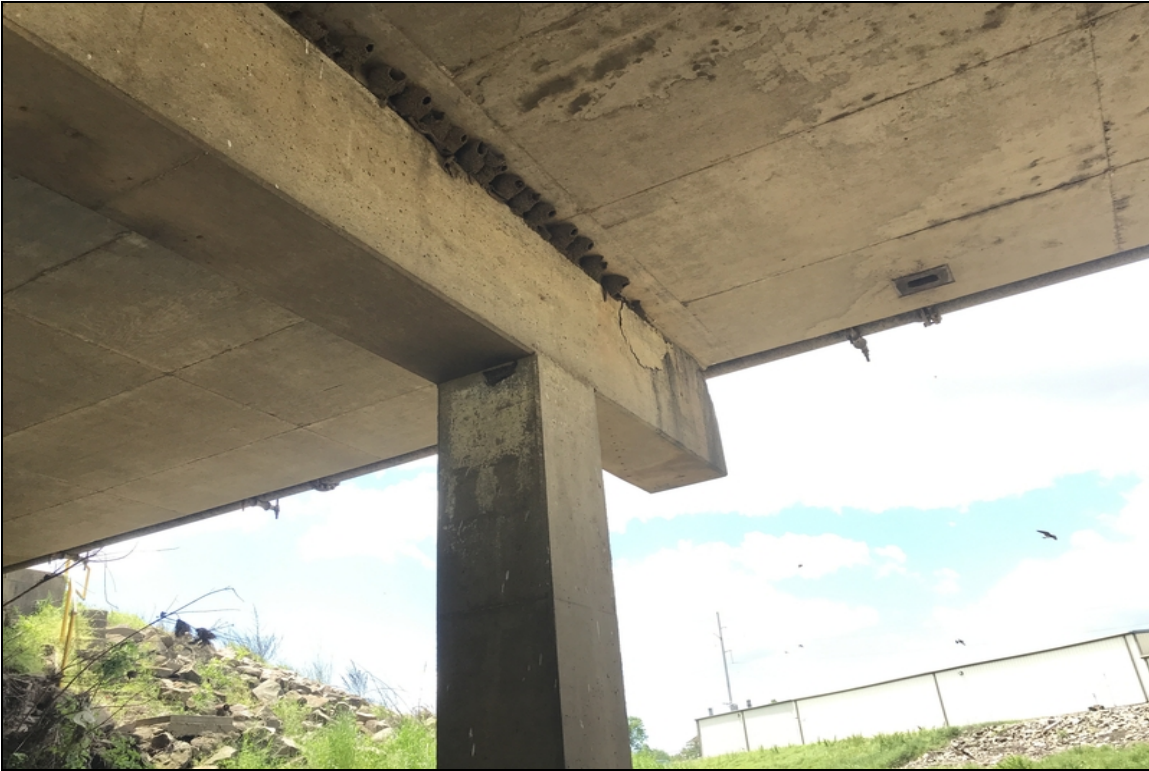
Bent # 2 Lt cap large delamination

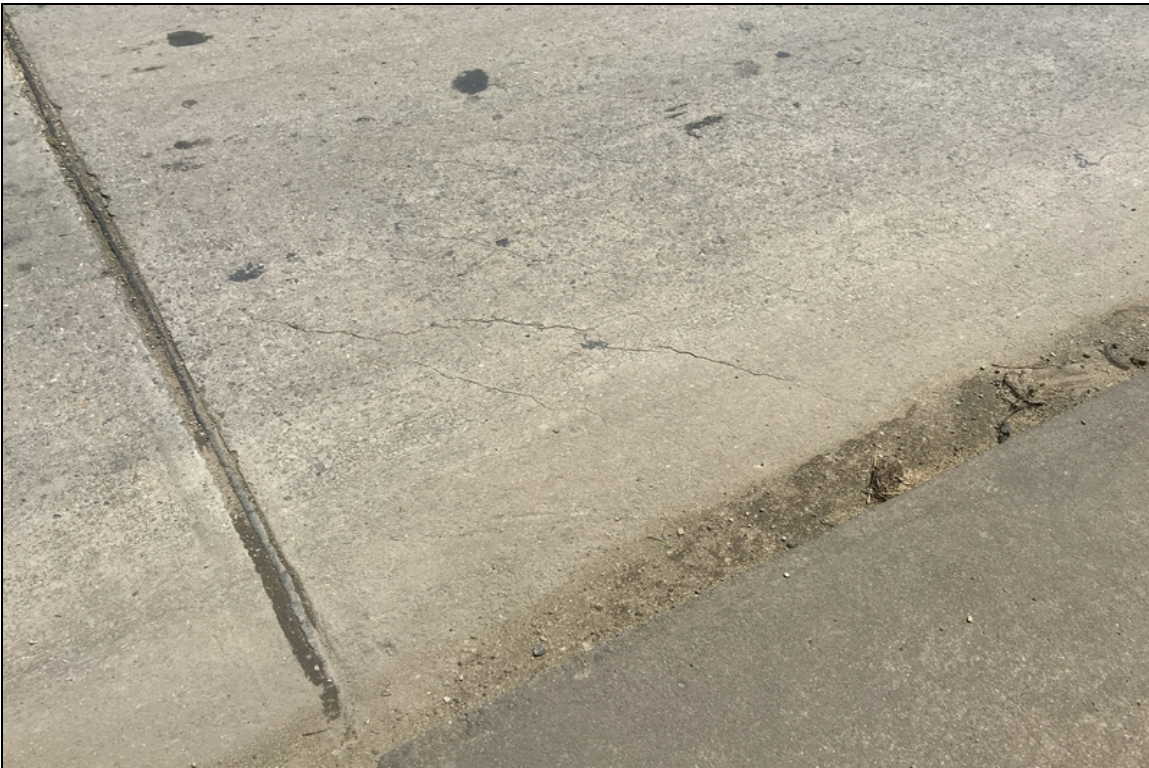
Sealable deck cracking.

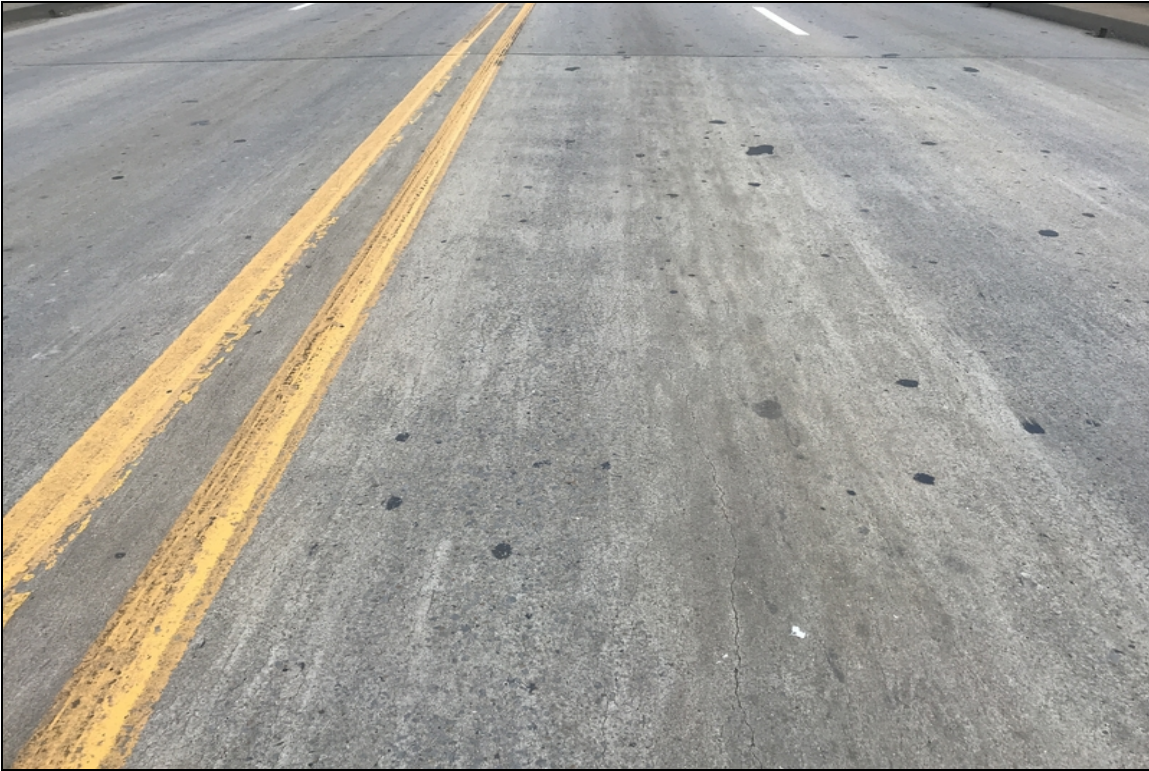
Longitudinal cracking on the driving surface of the slab.

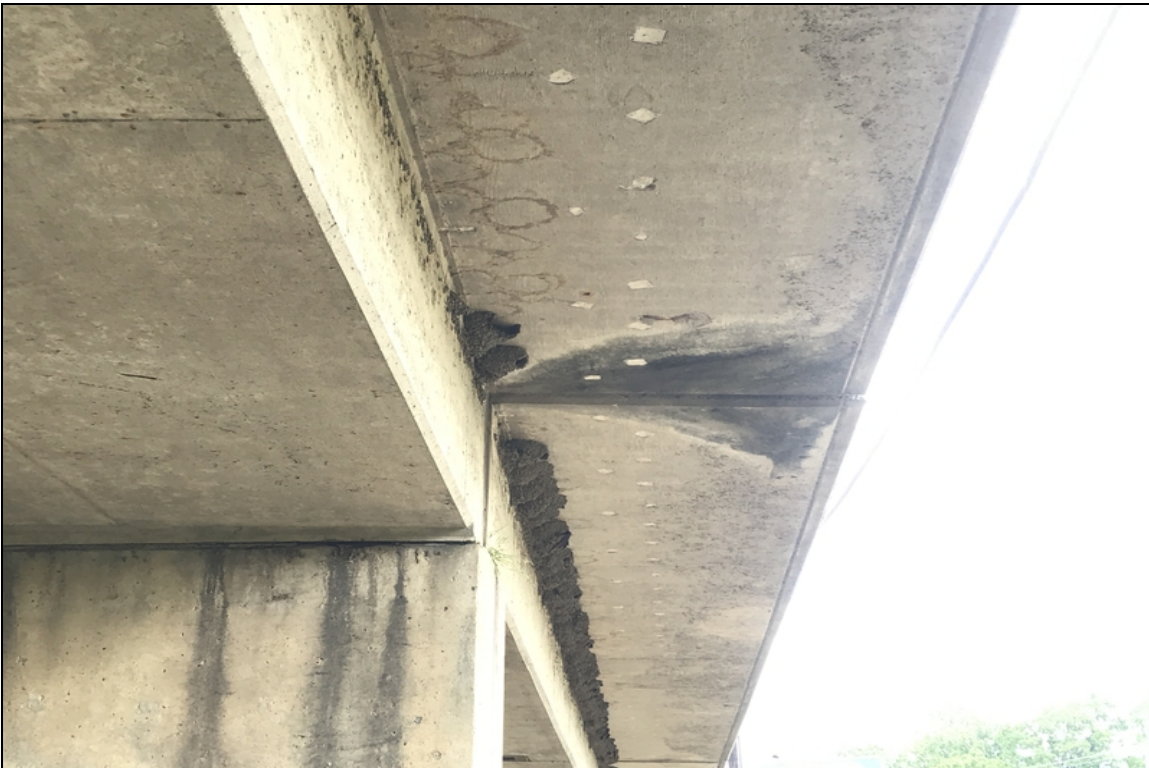
Span # 1 Rt shallow spalling with exposed reinforcing steel on the undersurface of the overhang.

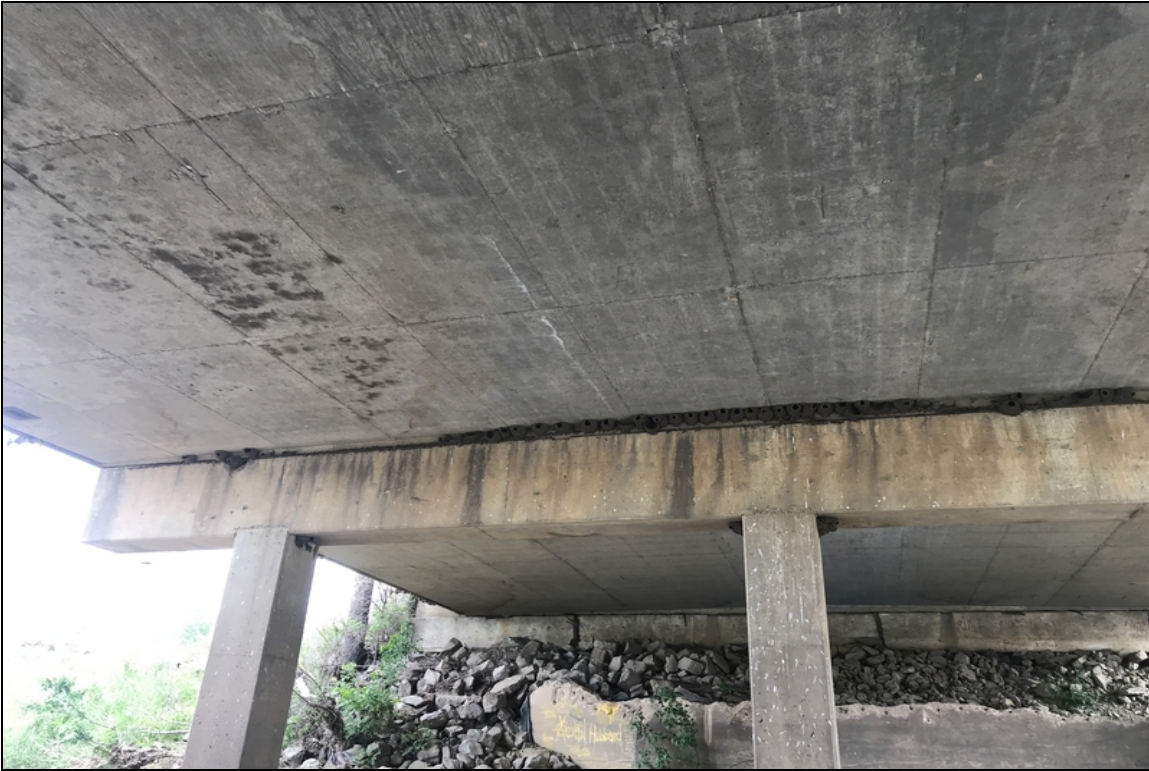
Span # 2 longitudinal cracking with light efflorescence buildup.

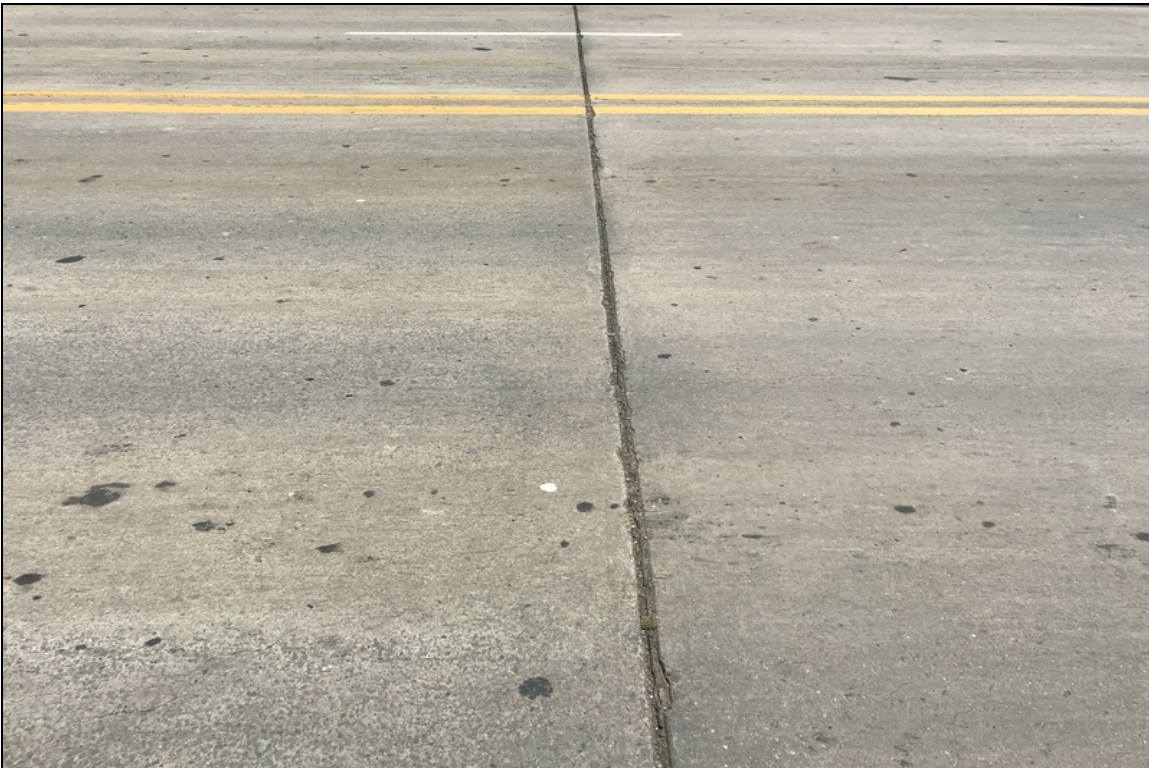
Bent # 1 joint seal with debris accumulation/ impaction.

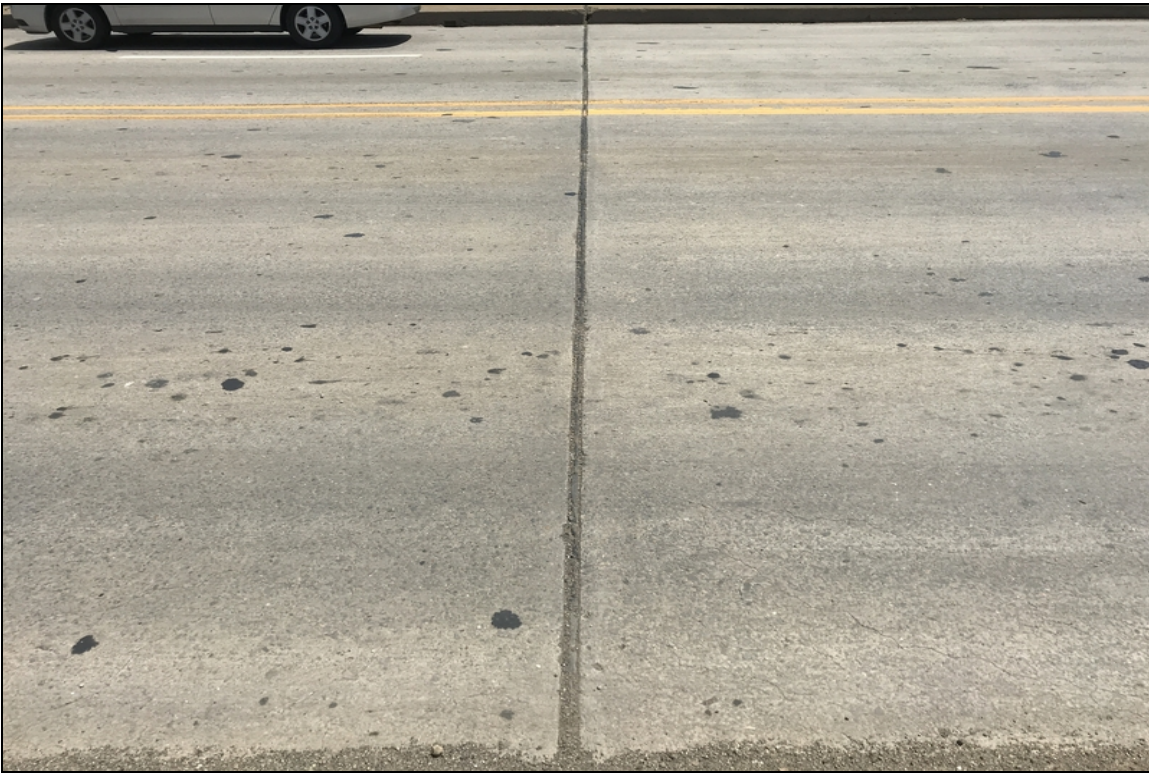
Bent # 2 joint seal with debris impaction.

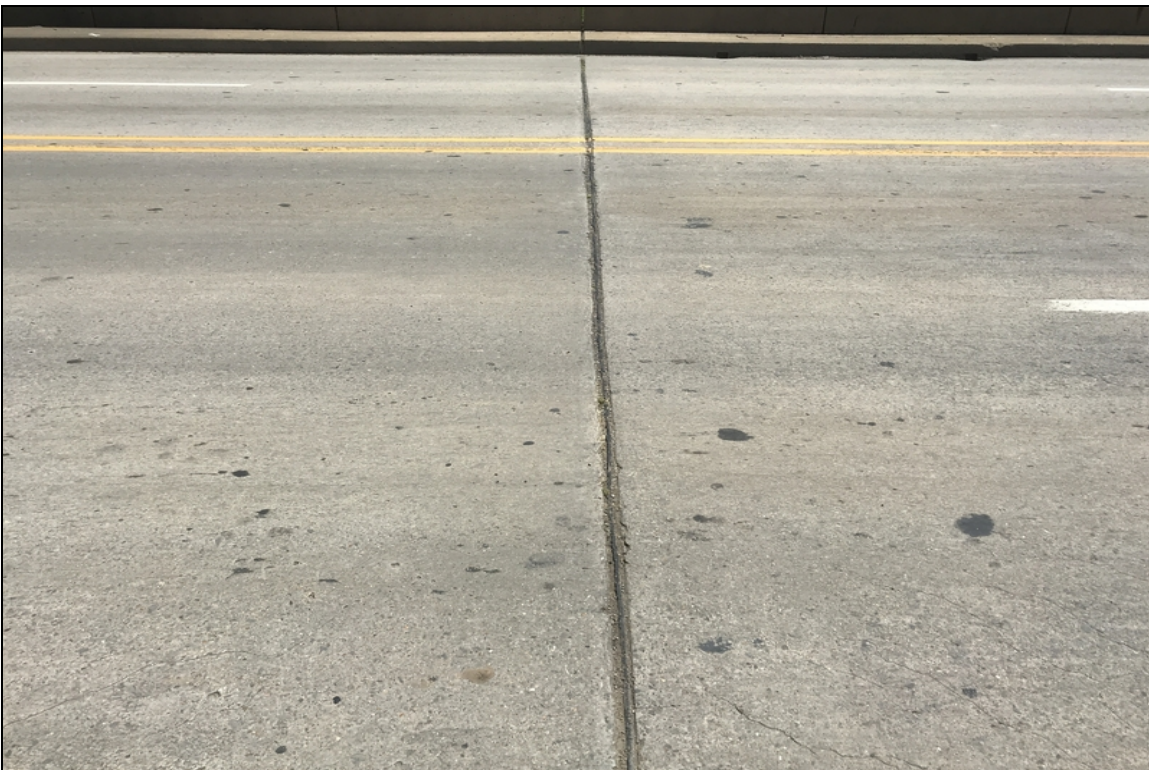
Bent # 3 joint seal deterioration with debris impaction.

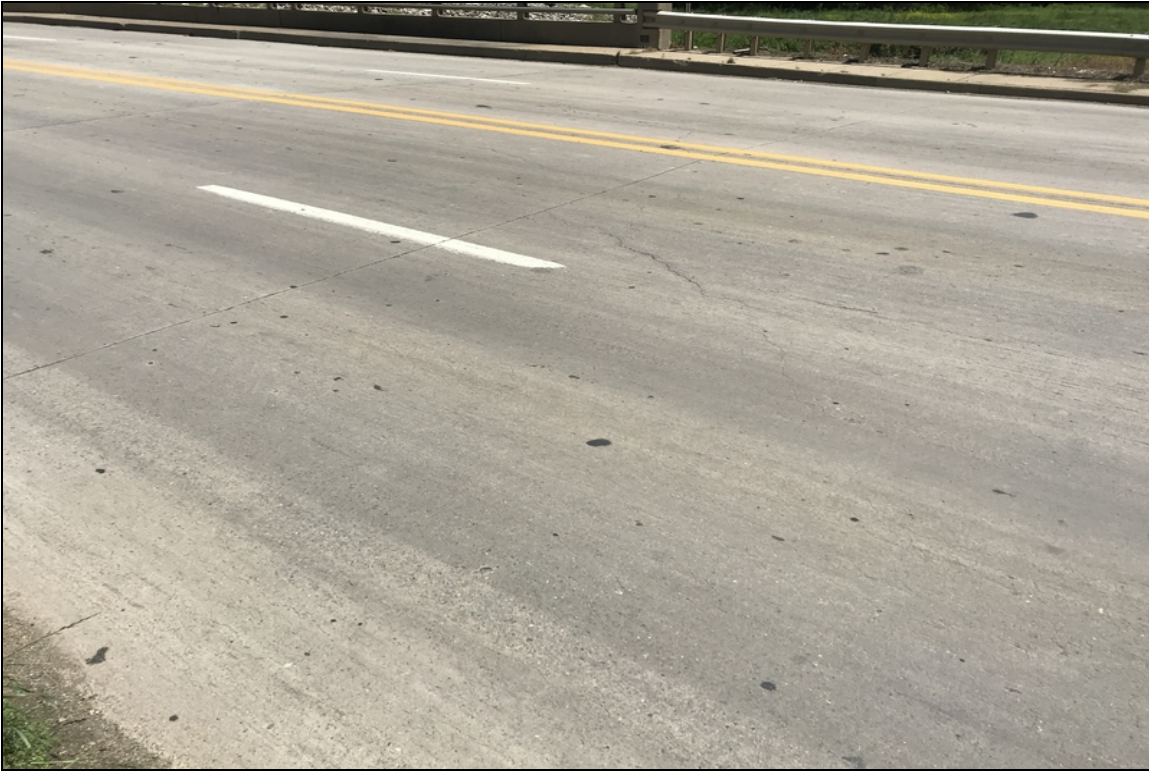
South approach slab cracking.

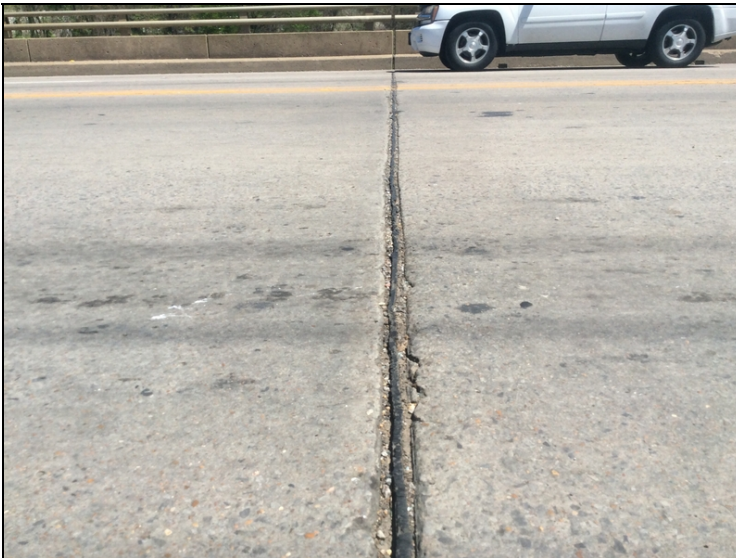
Deck -
Compression deck joint seals are deteriorated and full of incompressible material.

Bent #3 expansion joint-Debris impaction.

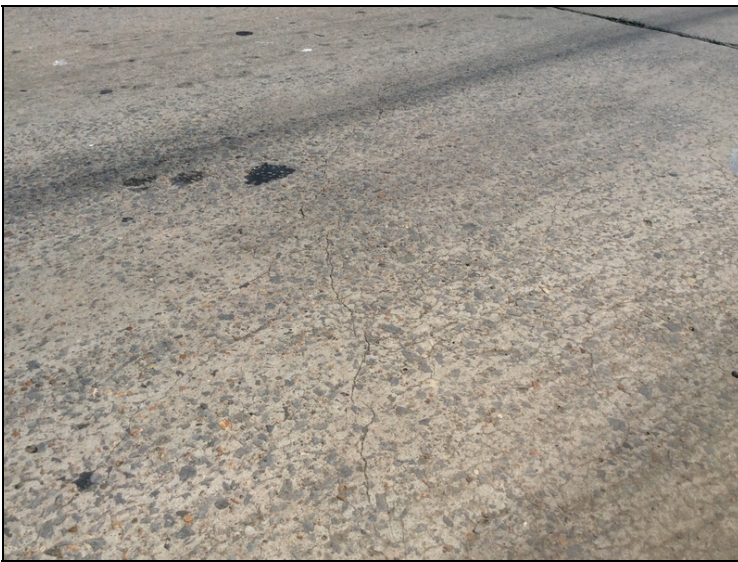
Deck -
The driving surface of the deck has sealable cracking and dirt and debris in the gutters.

Span #1, left lane-Cracking.

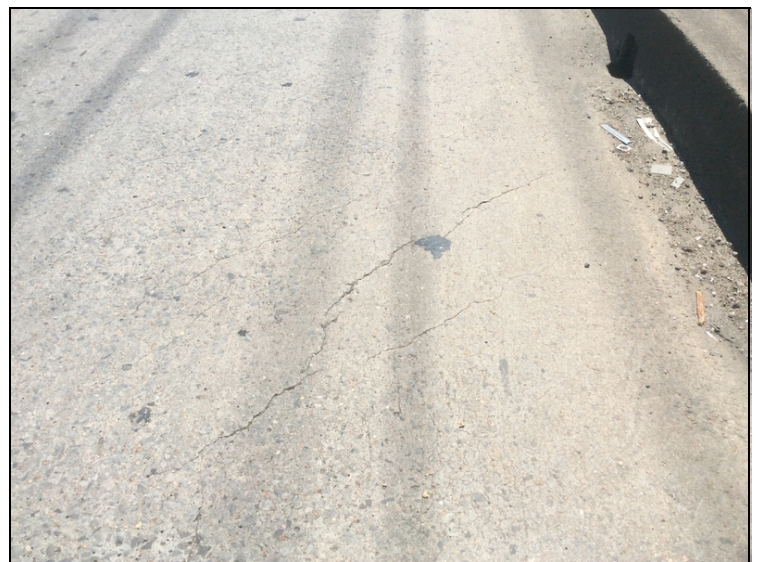
Span #2, left lane-Diagonal cracking.

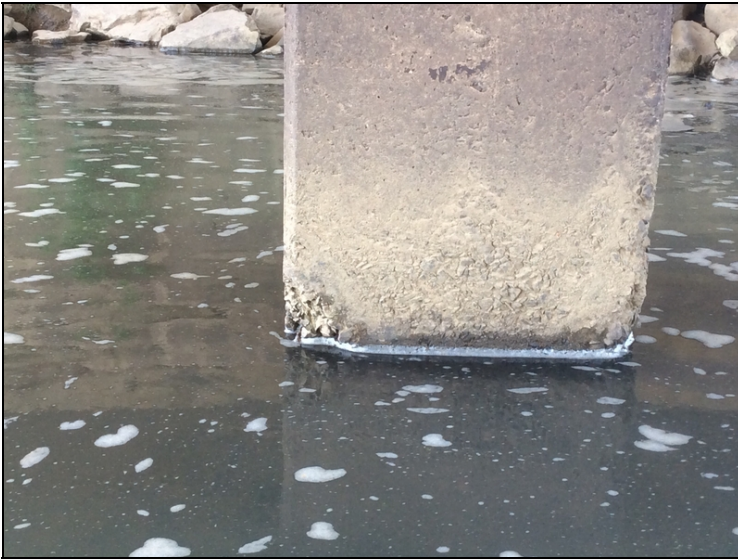
The base of Columns # 1 and # 2 of Bent # 3 has concrete deterioration / section loss.

Bent #3, column #2-Concrete deterioration with section loss.

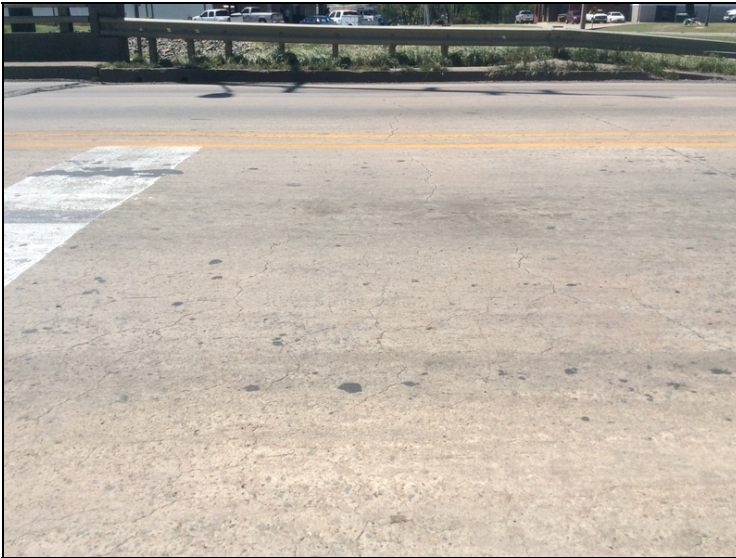
The North approach slab has settled approximately 1 1/2" and has sealable cracking.

North approach slab-Cracking.

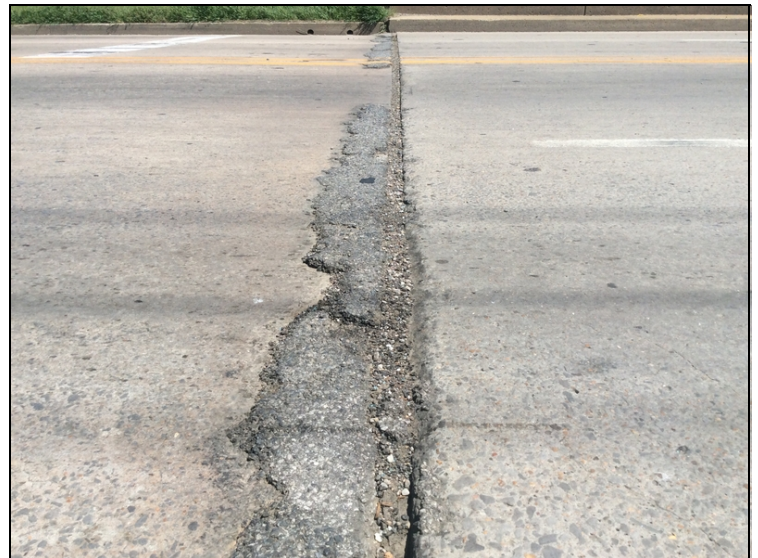
North approach slab settlement.

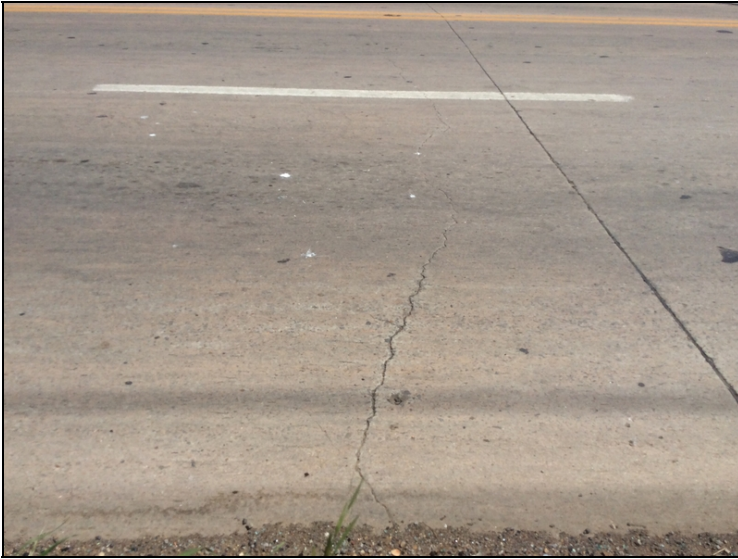
The South approach slab has wide sealable cracking.

South approach slab-Transverse cracking
