Bridge Inspection Report

00381

State Highway 22
over
Mine Brook-Logan Co.

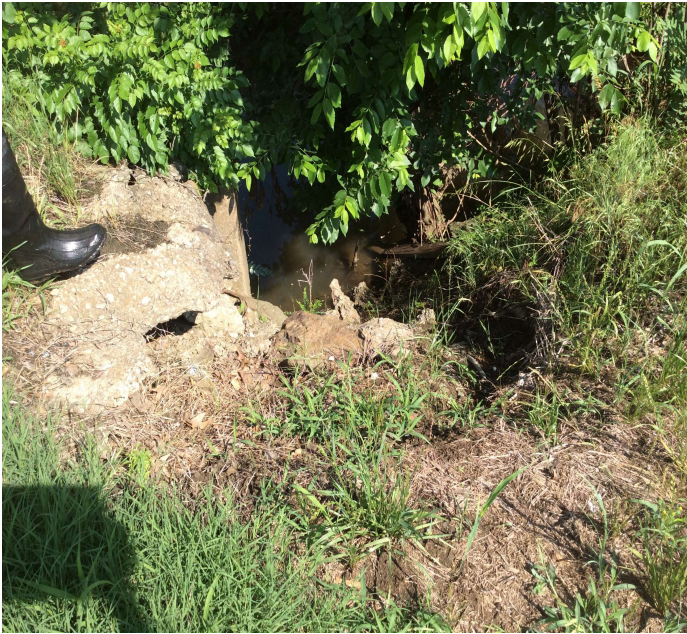
The approach roadway has minor erosion behind the Northeast wing wall.

PHOTO 1 Description Erosion behind the Northeast wing wall.

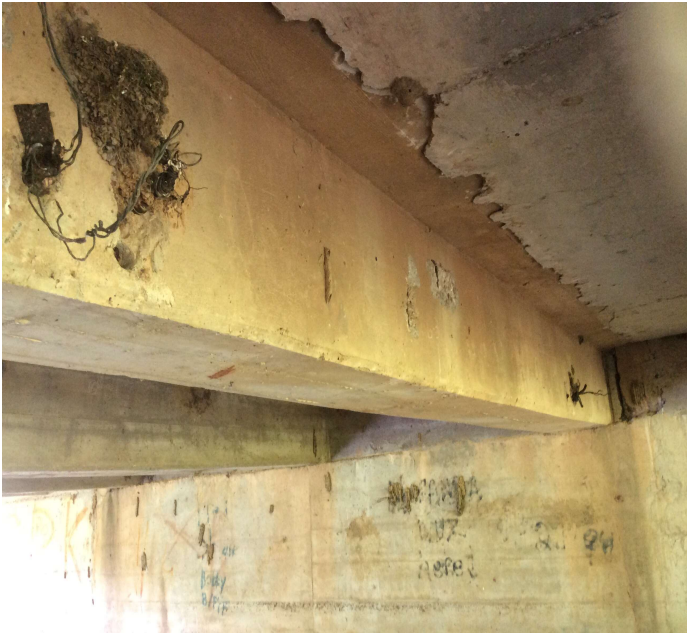
Girder # 3 & 5 has concrete spalls with exposed reinforcing steel.

PHOTO 1 Description Girder # 3 spalling with exposed reinforcing steel.
