Bridge Inspection Report

03909
SH 22-Logan Co.
over
Little Shoal Creek

Structure Number: 03909

Facility Carried: SH 22-Logan Co.

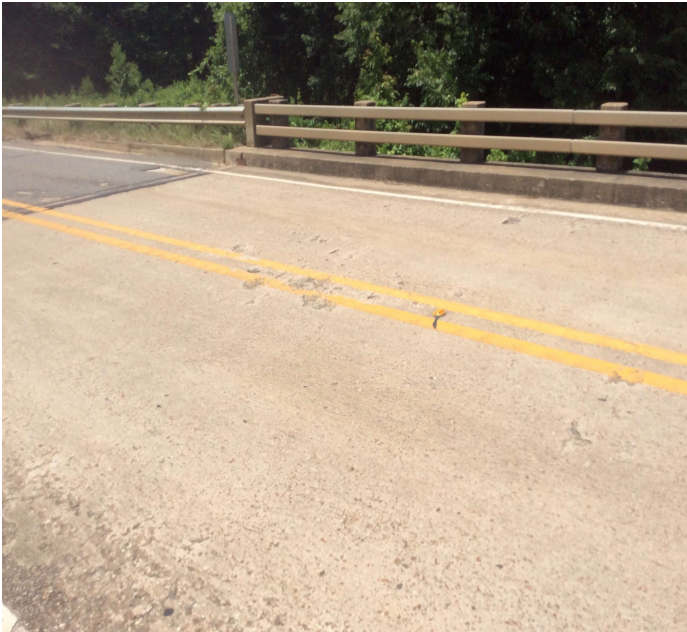
Driving surface of the deck has a few delaminated areas and shallow spalls with exposed reinforcing steel.

PHOTO 1 Description Span # 1 concrete deterioration.

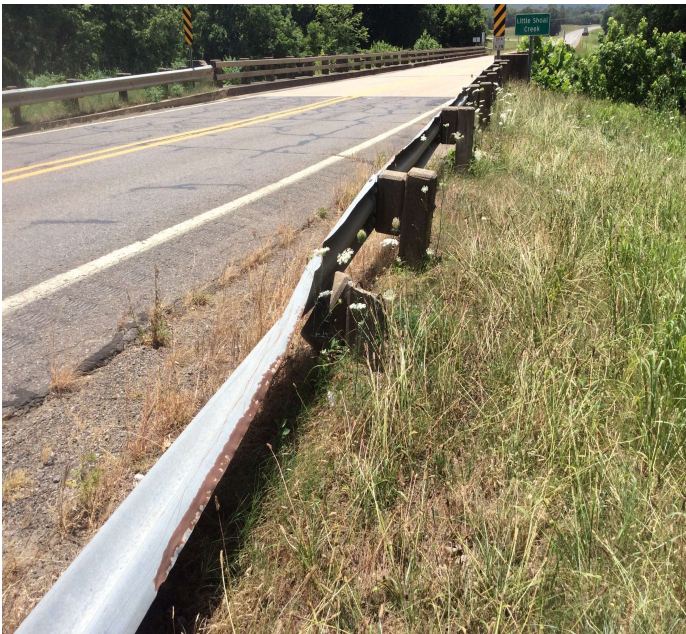
Approach guard rail posts are deteriorated with areas of collision damage.

PHOTO 1 Description Northeast bridge rail damage.

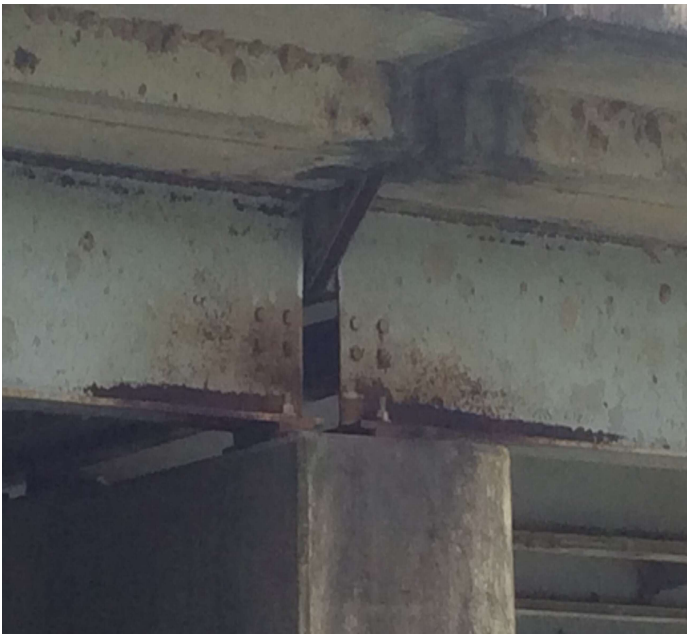
The ends of beams have active corrosion adjacent to the bearings.

PHOTO 1 Description Active corrosion at the beam ends. No visible cracks in the beams.

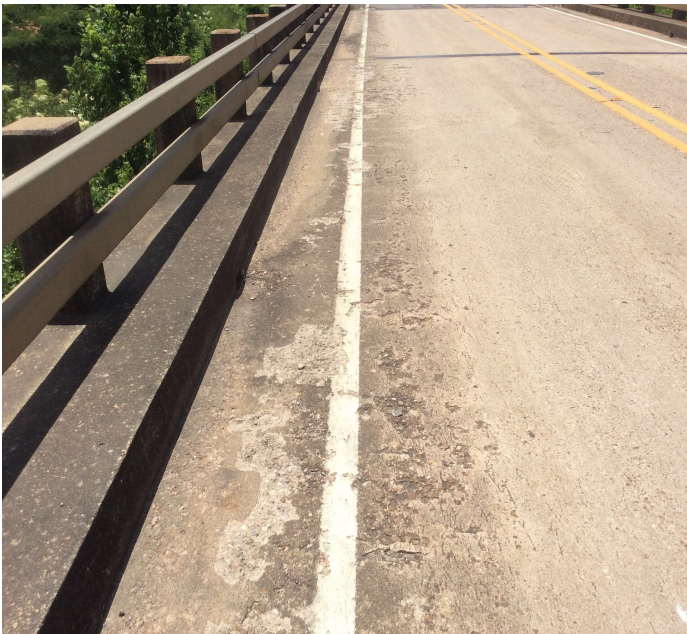
The gutters have areas with medium scale.

PHOTO 1 Description Concrete delamination in the gutters.

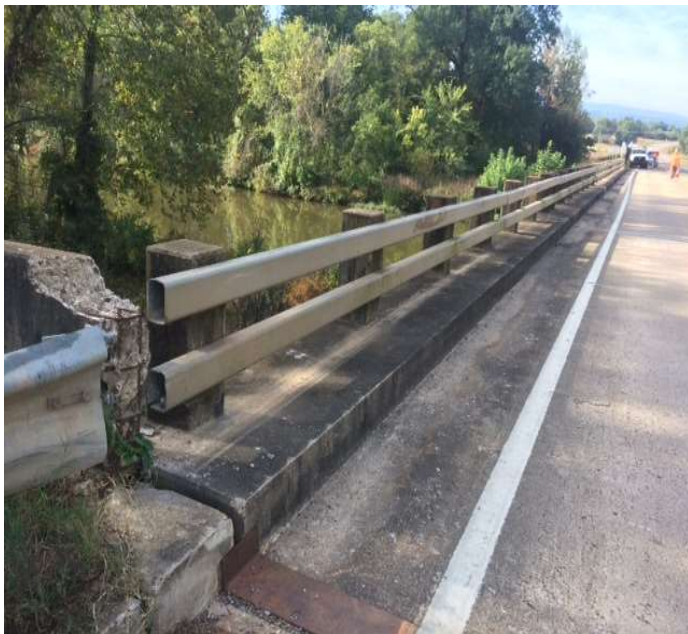
PHOTO 1 Description

Minor collision damage on the right side of Span # 3. The end post at Bent # 6 right has been impacted by traffic and is twisted with large spalls.

Repaired bridge railing only at this time 11/1/2017. Will schedule the end post at a later date. By Crew #04001

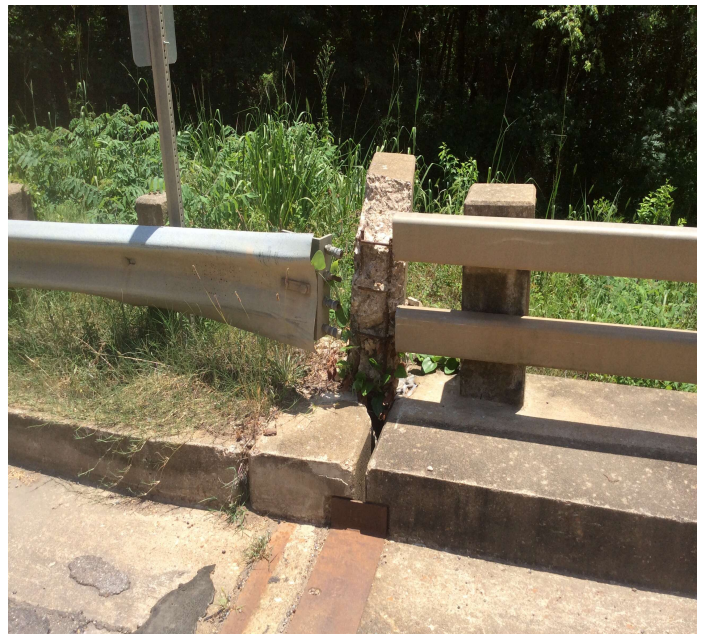
PHOTO 2 Description Southeast bridge rail damage.

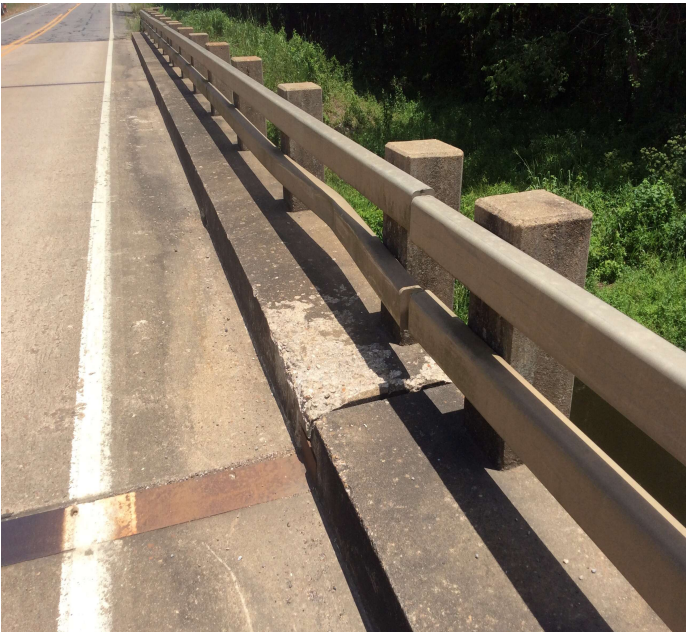
330 - Metal Bridge Railing	1- Ben.	454	ft.	447	7	0	0
-Collision damage on the Rt side of Span 4 over Bent 4 with a fractured post base on the undersurface of the deck. -The end post at Bent 6 Rt has been impacted by traffic and is twisted with large spalls.							
7000 - Damage		7		0	7	0	0

PHOTO 4 Description Span # 4 RT bridge rail damage.

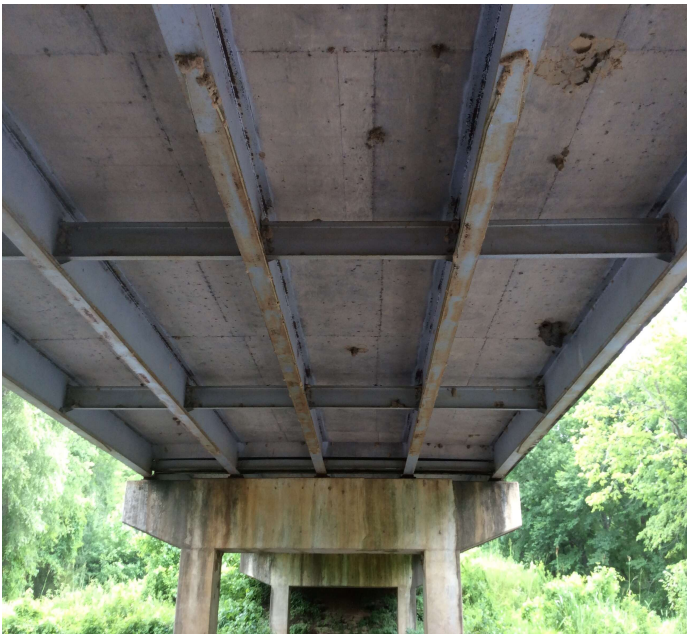
The paint system is failing with a light rust coating showing through the paint.

PHOTO 1 Description Typical undersurface of the deck.
