Bridge Inspection Report

A0460
SH 22-Logan Co.
over
Shoal Creek

Structure Number: A0460

Facility Carried: SH 22-Logan Co.

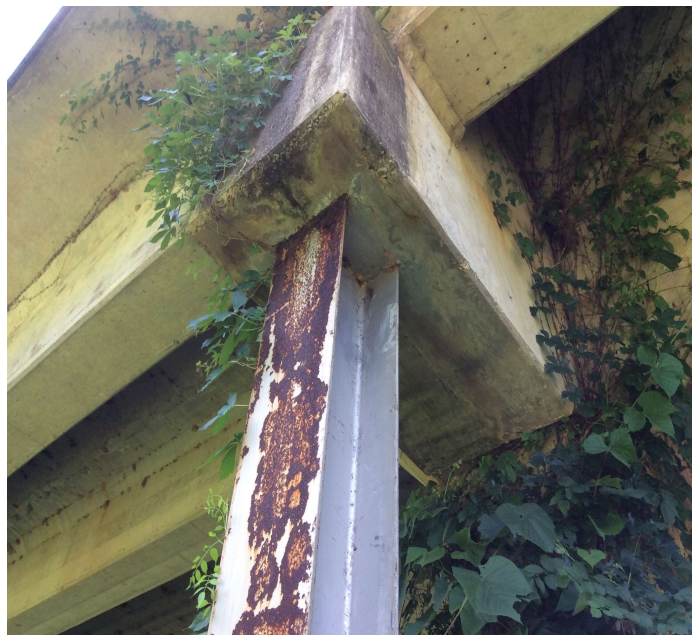
Substructure. Steel columns at the intermediate bents.

Steel columns have a failing paint system with active corrosion, flaking rust, and section loss at the cap juncture.

PHOTO 1 Description Left column of Bent # 4.

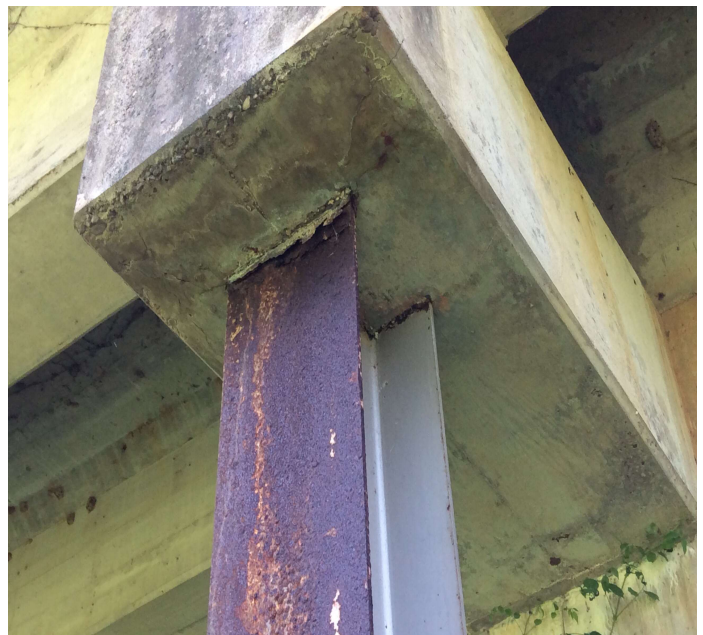
PHOTO 2 Description Left piling. Bent # 5.

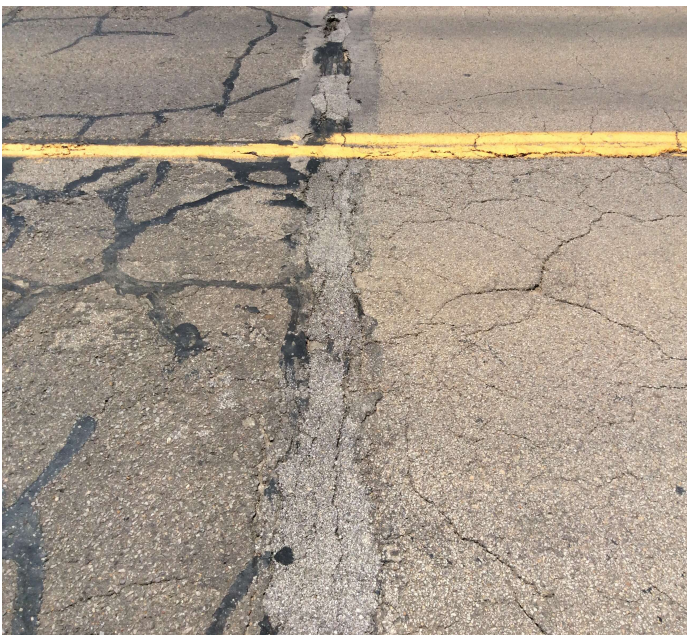
Deck.
Asphalt is breaking apart over the expansion joints.

PHOTO 1 Description Expansion joint over Bent # 11. East abutment.

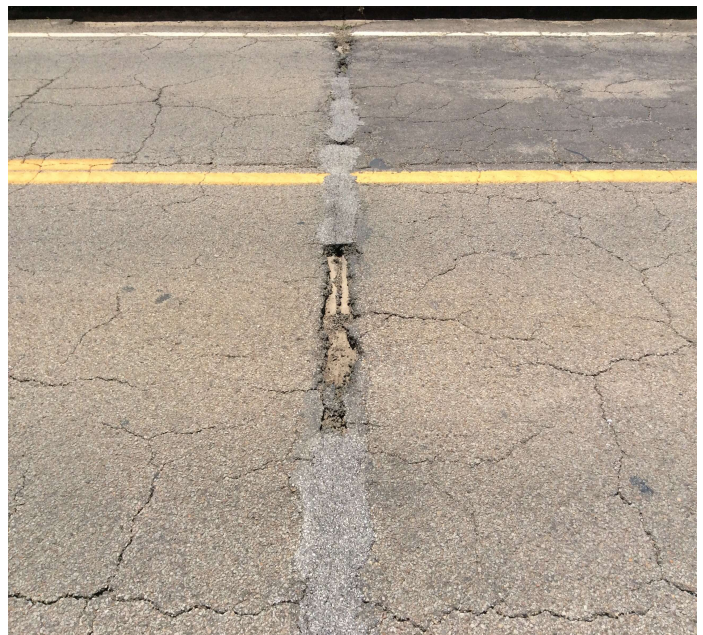
PHOTO 2 Description Expansion joint over Bent # 3.

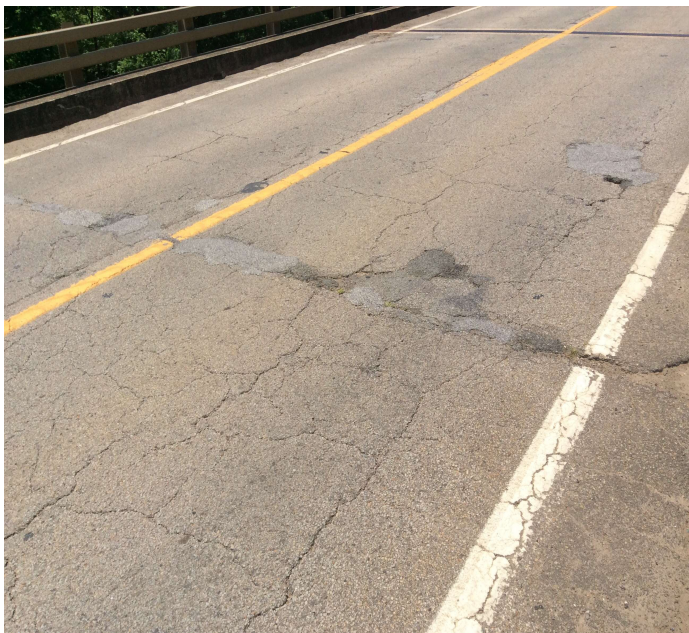
PHOTO 3 Description Expansion joint over Bent # 7.

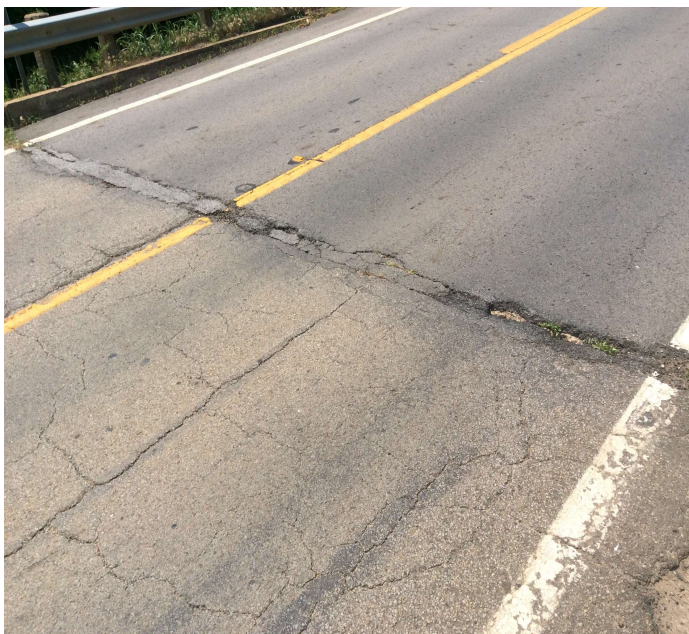
PHOTO 4 Description Expansion joint over Bent # 1.

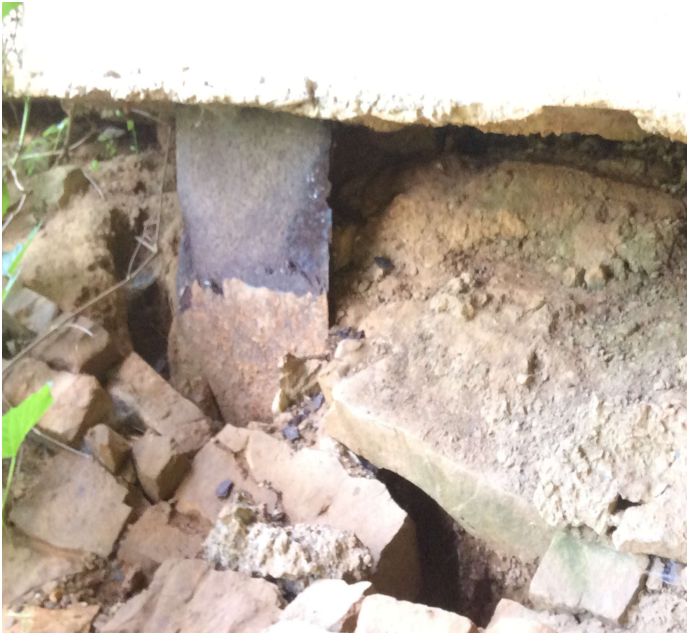
There is Earth settlement under abutments that expose the steel piling. Steel piling has active corrosion and flaking rust. There is knife edge section loss with reduction in flange width.

PHOTO 1 Description Bent # 11. Left piling . Knife edge section loss.

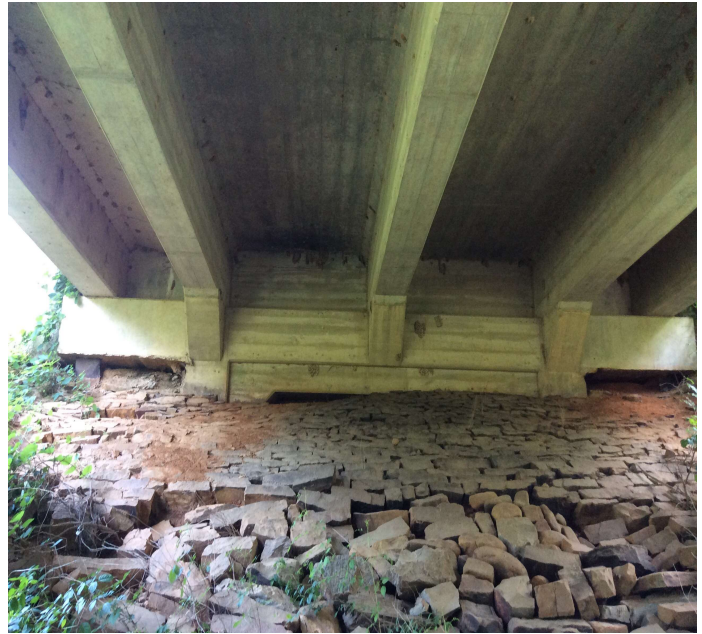
PHOTO 2 Description Bent # 11. Typical.

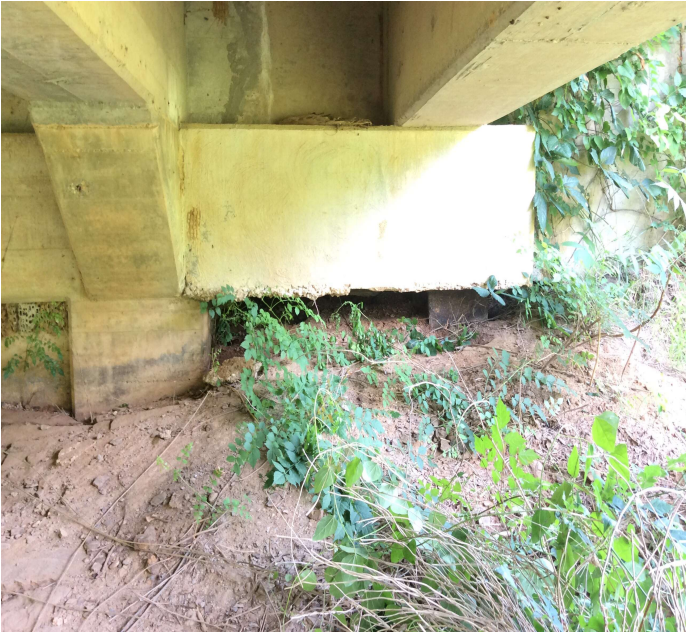
PHOTO 3 Description Bent # 1. Left side. Exposed Piling.

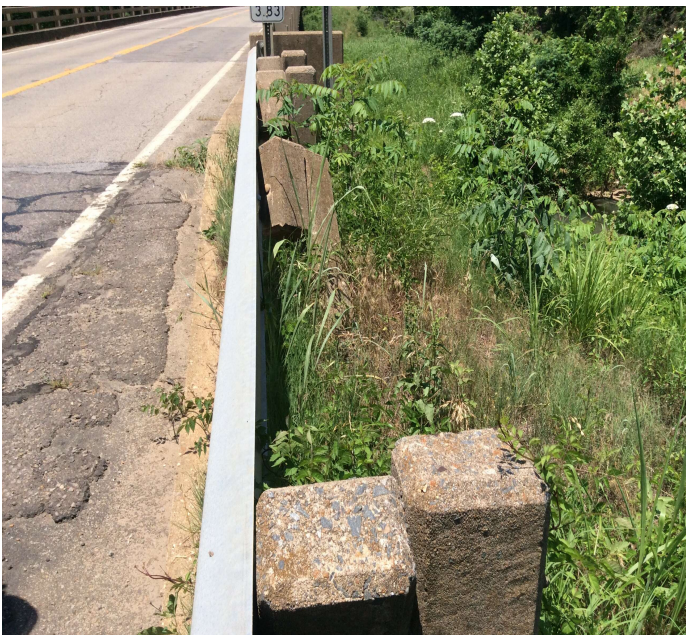
The Northeast Approach Guard Rail.
The Northeast Approach guard rail has fractured posts.

PHOTO 1 Description Northeast approach guardrail.

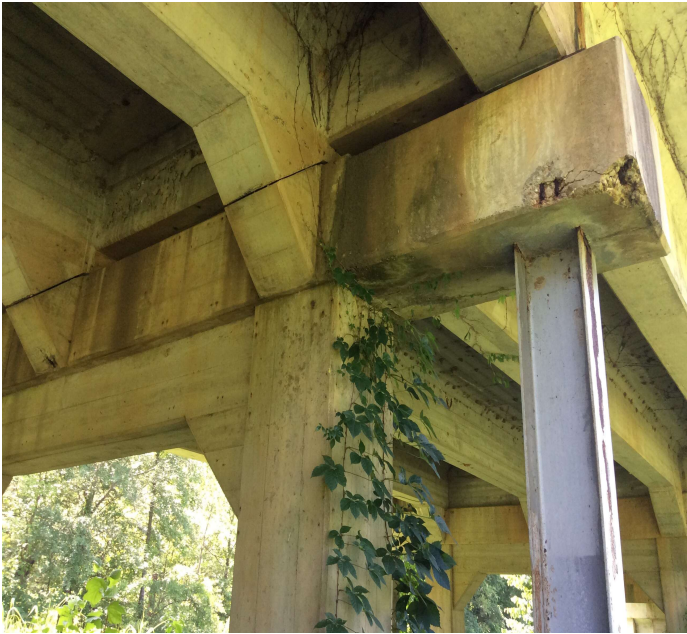
PHOTO 1 Description

The caps and cap haunches have cracking, spalling and delaminations. A few of the spalls expose reinforcing steel that has active corrosion and initial section loss.

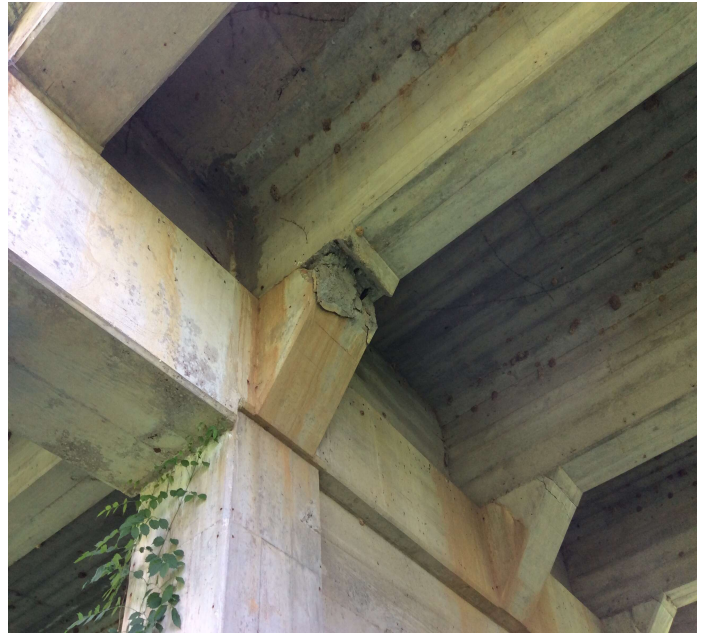
PHOTO 2 Description Repair delaminated under Girder # 2.
Bent # 5.

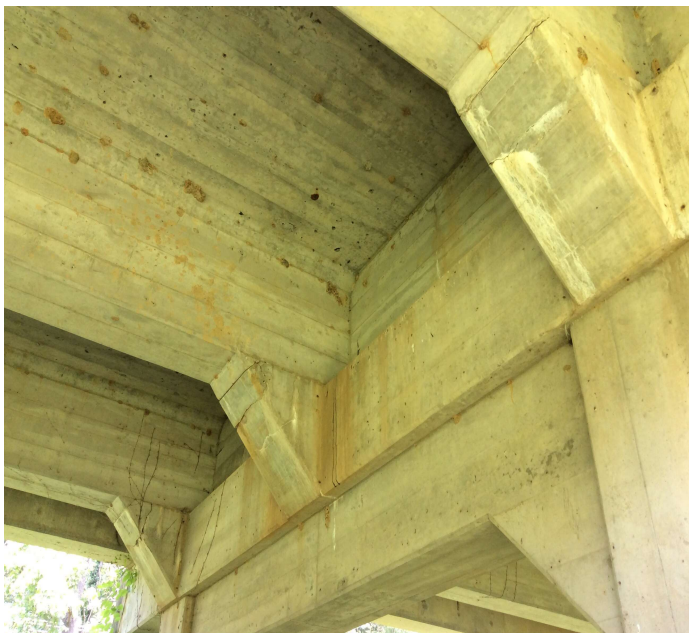
PHOTO 3 Description Span # 6 side of Bent # 7 cap.

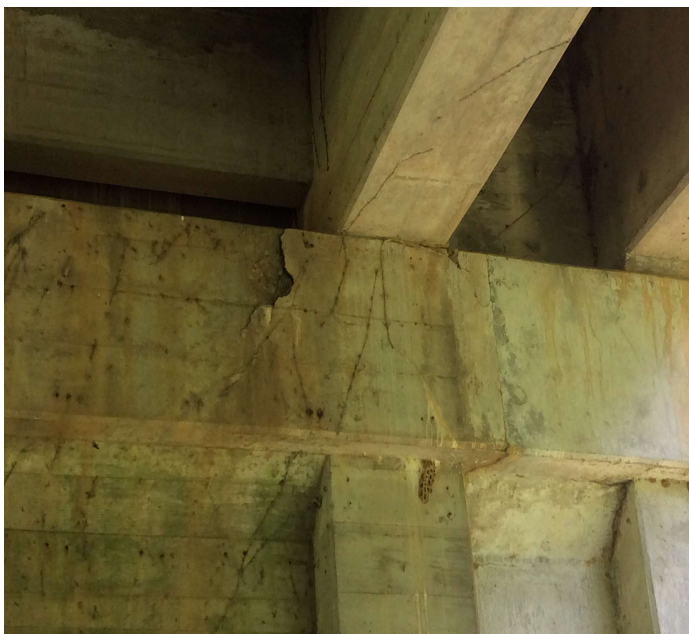
PHOTO 4 Description Delaminated area in Span # 8 side of Bent # 9 cap under Girder # 4.
