Bridge Inspection Report

A0488
SH 22-Logan Co.
over
East Fork Hagwood Creek

Structure Number: A0488

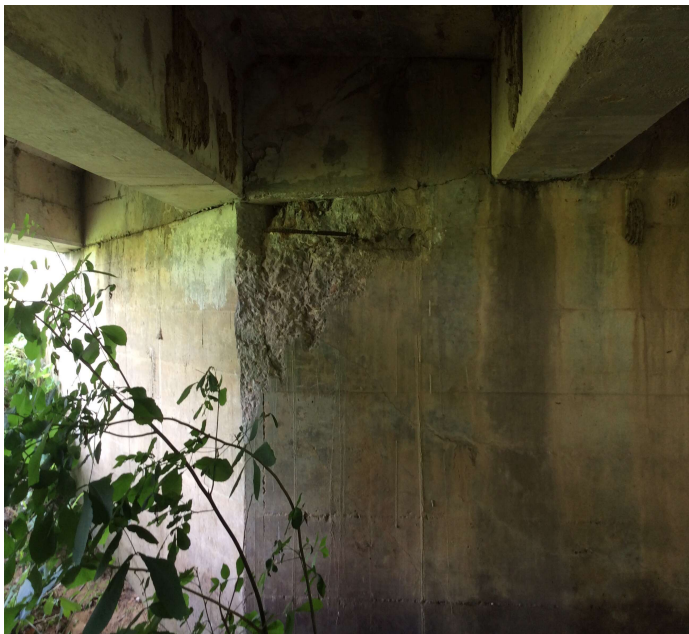
The Left side of Bent # 2 has a 2' X 2' spall with exposed reinforcing steel adjacent to Girder # 2. The Right side of Bent # 2 has a 2' X 2' delaminated area adjacent to Girder # 6.

PHOTO 1 Description Bent # 2 Lt spalling with exposed reinforcing steel.

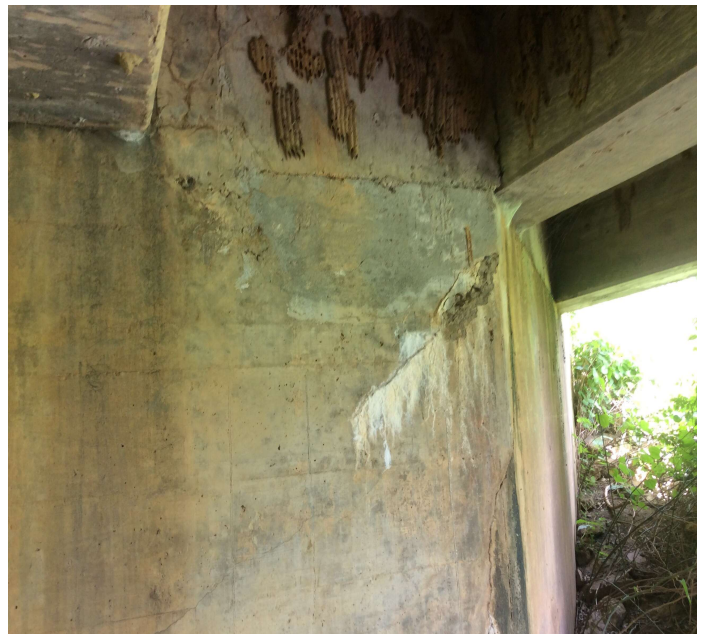
PHOTO 2 Description Bent # 2 RT delaminated area.

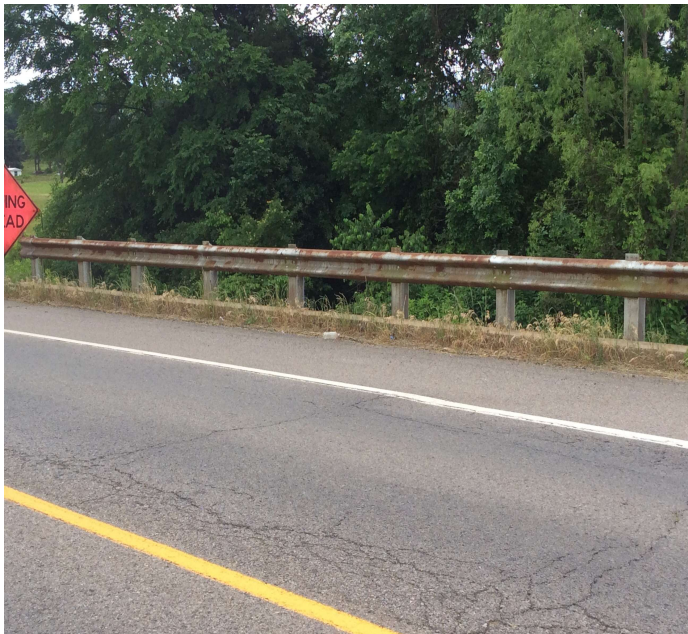
330 - Metal Bridge Railing	1- Ben.	60	ft.	0	60	0	0
	-The paint system is failing with rust showing through the paint.						
1000 - Corrosion		60			60		
515 - Steel Protective Coating		373	sq. ft.	0	373	0	0

The paint system is failing with rust showing through the paint.

PHOTO 1 Description The paint system is failing with rust showing through the paint.

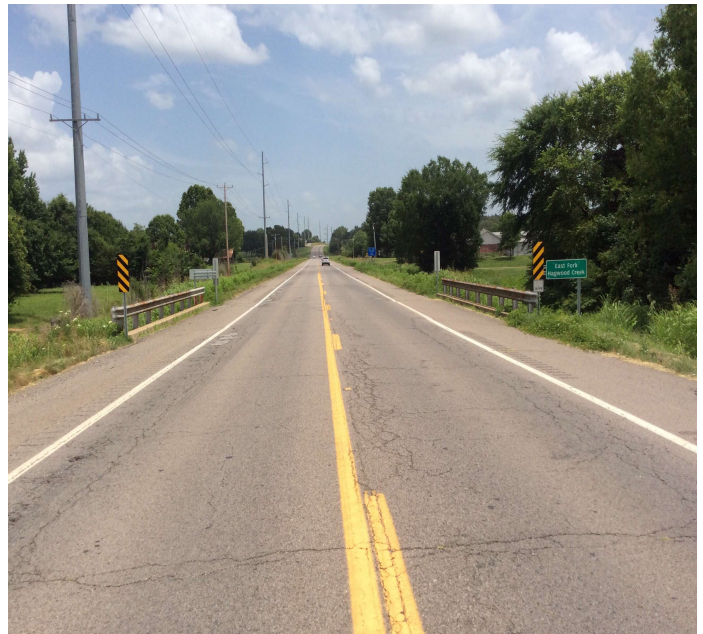
PHOTO 2 Description Bridge rails have a failing paint system.
