# Bridge Inspection Report

**02649**

**State Highway 28  
over  
Negro Creek-Scott Co.**

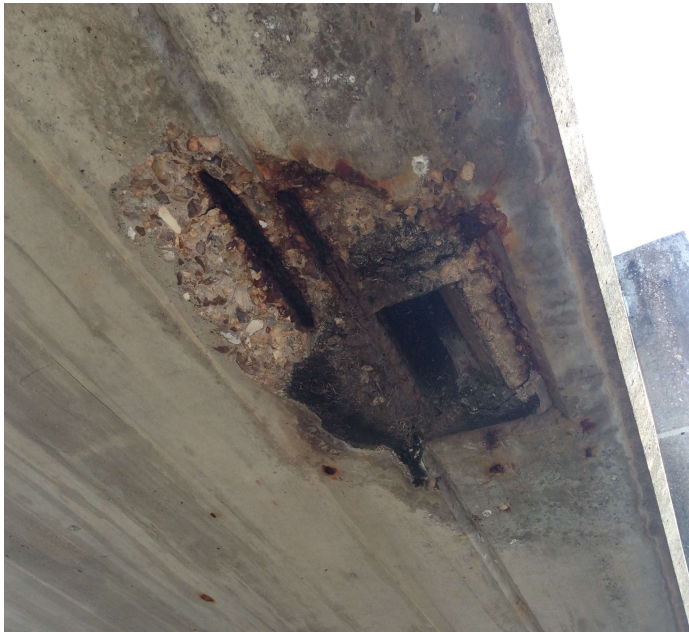
Spalling with exposed reinforcing steel on the undersurface of the slab adjacent to the deck drains.

PHOTO 1      Description      Spalling with exposed reinforcing steel adjacent to deck drain on Right side of span #3.

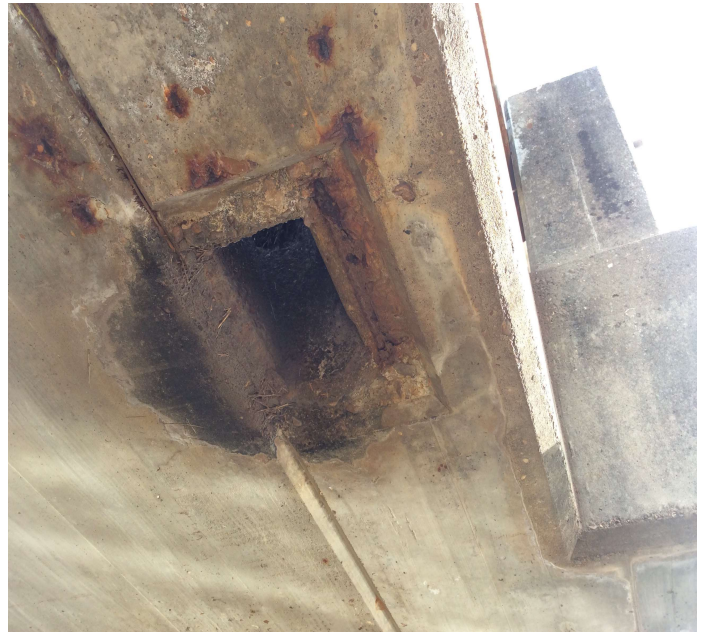
PHOTO 2      Description      Spalling with exposed reinforcing steel adjacent to deck drain.

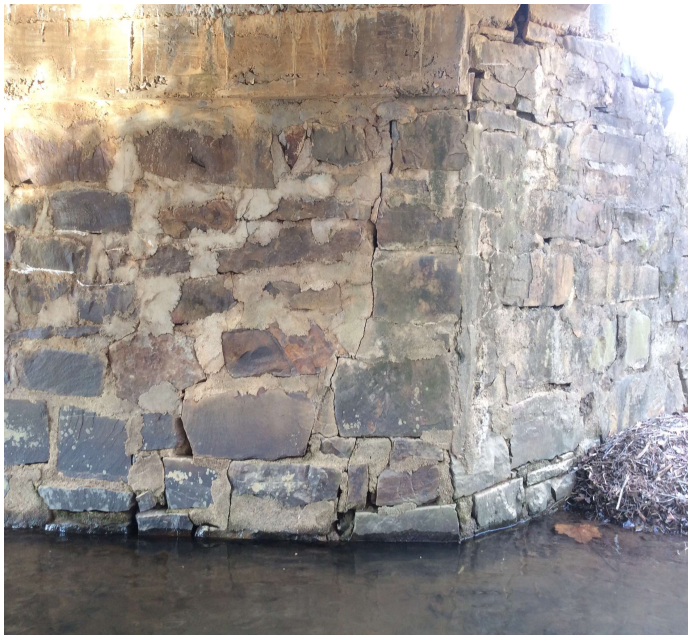
Cracking adjacent to the wing walls.

PHOTO 1      Description      Vertical crack in the Right side of the West abutment breast wall.

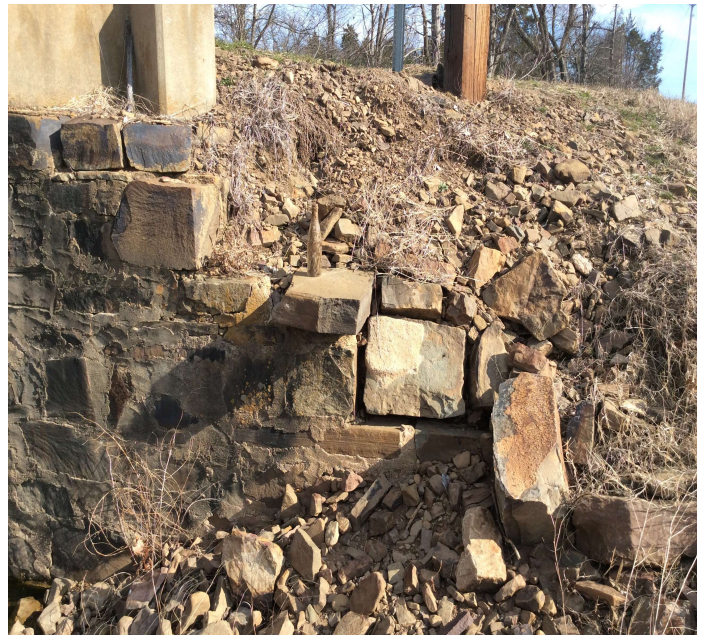
The Southeast stone masonry wing wall has apparent collision damage that has displaced stones from the top of the wing wall.

PHOTO 2      Description      Southeast wing has Displaced stones.

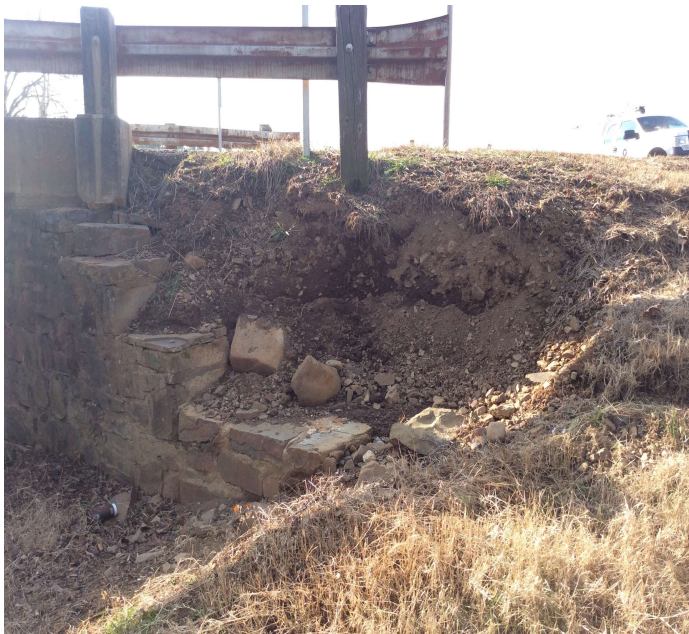
The North slope at the West Bridge end has an area of erosion that has caused loss of embankment material and is nearing the approach roadway.

PHOTO 1      Description      Erosion to the North slope at the West bridge end.
