Bridge Inspection Report

02652

SH 28 - Scott Co.

Dripping Springs Creek

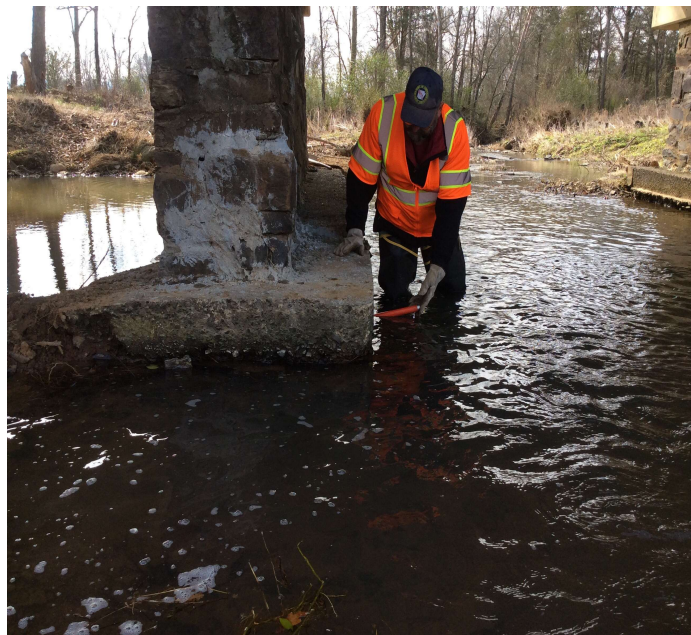
The intermediate bents have scour/undermining along the edges of footings. Bent # 4 is the most extreme case with an area of undermining at the inlet end that is approximately 3' long measured along the length of the footing that penetrates the full width of the pier wall.

PHOTO 1 Description Undermining to inlet end of Bent #4, photo #1.

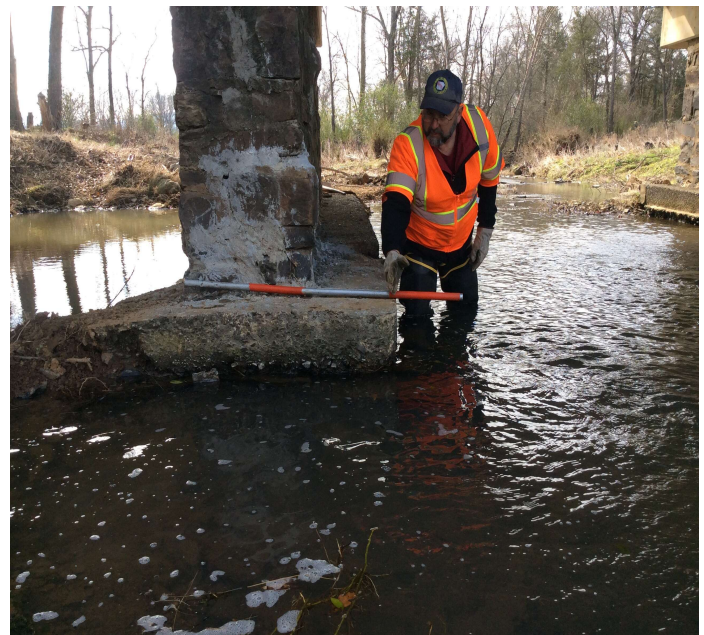
PHOTO 2 Description Undermining to inlet end of Bent #4, photo #2.

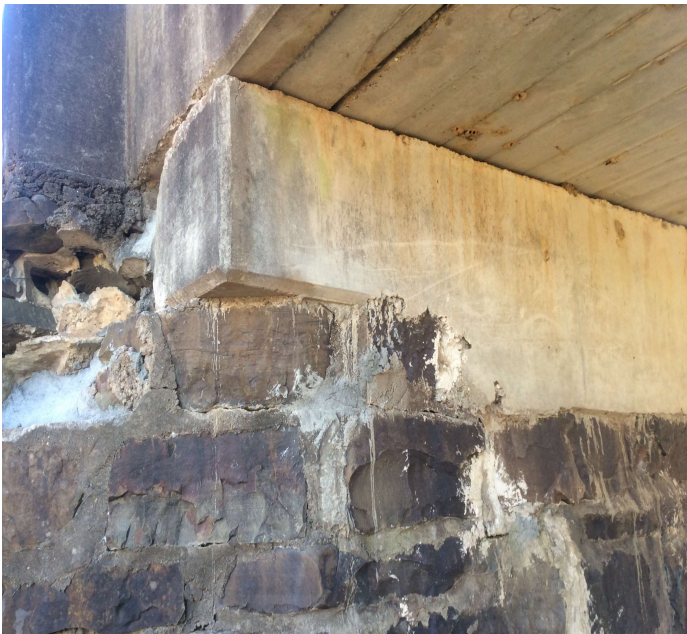
Rock displacement on the top of the wing walls at Bent # 5.

PHOTO 1 Description Rock missing behind the cap at Bent # 5 left side.

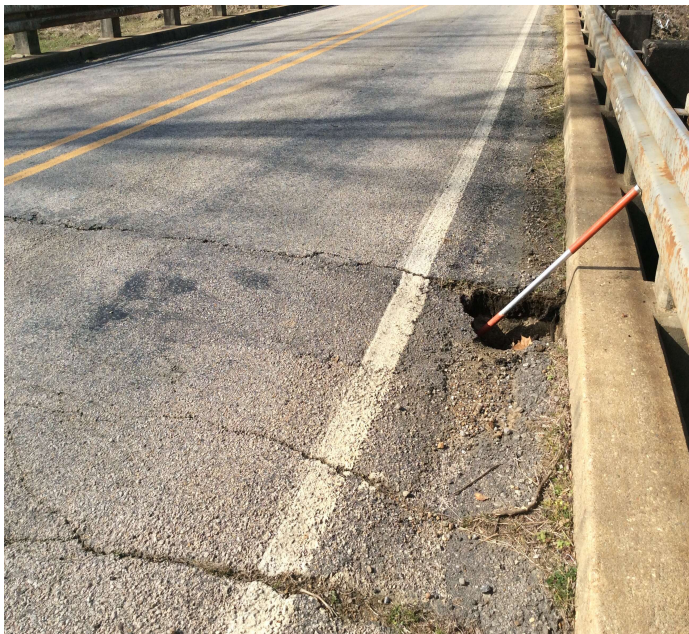
The approach roadways have settlement at the bridge ends. The East approach roadway has a hole that is approximately 14 inches in diameter and approximately 10 inches deep located in the left shoulder adjacent to the abutment.

PHOTO 1 Description Settlement at East approach.

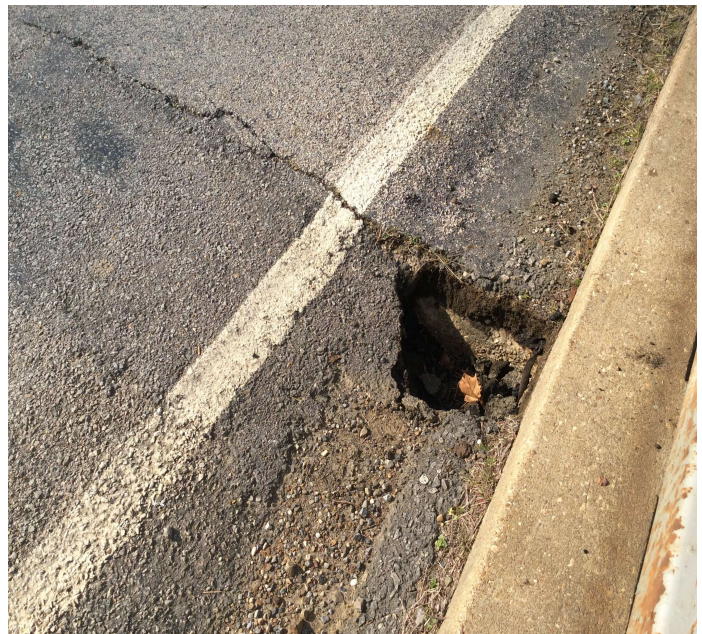
PHOTO 2 Description Settlement in the East approach roadway with a hole in the Left shoulder at the bridge end.
