Bridge Inspection Report

02656

**State Highway 28
over
Dailey Creek-Scott Co.**

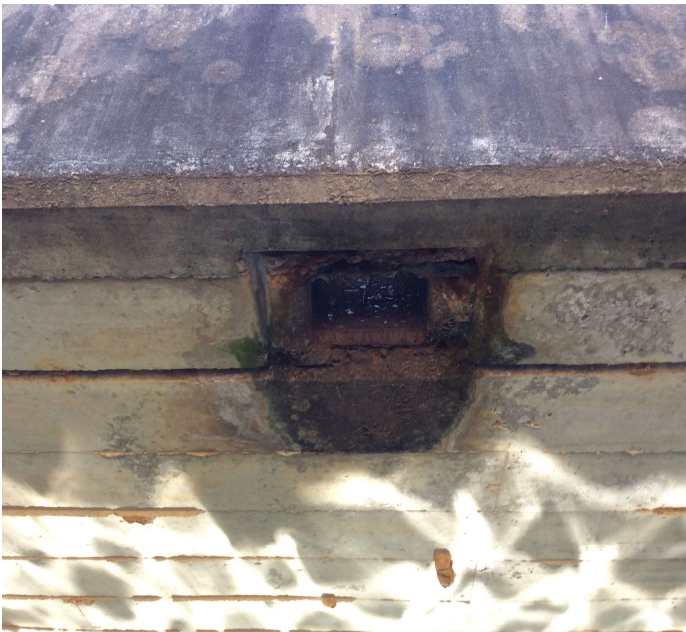
There is spalling around the deck drains that exposes the reinforcing steel with initial section loss.

PHOTO 1 Description Spalling with exposed reinforcing steel around both deck drains in Span 2. Exposed reinforcing steel has active corrosion and layers of rust.

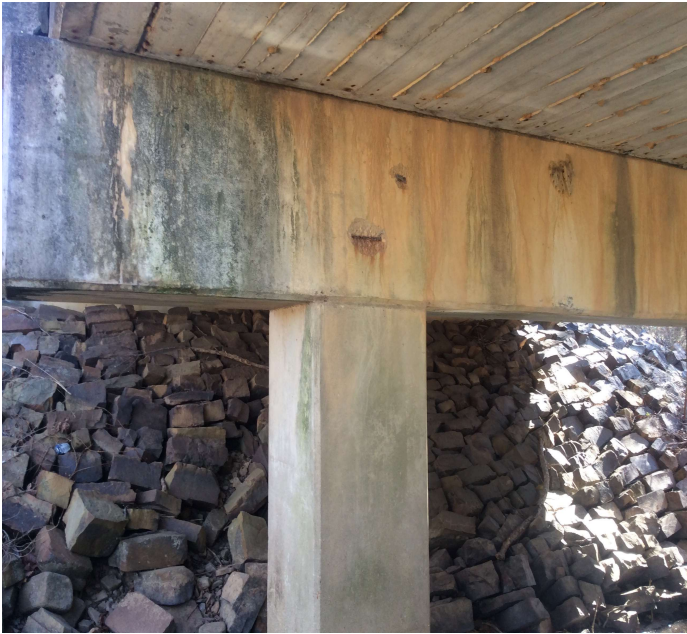
PHOTO 1 Description

Bent 3 cap (span 2 side) has spalling with exposed reinforcing steel.
